**The Performance of Defected Spent LWR Fuel Rods in  
Inert Gas and Dry Air Storage Atmospheres**

**January 1985**

NUREG/CR-4074  
EGG-2364  
Distribution Category: RJ

**THE PERFORMANCE OF DEFECTED SPENT LWR FUEL  
RODS IN INERT GAS AND DRY AIR STORAGE  
ATMOSPHERES**

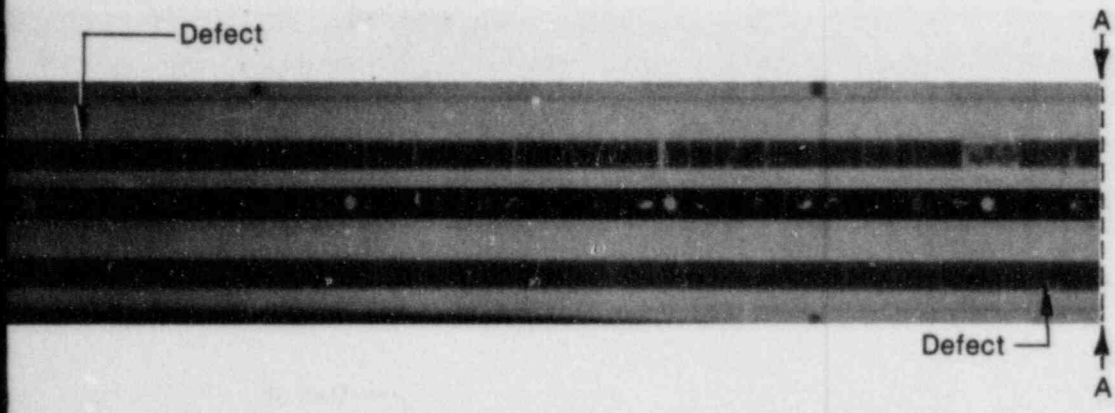
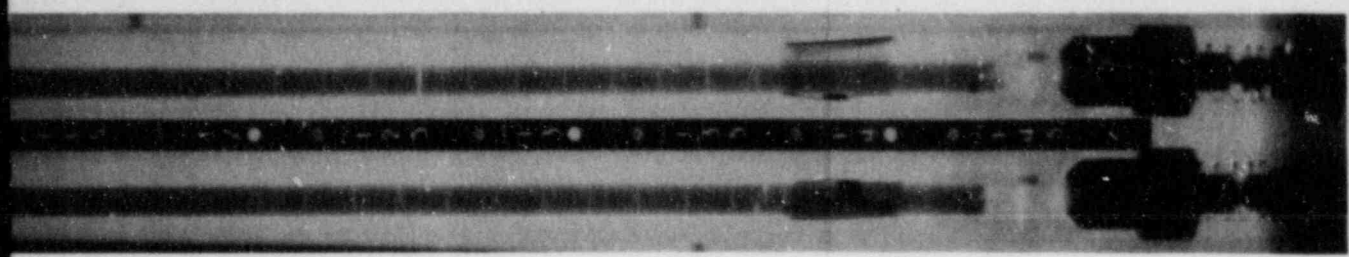
Figure 11. Neutron radiographs

The neutron radiographs for the defected PWR fuel rods are shown in Figures 11 and 12. The radiographs for the sections from the BO5-E7 fuel rod (Figures 11 and 12) and the center section from BO5-G7 (Figure 11) indicate that the fuel is not oxidized. The fuel shows distinct pellet/pellet interfaces with a small amount of pellet cracking in BO5-E7 top section. Some fuel appears oxidized at the defect in the BO5-G7 top section.
