**POWER
SYSTEMS**
COMBUSTION ENGINEERING, INC

DESTRUCTIVE EXAMINATION
OF TUBE L29R84 FROM THE
B STEAM GENERATOR AT
FORT CALHOUN

JUNE 1984

SUMMARY

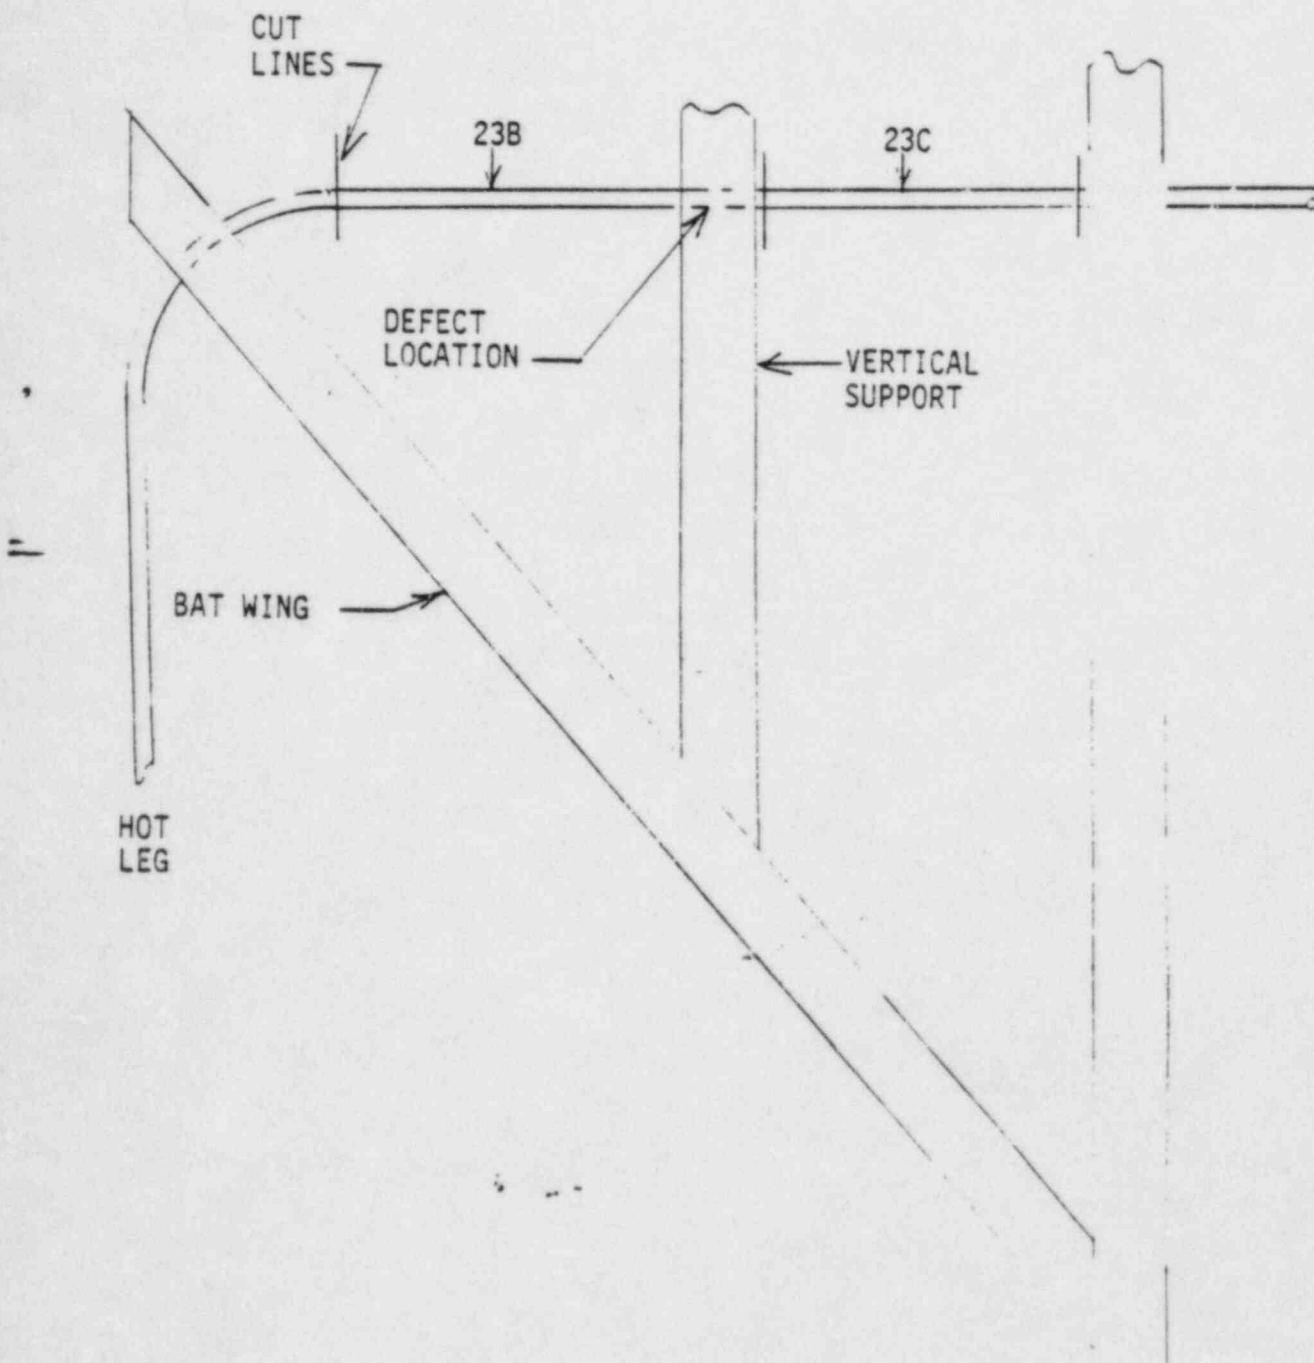
C-E received two sections, identified as 23B and 23C, from the horizontal run of tube L29R84. Tube section 23B was the length of tube extending from near the hot leg 90° bend to the inboard side of the first vertical tube support, and contained the throughwall defect. Tube section 23C was the section of the same tube extending from inboard of the first vertical support to outboard of the middle vertical support. Figure 1 illustrates the relative position of the tube sections in the steam generator.

Figure 1. Location of Tube Sections 23B and 23C of Tube L29R84 in the B Steam Generator.

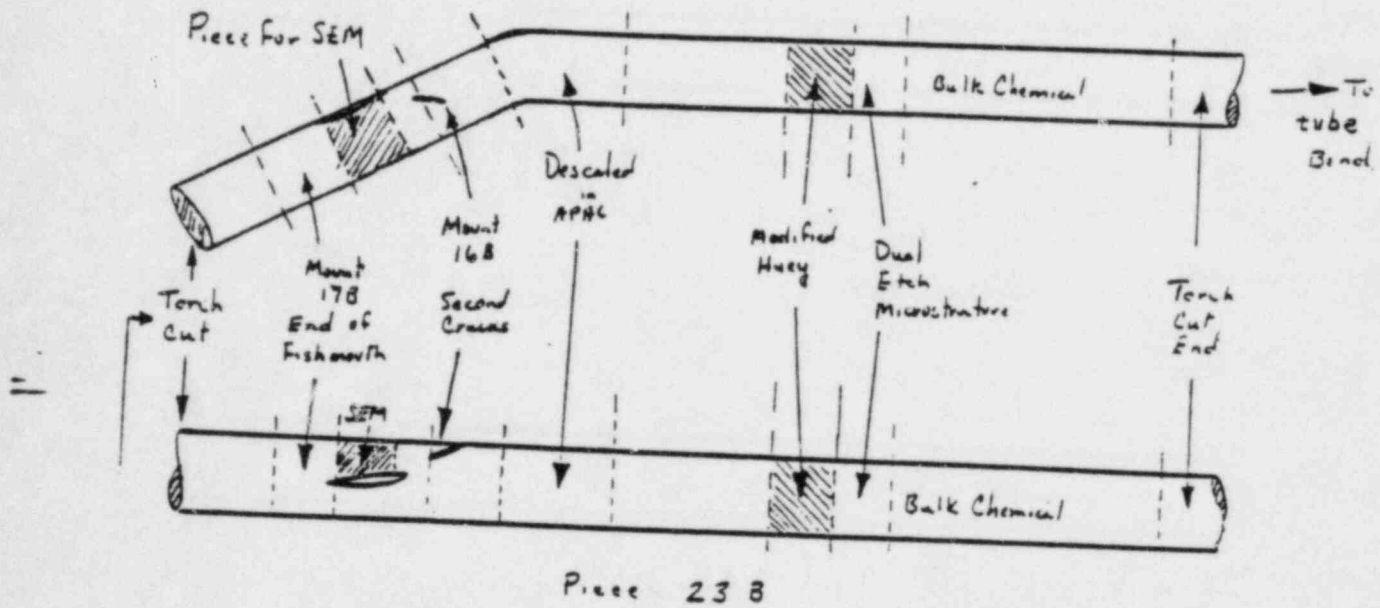
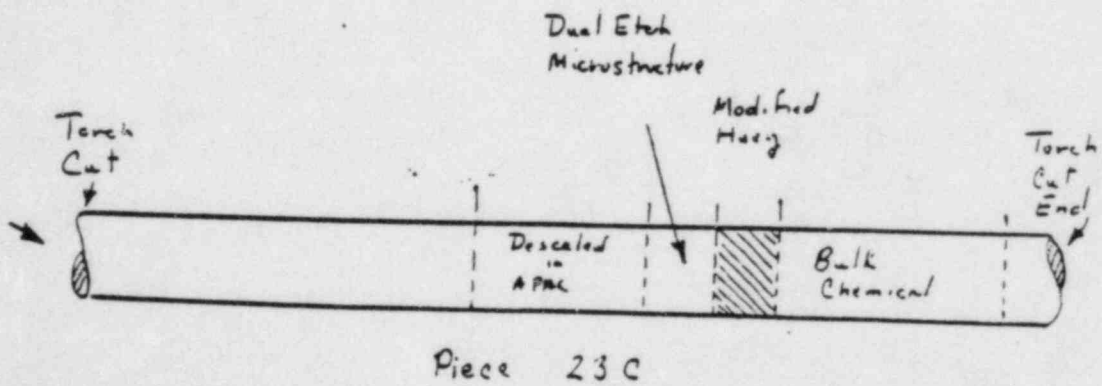
C-E sectioned tube sections 23B and 23C in accordance with Figure 5 to provide samples for both materials characterization and defect characterization. The objective of the materials characterization testing was to determine if tube L29R84 was typical of mill annealed Alloy 600 tubing.

Figure 5 shows how sections 23B and 23C were further sectioned to provide samples of the defects for characterization.

Figure 5. Sectioning Diagram Showing the Location of Samples Removed for Various Analyses.
