QUESTIONS ON WATERFORD 3 BASEMAT
3/26 MEETING IN BETHESDA

Allegations recently reported in a GAMBIT newspaper article and in staff investigations concerning the GAMBIT article have lead to the assignment of additional reviewers to evaluate the base mat adequacy. This transmittal is a composite set of Questions from the reviewers, and is intended to faciliate LP&L's preparation for the meeting on March 26, 1984 in Bethesda.

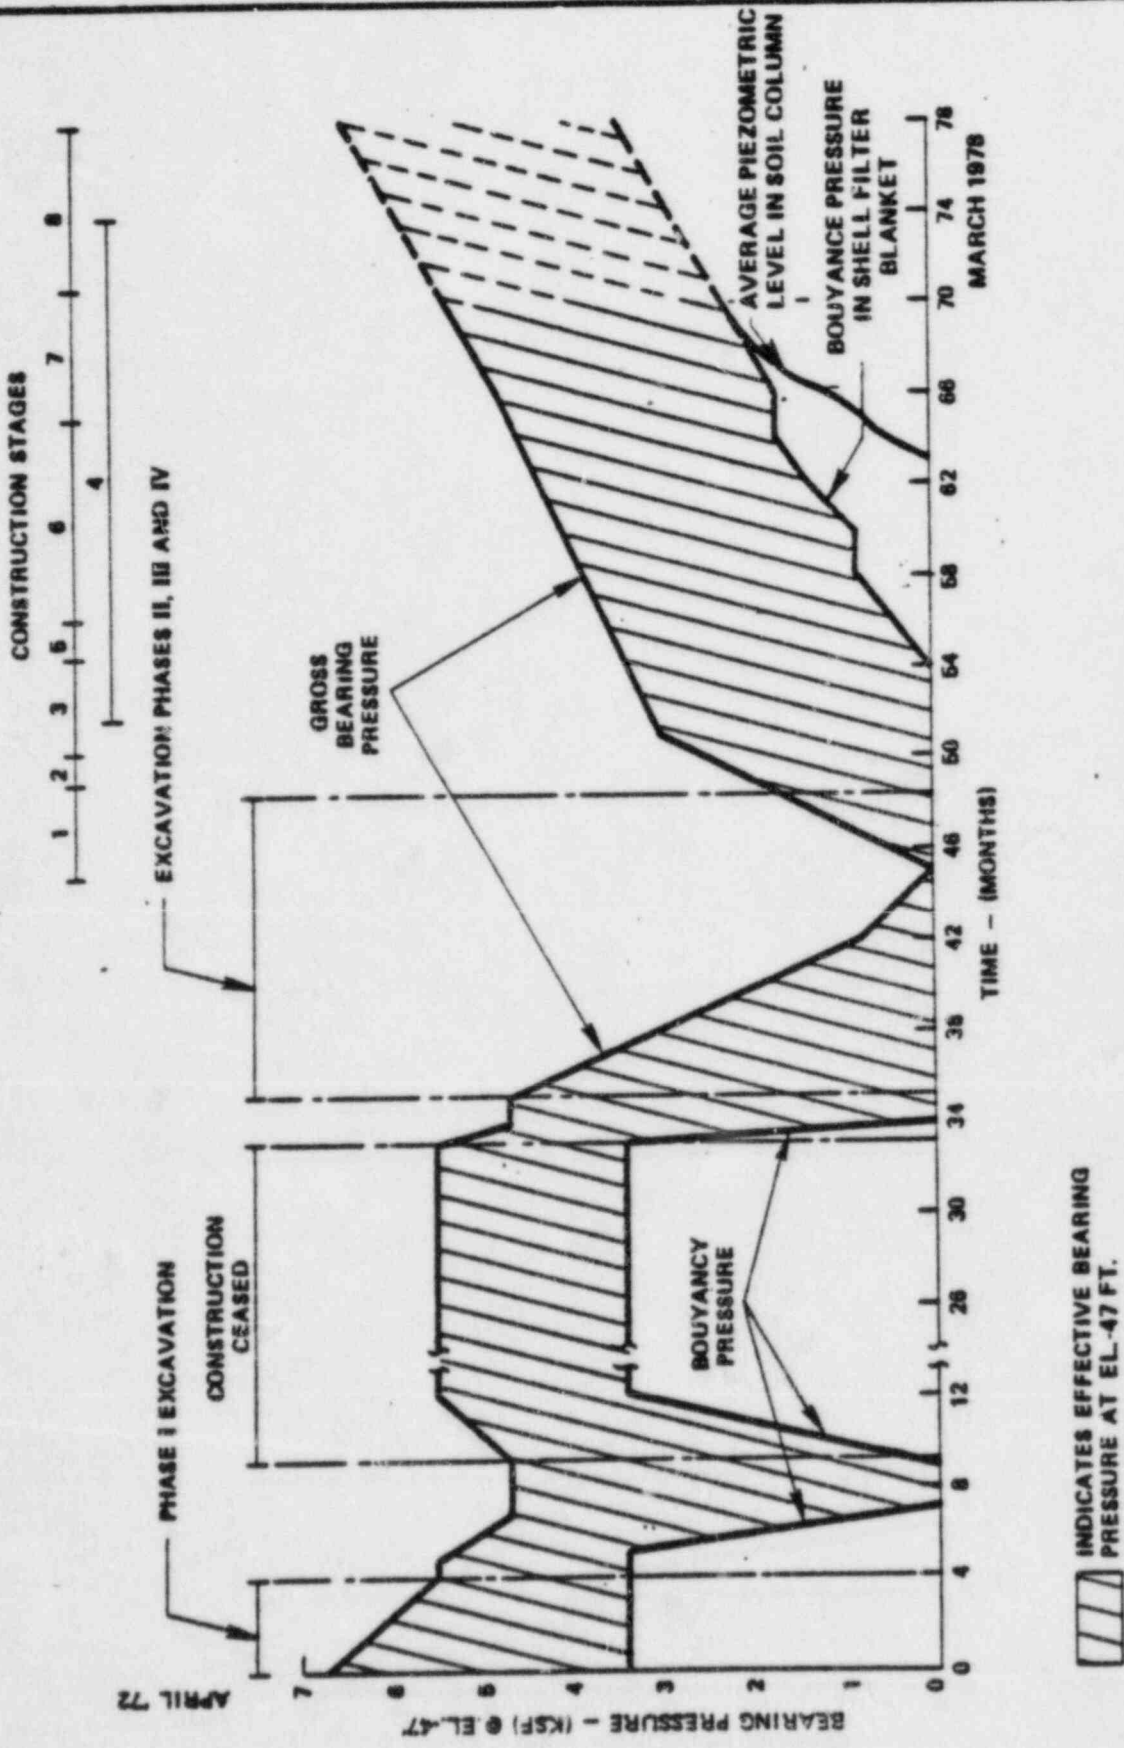
BEARING PRESSURE HISTORY AT -47 FT. @ SL

A computer program was developed and maintained weekly to monitor the placements made. Accumulative soil stresses were identified and maximum/minimum total stresses were noted. These figures and the differential stresses were reviewed. Differential stress did not exceed the maximum allowable of 1.0 KSF. *define*

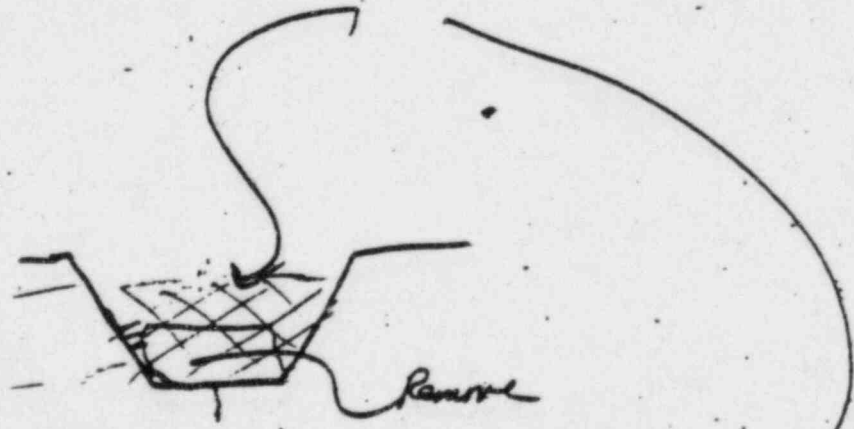
Hi-Mod w/ ^{Sika} quarts Aggre filler

1. Coat w/ neat coat - Hi-Mod
2. Fill w/

Accepted
E. J. Gallagher

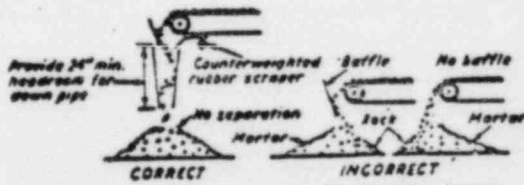
CONTROL OF SEPARATION AT END OF CHUTES

Applies to sloping discharges from mixers, truck mixers and to longer chutes but not when concrete is discharged into another chute or onto a conveyor belt.

CORRECT
The above arrangement prevents separation of concrete whether it is being discharged into hoppers, buckets, cars, trucks or forms.

INCORRECT
A baffle or shallow hopper merely changes the direction of separation. Discharge from end of belt without a hopper results in separation.

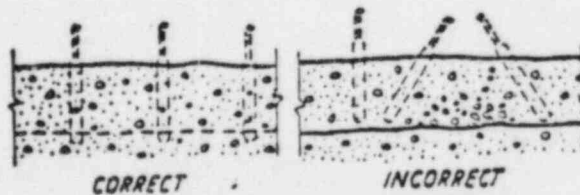
CONTROL OF SEPARATION OF CONCRETE AT END OF CONVEYOR BELTS

CORRECT
Vertical penetration of vibrator a few inches into previous lift (which should not yet be rigid) at systematic regular intervals will give adequate consolidation.

INCORRECT
Haphazard random penetration of the vibrator at all angles and spacings without sufficient depth will not assure intimate combination of the two layers.
