EA-142 PROTOTYPE TEST

Supplement to
NUCLEAR PACKAGING, INC.
ENVIRALLOY
HIGH INTEGRITY CONTAINERS

February 1985

Enviralloy 190 Cubic Foot Prototype Drop Test

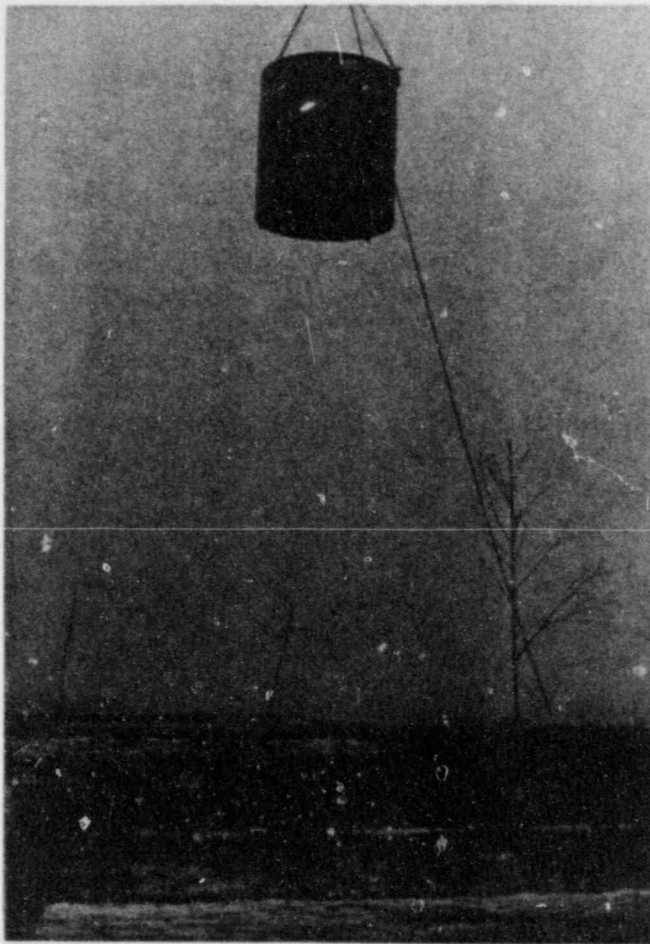
Figure 17 25 Foot Top Down Drop

The container did not sustain any significant damage from any of the drops. The only damage that was sustained by the container was a slightly dented lift lug on the top due to the four foot drop on the top straight down, and some damage on the corners due to the four foot drop. The lifting lug was not bent or deformed sufficiently to prevent its use. The container was slightly bowed due to the corner drop on the four foot drop. Also the ends, top and bottom were plastically deflected from the corner drop. None of these deformations were in the excess of 1/2 inch. The container did not sustain any loss of contents as a result of any of these drops. The container was not damaged either on the outside or on any of the inside supports, such that it would prevent its use. The container was cleaned up after the drop and all welds were magnetic particle tested to detect any damage to the welds. No damage was detected.
