SUBJECT: REVIEW OF PRELIMINARY ACCIDENT SEQUENCE PRECURSOR ANALYSIS OF
LICENSEE EVENT REPORT NO. 95-005-00 AT ARKANSAS NUCLEAR ONE, UNIT 1

LER No. 313/95-005

Event Description: Trip with one EFW train unavailable

TITLE (4)
Reactor Trip Initiated by Main Turbine Generator Protective Circuitry as a Result of a Logic Circuit Ground Caused by Vibration Induced Insulation Wear

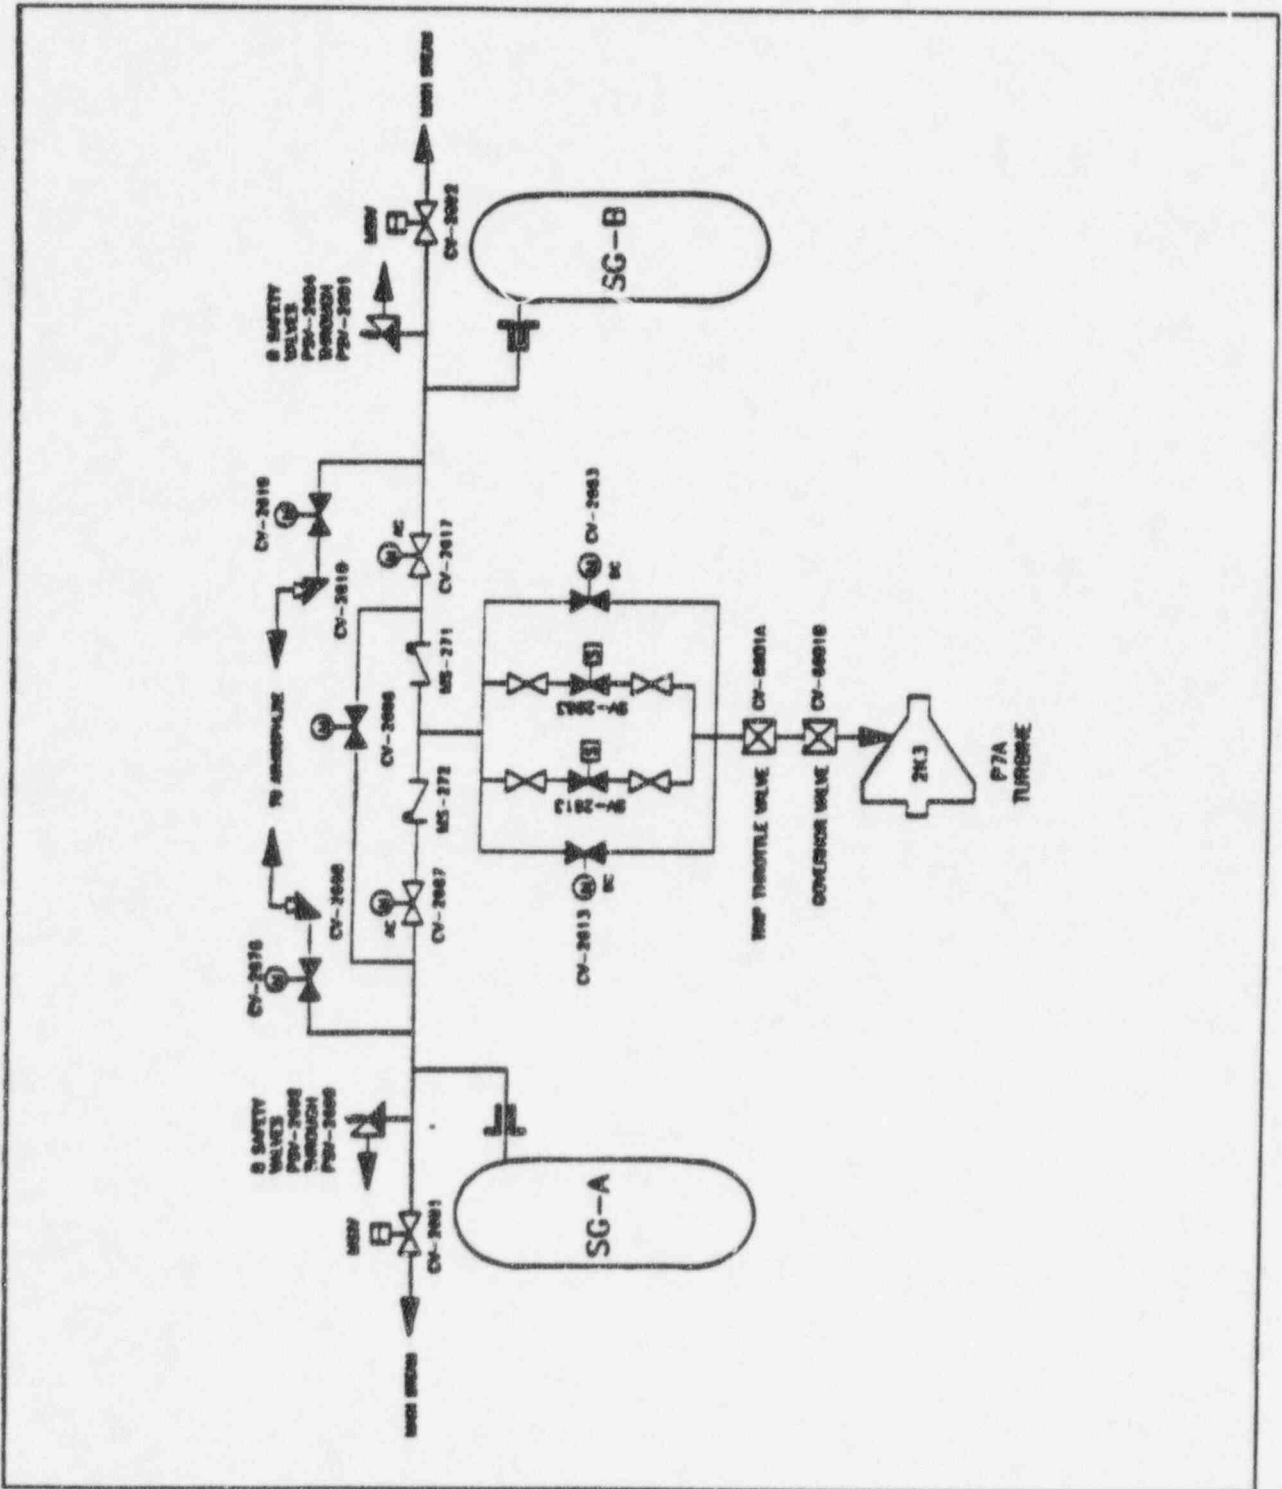
Figure 1 ANO 1 Emergency Feedwater System.

Control of EFW flow control valves CV-2646 and CV-2648 was lost when a +5 vdc power supply in EFIC train "A" failed. This was apparently due to a random failure of a voltage regulator within the power supply. No information was provided which specifically indicated an increased potential for common-cause failure of the TDEFW train valves, so no increase in common-cause failure probability was modeled.

To implement the assumed failure of the MDEFWP flow control valves, the valves associated with the MDEFW_R (Basic Event EFW-MOV-CF-DISM) were set to TRUE (i.e., the valves were failed). This caused the motor driven train of the EFW to be failed in the model. The turbine driven train was still available and not subject to the common cause failure which rendered the MDEFW valves inoperable. The 4-valve common-cause failure event (EFW-MOV-DF-DISAL) was therefore "removed" from the model by setting it as FALSE (i.e., $p = 0.0$) because the cause of the failure of the MDEFWP valves would not affect the TDEFWP valves.
