SUBJECT: WATERFORD 3 SES  
ADDITIONAL INFORMATION ON BASEMAT  
HAIRLINE CRACKS

The purpose of this report is to review the results of nondestructive testing (NDT) of Nuclear Plant Island Structure (NPIS) basemat hairline cracks to evaluate their significance with respect to the structural integrity of the NPIS.

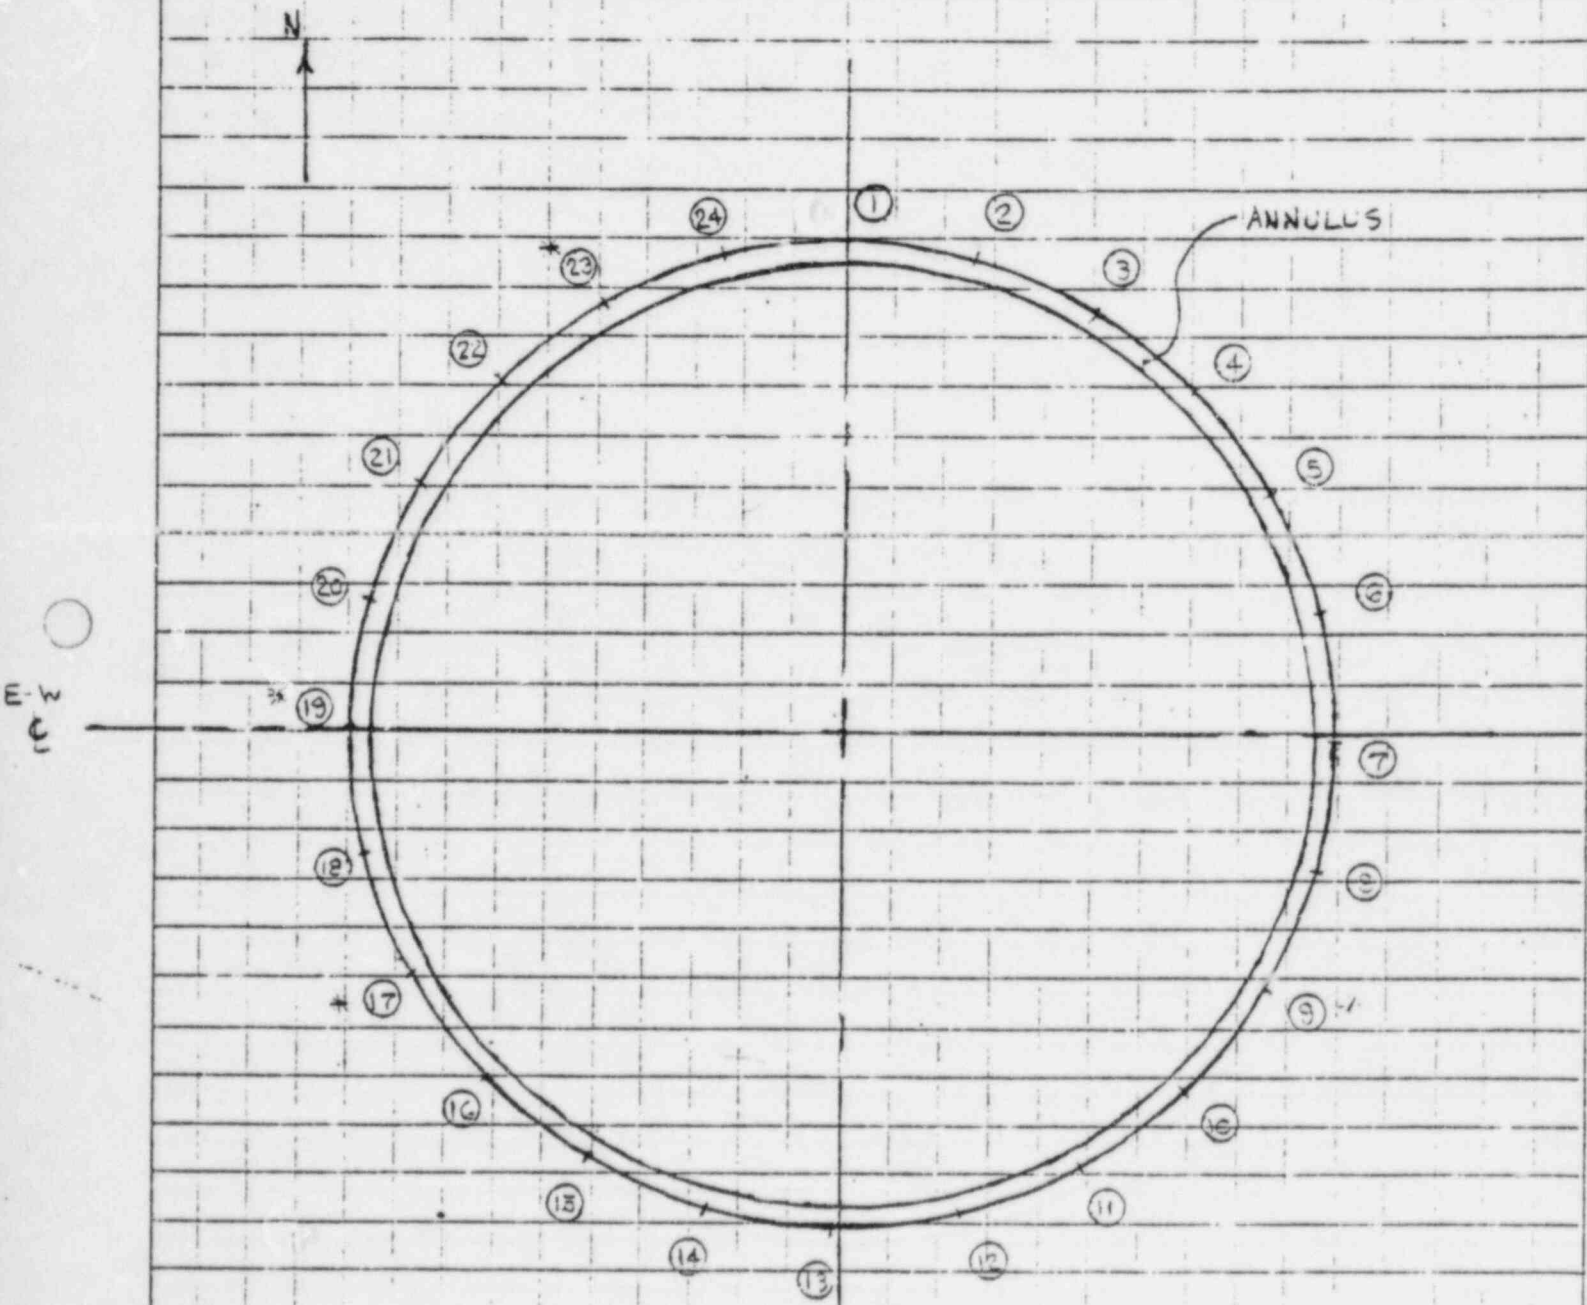
LOCATION OF TEST POINTS

Our answer, at the time of inquiry was, "that by transducer test locations and manipulation, we felt that the transmitted sonic energy never entered the fill concrete because of a nonbond condition at that interface". However, this assumption was based upon indirect test data and it was suggested, that a more direct test program be conducted. As a result, a series of tests using 0° and 45° transducers, see drawing number 1, were conducted from the top of fill concrete, around the annulus, down to the mat-fill concrete interface. See drawings numbered 2 for test locations.

Test data indicates that a nonbond condition exists at 20 of our 24 test locations. This substantiates our original assumption; that sonic energy could not be penetrating the fill concrete, and that internal reflectors are located in the mat concrete.

\* INDICATES TEST POINTS  
 AT WHICH SOME BONDING  
 EXISTS

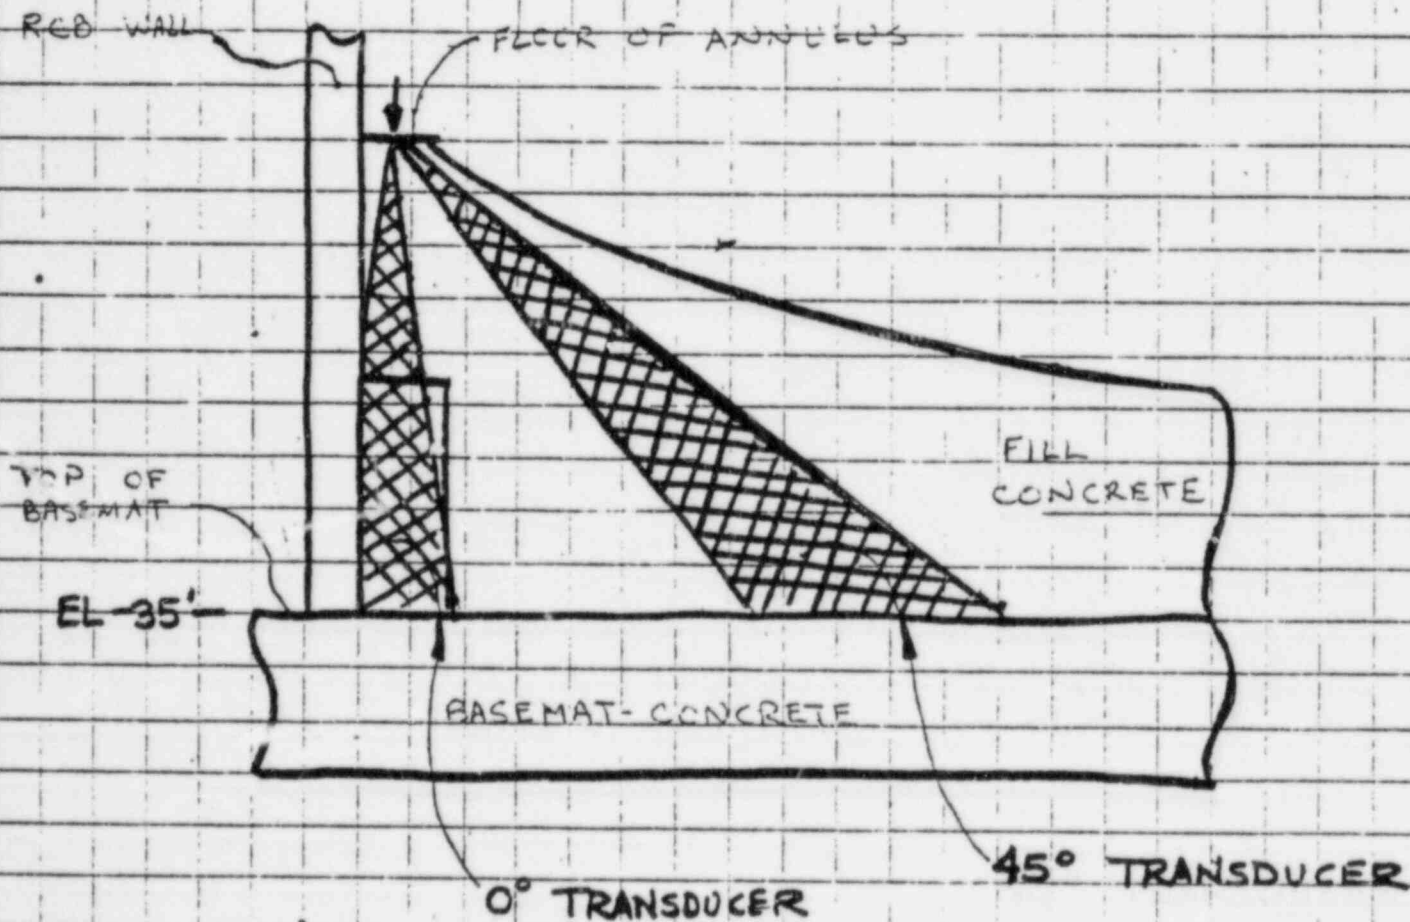
TRANSDUCER COVERAGE WITH  
 $0^\circ$  &  $45^\circ$  TRANSDUCER

It would be our opinion, based upon this test program and prior test data, that sufficient nonbonding exists at the mat-fill concrete interface to preclude sonic energy from entering and reflecting from the fill concrete interior. Furthermore, the intermittent character of the slight bond, that does exist, would not be capable of producing the positive and high amplitude reflectors upon which our original crack location data is based.
