UNIVERSITY OF VIRGINIA
DEPARTMENT OF NUCLEAR ENGINEERING AND ENGINEERING PHYSICS
NUCLEAR REACTOR FACILITY
SCHOOL OF ENGINEERING AND APPLIED SCIENCE
CHARLOTTESVILLE, VA 22901

Subject: Licensee Event Report

Description of Incident - Levels and Causes

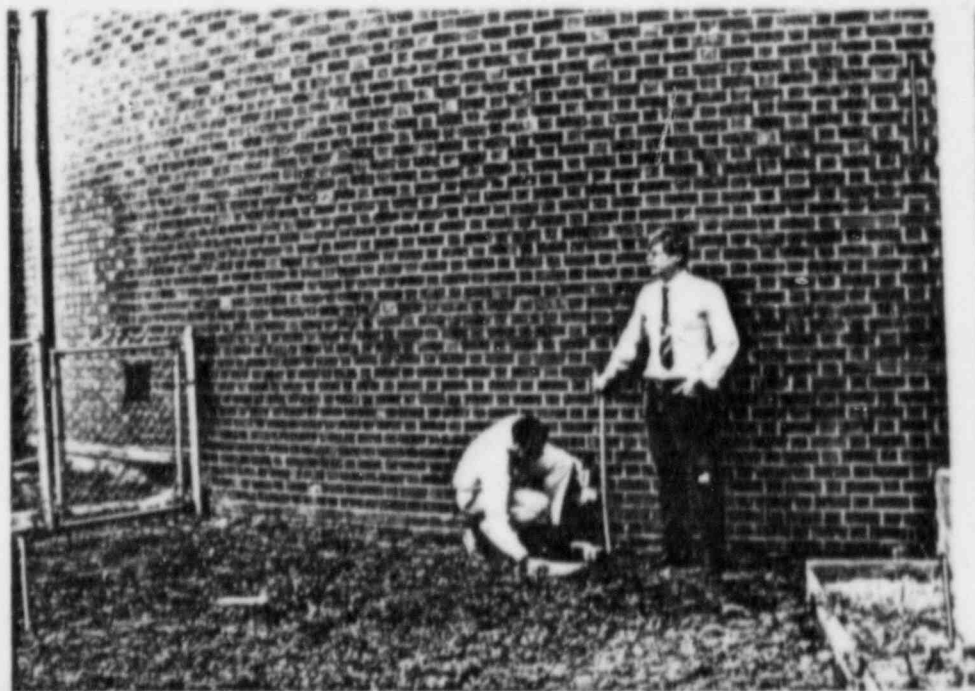
RADIATION AREA DIAGRAM

On October 2, 1984, during a routine unannounced inspection conducted by NRC Region II Inspector Mr. Roy Weddington, of the University of Virginia Reactor Facility in the areas of health physics, effluent control and radiation safety, a high radiation "hot spot" was discovered at ground level along the outside wall of the UVAR reactor room, between the escape hatch and the gate to the roof leading to the cooling tower (Please refer to the attached enclosures). The maximum radiation level at ground level was measured at just below 40 mR/hr. The established radiation field was such that 5 mR/hr levels were reached at distances of about 30" in a circular radius about the hot spot and out to about 40" away from the wall.

The "hot spot" was produced by an experiment which had been placed in one of a series of 4" I.D. steel pipes, sunk into the reactor room floor next to the reactor room's outer wall at the time of construction of the Facility. The intended purpose of these shielding pipes was to accommodate and shield the activated reactor control rods, during repairs to the control rod drives or reactor core. In actuality, these pipes had been rarely, if ever, used before this instance, for this intended purpose or for the shielding of experiments.

The radiation field in question was inadvertently created, in part because of a reactor room building construction design deficiency. The grade level on the building's external side was 10" below the reactor room floor level, compromising the effective shielding to the outside of the Reactor Room. For lack of windows, this situation of reduced shielding to the outside with adequate shielding on the inside was never realized.

Following the discovery of the "hot spot" the Facility staff immediately removed the radiation source and relocated it to a shielded cask. On October 12, 1984 the source was replaced for a short time in the original shield pipe, under direct supervision of the HP staff, so that measurements could be made of the radiation levels produced outside of the building. These results of these measurements have been described in the preceding section. On October 16, 1984 a spectral analysis of the isotopes present in the source was made. Back-calculations revealed that the estimated field strength at the time the source was initially placed in the "shielded" pipe was 15% higher than at the time of discovery during the NRC Inspection. Since the experiment had been stored underwater in the reactor pool during one month, very short lived isotopes had decayed away by the time that the experiment was set into the pipe.
