NUREG/CR-6074
04-4448-010
Vol. 2

Sealed Source and Device Design Safety Testing

Technical Report on the Findings of Task 4

Investigation of Failed Nitinol Brachytherapy Wire

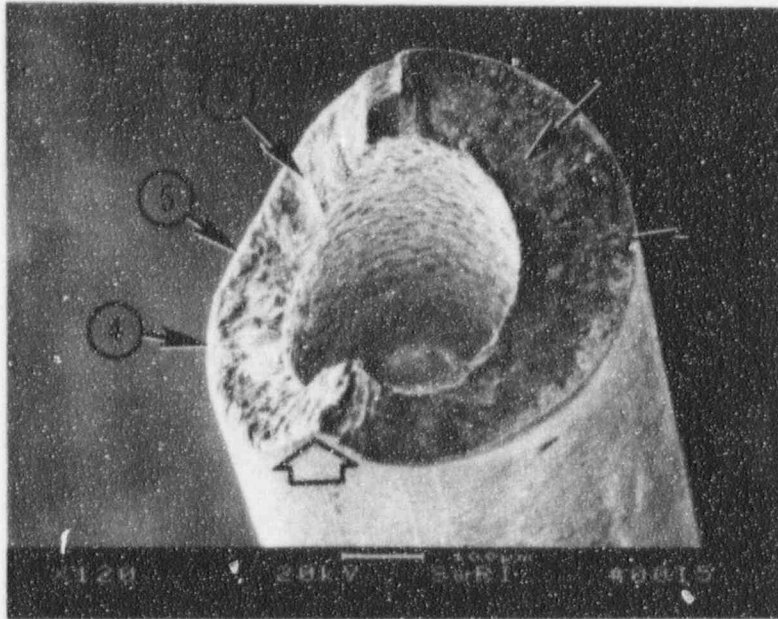
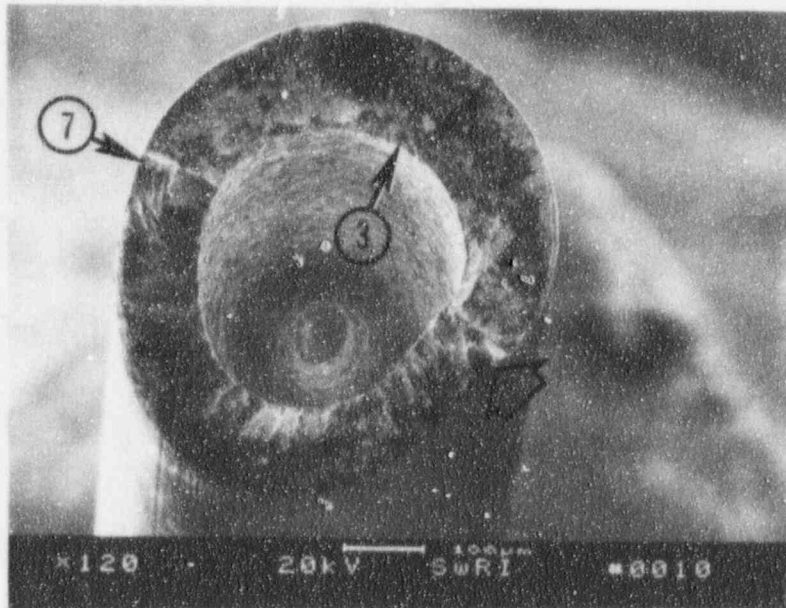
SEM photomicrographs of the complete fracture surface are shown in Figure 2-1. The fracture developed through the wall of the source cavity a short distance from the bottom of the cavity. The fracture surface was comprised of two major zones, each representing approximately 50% of the total fracture. One of the zones was extremely flat and oriented essentially normal to the axis of the wire. The remaining half of the fracture was a slant surface oriented approximately 45° to the wire axis. The slant fracture exhibited somewhat rougher features than the flat fracture. In the as-received condition, the end of the wire and the fracture surface were covered with a deposit material that had a non-metallic appearance. The SEM photomicrographs of Figure 2-1 and the subsequent detailed fractographs were taken after ultrasonic cleaning in deionized water and nonaggressive solvents.

Limited low-magnification examinations of the fracture surface on the source side of the failure also revealed approximately 50% flat fracture and 50% slant fracture.* However, the two parts did not provide an exact match in that the slant fracture zones were oriented in opposite directions. This feature indicates that a portion of the wire between the two slant fractures was broken loose and lost in the failure incident.

There were no general features to indicate any significant plastic deformation of the wire during the fracture process. On the basis of this feature, the failure may be classified as a brittle fracture.

The fractographic details of the slant zone are illustrated in Figures 2-4 and 2-5 [also see Figure 2-1(b)]. This zone was relatively flat and smooth, but exhibited numerous small steps emanating from the cavity surface [Figure 2-1(b) and Figure 2-4(c)]. The nature and orientation of these steps indicate that, within the slant zone, crack initiation occurred along the cavity wall and propagated outward through the wall thicknesses at central locations and back toward the flat zone at the extremities of the zone. There was some curvature to the surface at the bottom of the flat zone on the outside surface of the wire [Figure 2-4(a)]. This area also exhibited numerous fine-scale steps. The fractographic character of this area [Location 4, Figure 2-1(a)] is consistent with fracture in a through-wall direction from the inside out. Other step features were present at the outer periphery of the slant zone [Figure 2-5(a)], but there were no fine-scale features to identify the particular fracture mechanism involved for this zone. The intersection of the slant zone and flat zone is shown in Figure 2-5(b). A through-wall longitudinal crack was present at this location, but, again, there were no features to positively identify the mechanism of fracture in the slant zone or positively establish the sequence of the fracture process.

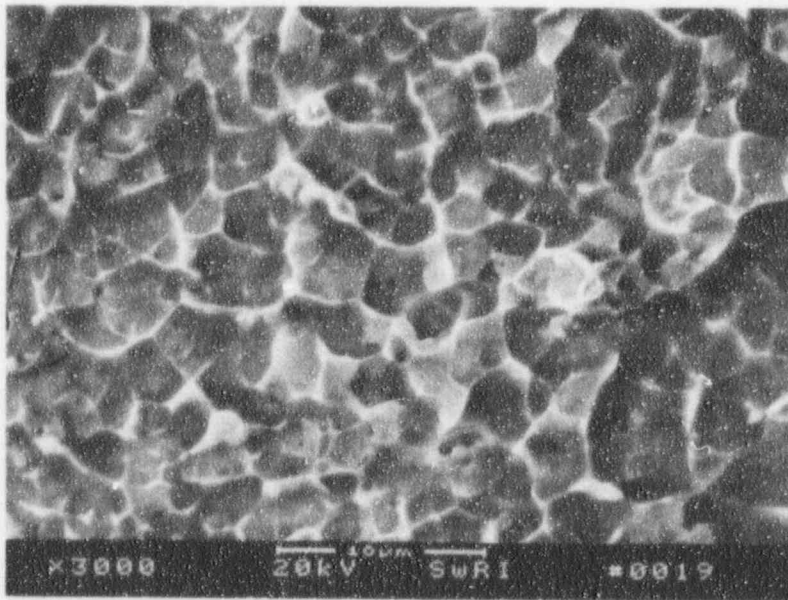
Figure 2-2 Photomicrographs from Flat Zone of Sample No. 410. Location 1, Figure 2-1.

Representative SEM fractographs illustrating the fine-scale topographic features of the wire-side fracture surface of Sample No. 410 are shown in Figures 2-2 through 2-5. The flat zone exhibited uniform, generally equiaxed dimples indicative of fracture by microvoid growth and coalescence; see Figures 2-2 and 2-3. A very thin, continuous shear lip was present around the outer periphery of the flat zone [Figure 2-2(a)]. There were no fractographic features to identify any unique fracture initiation sites within the flat zone and no indications of any preferred direction of cracking in that zone.

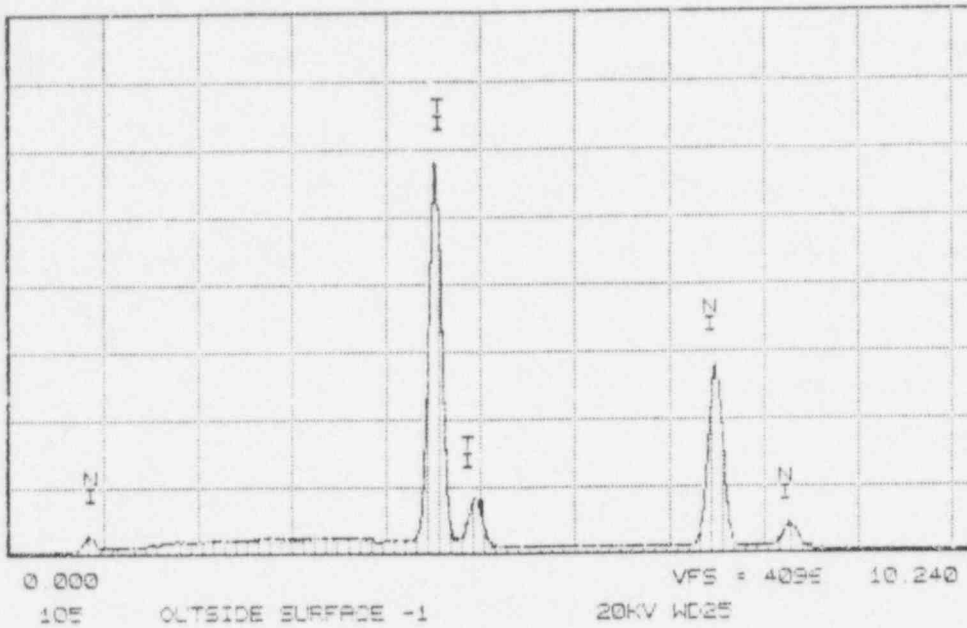
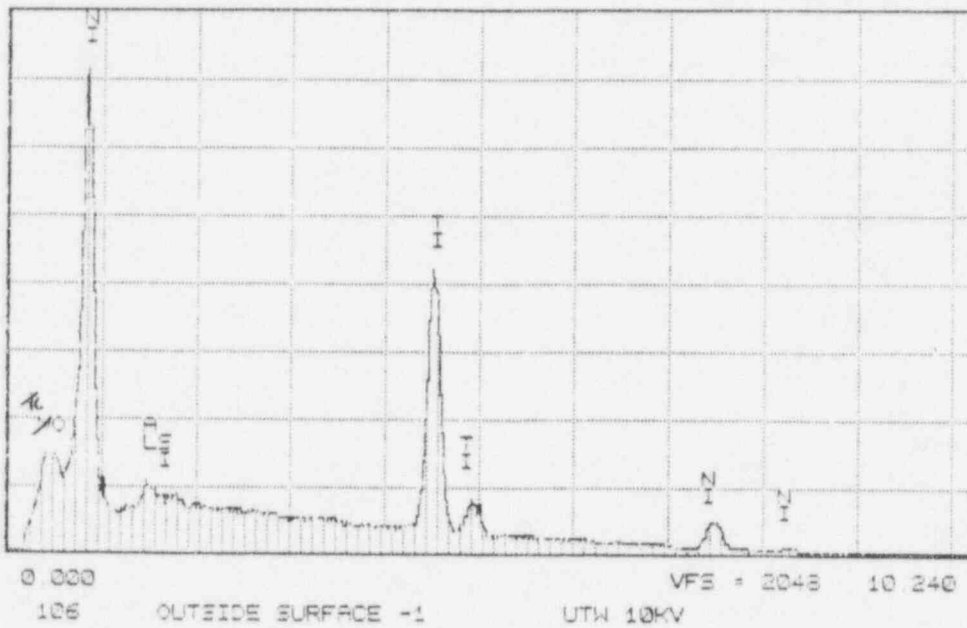
Figure 2-10 X-ray Energy Spectra from Outside Surface. Sample No. 410.
 Upper: β e window, 20 kV; Lower: Ultra-thin window, 10 kV

The deposit materials on the outside wire surface and in the source cavity surface were also analyzed; representative X-ray energy spectra are shown in Figures 2-10 and 2-11. On the outside, the only elements indicated, other than Ti and Ni, were barely detectable amounts of aluminum and silicon, see Figure 2-10. In the case of the inside cavity surface, very small quantities of Al, Si, S, Cl, and K were indicated along with moderate oxygen (O) and fluorine peaks, see Figure 2-11.

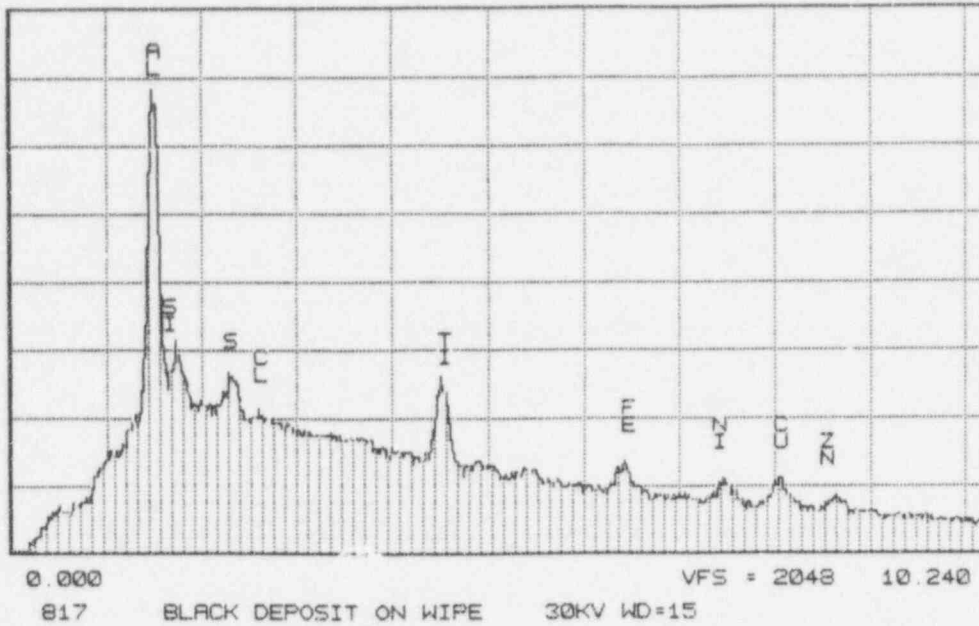
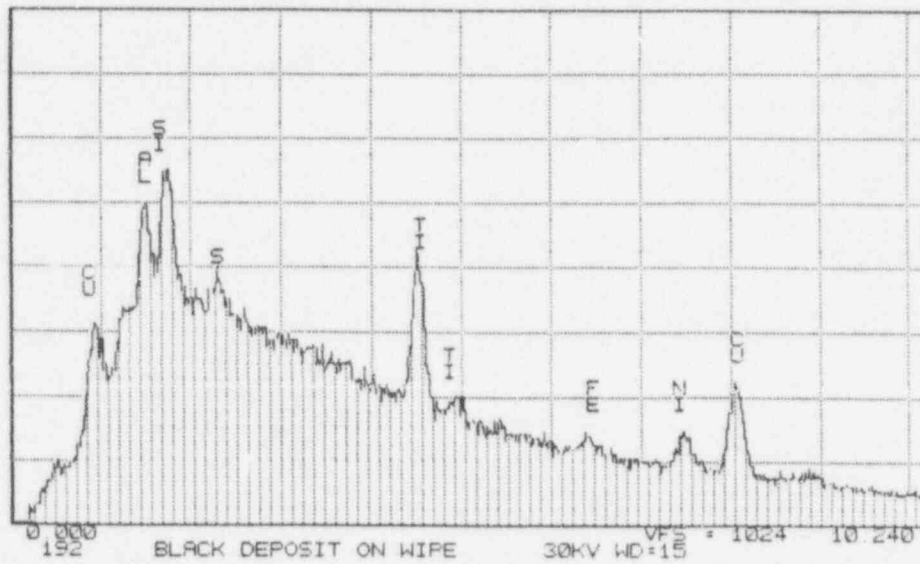
Figure 2-12 X-ray Energy Spectra for Black Deposit on Wipe from Failed Source Wire at Facility A (Sample No. 410)

At the time of the initial on-site investigation of the sourcewire failure several wipe tests of the sourcewire were made. These tests are usually performed as a means of detecting radioactive contamination. In this case, small quantities of a dark gray or black deposit were collected on the cloth wipe patches. These were analyzed by EDS and the results are shown in Figures 2-12 and 2-13. The strongest peaks in the spectrum for the black deposit on the wipe were for oxygen, aluminum, and titanium. Small to moderate amounts of silicon, iron (Fe), nickel, copper, and zinc were also detected. An X-ray spectrum from a clean area on the wipe material is shown in Figure 2-4. This spectrum exhibits a strong aluminum peak with a small silicon peak and probably indicates that the Al and Si peaks obtained for the deposited coating can be attributed to the underlying wipe material.

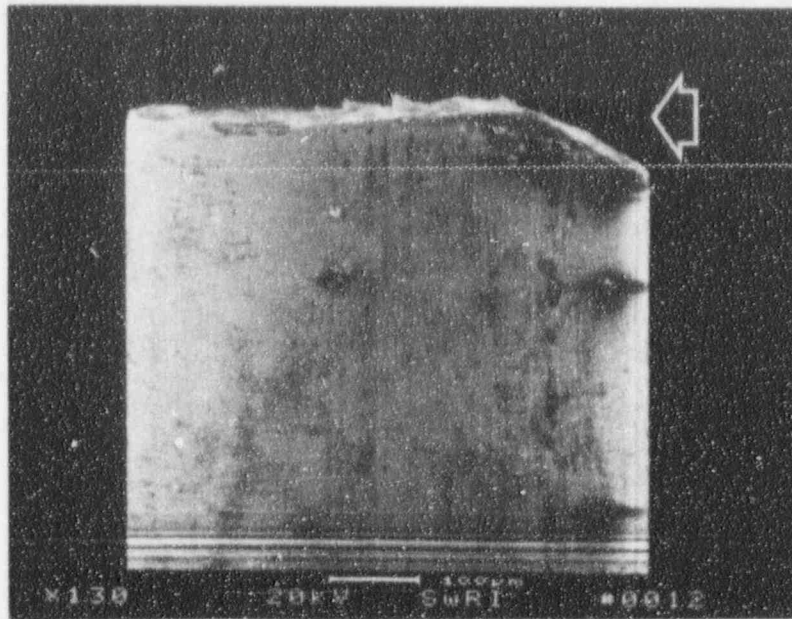
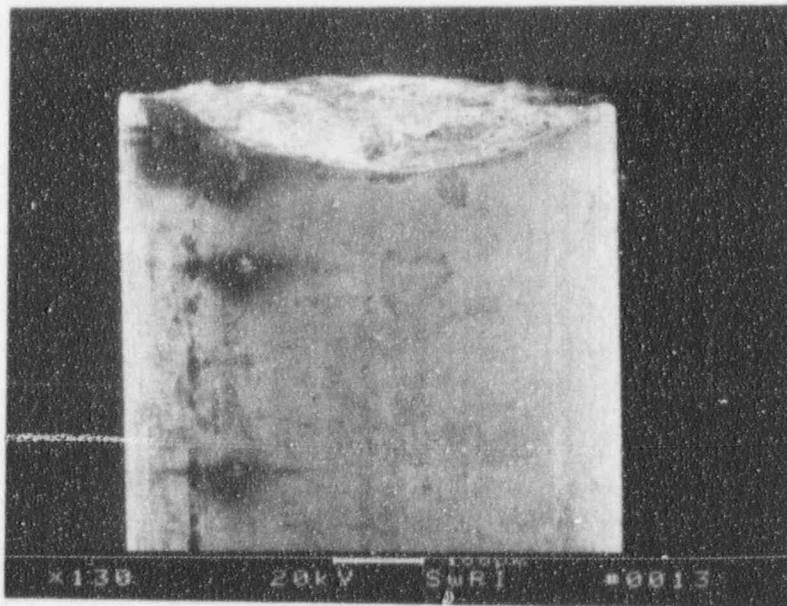
Figure 2-15 SEM Photomicrographs of Failed Source Wire from Facility B (Sample No. 411). Wire side of fracture.

The overall features of the fracture in the sourcewire from Facility B (Sample No. 411) are illustrated by the SEM photomicrographs shown in Figures 2-15 and 2-16. In this case, the fracture was located very close to the bottom of the source cavity. This fracture was similar to that in Sample No. 410 in that it was comprised of a flat zone oriented normal to the wire axis and a slant zone. In this case, however, the flat zone was predominant, comprising approximately 75% of the total fracture surface.

In the as-received condition, the entire fracture surface, and the shallow depression corresponding to the bottom of the cavity were covered with a relatively thick deposit material with nonmetallic characteristics. The SEM photomicrographs and fractographs shown in Figures 2-15 through 2-19 were all taken after ultrasonic cleaning in nonaggressive solvents.

There were no clearly defined initiation sites or directional features, but the occurrence of a few small steps at the inside edge of the flat zone [Figure 2-17(b)] and the orientation of tear dimples [Figure 2-17(c)] suggests that, in the flat zone, fracture might have initiated at the cavity wall. The orientation of tear dimples in the slant zone (Figure 2-18) clearly indicates that the direction of fracture was down the slope, as viewed in Figure 2-15.

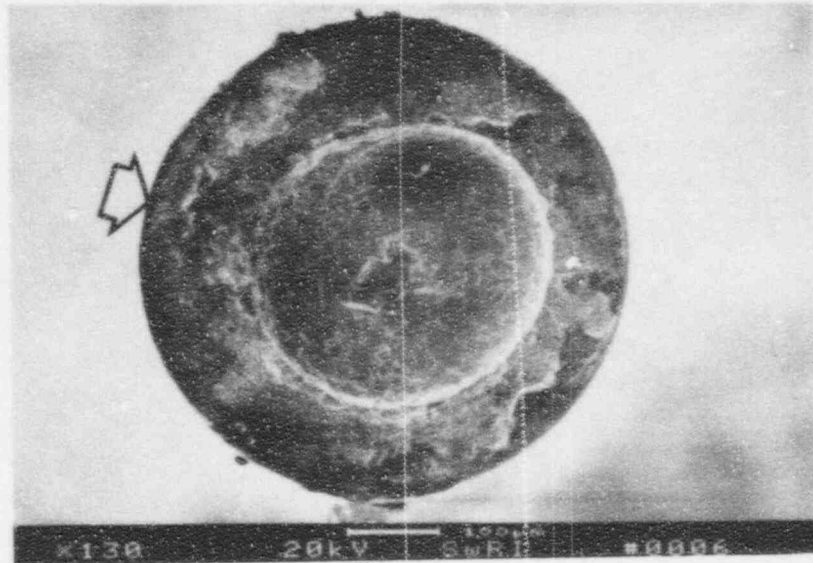
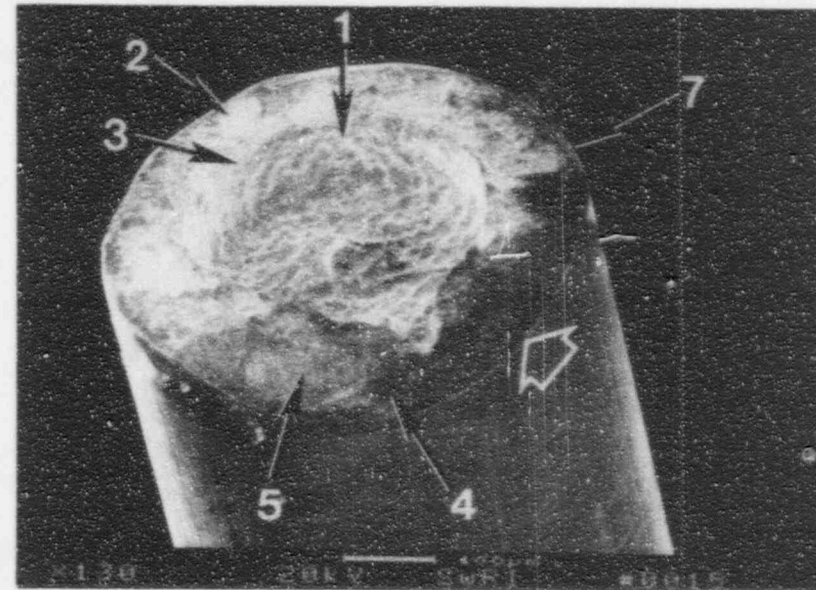
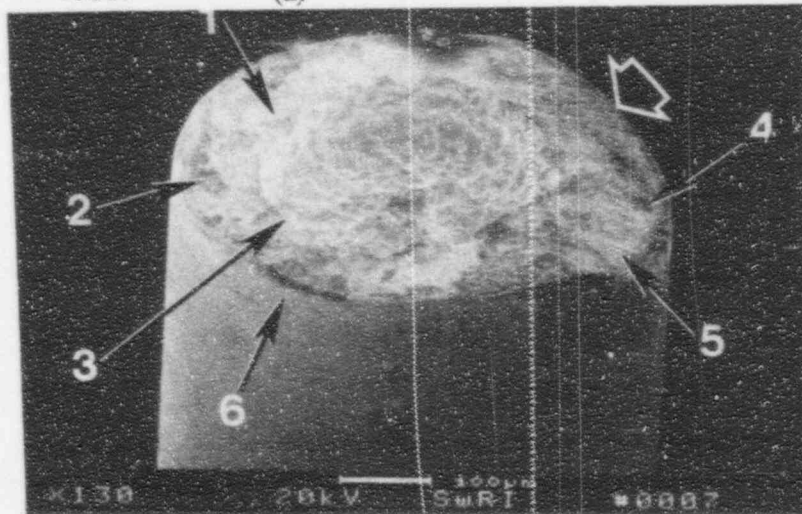
Figure 2-16. SEM Photomicrographs of Failed Source Wire from Facility B (Sample No. 411). Fracture surface on wire side of failure. After cleaning. Block arrows indicate match points for three views.

The cross section at the fracture remained very round [Figure 2-16(a)] and there was no evidence of overall plastic deformation of the wire. The overall character of the failure serves to classify it as brittle fracture. At the fracture location, the cavity wall was not uniform in thickness [Figure 2-16(a)], but this feature is attributed to the cavity being slightly off center and does not indicate thinning due to plastic deformation.

A distinct thin rim, resembling a shear lip, was present almost completely around the periphery of the fracture. This feature is evident in Figure 2-16(b) and detailed features are shown in Figure 2-19(a). Another feature noted in the examination was the presence of small subcritical cracks near the fracture surface, as shown in Figure 2-19(b). Those cracks in Figure 2-19(b) represent the largest of any outside surface defect noted and were confined to the immediate locale of the main fracture. The small gap in the rim, which is evident in Figure 2-19(a), could possibly represent a subcritical crack involved in the final fracture. However, this feature cannot be fully evaluated without direct comparison of the mating fracture surfaces.

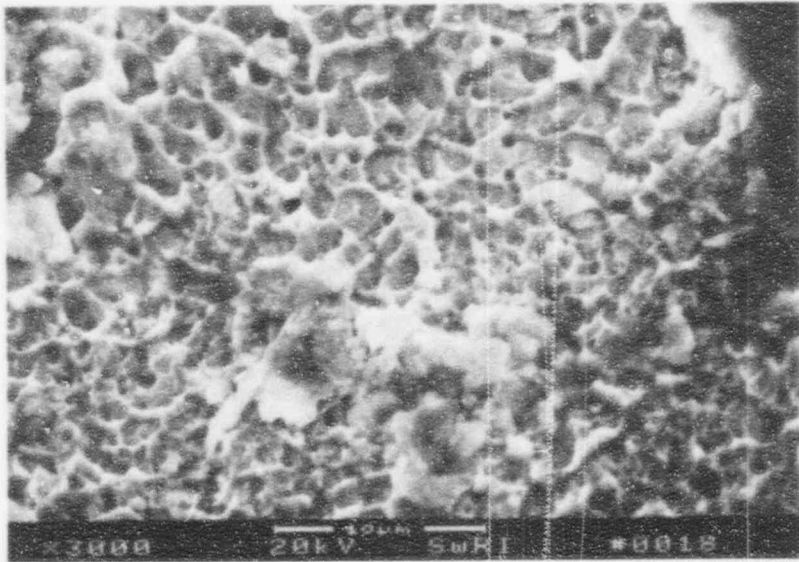
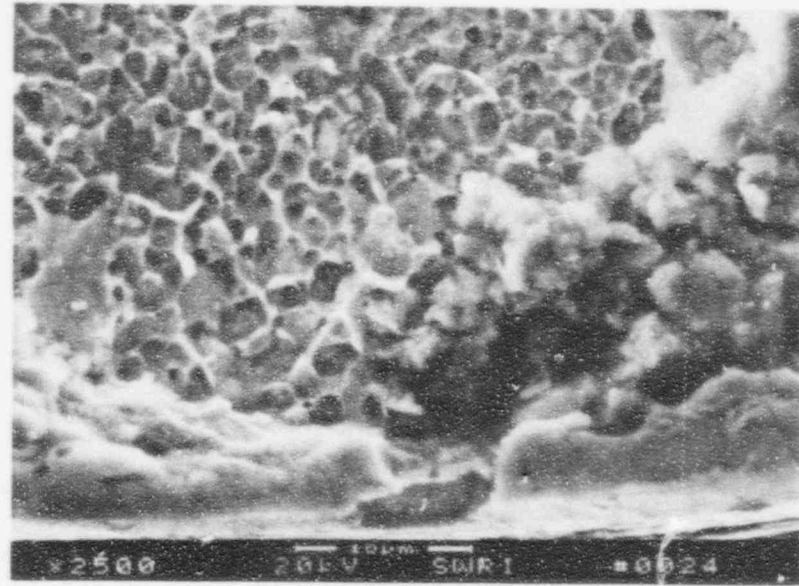
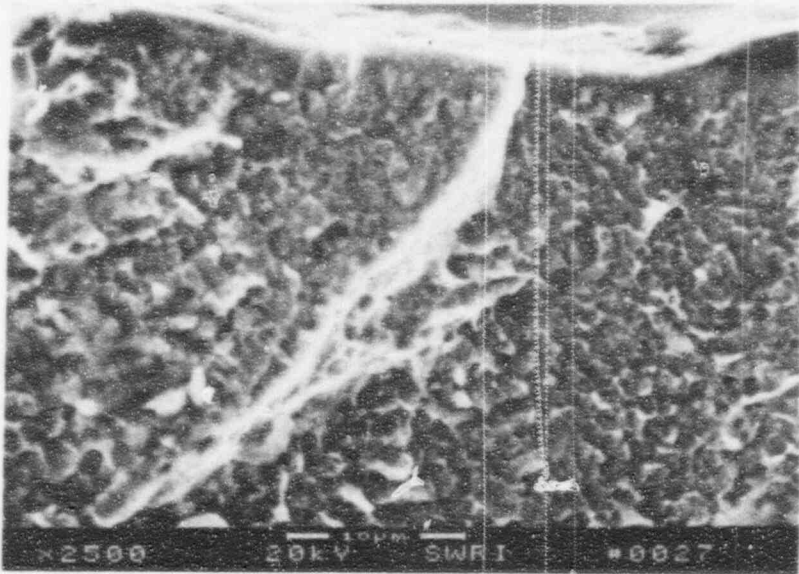
Figure 2-17. SEM Fractographs From Failed Sourcewire From Facility B. See Figure 2-16 for locations.

The fine-scale fractographic features of the fracture surface are shown in Figures 2-17 and 2-18. Both the flat zone and the slant zone exhibited a distinct dimpled topography characteristic of fracture by microvoid growth and coalescence.

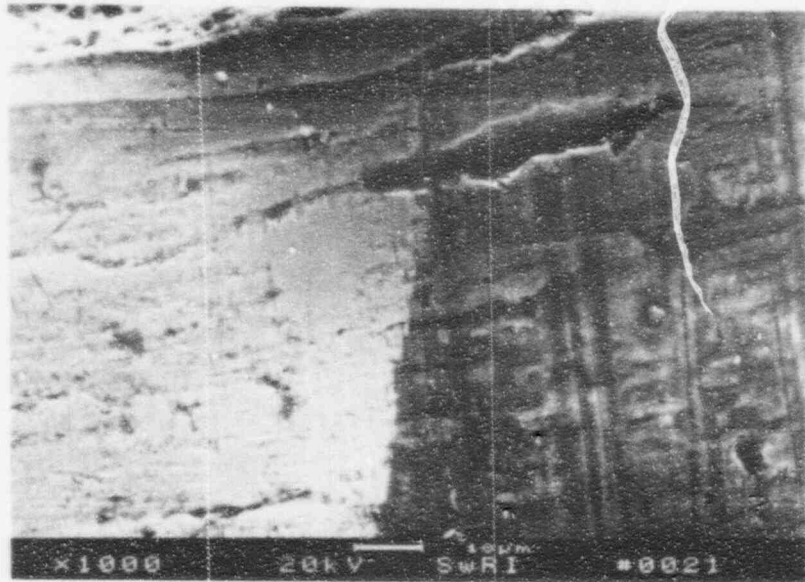
59527

(b) Location 6. Outside surface of wire

Figure 2-19. SEM Photomicrographs of Failed Source Wire from Facility B (Sample No. 411). See Figure 2-16.

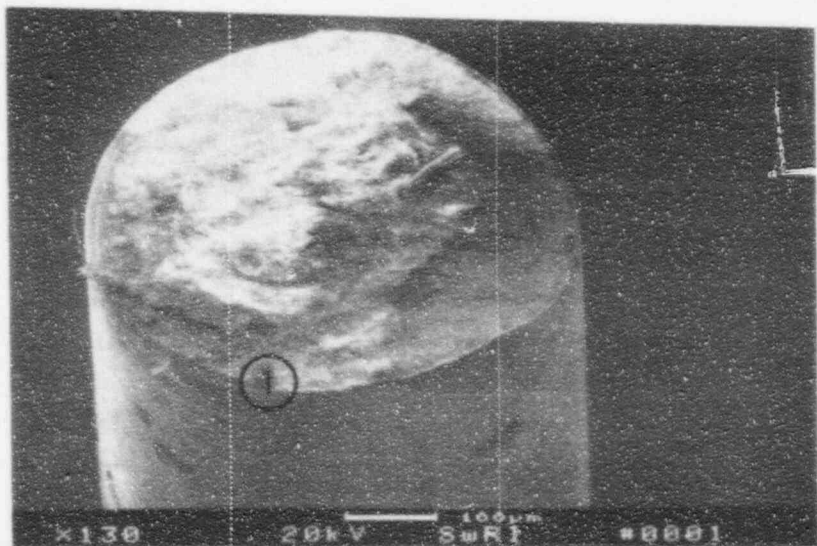
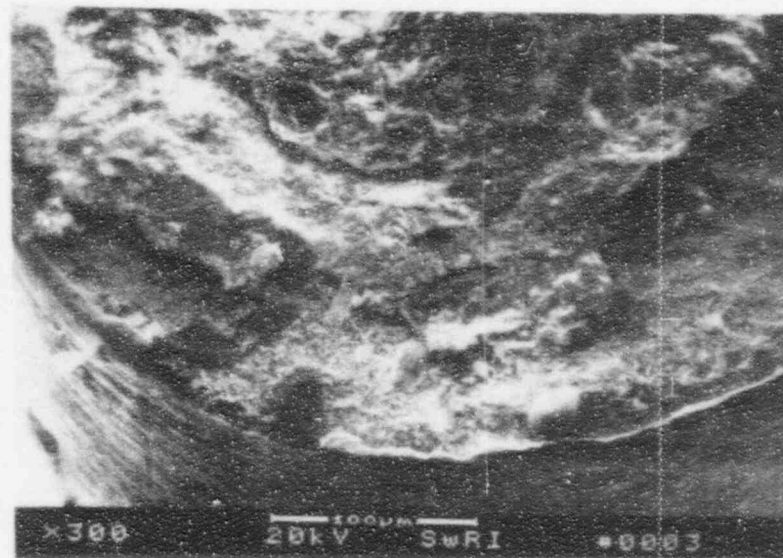
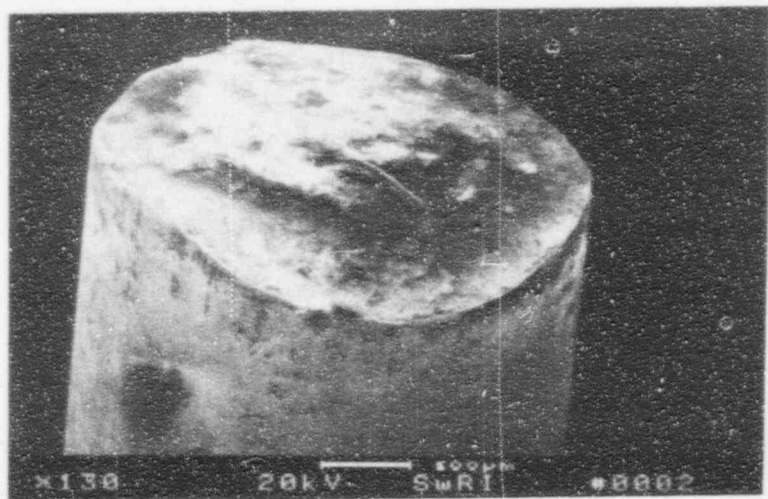
59514 (c) Location I in (a).

59513 (b) View in direction of block arrow in (a).

Figure 2-20. SEM Photomicrographs of Failed Source Wire from Facility B (Sample No. 411). As received.

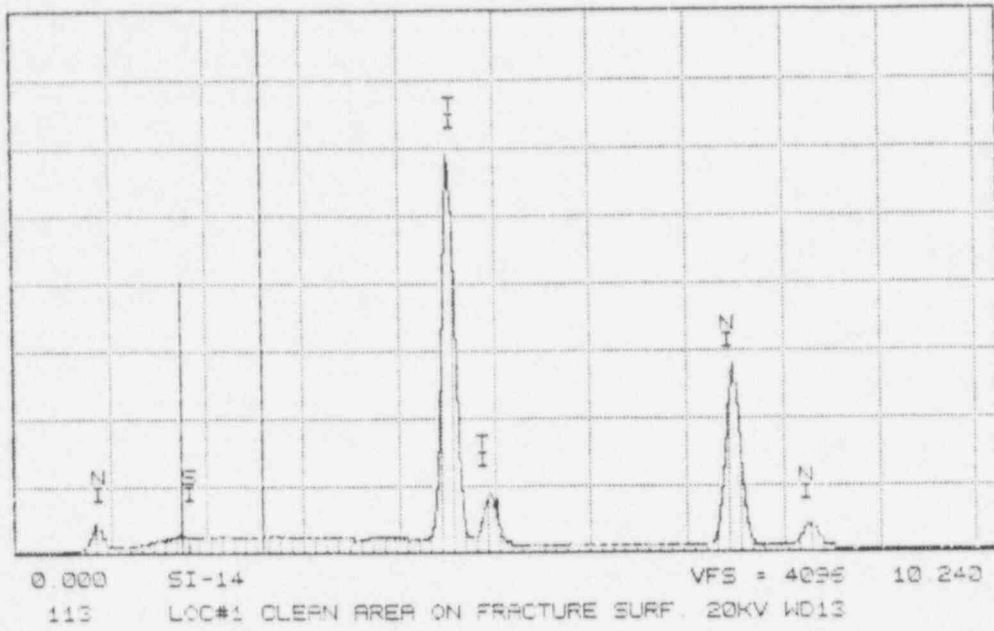
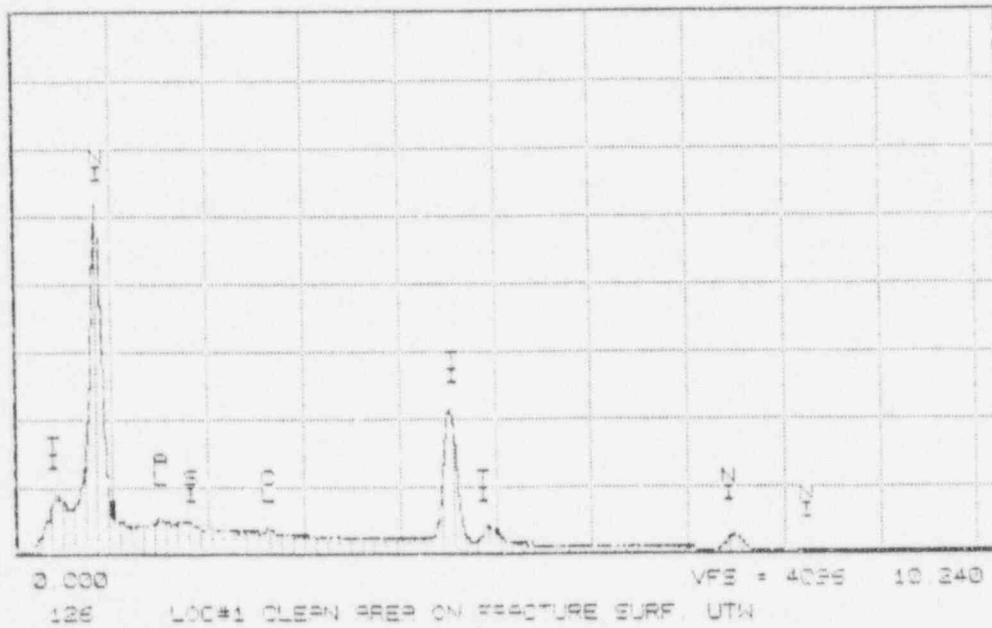
Figure 2-23 X-ray Energy Spectra for Clean Nitinol Wire. Sample 411. See Figure 2-20. Upper: β e window; Bottom: Ultra-thin window

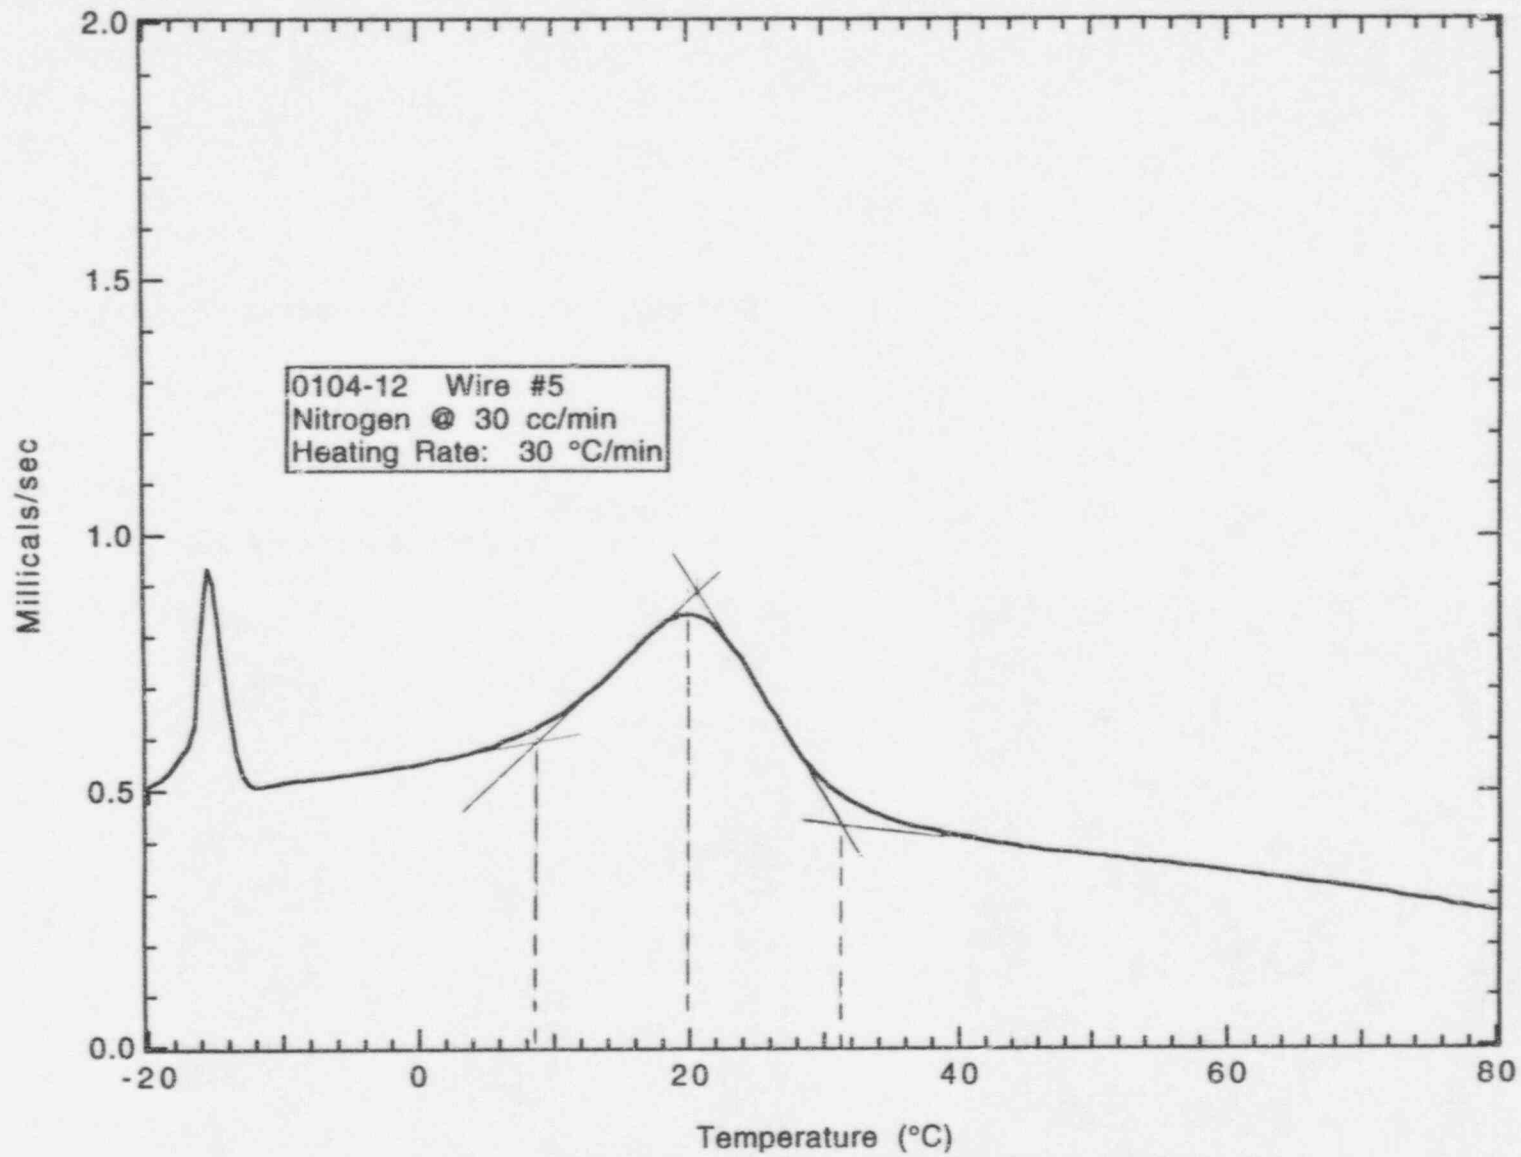
Figure 2-24. DSC Curve for Nitinol Wire Specimen. Sample No. 414

In this case, specimens taken from Sample No. 414 were analyzed in the Perkin Elmer DSC-4 thermal analyzer over a temperature range of -20 to 80°C at a scanning rate of $30^\circ\text{C}/\text{min}$. A DSC curve representative of the results obtained is shown in Figure 2-24. A distinct peak is evident over the temperature range of 10 - 20°C , which indicates a solid-state transformation within that range. The maximum of the peak occurs at 20°C , which indicates conformance to the transformation temperature value of $15 \pm 5^\circ\text{C}$ presented in the mill test report.

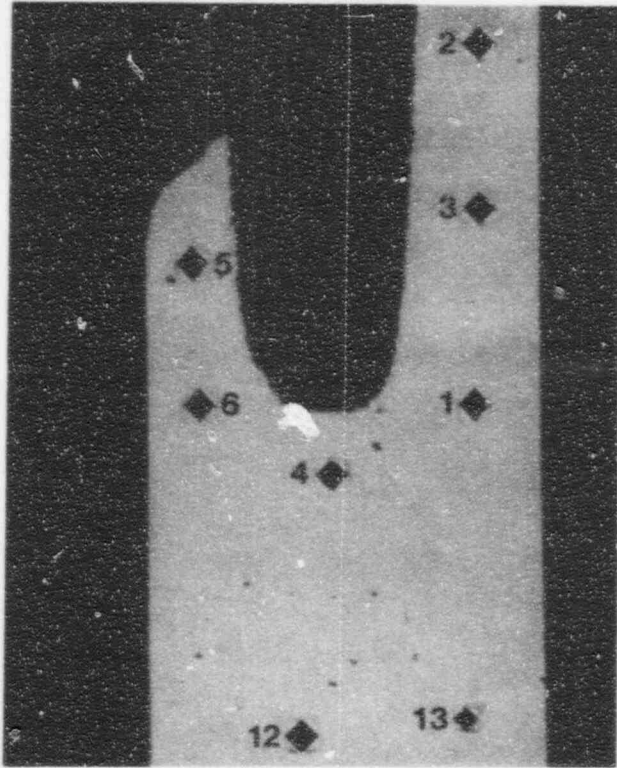
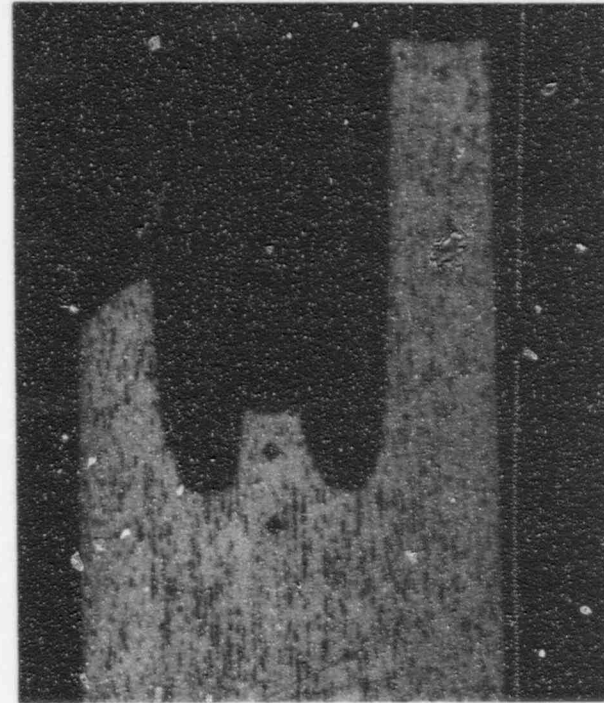
The overall configuration of the cross sections through the sourcewire from Facility A is shown in Figure 2-25. The relative positions of the flat and slant zones and the position of the fracture relative to the bottom of the cavity are readily evident. The microstructure consists of uniformly distributed, elongated particles and dispersed smaller particles in a generally featureless matrix, see Figure 2-26(a). No grain boundaries were evident in the matrix. This two-phase structure is consistent with the composition and the elongated particles are typical of drawn wire. In the course of the metallographic examination, the thin altered case on the inside of the cavity and several small crack-like defects in the cavity wall were evident. These features are illustrated in Figures 2-26(b) and (c). Figure 2-27 shows the longitudinal crack at the junction of the slant and flat zones. This is the crack that was observed in the fractographic examinations and illustrated earlier in Figure 2-5(b). The crack extended only 0.01 inch beyond the fracture surface in the longitudinal direction.

(a) Section between centerline and outer limit of cavity.
As polished. 500 gm hardness indentations.

(b) Section near centerline Etchant: HF + HNO₃, 200
gm hardness indentations.

Figure 2-25. Longitudinal Cross Sections of Sample No. 410. Wire side of fracture.

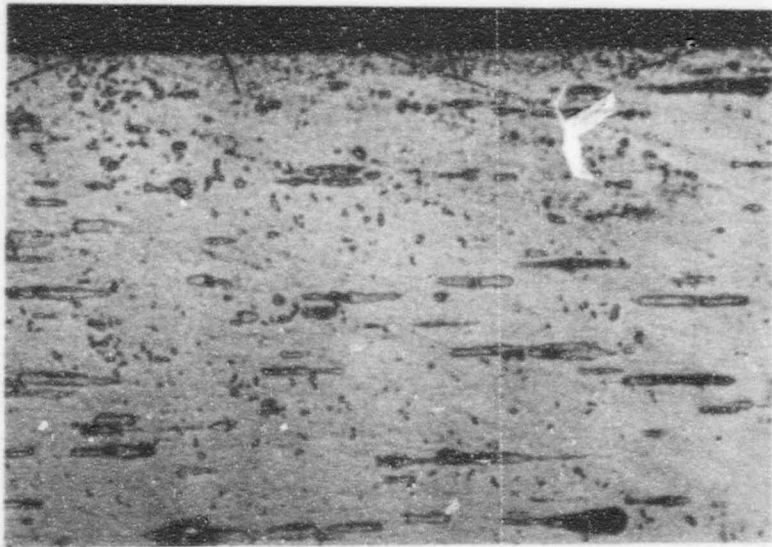
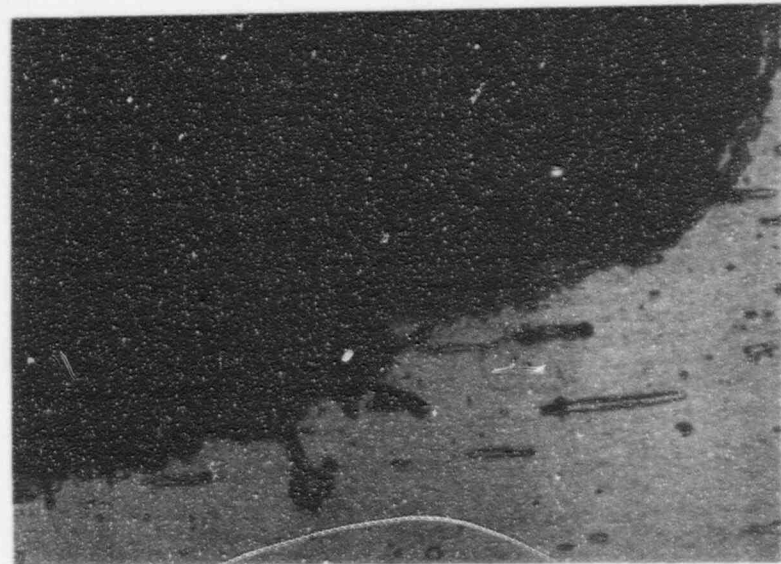
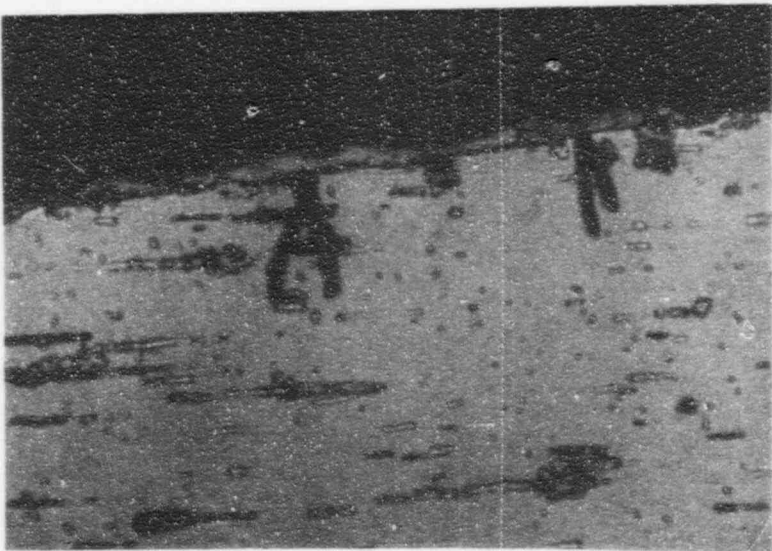
(a) Typical microstructure

(c) Near bottom of cavity

(b) At inside of cavity wall.

Figure 2-26. Photomicrographs from Longitudinal Sections through Sample No. 410. Etchant: HF + HNO₃

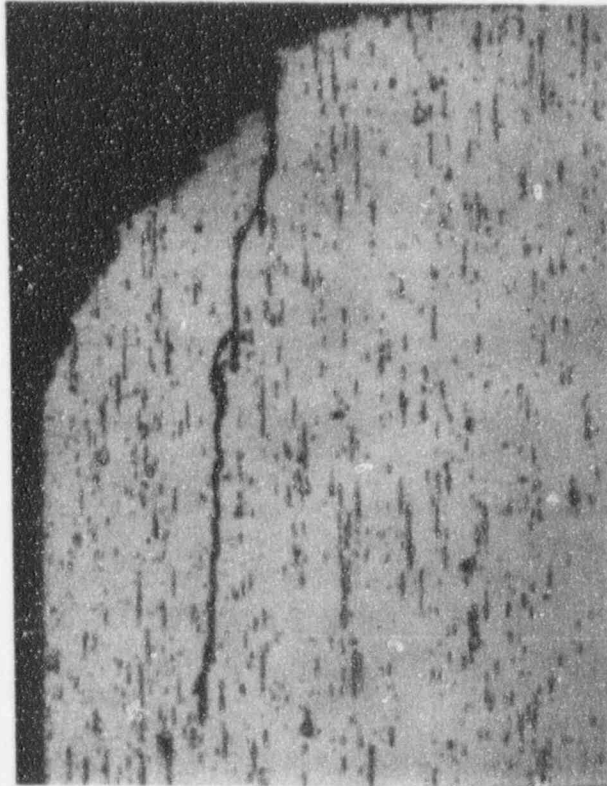
Figure 2-27. Photomicrograph from Longitudinal Section through Sample 410.
Location at intersection of flat fracture and slant fracture. Section within wall thickness prior to grinding into cavity.

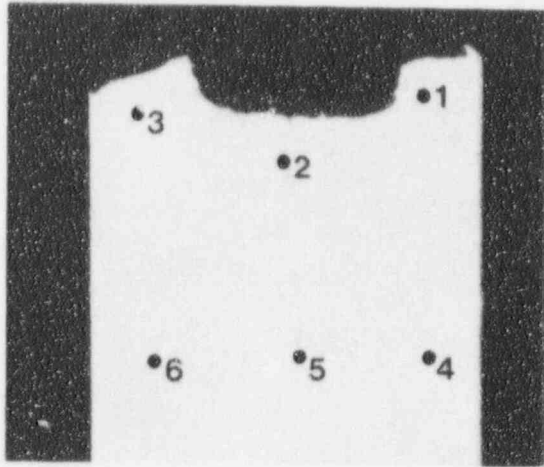
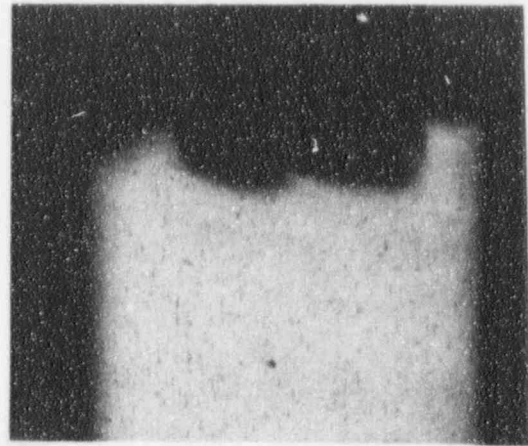
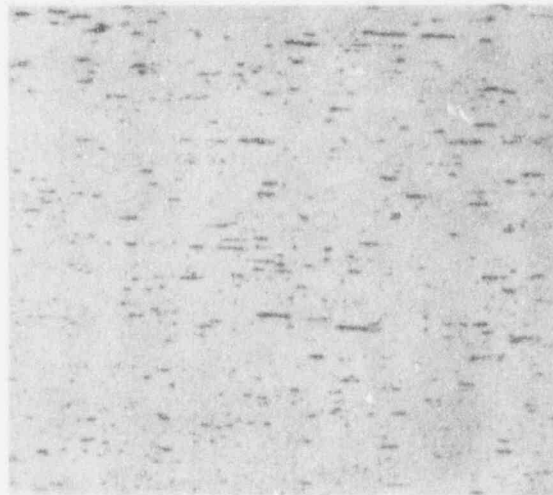
Representative microstructural features of the sourcewire from Facility B (Sample No. 411) are shown in Figures 2-28 and 2-29. The proximity of the fracture to the bottom of the cavity is evident in Figure 2-28(a) and the section shows the relationship of the flat and slant zones. The microstructure is identical to that of Sample 410 [Figure 2-28(b)] and a few similar cavity surface defects were noted (Figure 2-29).

(a) Wire side of fracture.

Figure 2-28. Photomicrograph from Longitudinal Section of Sample 411. Etchant: HF +HNO₃.

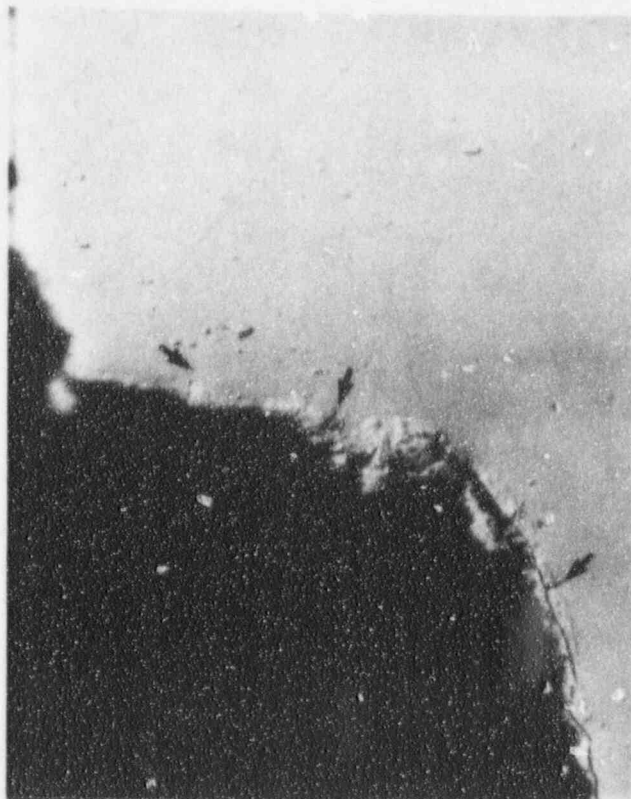
Figure 2-29. Photomicrographs from Longitudinal Section of Sample No. 411. As polished. Arrows mark small defects at cavity surface.

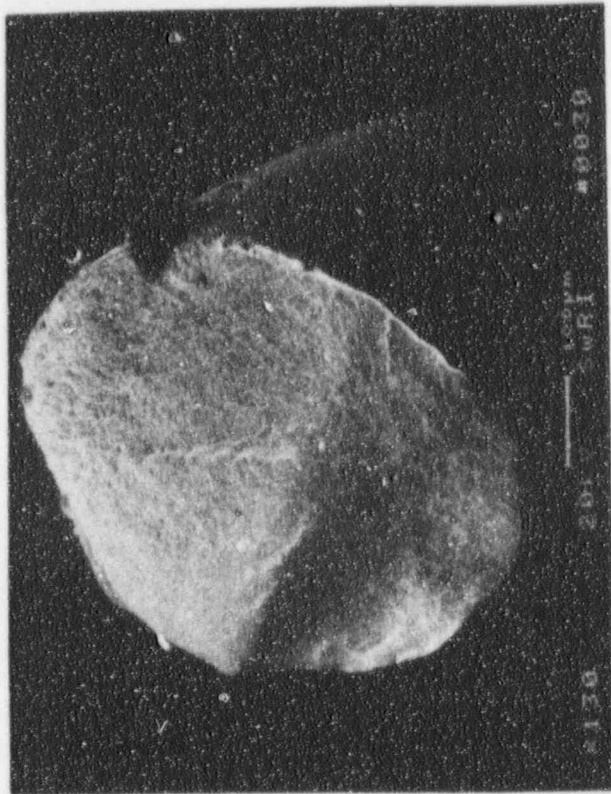
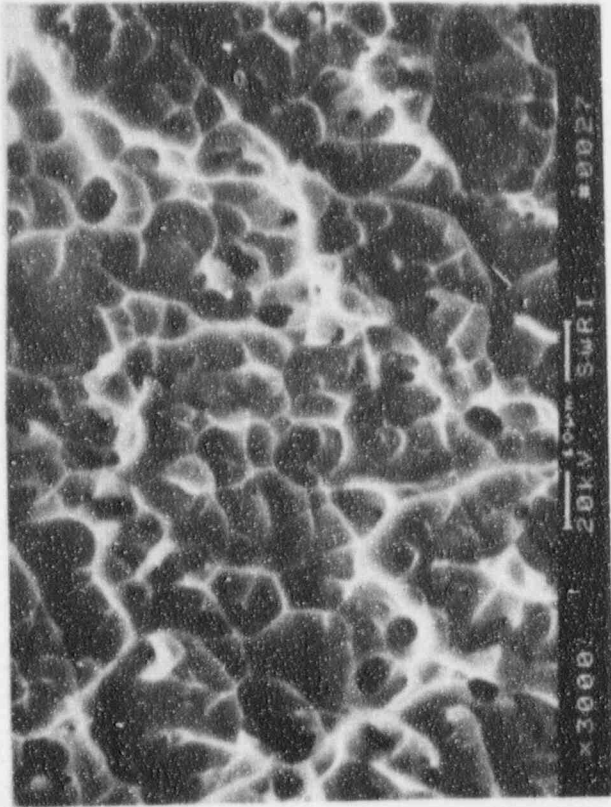
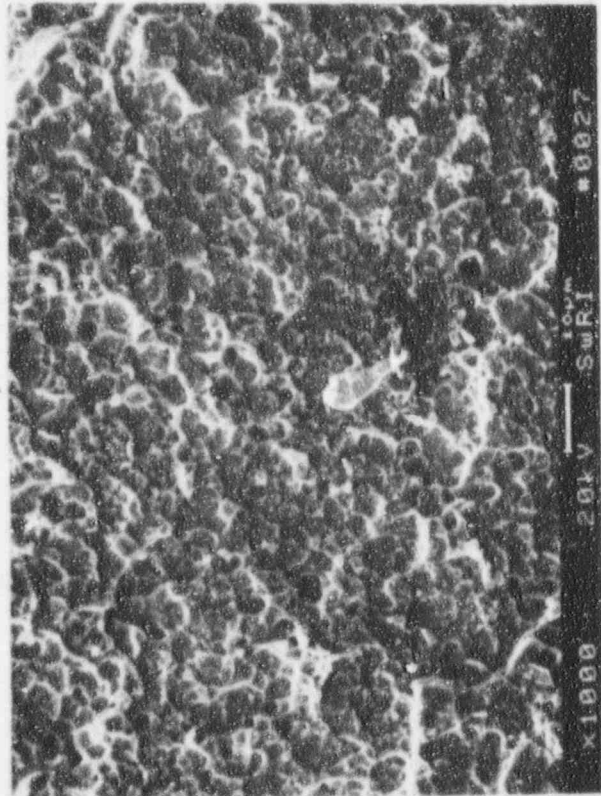
Figure 3-1. SEM Fractographs of SwRI Wire No. 412.

A one-inch section of solid wire was cut from the wire that failed at Facility A. The wire was gripped with a pair of pliers and intentionally reverse flexured until the wire failed. The wire did not fail easily. The ends of the wire touched, when crimped, then the wire was reverse flexed. Figure 3-1 shows the failed wire that had some permanent set indicated by the curvature of the wire. The fracture surface had microfeatures of dimples. The fracture planes were slanted at the OD where the wire was flexed. The middle section was flat. The simple bend test of a solid wire indicated the Nitinol wire was very ductile. The permanent set and dimples were characteristic of overload.

- A simple bend test of a solid wire indicated that the Nitinol wire was very ductile and did not fail until crimped, then reverse flexured. The macrofeatures of the overload condition included permanent set with microfeatures of dimples.
- The preliminary HF exposure tests indicated the Nitinol wire was embrittled by HF.

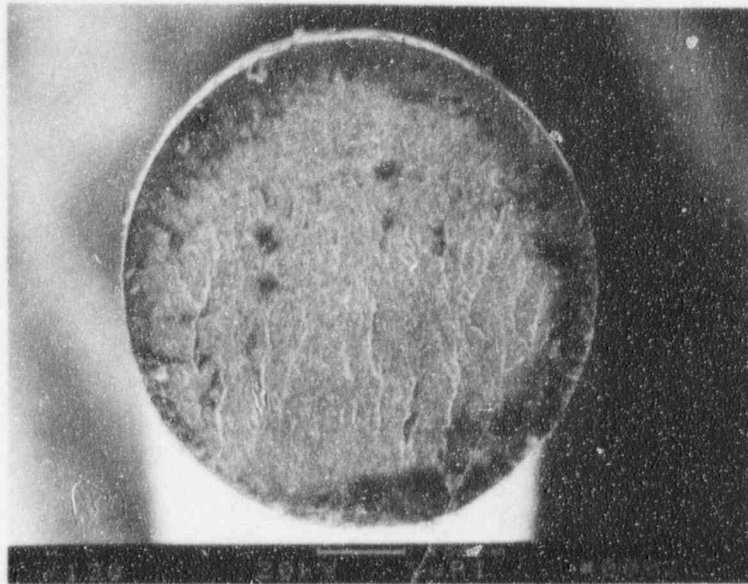
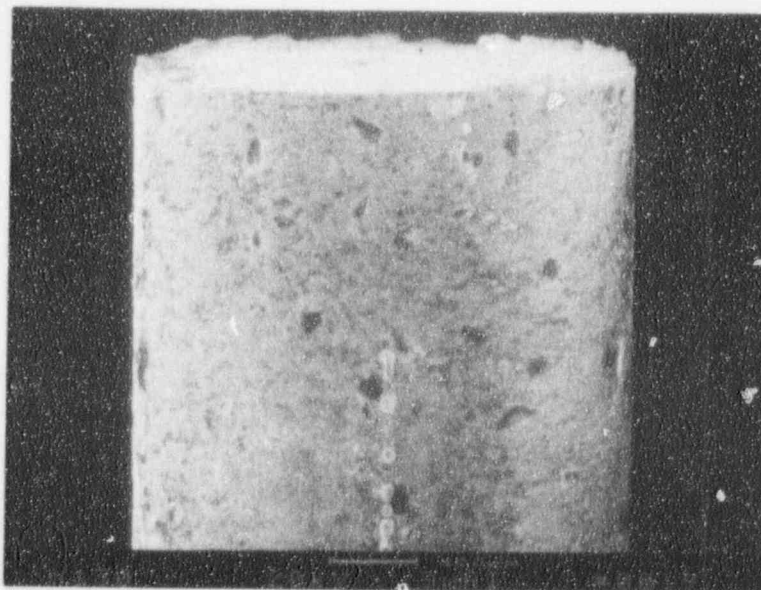
Figure 3-2. SEM Fractographs of SwRI Wire No. 415.

Figure 3-2 shows the wire failed in a brittle manner with a flat fracture across the section of the wire. Fracture flow marks proceeded across the cross section. Figure 3-3 shows fracture surface microfeatures were predominantly dimpled. However, around the periphery at the OD surface was a rim that was not dimpled. The rim was feathery in appearance and the features had a slight curvature which may indicate crack direction around the periphery. The HF test indicated that Nitinol wire was embrittled.
