NUREG/CR-6074
04-4448-010
Vol. 2

Sealed Source and Device Design Safety Testing

Technical Report on the Findings of Task 4

Investigation of Failed Nitinol Brachytherapy Wire

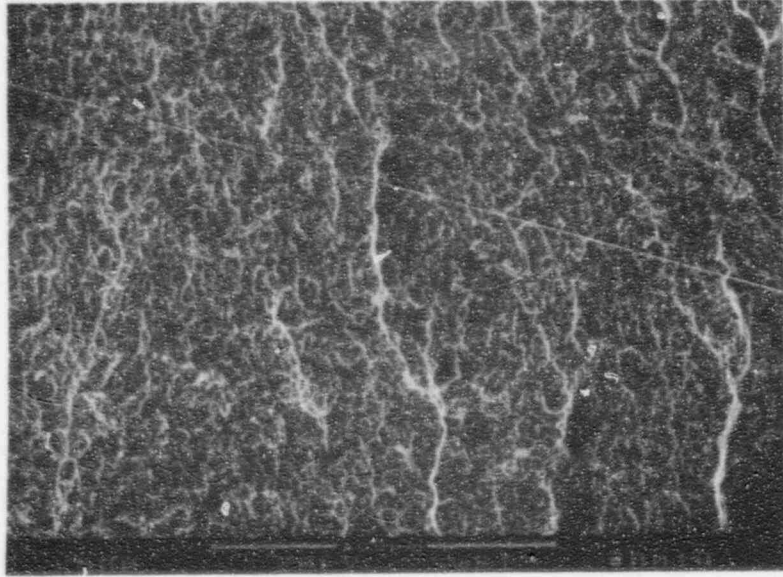
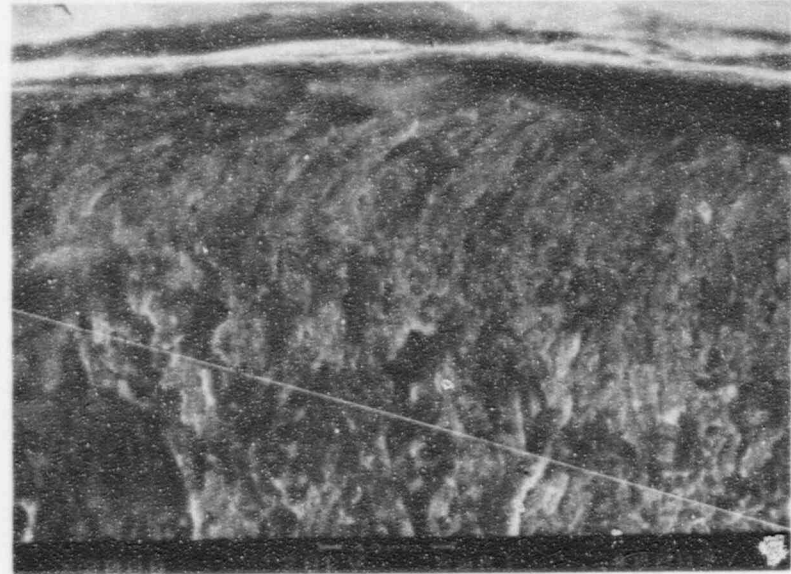
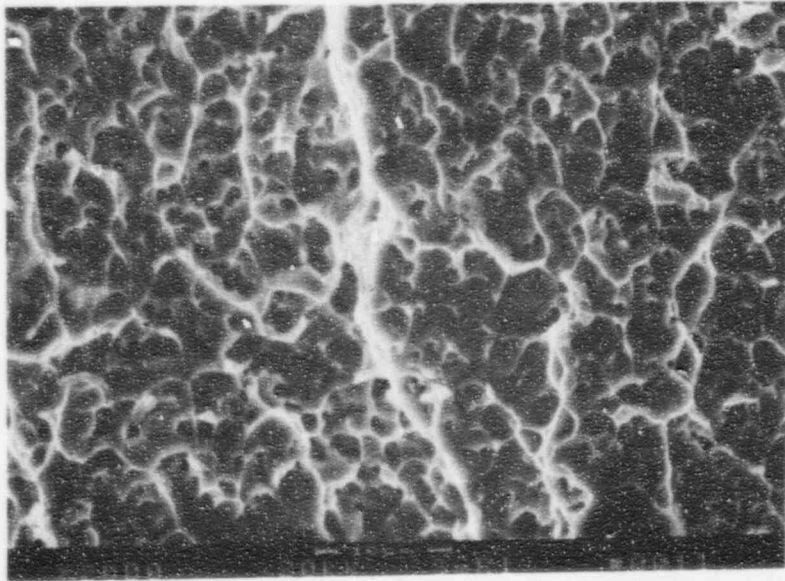
Figure 3-3. SEM Fractographs of SwRI Wire No. 415.

Figure 3-2 shows the wire failed in a brittle manner with a flat fracture across the section of the wire. Fracture flow marks proceeded across the cross section. Figure 3-3 shows fracture surface microfeatures were predominantly dimpled. However, around the periphery at the OD surface was a rim that was not dimpled. The rim was feathery in appearance and the features had a slight curvature which may indicate crack direction around the periphery. The HF test indicated that Nitinol wire was embrittled.

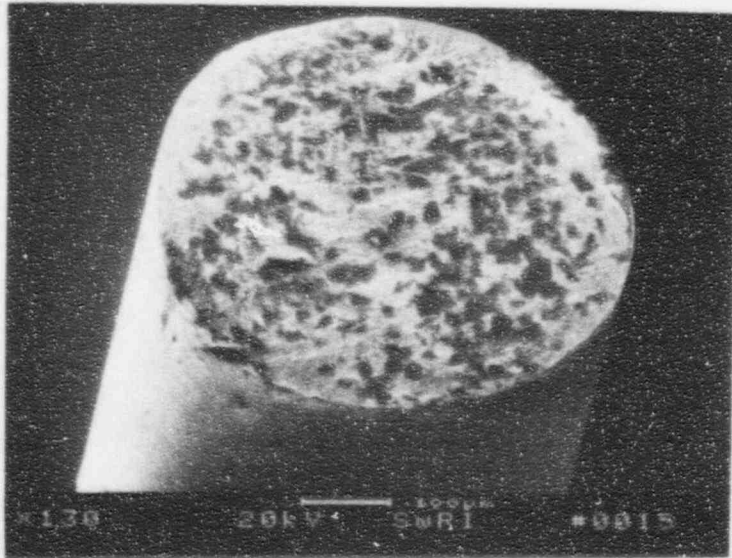
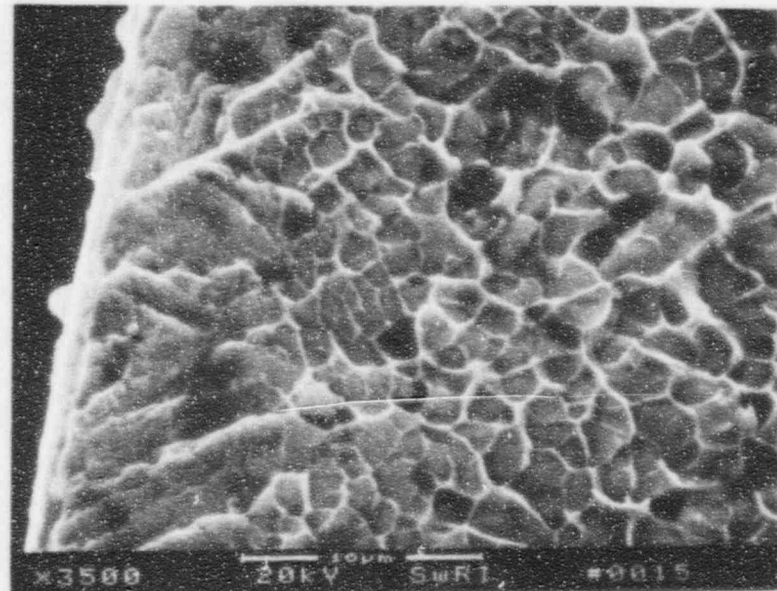
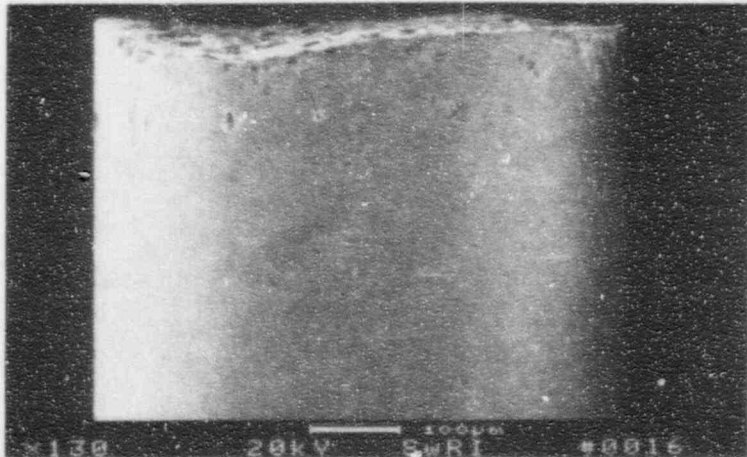
Another test included exposing solid wires for 6 hrs. and 45 minutes to 0.1%HF, then manually bent. Figure 3-4 shows the fracture surface which was flat and covered with some residual product. Figure 3-5 shows the EDX spectra of the residual product on the fracture surface. Expected elements of nickel and titanium were identified and potassium, sodium, sulfur, chlorine, and oxygen. The source of all these elements is uncertain. Fluorine was not identified as a by-product. An interesting note was microcracks identified on the compression side of the wires shown in Figure 3-6. The microcracks indicate that the OD was embrittled; the cracks had a slight angle. The cracks on the compression side is not a normal occurrence in conventional loading conditions. Two possible explanations to consider; first, cracks may initiate because the shear strength of the brittle layer is low. When the wire is initially flexed, shear stresses are present on 45° planes on the compression side. Therefore, shear cracks could develop in the brittle layer on the inside of the bend. Alternatively, the microcracks may have occurred when the wire was reverse flexed. In either case, the microcracks indicate HF had an embrittling effect on the Nitinol wire.

Figure 3-4. SEM Fractograph of Wire Exposed to .1% HF Acid.

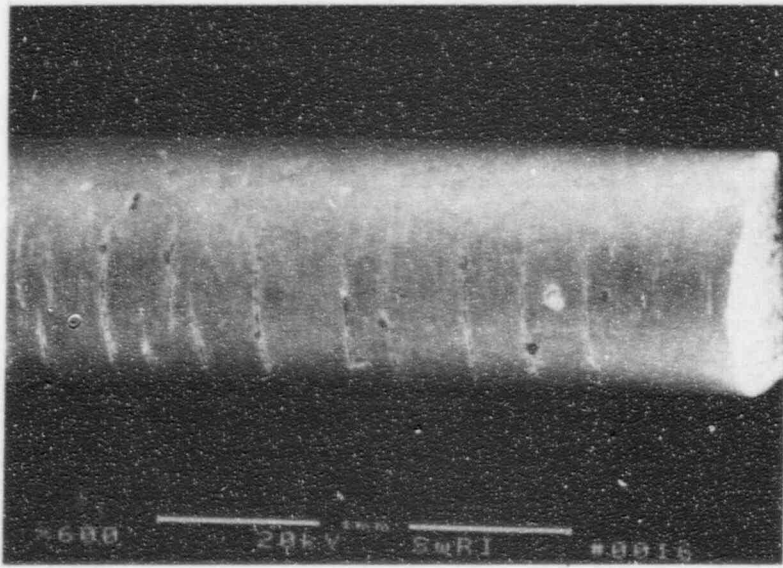
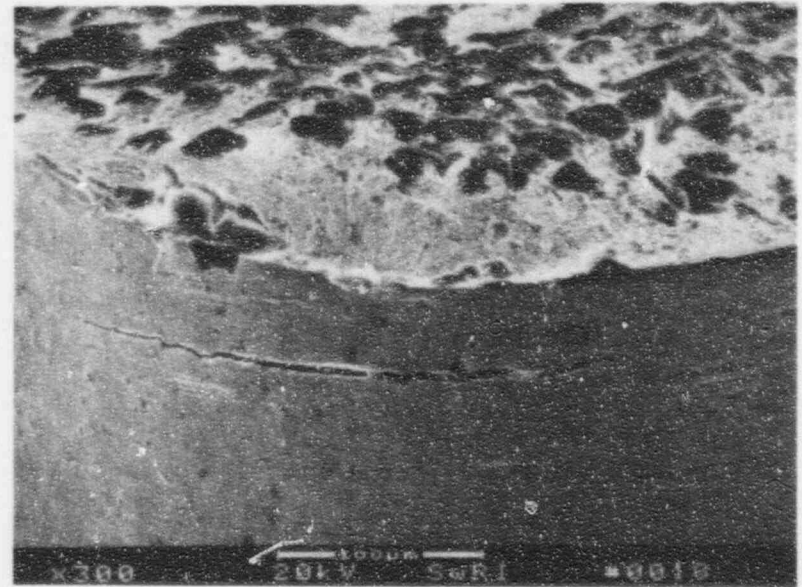
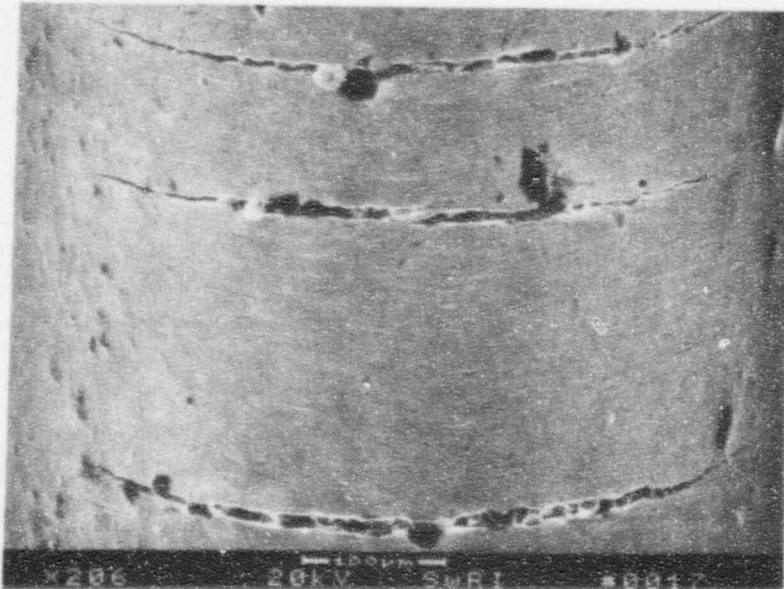
Figure 3-6. SEM Photographs of the OD Compression Side of the Specimen.

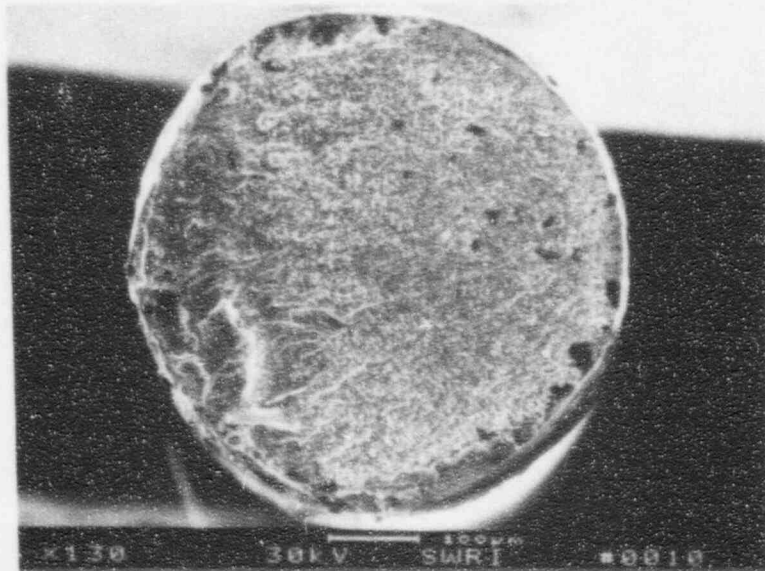
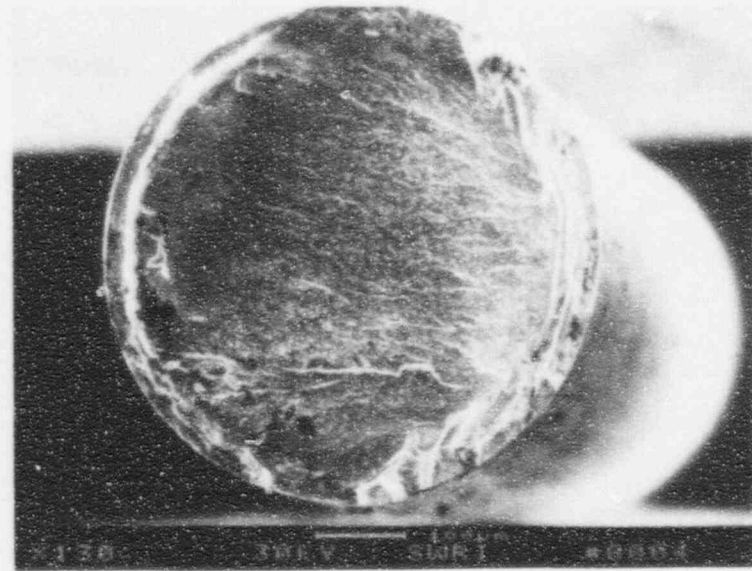
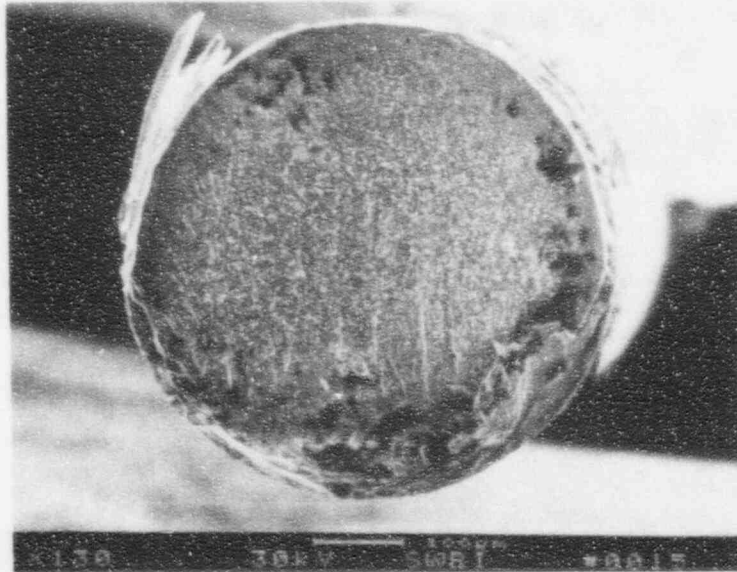
A solid wire was electrolytically charged for two hours with hydrogen at SwRI (see Appendix D for details on charging procedure) then manually bent, either instantly with no delays or with a five hour delay or with a seventy hour delay. Figure 3-7 shows that all the specimens failed in a brittle manner. Each of the fractures had a flat fracture plane with flow lines from one side of the fracture to the other side of the fracture, micro-dimples on the fracture, and a rim or shell on the OD of the wire, shown in Figures 3-7 and 3-8. In some cases, longitudinal microcracks were evident and a separation or delamination occurred. Also noted was smaller dimples adjacent to the initiation site.

- The specimens that were hydrogen charged failed in a brittle manner.
- In view of these preliminary results, it was concluded that Nitinol can be embrittled by HF or hydrogen. A more comprehensive test plan, discussed in Section 5.0, was developed.

Figure 3-7. SEM Fractographs of Hydrogen Charged Specimens.

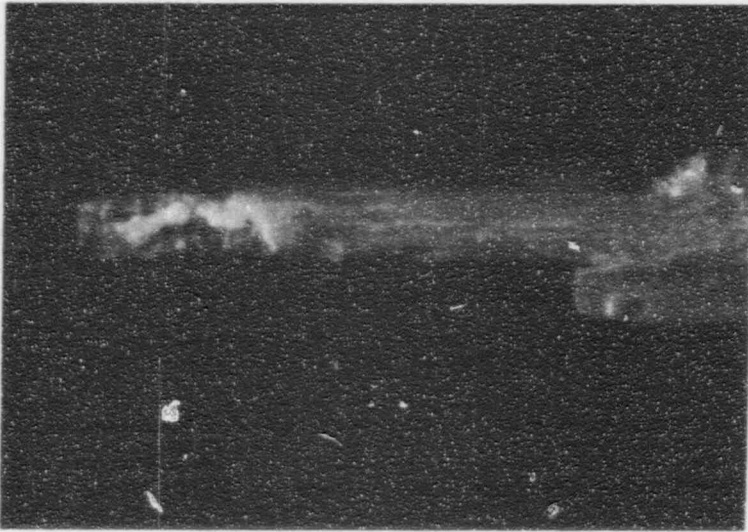
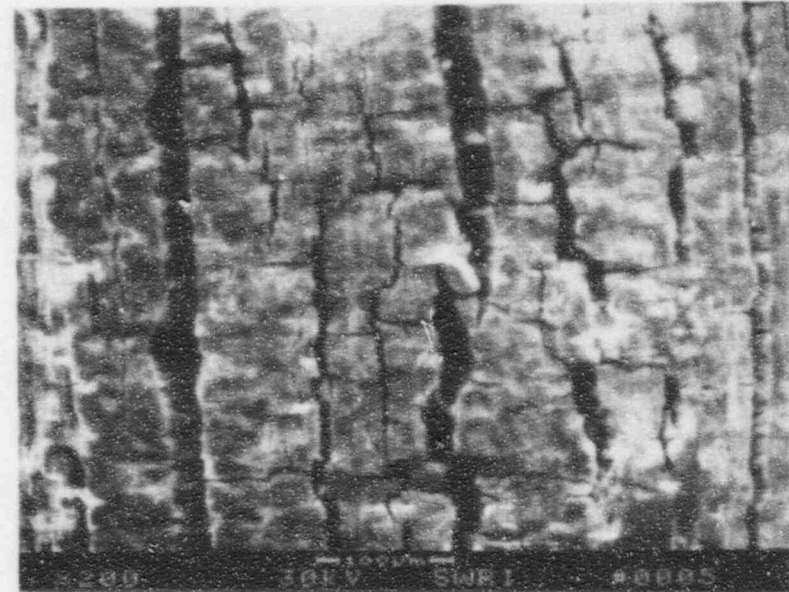
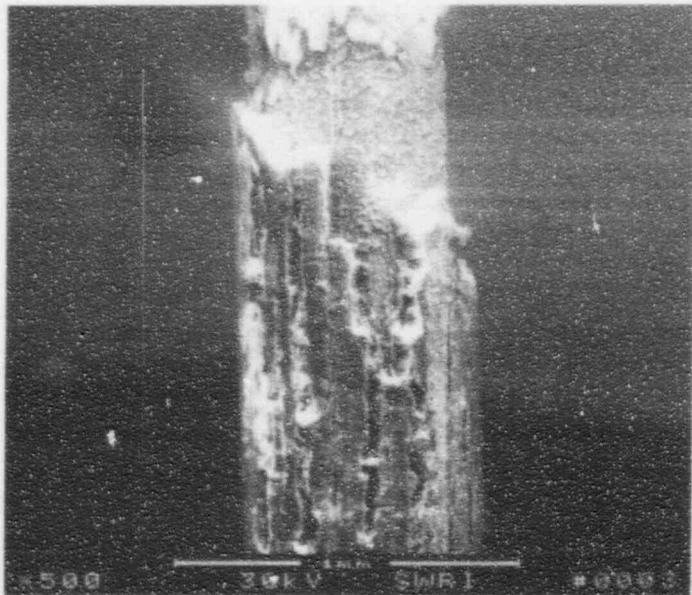
Figure 4-2. Photographs of SwRI Wire No. 416.

SwRI No. 416 was used successfully in clinical applications for three months. When the wire was extracted from its storage cask, it was severed and severely deteriorated. Figure 4-2 shows the end of the teflon catheter with the teflon lining removed. The teflon sheathing was degraded, brown in color, and cracked. Figure 4-3 shows the end of the failed wire filled with debris. The wire was cleaned first with acetone. Some of the debris was removed, but not completely, as shown in Figure 4-3(b). The wire was ultrasonically cleaned in hexane, and most of the debris was removed (Figure 4-4).

c) Degraded teflon

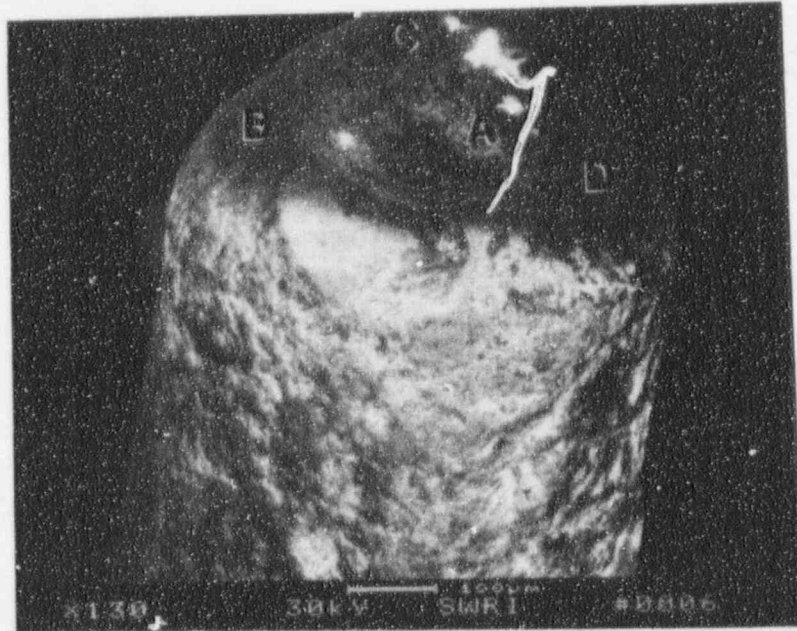
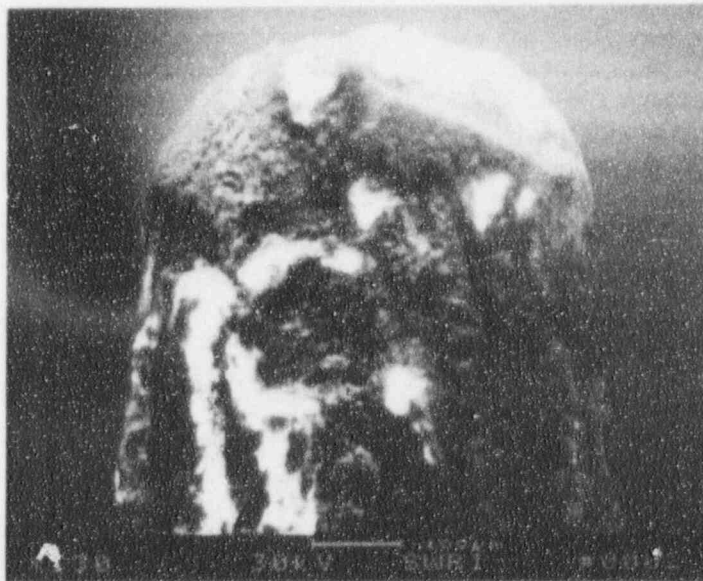
Figure 4-3. SEM Photographs of the Wire End of SwRI Wire No. 416.

The fracture had two distinct planes with a slight angle. The two planes intersected mid-axis of the wire. The fracture surfaces were smooth and burnished with no distinct features, indicating probable sourcewire failure prior to extraction.

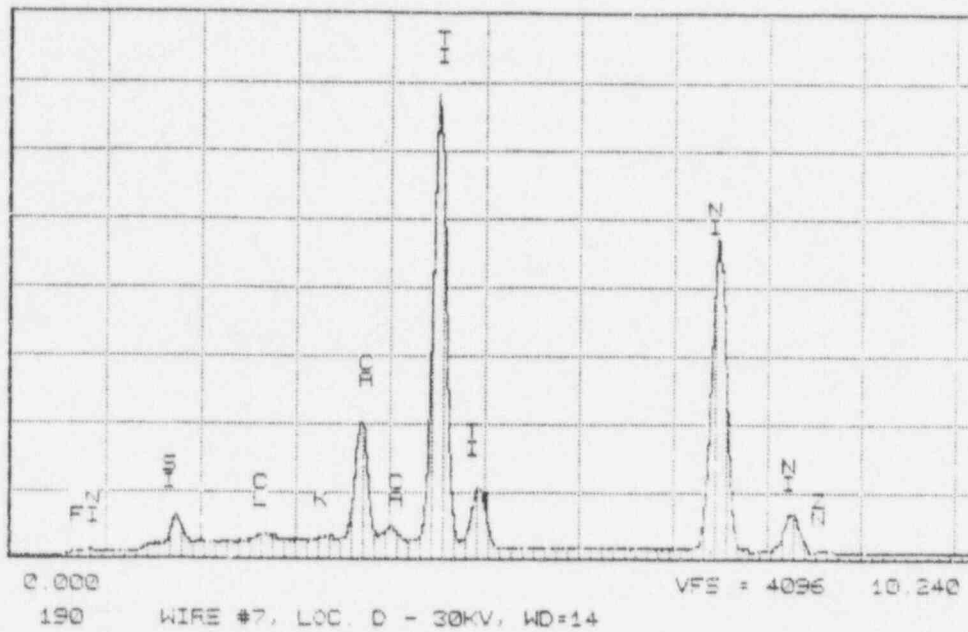
Figure 4-7. Energy Dispersive X-Ray Spectra of the Uncleaned Fracture Surface of SwRI Wire No. 416.

Energy dispersive X-ray analysis was conducted on the deposit found in the sectioned cask, on the fracture surface in the cleaned and uncleaned condition, and on the EDM surface. Figures 4-7 and 4-8 show the EDS spectra for the cleaned and uncleaned fracture surface. In addition to the base metal elements of titanium and nickel, fluorine (F), silicon (Si), chlorine (Cl), potassium (K), calcium (Ca), aluminum (Al), magnesium (Mg), and zinc (Zn) were detected. Figures 4-9 and 4-10(a) show the EDS spectra of the center region, which identified oxygen, fluorine, aluminum, silicon, calcium, and sulfur.

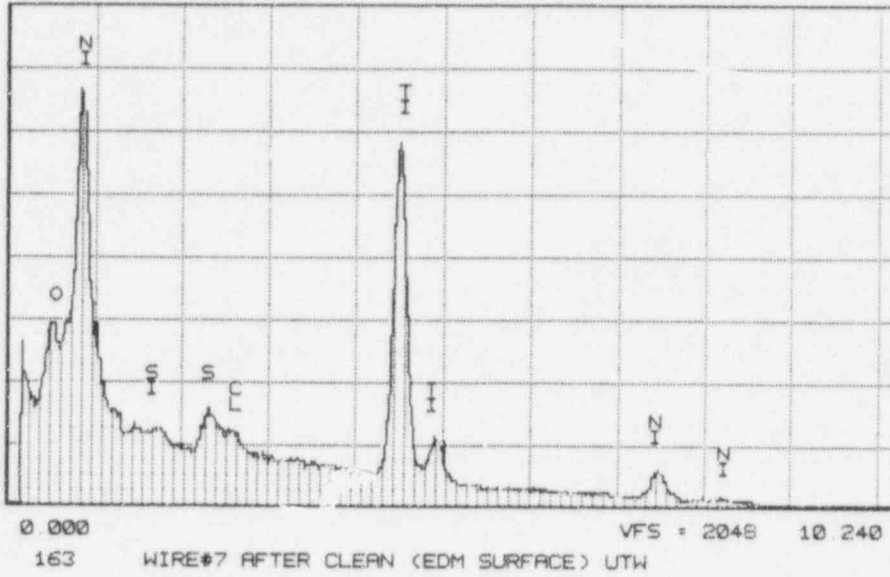
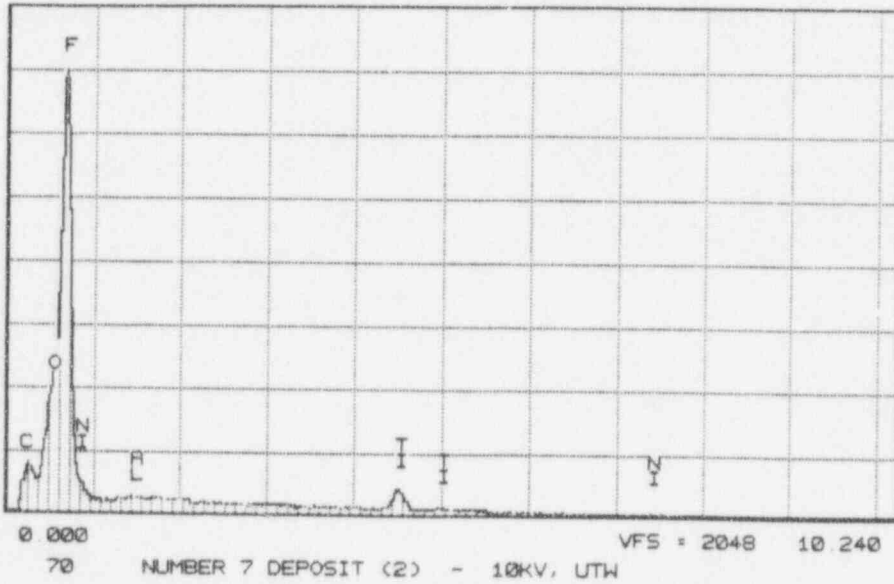
Figure 4-10. Energy Dispersive X-Ray Spectra of the EDM Surface and Deposit for SwRI Wire No. 416.

Figure 4-10 shows the EDS spectrum for the deposit found in the sectioned cask. The deposit was collected with acetate replica tape, then analyzed. Identified elements included carbon, fluorine, aluminum, nickel, phosphorous, and titanium. A higher oxygen peak than in the other EDS spectra was observed. Identification of carbon and fluorine indicates teflon was present in the deposit.

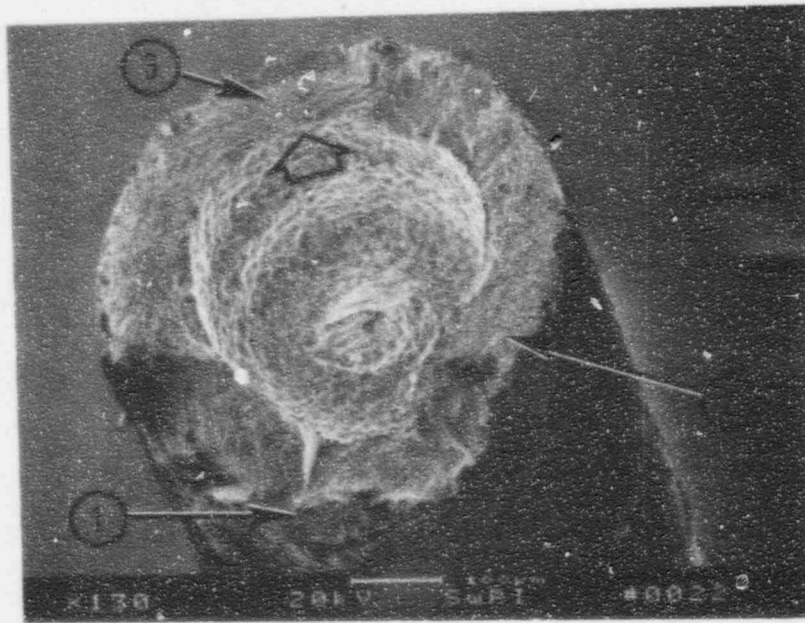
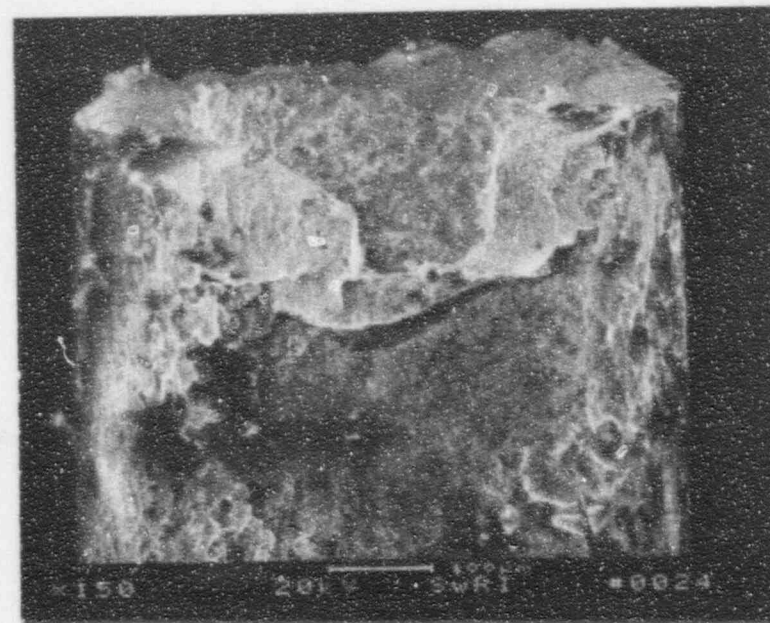
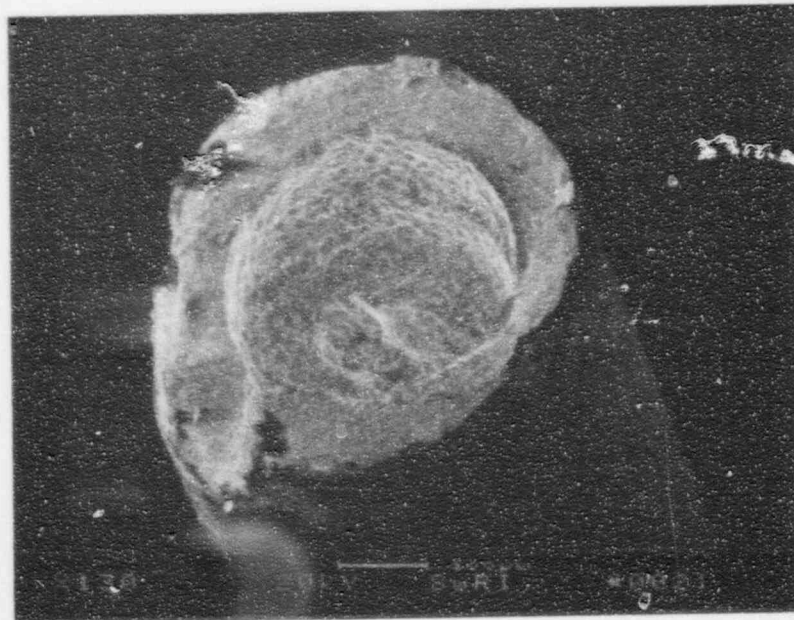
Figure 4-11. SEM Fractographs of SwRI Wire No. 417.
Arrow shows origin.

SwRI Wire No. 417 was exposed to a wet teflon environment for 8 days, then failed in a bend test at the manufacturer. Figure 4-11 shows multiple fracture planes formed during bending of the wire. Two flat areas appeared to have initiation sites at the ID surface. The wire diameter was uniform and the hole centered. The flat regions transitioned to a slant fracture, then a final fracture, shown in Figure 4-11(c). The fracture was characteristic of a brittle failure. Figure 4-12 shows a side view of the failed wire. The OD surface appeared to be covered with some debris. No cracks were noted on the OD surface. Figure 4-13 shows the microfracture features at three locations. The fracture had characteristic dimples in all locations. In Location No. 1, the dimples were elongated, indicating the direction of the failure away from the initiation sites. The EDM surface of the cavity did not have cracks that would have caused the failure.

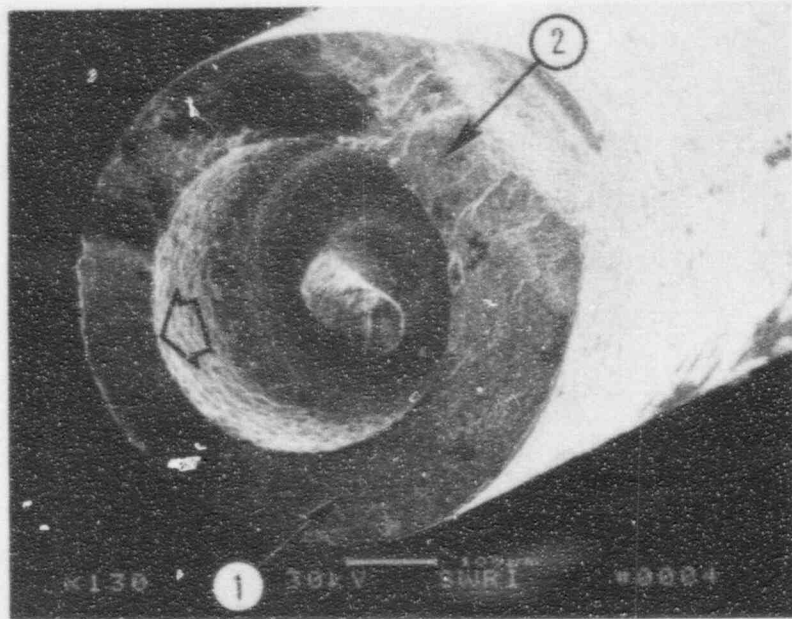
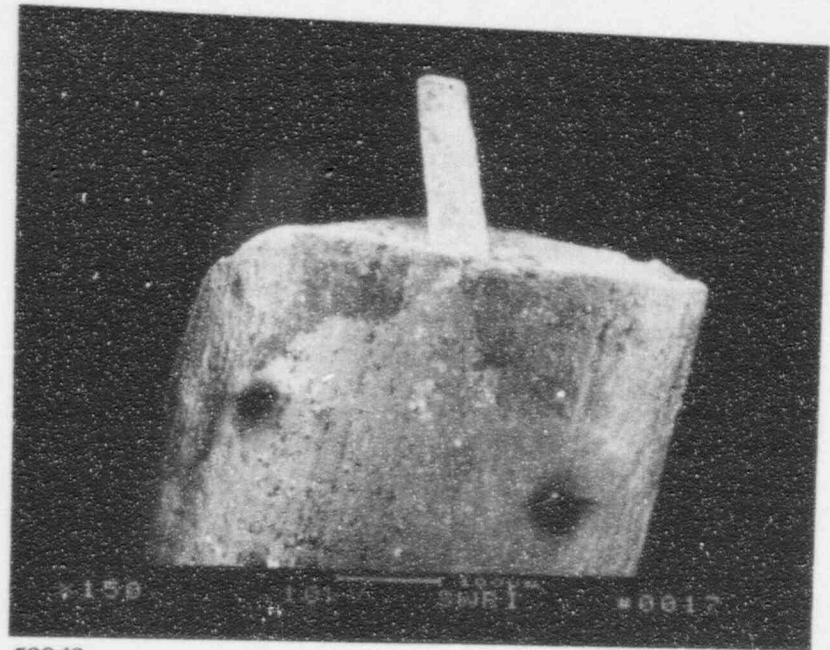
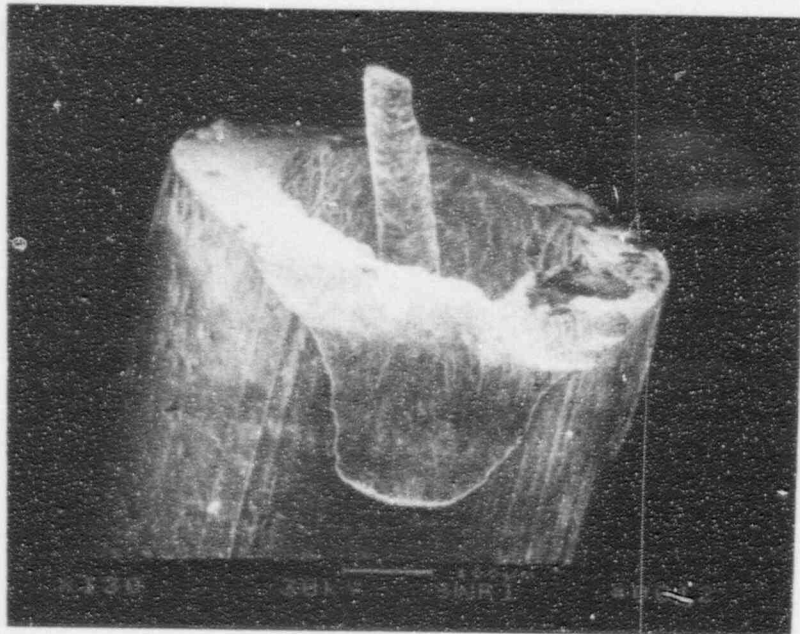
Figure 4-14. SEM Fractographs for SwRI Wire No. 419.

SwRI Wire No. 419 was successfully used in clinical applications, subsequently stored in teflon for 36 days, then fractured in a bend test at the manufacturer. Figure 4-14 shows that the fracture was predominantly flat with a slight slant fracture on one side. The fracture was brittle looking in nature. The diameter of the wire was 0.021 inch. The cavity through the center was slightly offset. The thinned side was 0.0032 inch thick, while the thicker side was 0.0052 inch thick. Figure 4-15 shows flow lines radiating from the ID of the wire at the thinned region. Fracture initiated at the ID, then propagated until complete failure had occurred through the cross section. In the initiation region, the dimples were small and flat, shown in Figure 4-15(b). Figure 4-16 shows the fracture features at other locations on the fracture. The elongated dimples in Figure 4-16(a) indicate that the crack propagated from the initiation site towards the opposite side. The fracture flow lines at the final fracture region, shown in Figure 4-16(b), extended from the ID to the OD surface at a slight angle.

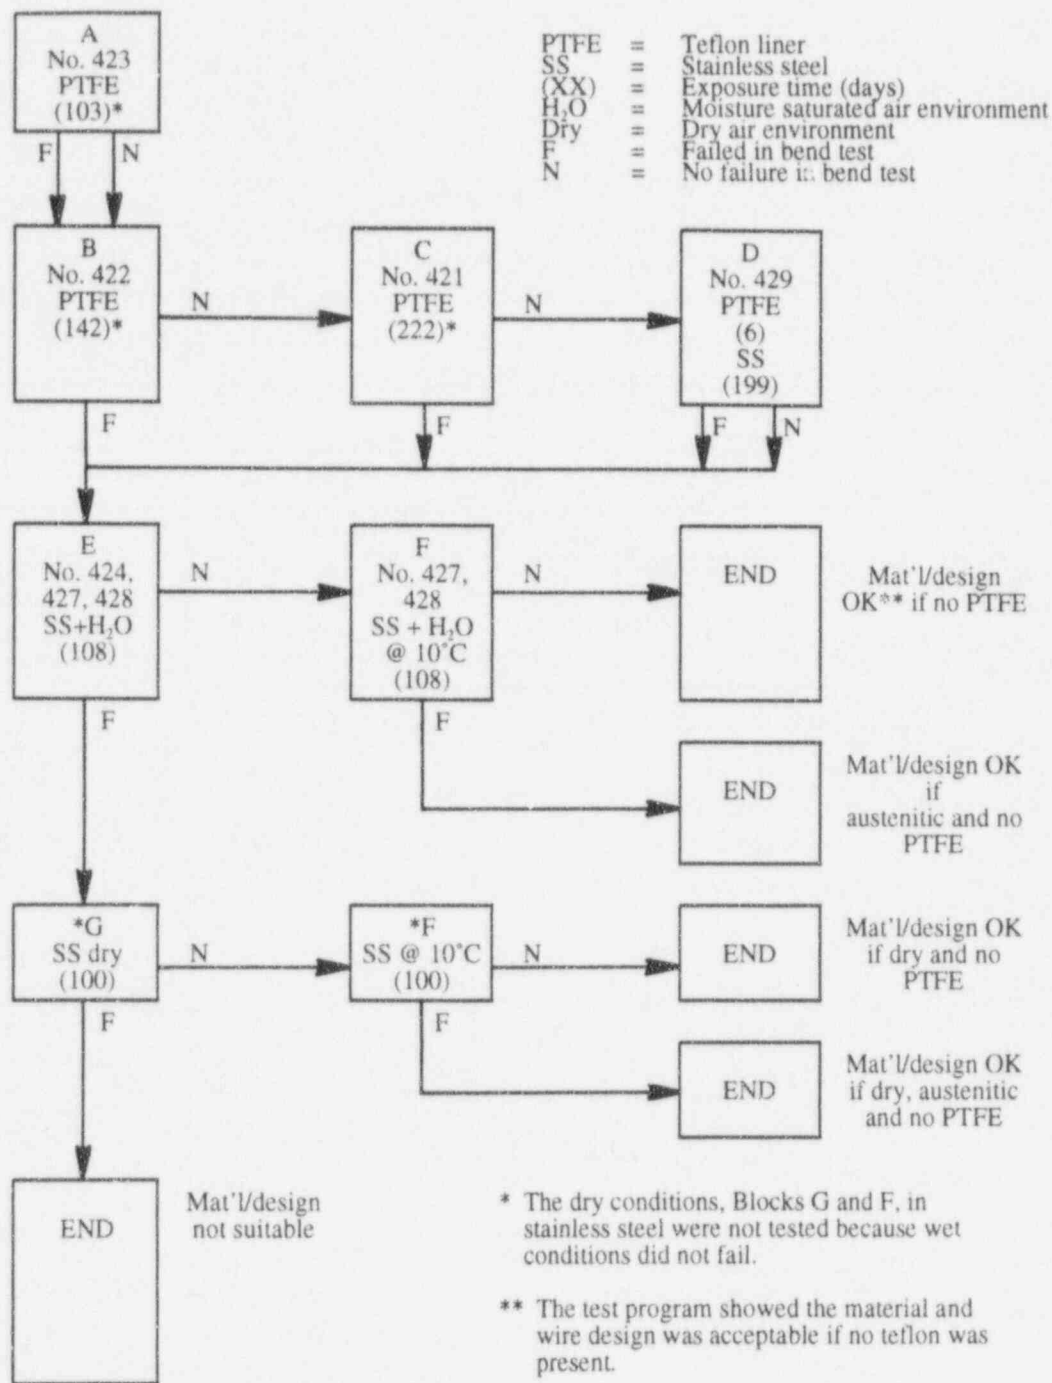
Figure 5-1. Production Source Wires

* The dry conditions, Blocks G and F, in stainless steel were not tested because wet conditions did not fail.

** The test program showed the material and wire design was acceptable if no teflon was present.

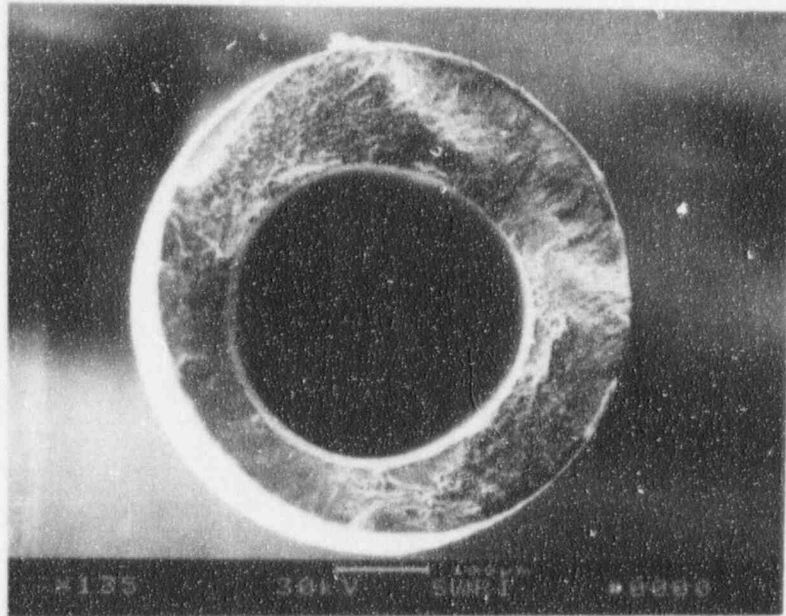
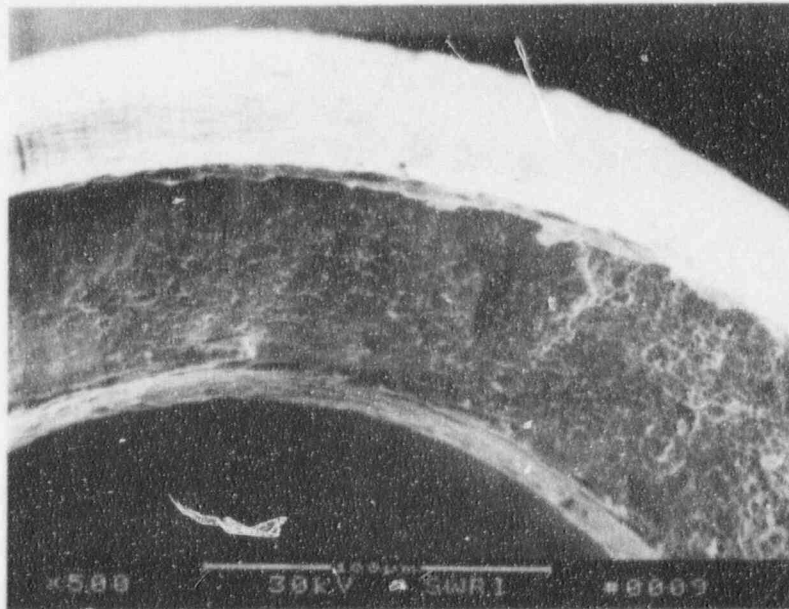
Figure 5-19. SEM Fractograph of SwRI Wire No. 426-1

None of the wires that were pre-tested failed due to embrittlement or a material defect. Wire Nos. 426, 441, 442, and 447 inadvertently failed because of an abnormal test condition. SwRI Wire No. 426 failed because it was overloaded beyond the acceptable strength of the material. Figure 5-19 shows the macroscopic features indicating that the wire yielded and the wall thinned. This type of fracture was unlike the clinical service failures. During these preliminary tests, some of the other wires were deflected nearly 90°. Later it was determined, based on the surface appearance of the wires and the failure of SwRI Wire No. 426, that 90° may have been too severe and actually may have taken the wire to an overload condition. The purpose of the bend test was to evaluate embrittlement conditions and not the maximum bending load to

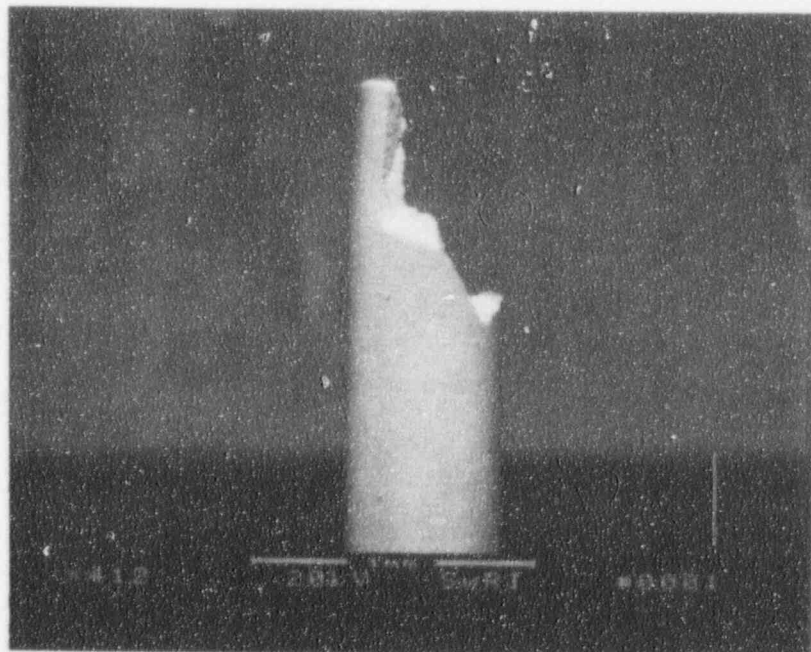
Figure 5-20. SEM Macrophotograph of SwRI Wire No. 442-1

During the pre-test, Specimen Nos. 441, 442, and 447 broke. It later became evident that the wires were not completely bottomed out when inserted into the test fixture. There was a groove in the aperture that prevented the wire from going down. As a result, the wires were loaded in an abnormal way. Failure occurred at the midway portion of the cavity. This was verified on Specimen No. 441, which actually had the pellets fall out and Specimen No. 447, which was broken 9.5 mm from the tip. The fracture surfaces of SwRI Nos. 441 and 447 were not examined because both ends were too radioactive. Figure 5-20 shows failed SwRI Wire No. 442. Appendix B has a more detailed evaluation of SwRI No. 442. Sample Nos. 443, 444, 445, 446, and 448 were bend tested with no failure, then stored in moisture as backup. These specimens were never retested.

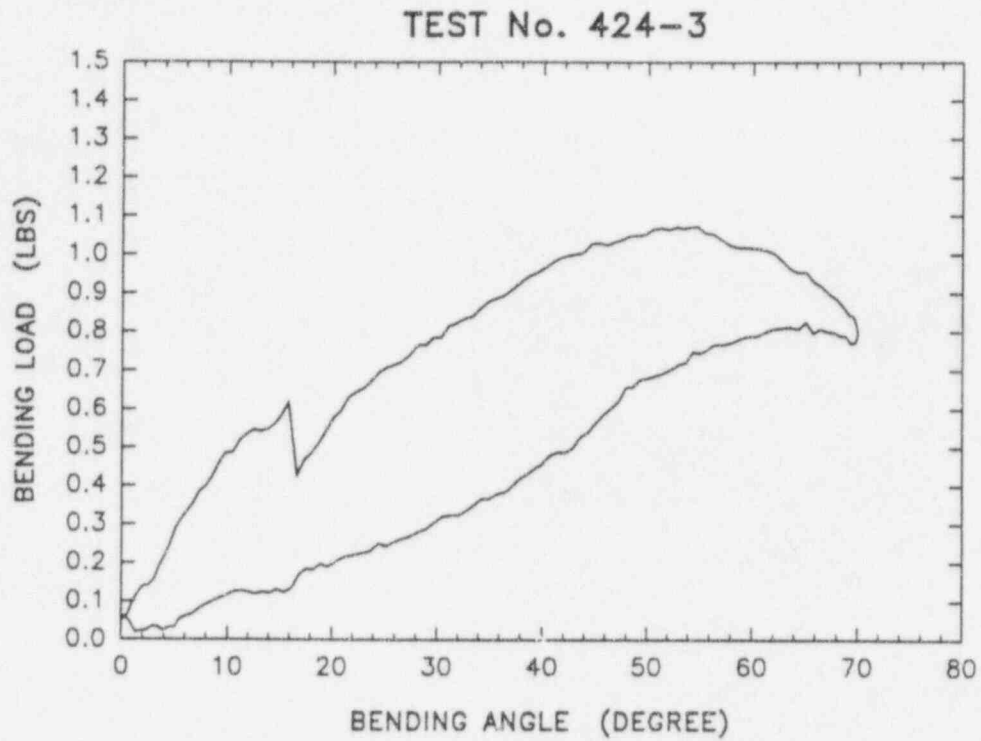
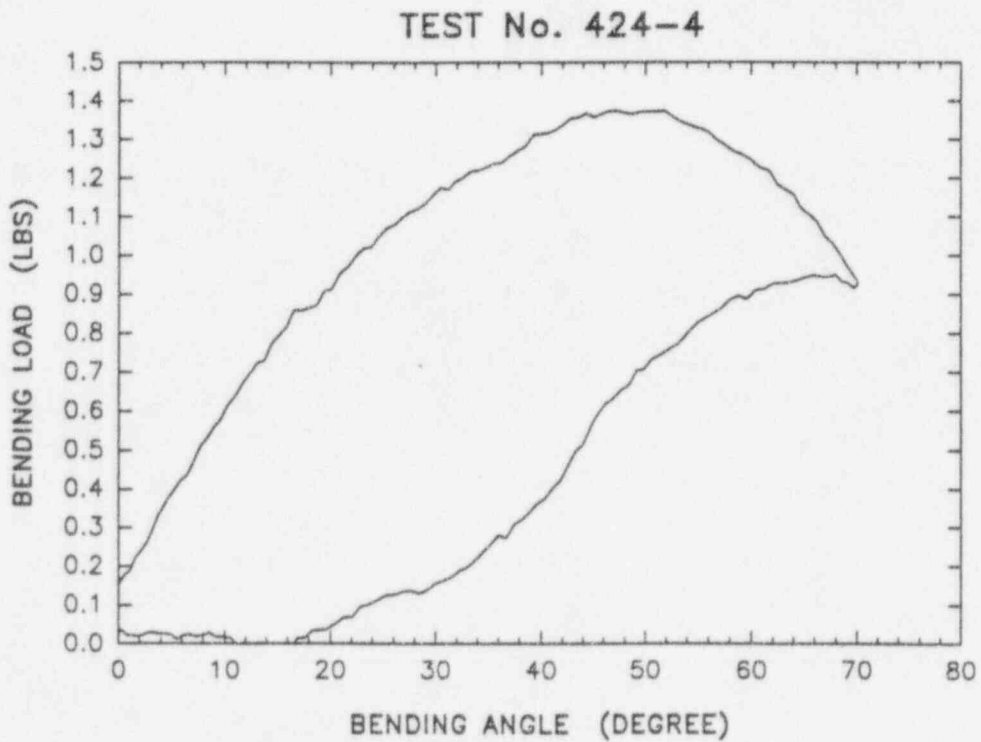
Figure 5-22. Bend Test Plots of Load vs. Angle of Deflection for SwRI Wires, Nos. 424-3 and 424-4

As a result of Sample No. 425 not being available, Sample No. 424 was tested and Sample Nos. 427 and 428 were retested at room temperature. All three samples were tested to a displacement of 0.36 inches and a deflection of 70°. Again, none of the samples failed. Sample No. 424 was bend tested two times. Figure 5-22 shows a slight load drop occurred at 16° deflection. To confirm that the wire was not cracked, the sample was rotated 180° then retested. No failure occurred, indicating that moisture alone had no detrimental effect on the Nitinol wire.

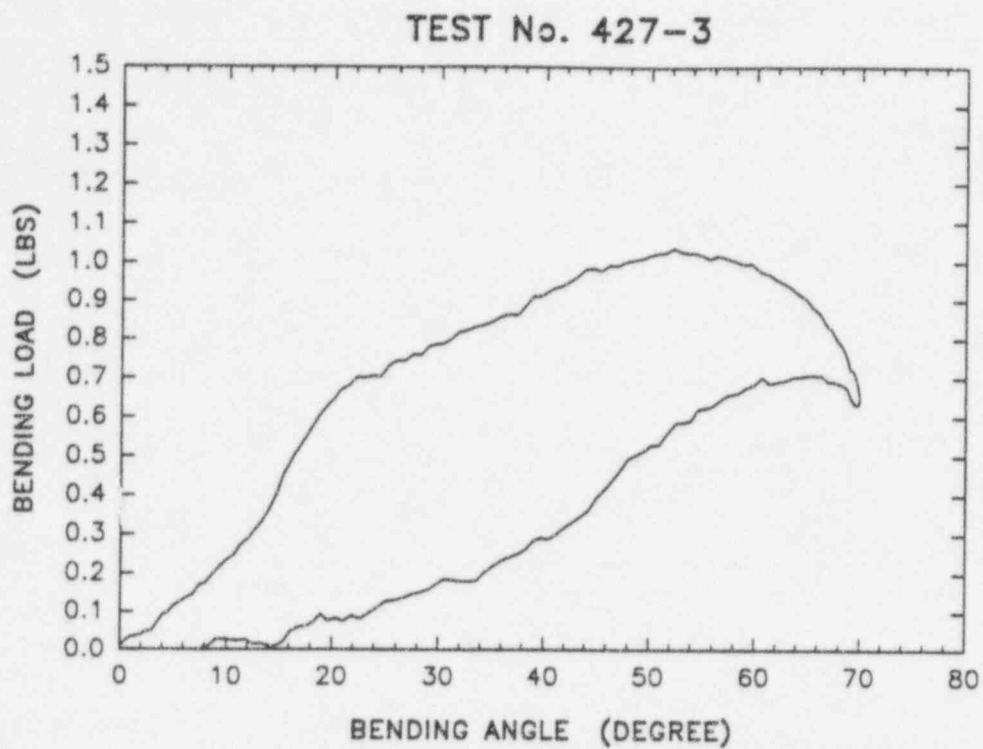
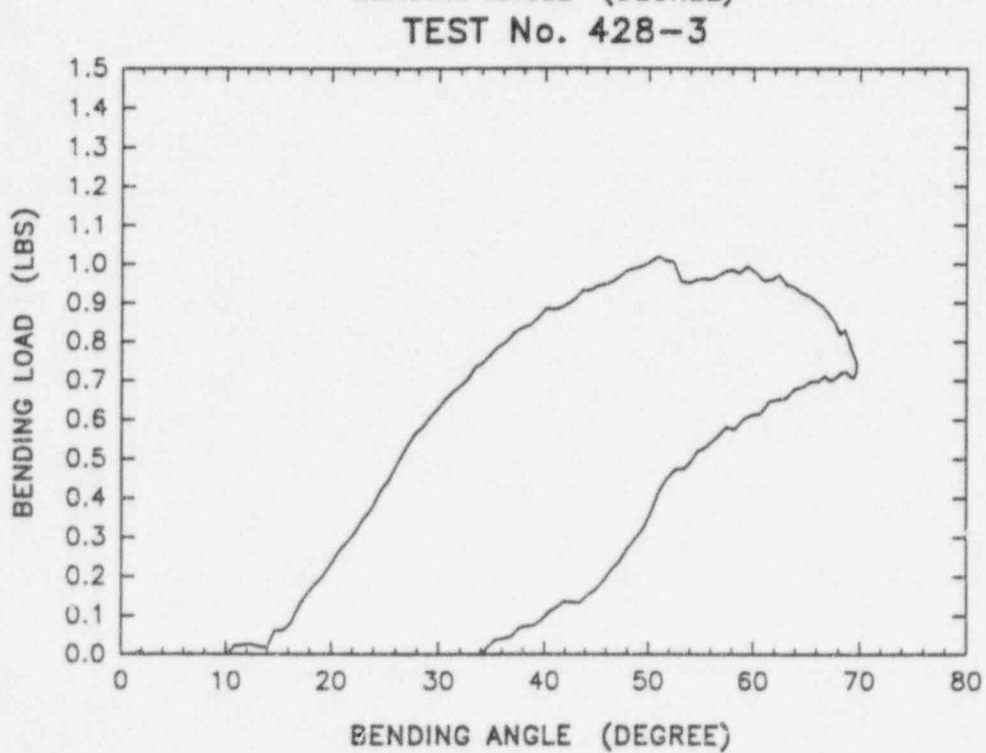
Figure 5-23. Bend Test Plots of Load vs. Angle of Deflection for SwRI Wires, Nos. 427-3 and 428-3

After 108 days exposure to moisture, Sample Nos. 427 and 428 were extracted from the lead casks and tested at temperatures below the transformation temperature in accordance with the description in Section 5.4.1. Figure 5-23 shows that both the wires deflected 70° with no failure.

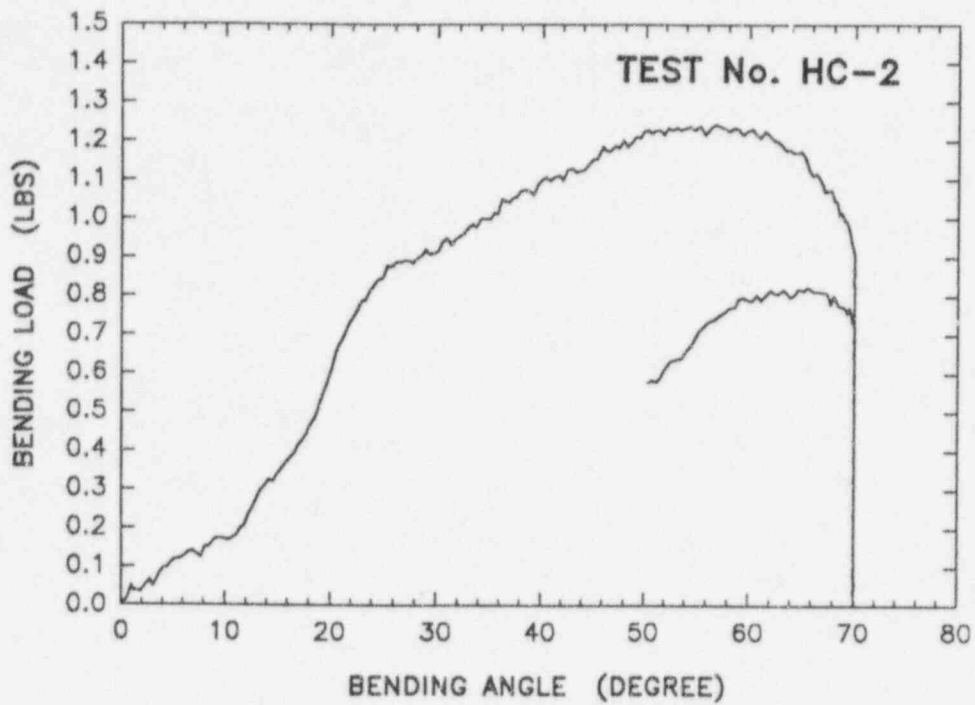
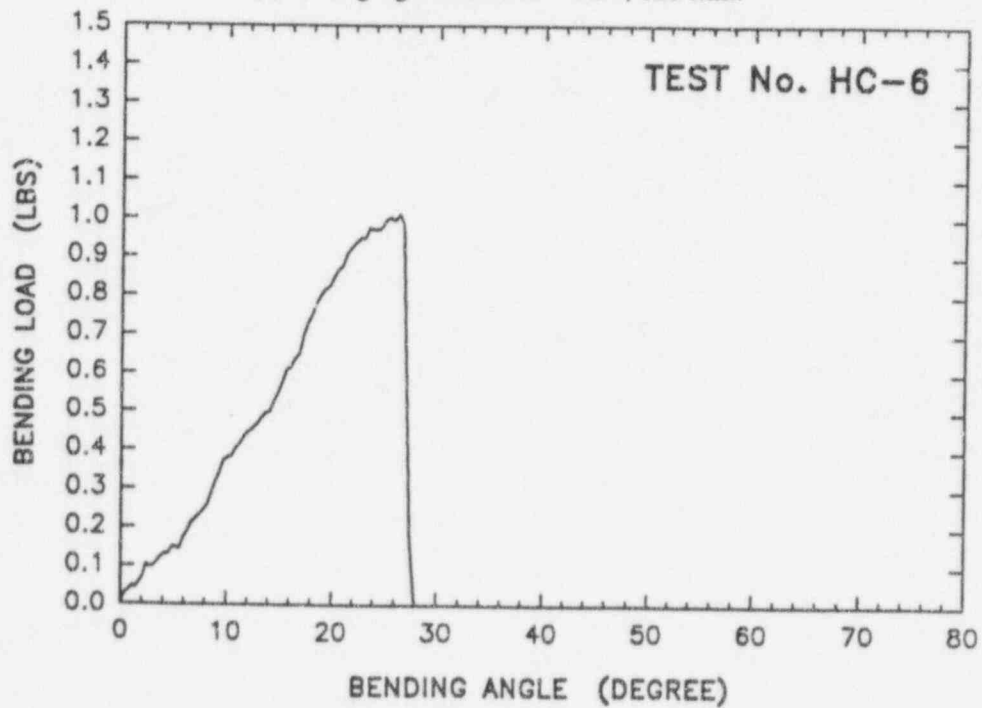
Figure 5-24. Load/Deflection Curves for Hydrogen-Charged Specimens

Initially, three tests were performed with a charging potential of -0.5v and a charging time of 120 minutes (Nos. HC-1, HC-2, and HC-3). None of the three specimens failed, indicating that the charging conditions were not adequate for significant embrittlement. A representative load/deflection curve from this group is shown in Figure 5-24(a). A second set was then tested after charging for 120 minutes at a potential of -1.0v (Nos. HC-4, HC-5, and HC-6). The results of these tests are included in Table 5-3 and presented graphically in Figure 5-24(b). Two of these three tests resulted in brittle fracture at bend angles of 28° and 34°. The low bend angle at fracture clearly demonstrates the embrittling effect of the charging conditions.*
