NUREG/CR-6074
04-4448-010
Vol. 2

Sealed Source and Device Design Safety Testing

Technical Report on the Findings of Task 4

Investigation of Failed Nitinol Brachytherapy Wire

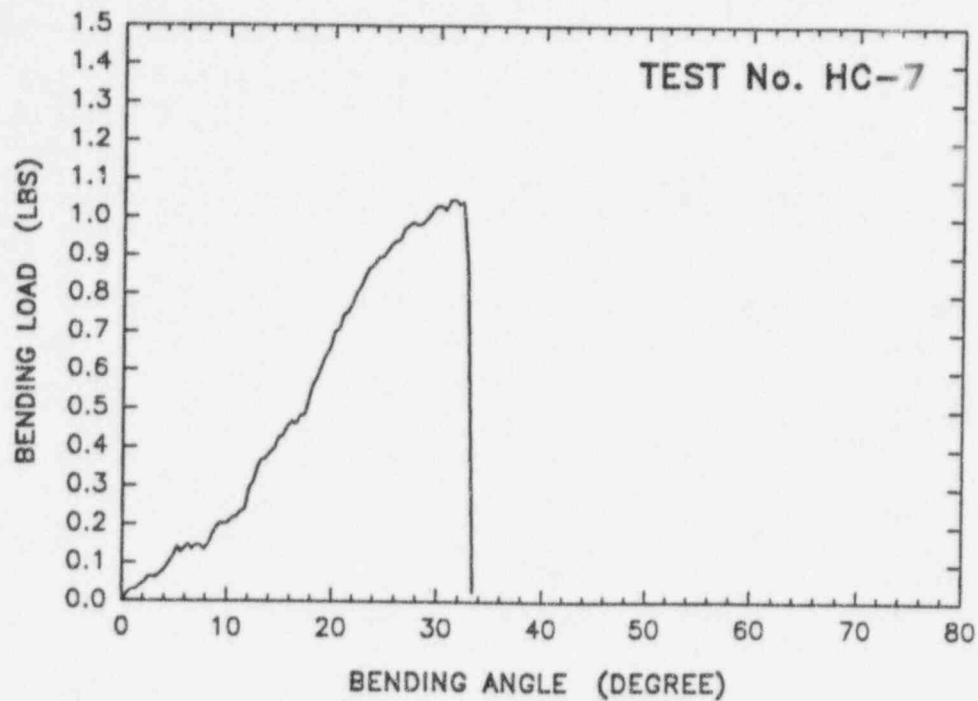
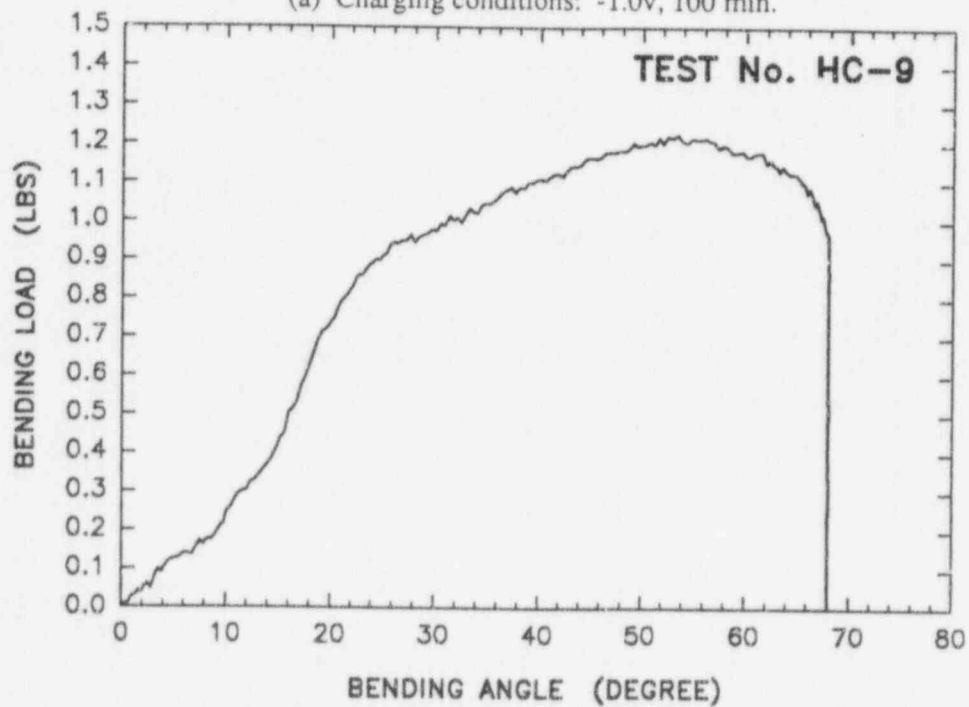
Figure 5-25. Load/Deflection Curves for Hydrogen-Charged Specimens

The third set of three tests maintained the charging potential of -1.0 volt, but employed successively shorter charging times of 100, 80, and 60 minutes. These results are included in Table 5-3 as Nos. HC-7, HC-8, and HC-9. Test No. HC-7 resulted in brittle fracture at a low bend angle, see Figure 5-25(a). Tests No. HC-8 and No. HC-9 both survived the full bend angle without fracture, [Figure 5-25(b)].**

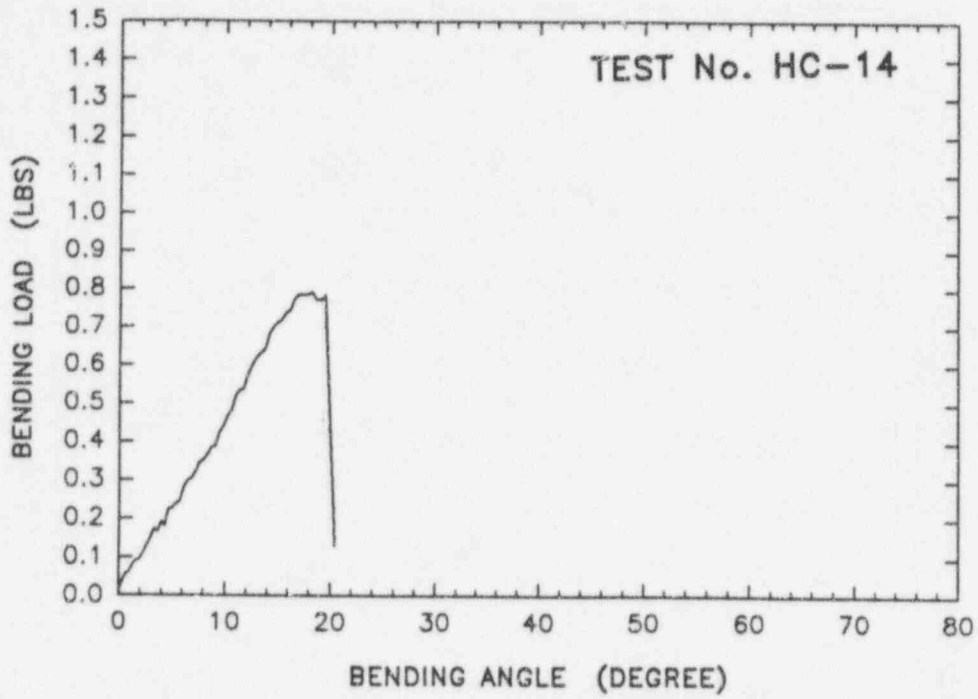
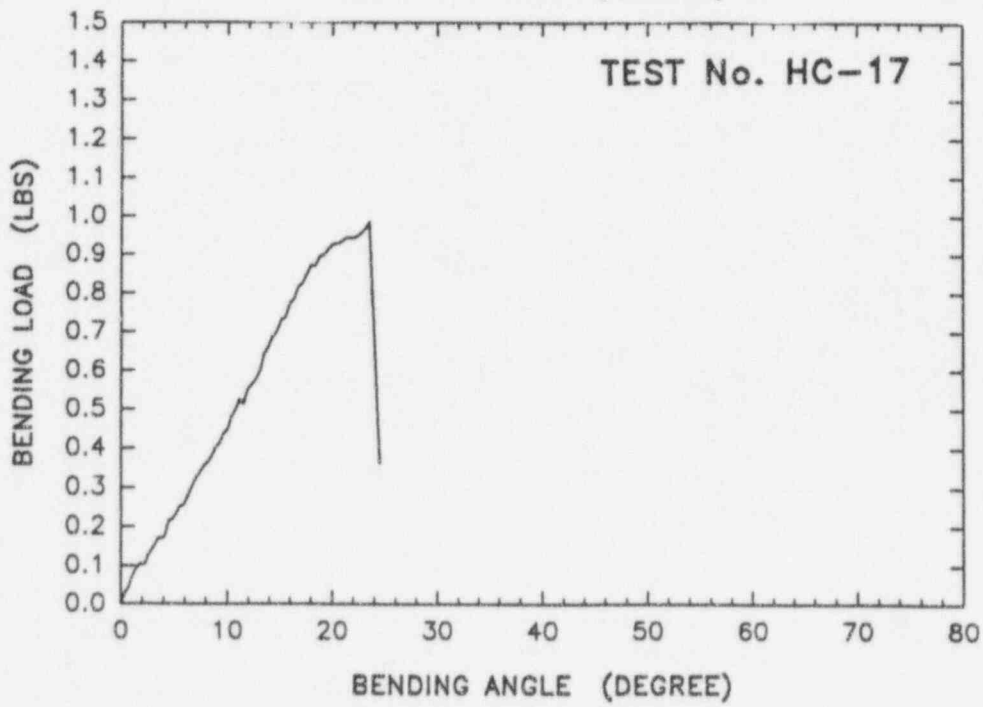
Figure 5-26. Load/Deflection Curves for Hydrogen-Charged Specimens. Charged at -f1.0v for 120 min.

Fourteen tests were performed on hydrogen-charged specimens to provide for triplicate tests at any one set of test conditions and to investigate the tendency for recovery of original properties after delay at room temperature and after a bake-out procedure. These test results are presented in Table 5-4 as Tests Nos. HC-12 through HC-23, and representative load/deflection curves are shown in Figures 5-26 and 5-27. The first three of these (HC-12, HC-13, and HC-14) constituted repeat tests for the particular charging conditions chosen (-1.0v, 120 min.). All three of these resulted in brittle fracture at low angles of deflection (19°-26°); see Figure 5-26(a).

Six other tests in this group (HC-15 through HC-20) were performed with planned delays of 16 hours and 52 hours after completion of the charging procedure. As may be noted in Table 5-4, all three specimens tested after a 16-hour delay failed at a low angle of deflection (24°-36°), see Figure 5-26(b). Those representing a 52-hour delay survived the full deflection angle without cracking or fracture; see Figure 5-27(a). Tests HC-21, HC-22, and HC-23 were performed after the charged specimens were baked out at 450°F for 2 hours. In all three cases, the full-bend angle (70°) was attained without cracking or fracture. A representative load/deflection curve for this group of three tests is shown in Figure 5-27(b). These results together with those from the test with a 52-hour delay demonstrate that the embrittlement process is reversible and of the same nature as the classic hydrogen embrittlement process involving the absorption of nascent hydrogen.

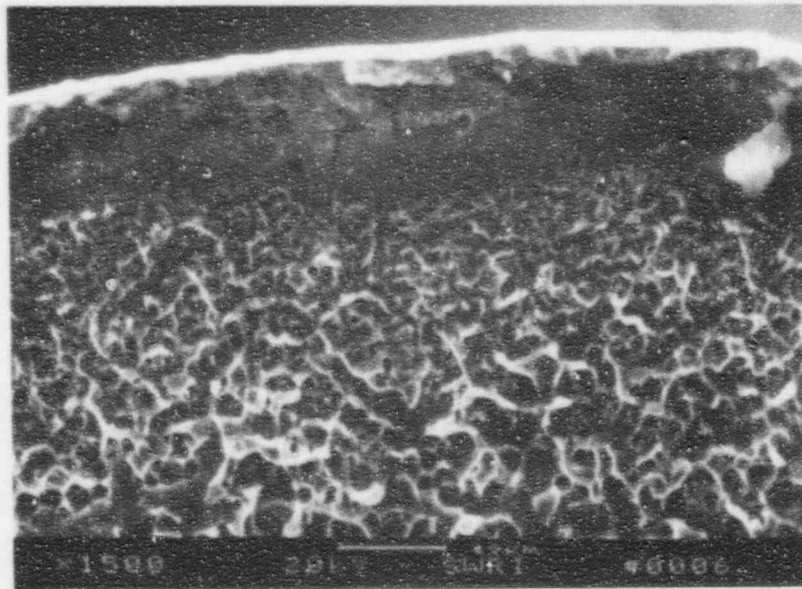
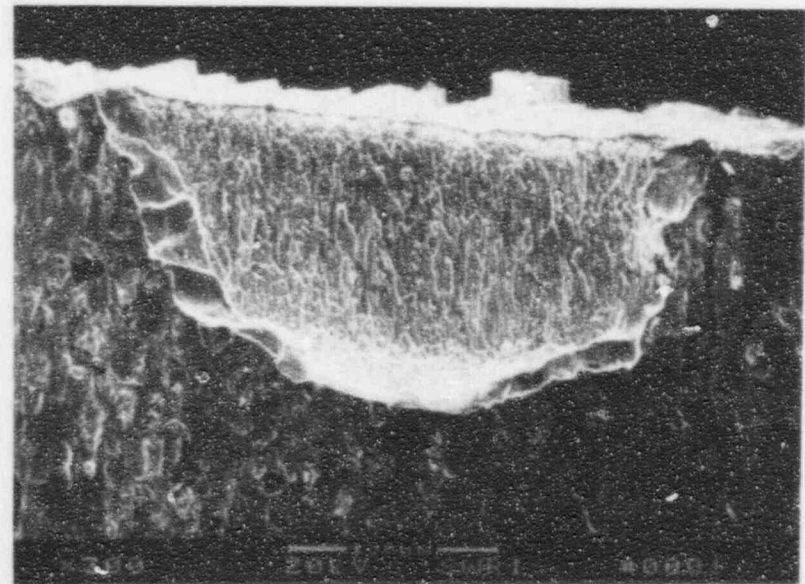
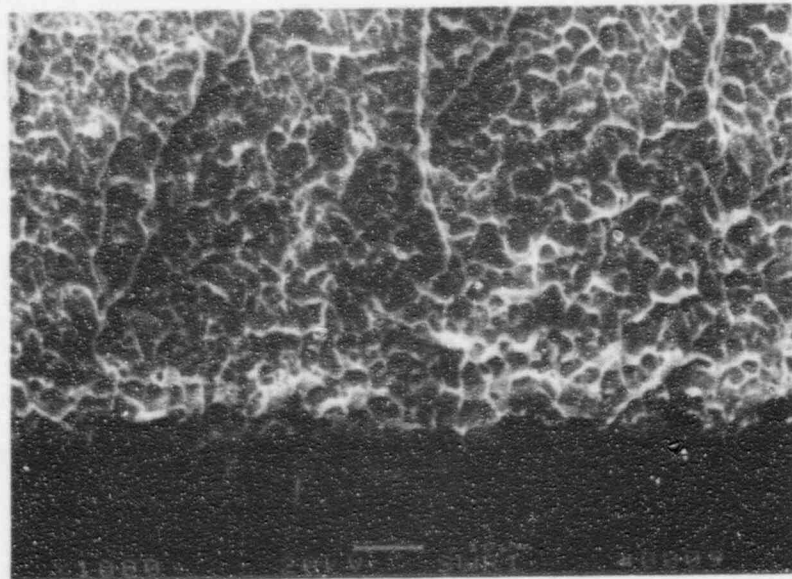
Figure 5-29. SEM Fractographs from Hydrogen-Charged Specimen. Test No. HC-6. See Figure 5-28 for locations.

The fine-scale topography consisted of well-developed, generally equiaxed dimples characteristic of fracture by microvoid growth and coalescence, see Figure 5-29. Localized tear dimples also confirmed the direction of crack propagation as from the tension side to the compression side of the bend.

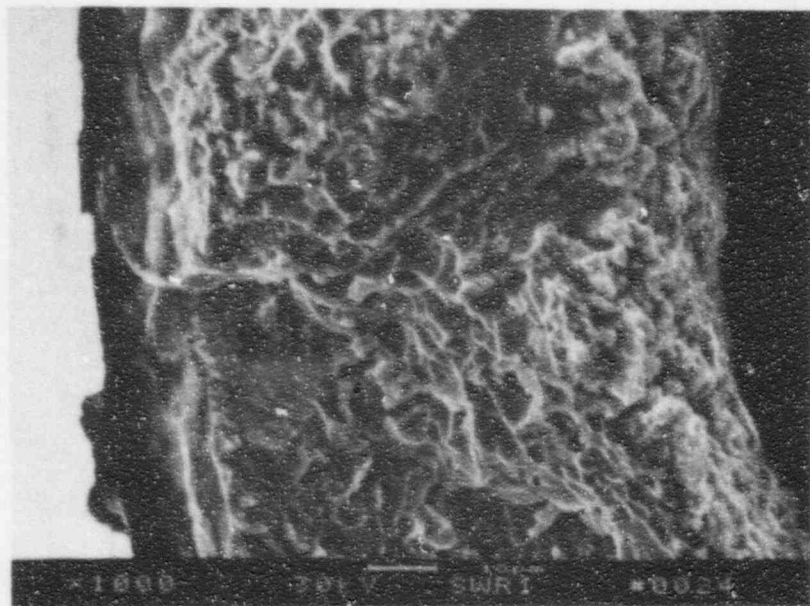
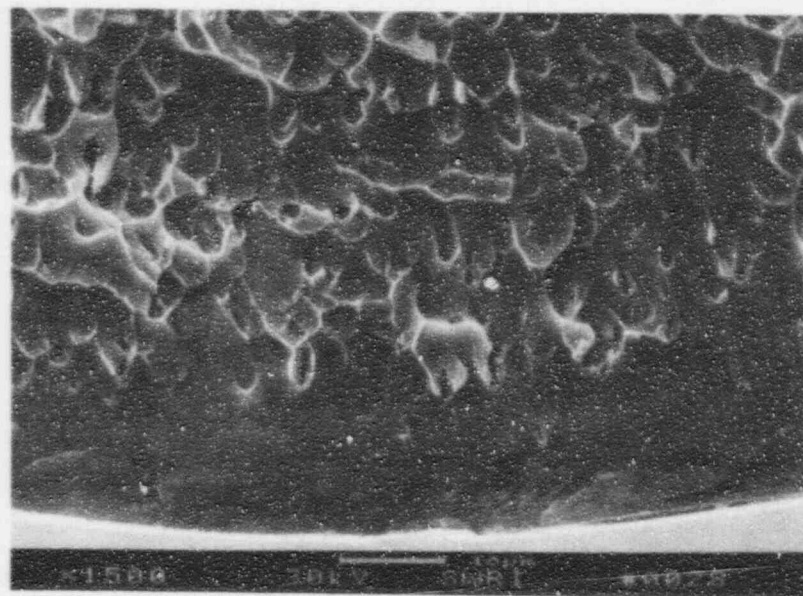
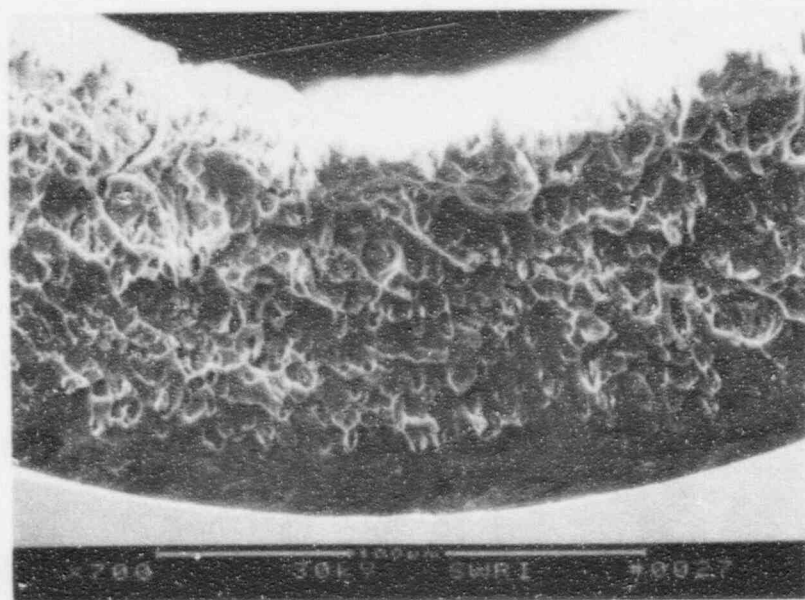
Figure 5-31. SEM Fractographs from Hydrogen-Charged Specimen. Test No. HC-10, simulated sourcewire. See Figure 5-30 for locations.

The fine-scale topographic features are illustrated in Figure 5-31. Distinct dimpled features characteristic of microvoid growth and coalescence were evident completely around the fracture surface. A distinct rim with a nearly featureless topography, similar to that observed in the solid wires was also evident at the outer periphery of the fracture. In both of these cases, the orientation of tear dimples indicated a direction of fracture from the outer rim inward through the cavity wall [Figure 5-31(b)].

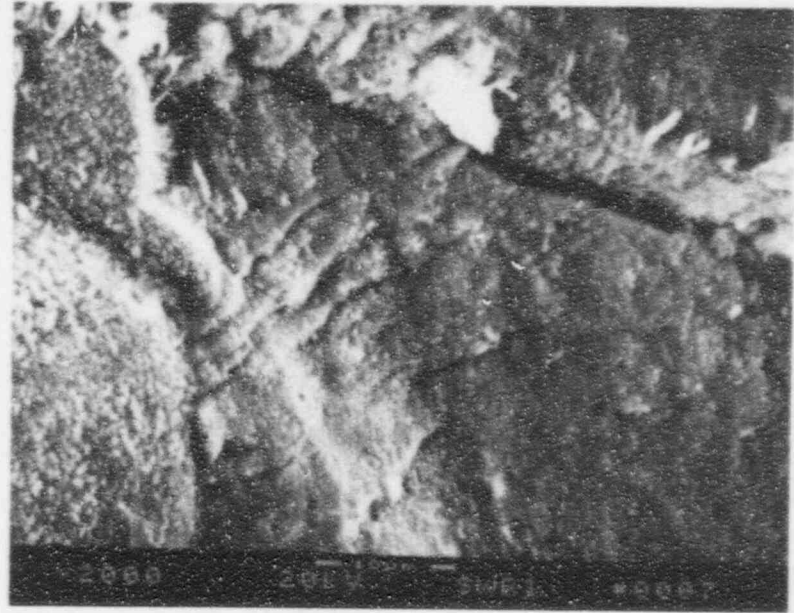
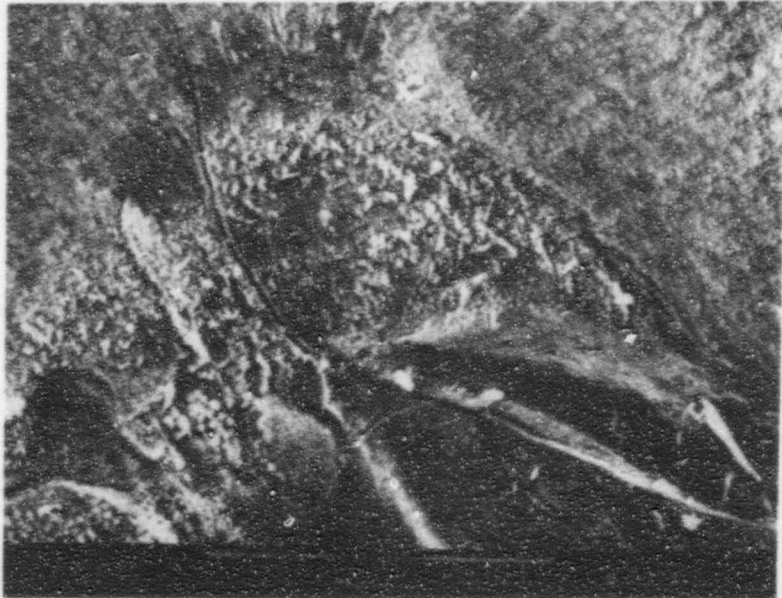
Figure B-11. SEM Fractographs of Locations C and D on Wire Sample No. 421-1 in Uncleaned Condition

Figure B-9 shows that the wire failed in the solid section of the wire which was beyond cavity. Overall the fracture was smooth with some relief. There was no distinct flat zone. Figure B-10 shows that the OD of the wire had a dirty, layered appearance causing the sample to charge in the SEM. Figure B-11 shows a longitudinal crack through the center of the fracture. The fracture surface, even after ultrasonic cleaning in acetone, was covered with debris. Figures B-12 and B-13 show a close-up of some of the debris and fracture surface which was brittle in nature.

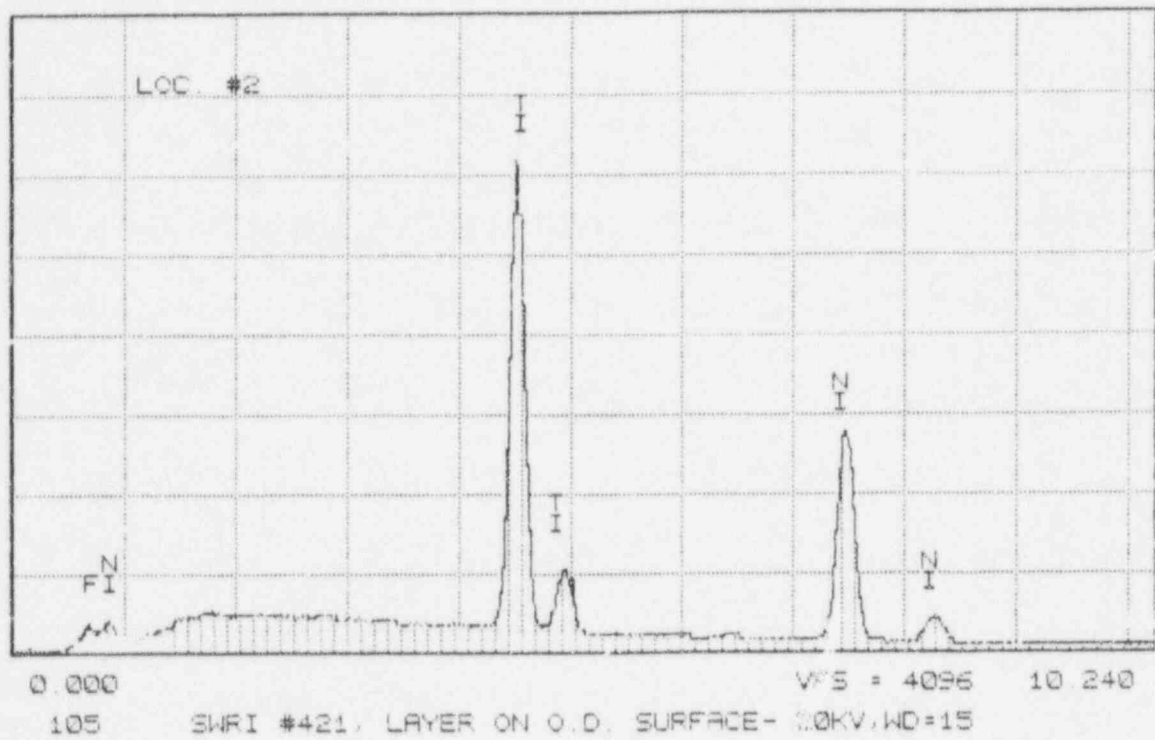
Figure B-15. Energy Dispersive X-Ray Spectra for the OD of SwRI Wire No. 421-1, Location 2

Energy dispersive X-ray spectra, shown in Figures B-14, B-15, B-16, and B-17, were generated on the OD of the wire and the fracture surface. The typical elements for Nitinol, titanium and nickel were identified. Additional elements identified included fluorine and oxygen. The fluorine obviously was a by-product of the teflon degradation. Figure B-51 shows that fluorine and carbon are the main elements for teflon. Even the fracture surface had significant amounts of fluorine present after cleaning the surface.

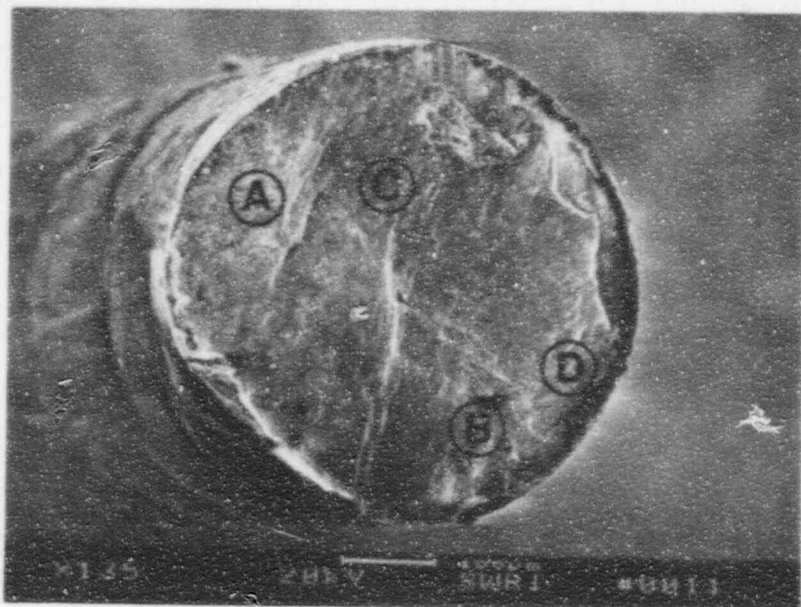
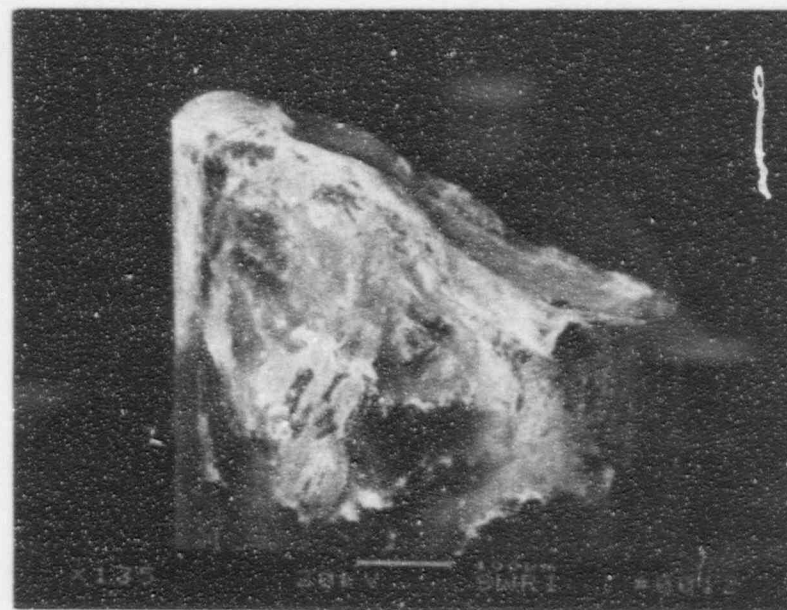
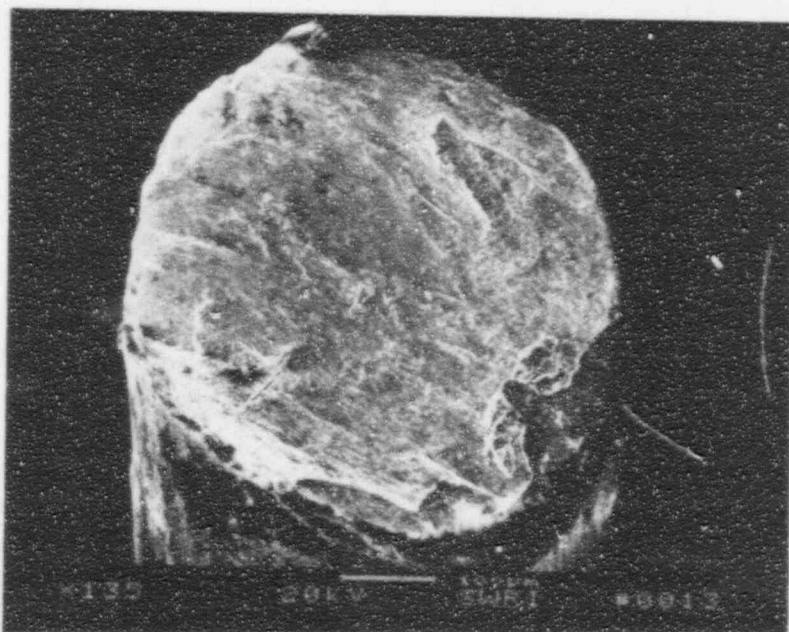
Figure B-18. SEM Fractograph of SwRI Wire No. 422-1

Wire sample No. 422 was stored in teflon 142 days. The wire was still intact and was not severed or deteriorated after extraction from the storage cask. The wire was bend tested and failed. Figure B-18 shows that the break occurred in the solid section of the wire. The fracture plane was angled at 30° from the axis of the wire. The diameter of the wire was uniform and measured 0.021 inch. The fracture surface was smeared and had shear marks on the surface. Figures B-19 and B-20 show that shear dimples were present in several locations. Microfracture features of the dimples indicate a shear, tearing failure occurred. The direction of the dimples and the elongated fracture flow lines indicated the fracture progressed along the slant fracture. Figure B-21 shows the OD surface had some evidence of contamination or debris build-up. EDS spectra, shown in Figure B-22, determined typical elements of titanium, and nickel about 3/8 of an inch away. Adjacent to the fracture, fluorine, oxygen, sodium, potassium, and aluminum were all identified.

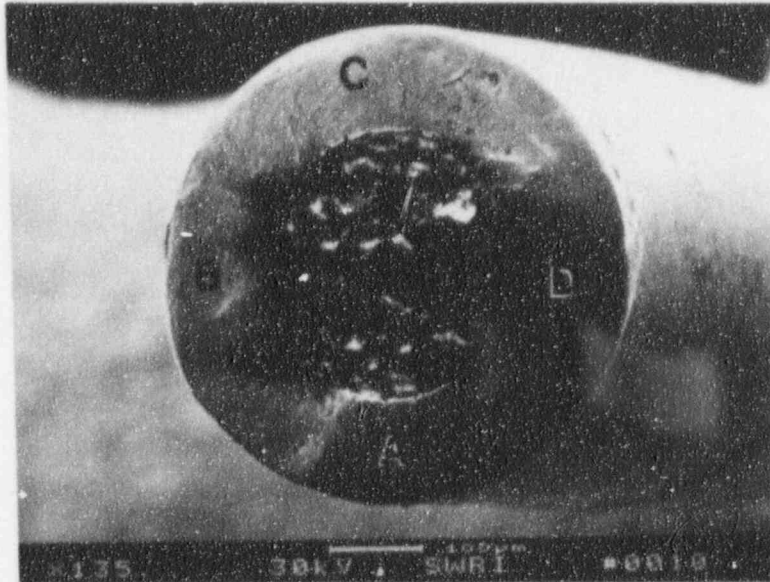
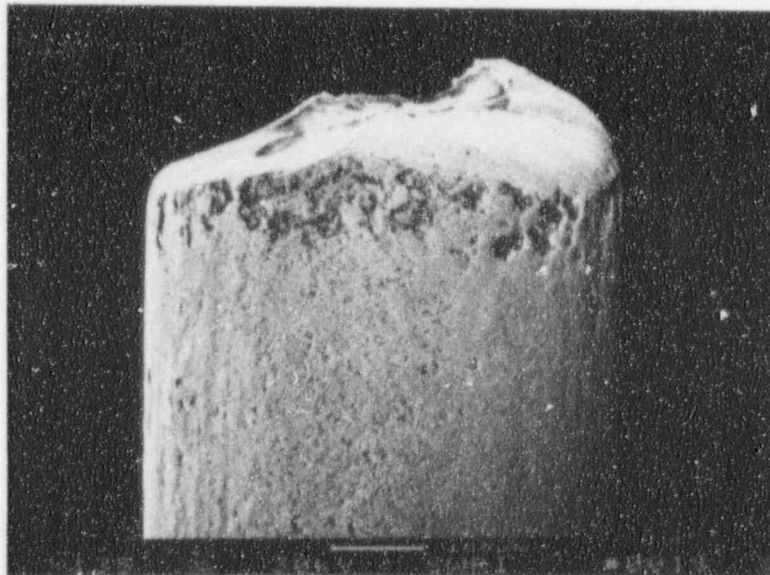
Figure B-23. SEM Fractographs of SwRI Wire No. 423-1.

Wire Sample No. 423 was stored in PTFE for 103 days, after extracting from the lead storage cask the wire was noticed failed. No bend test was performed on this wire. SEM fractography, shown in Figures B-23 and B-24, shows that the fracture occurred at the base of the cavity. Figures B-25 and B-26 show the fracture was burnished. Figure B-27 shows the fracture surface was covered with a film, oxide, etc. The wire did not display a layered surface appearance as wire Sample No. 421, see Figure B-10. No distinct or definitive fracture features were evident.

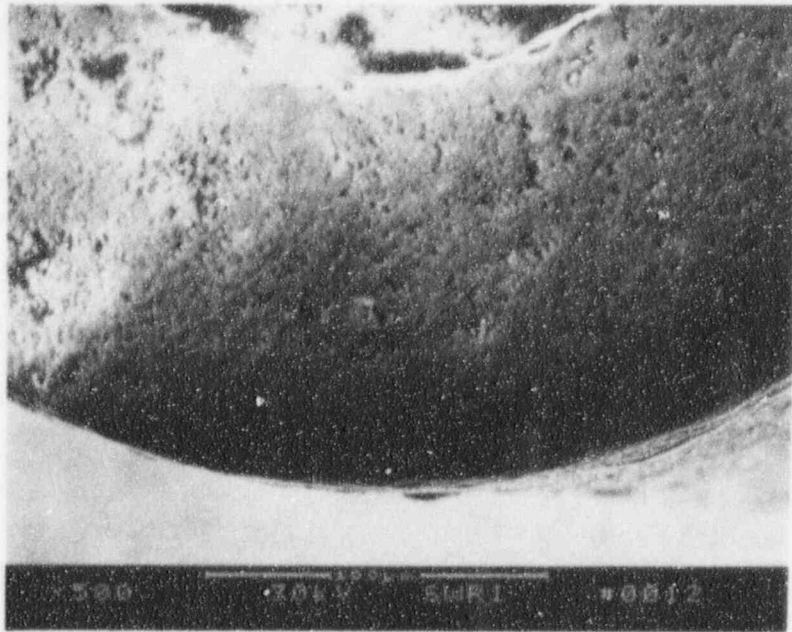
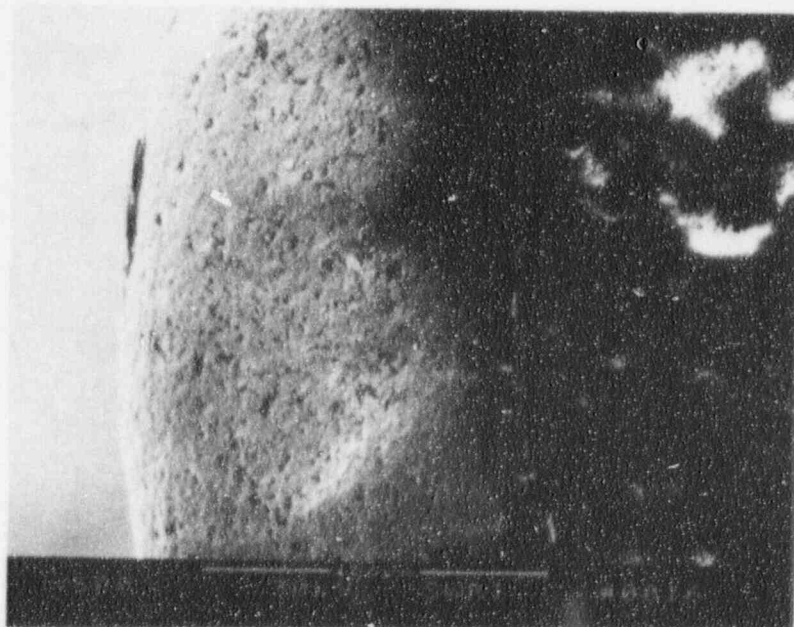
Figure B-25. SEM Fractographs at Locations A and B for SwRI Wire No. 423.

The profile of the failed wire showed a slight slant from two opposite sides of about 20°. The radial flow lines may be indicative of initiation on the inside diameter. The OD surface of the wire in the vicinity of the fracture appeared to have some residual material on the surface. However, the material was not deteriorated. The wall thickness of the cavity was not thinned and was uniform throughout. The diameter of the wire measured 0.020 from the SEM photograph.

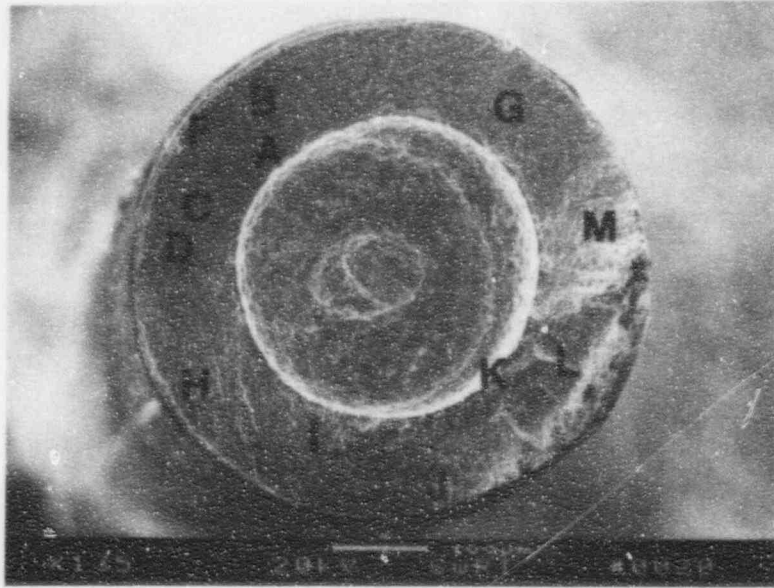
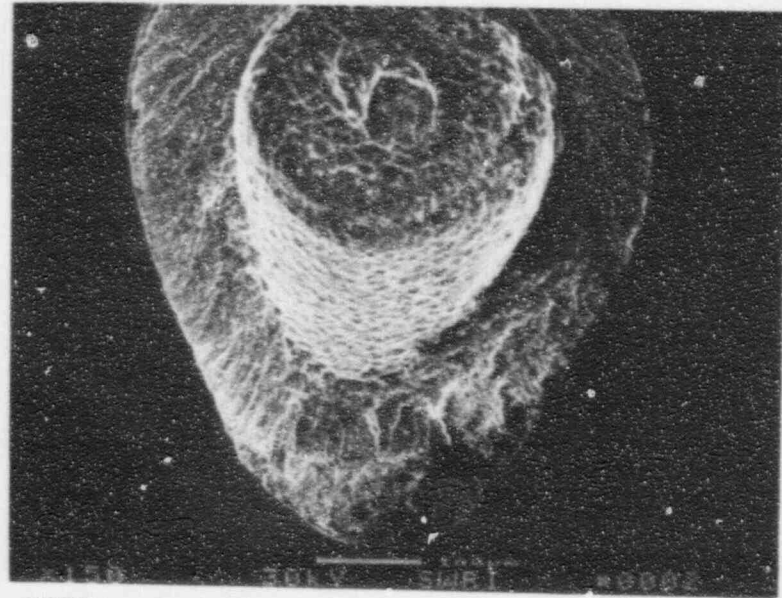
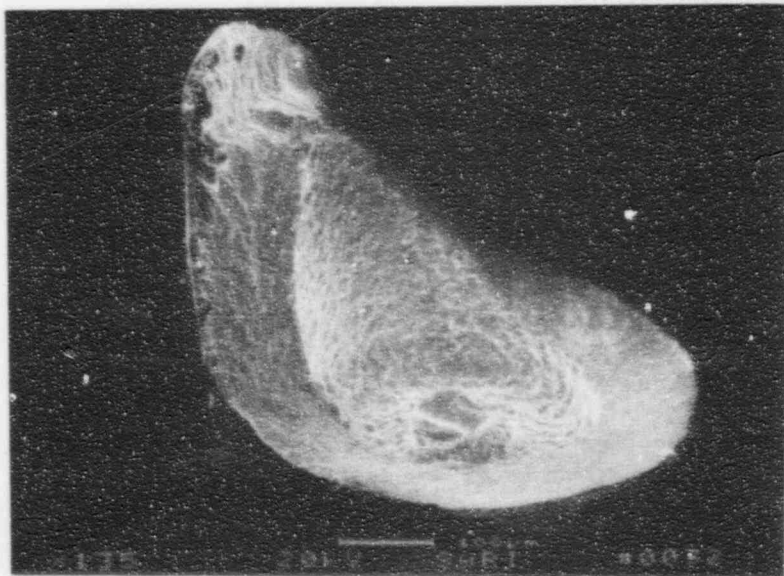
Figure B-28. SEM Fractographs of SwRI Wire No. 429-1.

Figure B-28 and B-29 show that failure occurred at the base of the cavity. A flat region existed for 50% of the fracture surface, then a steep slant occurred which eventually failed through the OD. The tip of the slanted portion extended about 0.016 inches from the flat region. The OD measured 0.022 inches. Figure B-30 shows the OD surface with a darkened network that appeared to etch or attack the surface. A stereo pair, shown in Figure B-31, identified the network to be small cracks.

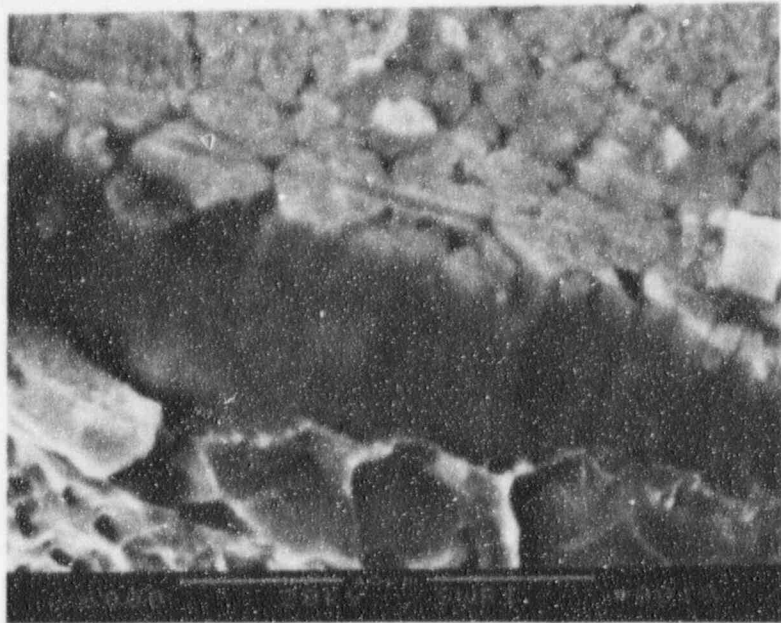
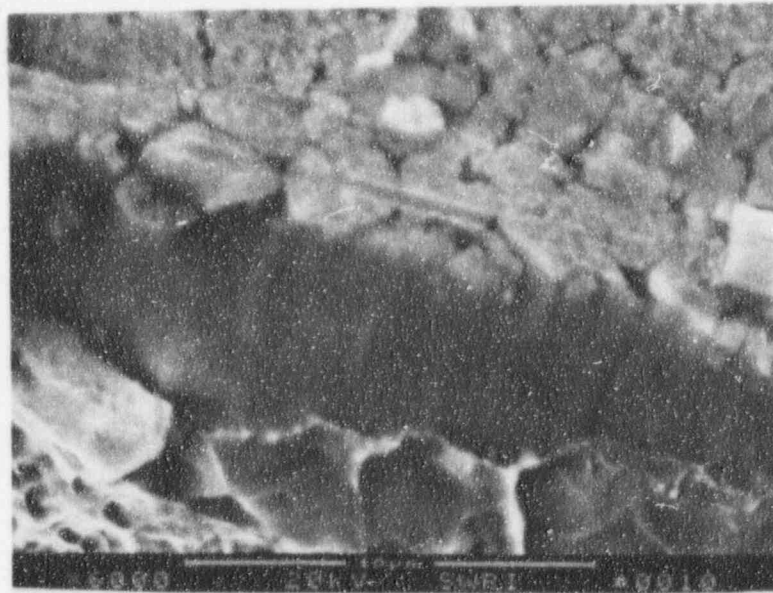
Figure B-31. SEM Fractograph Stereo Pair of the Attack Network on the OD Surface for SwRI Wire No. 429-1.

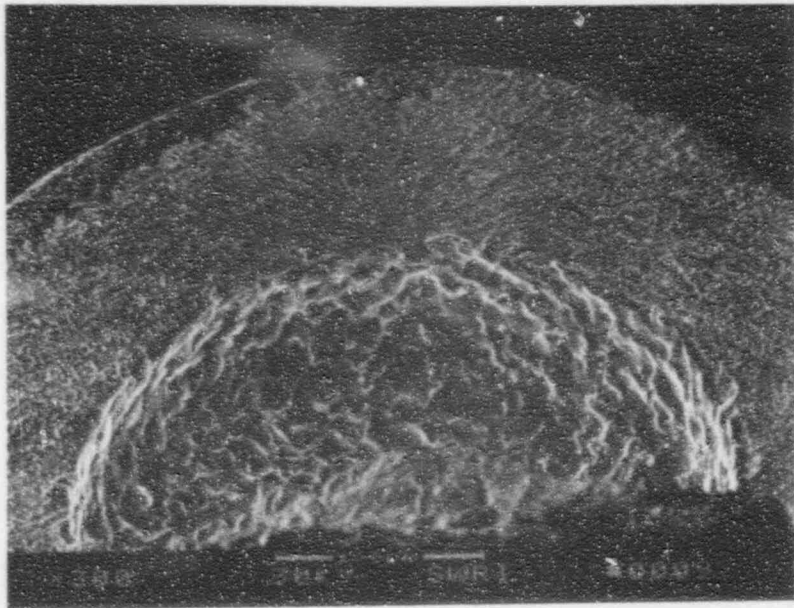
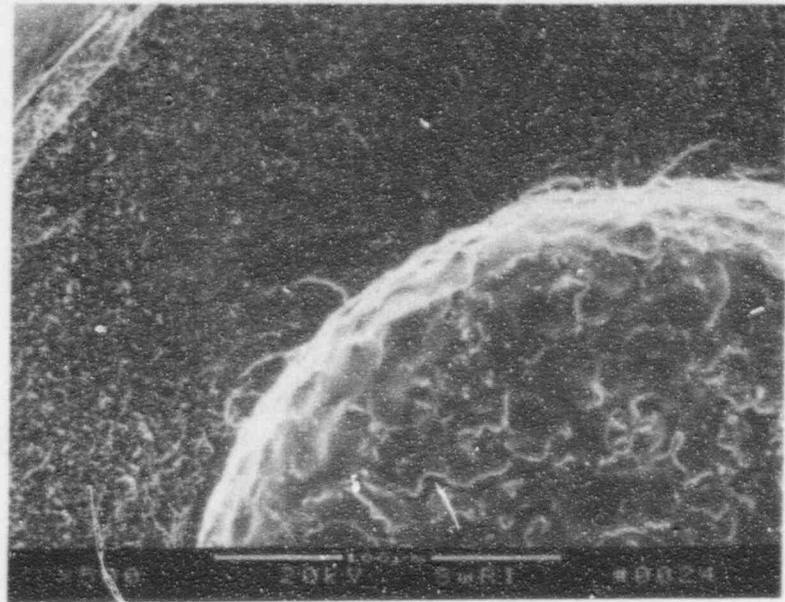
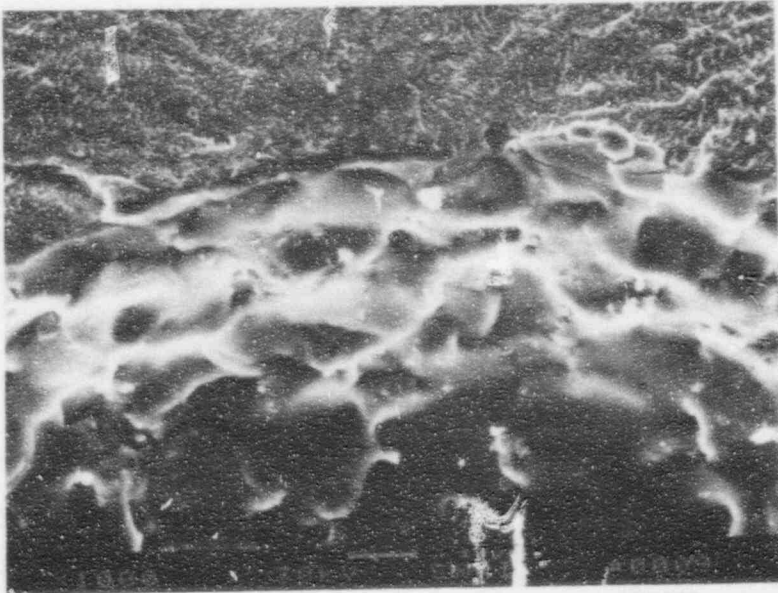
Figure B-32. SEM Fractographs of the Initiation Site at the Flat Region for SwRI Wire No. 429-1.

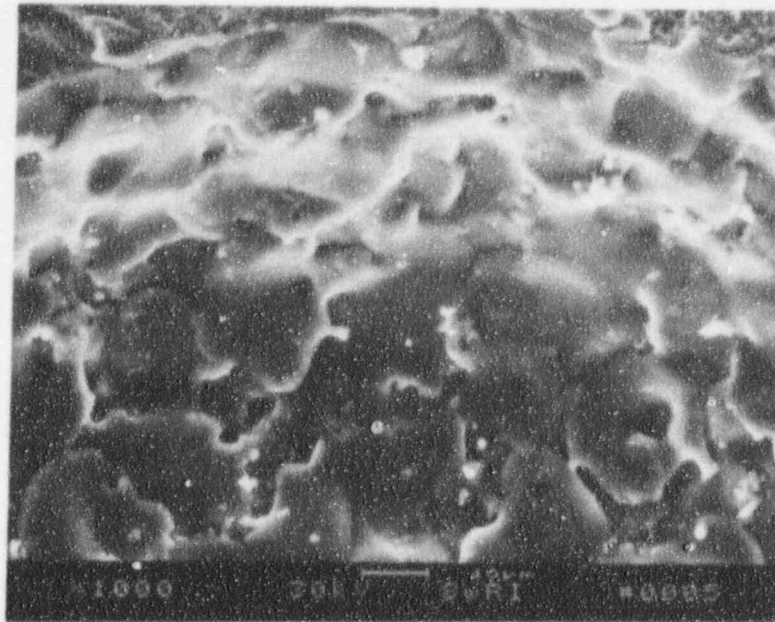
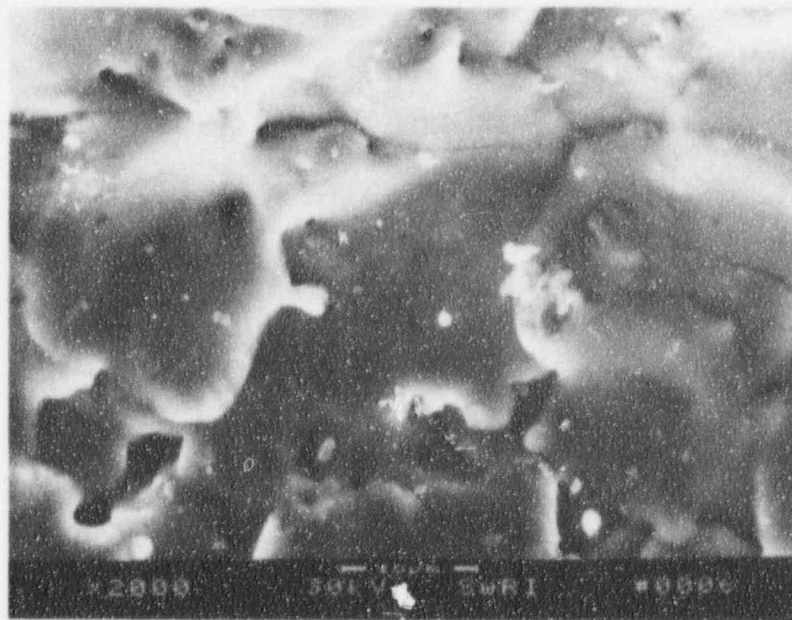
Figure B-33. SEM Fractographs of the Scale in the Cavity at the Flat Region for SwRI Wire No. 429-1.

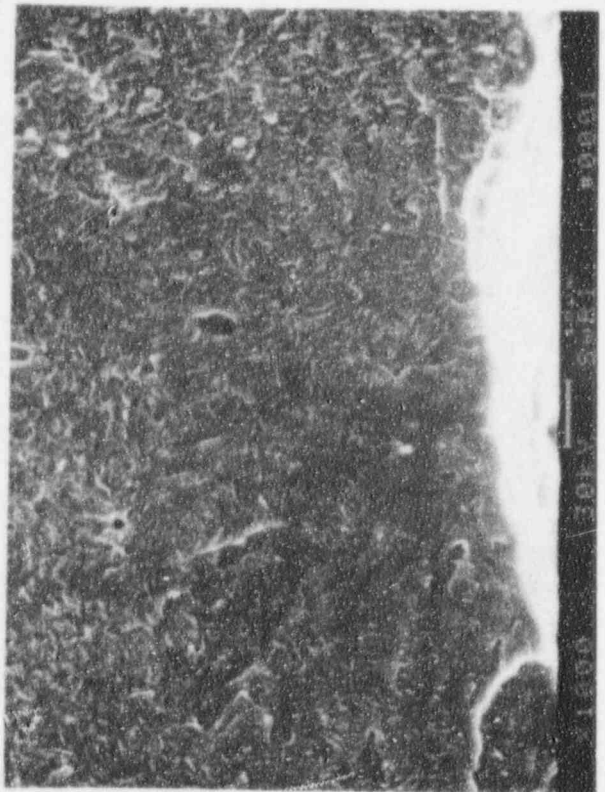
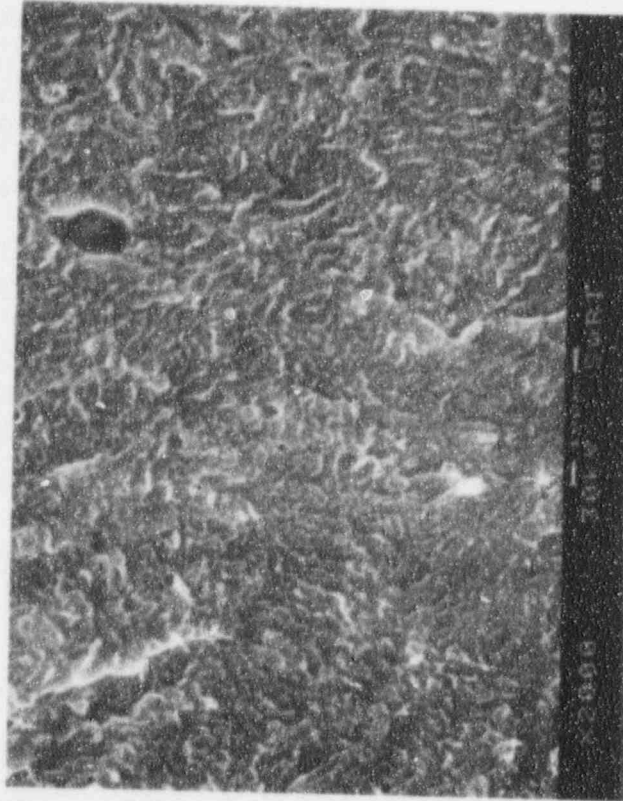
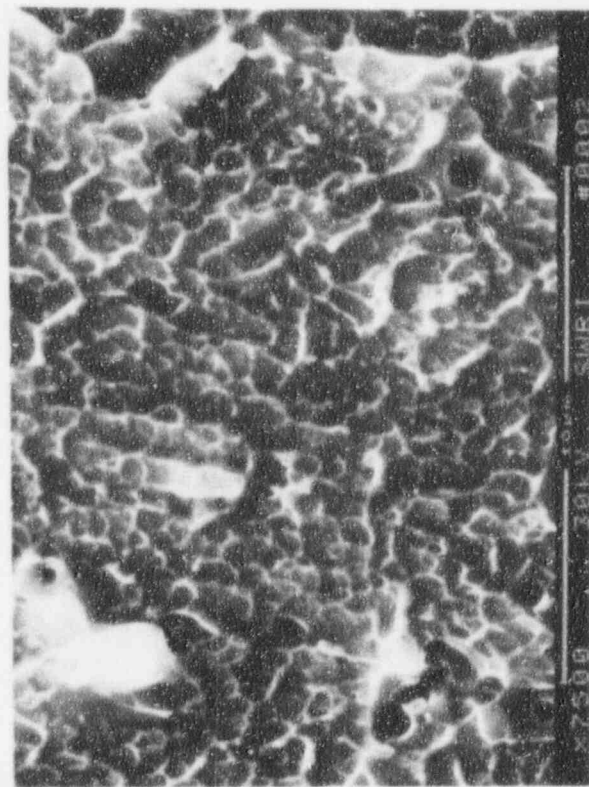
Figure B-34. SEM Fractographs at Location A for SwRI Wire No. 429-1.

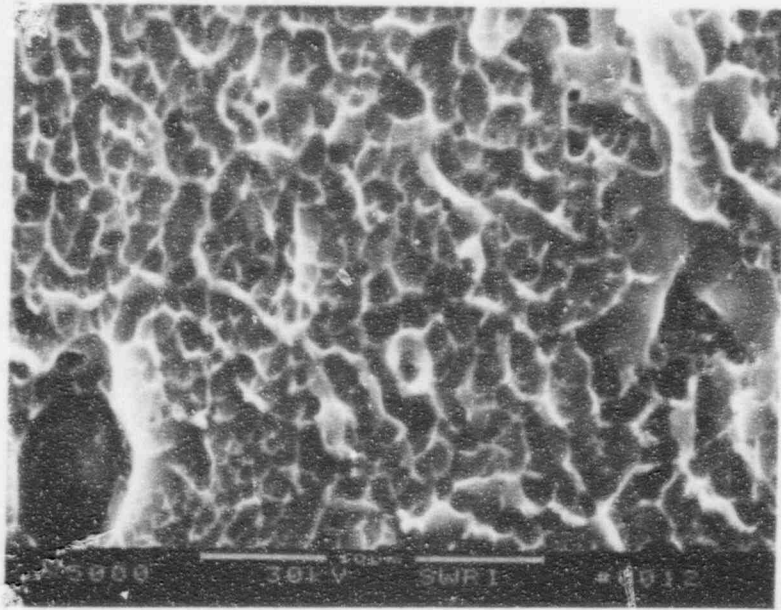
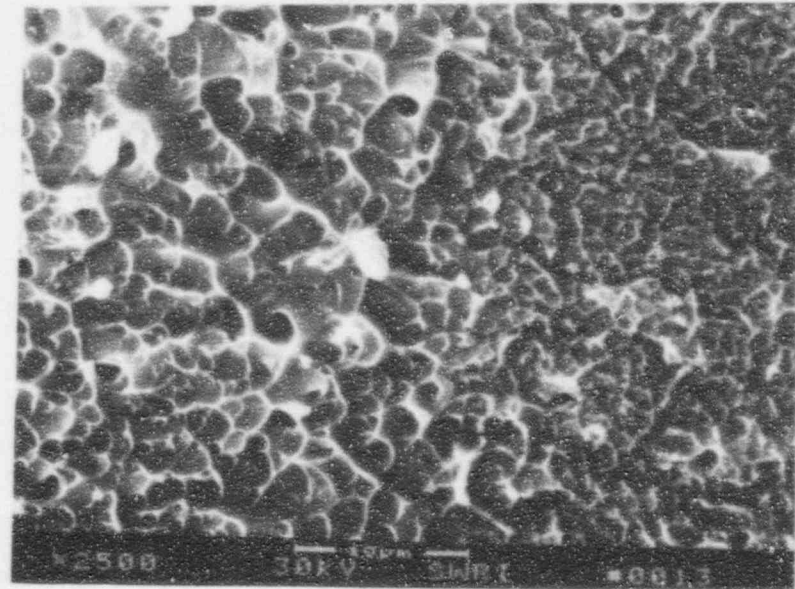
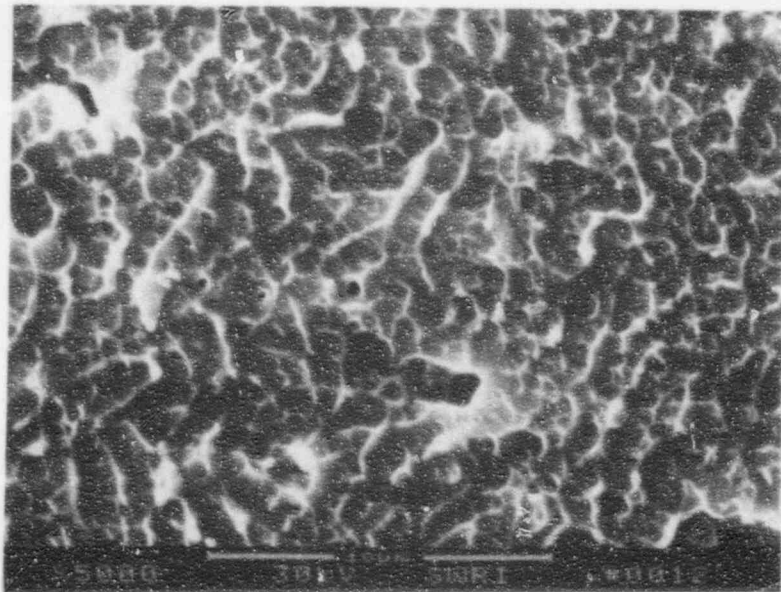
Figure B-35. SEM Fractographs of Locations B, C and D for SwRI Wire No. 429-1.

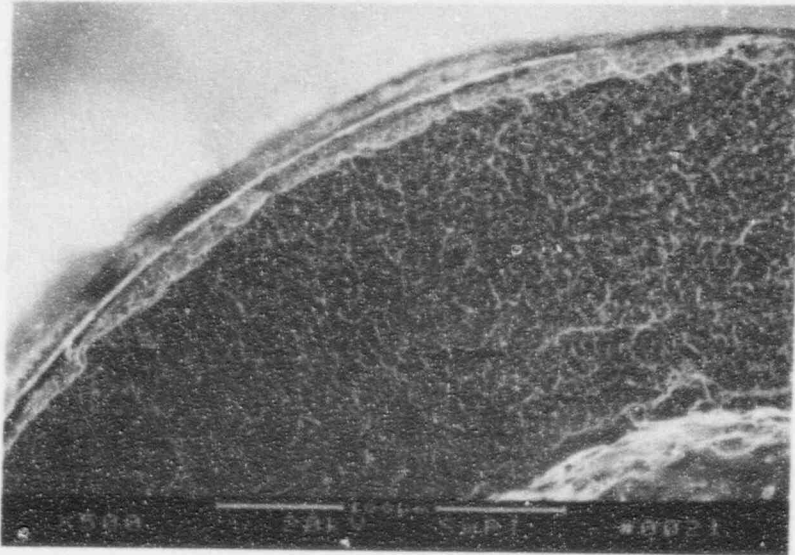
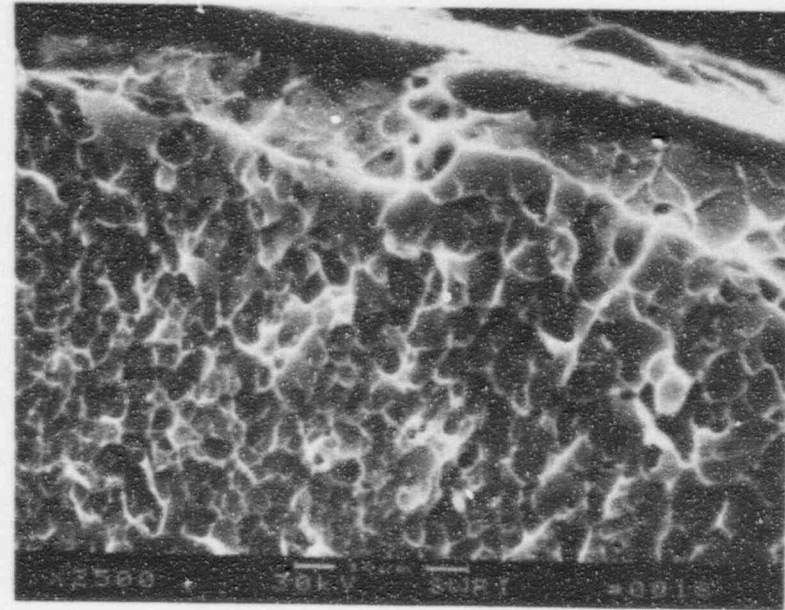
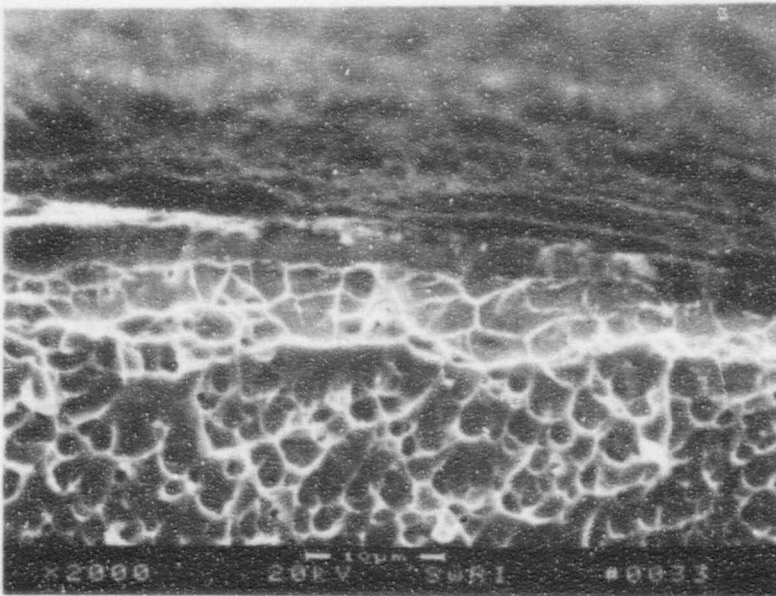
Figure B-36. SEM Fractograph of Location F, the OD Edge Adjacent to Flat Zone on SwRI Wire No. 429-1.
