NUREG/CR-6074
04-4448-010
Vol. 2

Sealed Source and Device Design Safety Testing

Technical Report on the Findings of Task 4

Investigation of Failed Nitinol Brachytherapy Wire

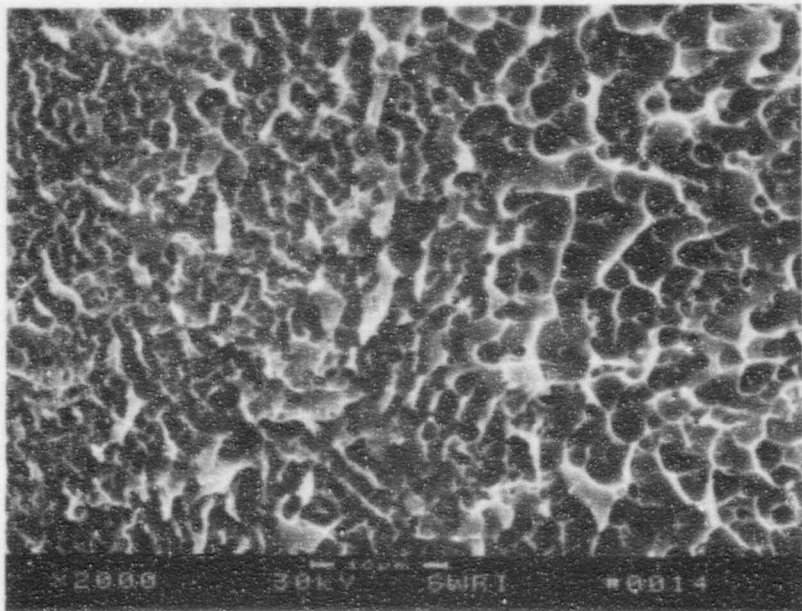
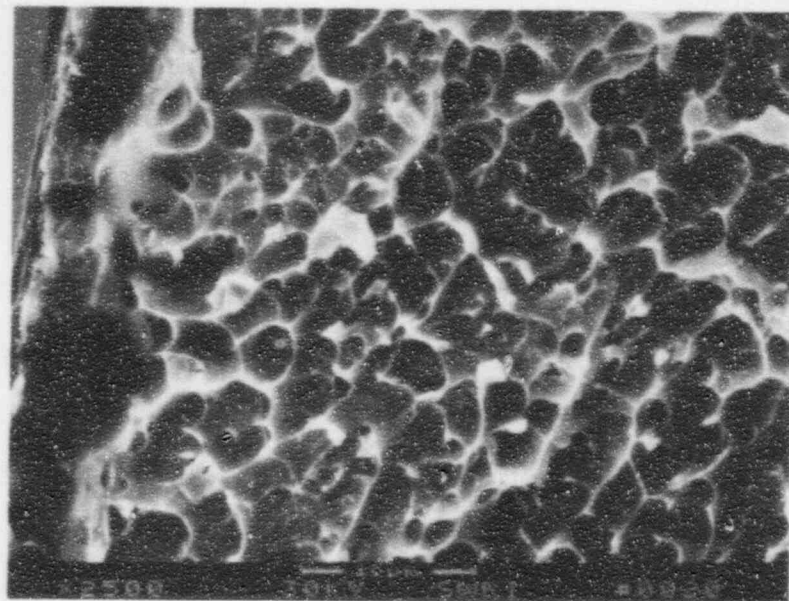
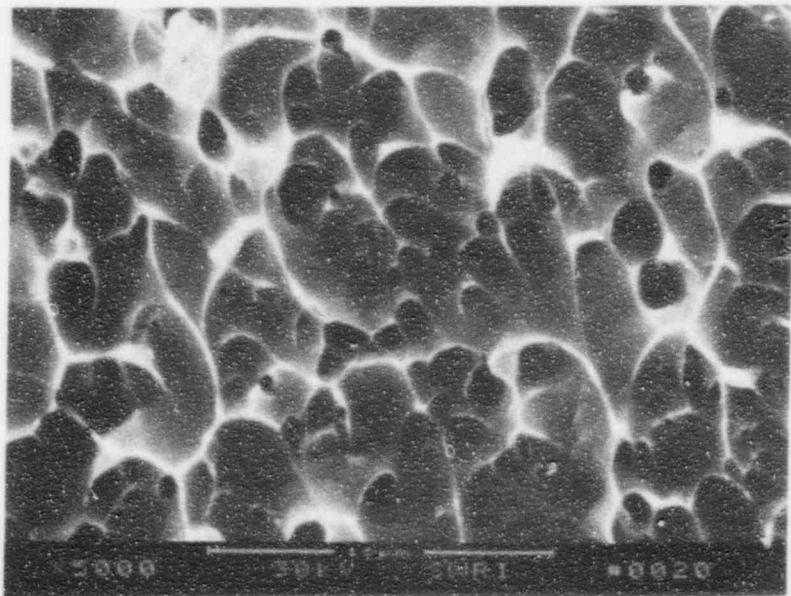
Figure B-37. SEM Fractographs of Locations E, G and H for SwRI Wire No. 429-1.

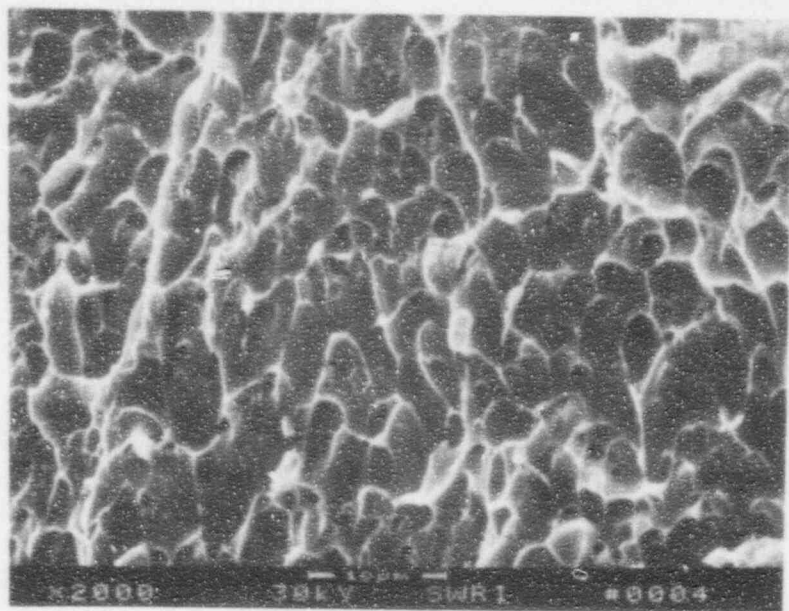
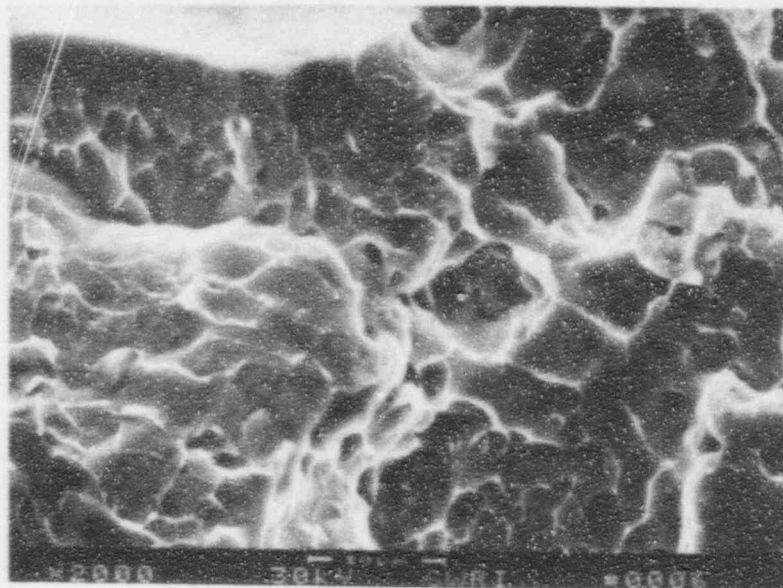
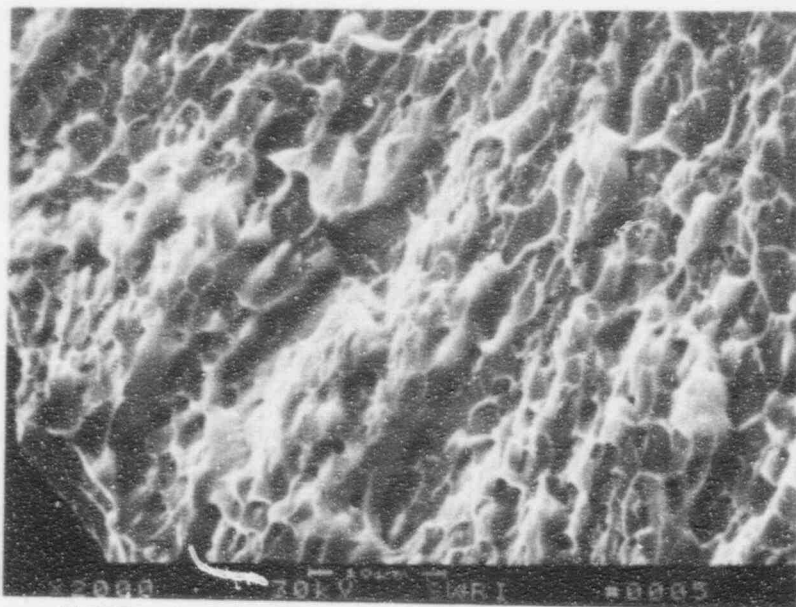
Figure B-38. SEM Fractographs of Locations I, J and K for SwRI Wire No. 429-1.

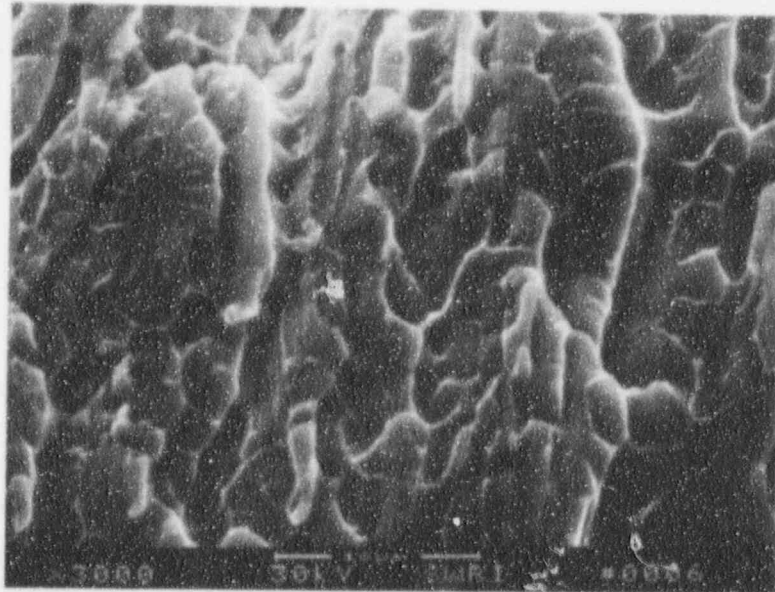
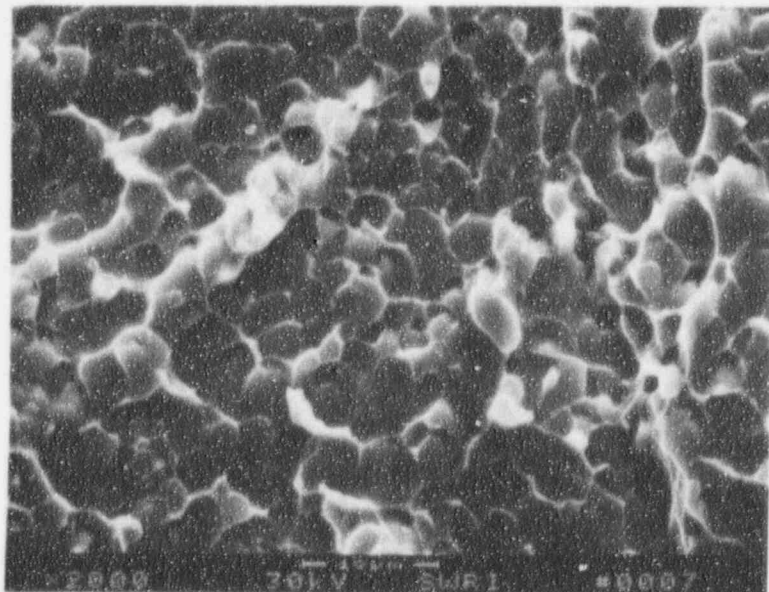
Figure B-39. SEM Fractographs of Locations L and M for SwRI Wire No. 429-1.

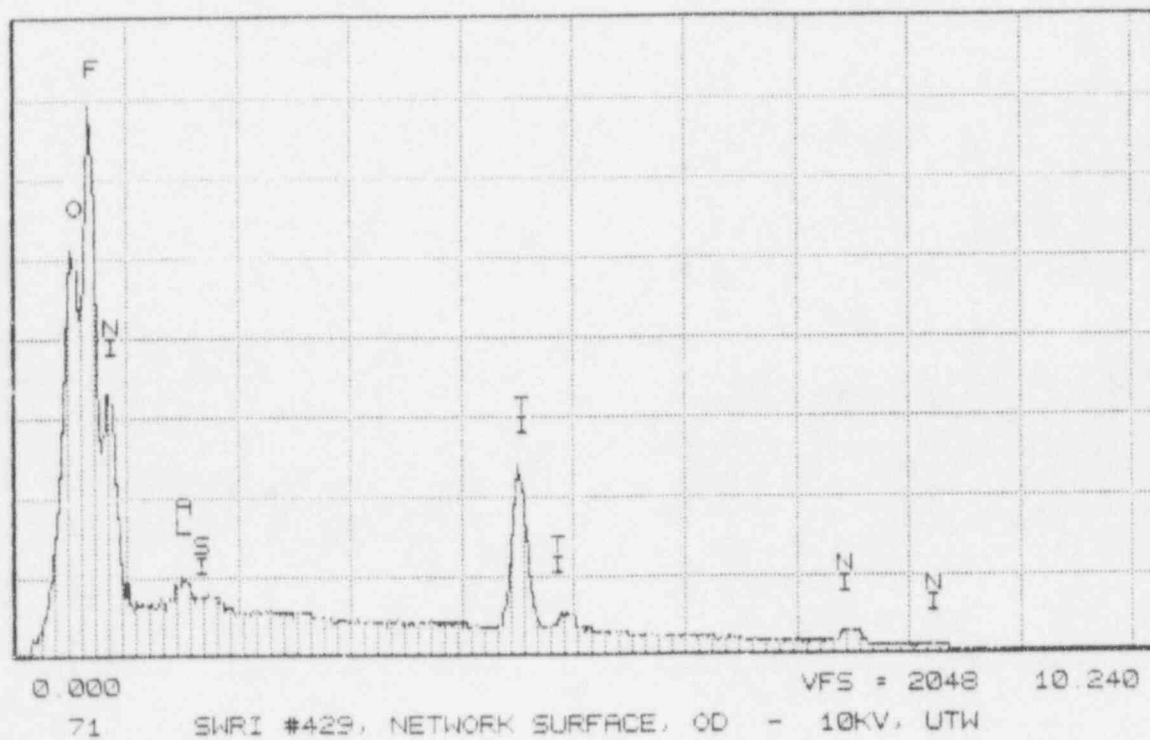
Figure B-40. Energy Dispersive X-Ray Spectra of the Network on the OD Surface for SwRI Wire No. 429-1.

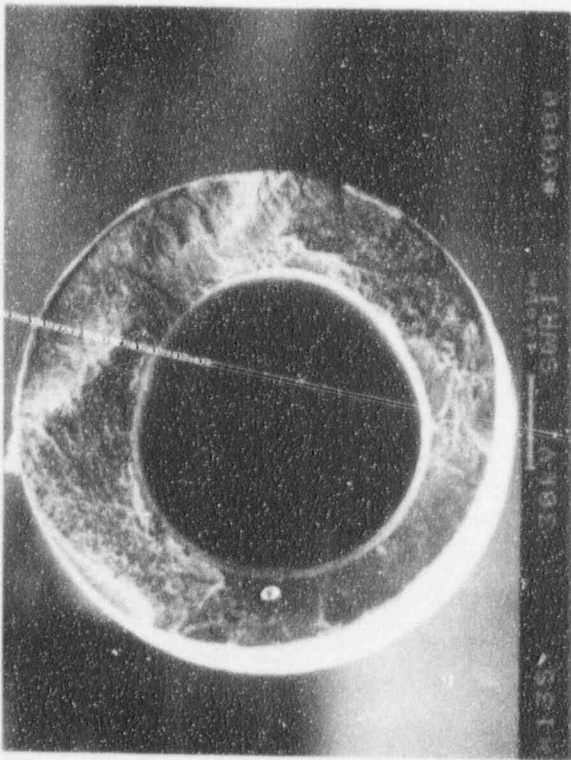
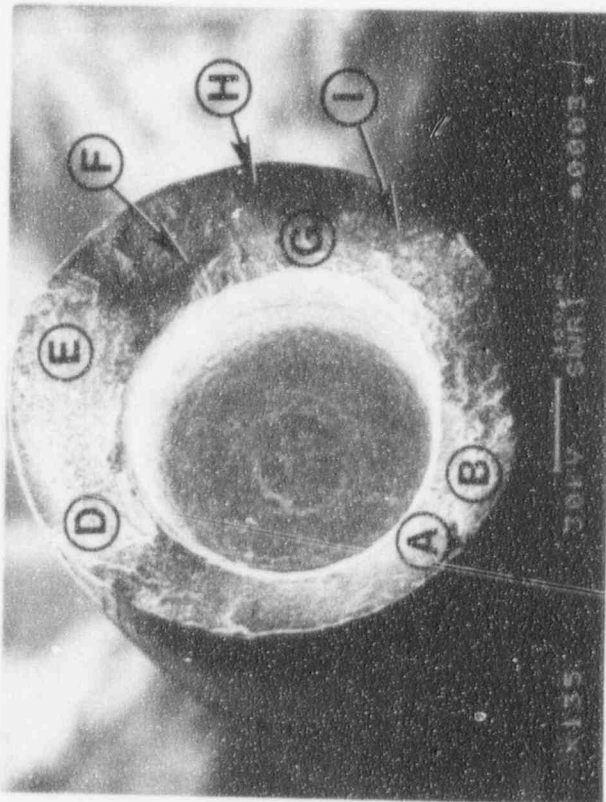
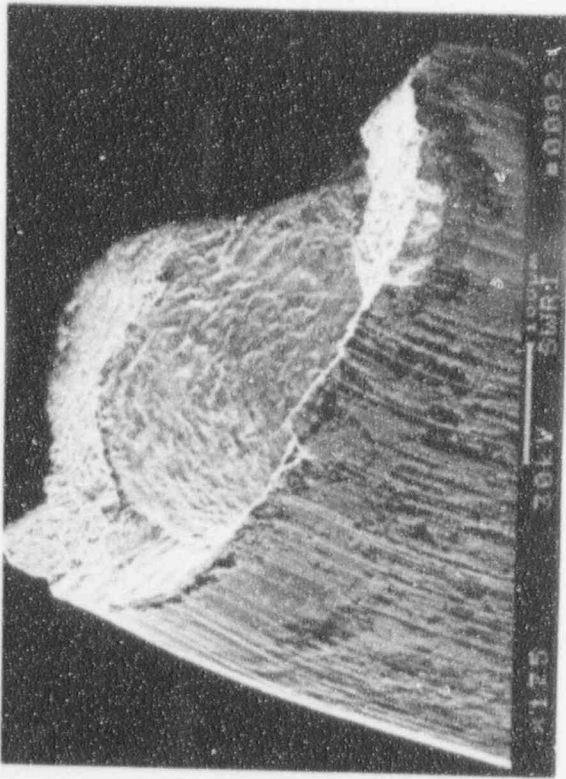
Figure B-41. SEM Fractographs of the Overall Fracture for SwRI Wire No. 426-1.

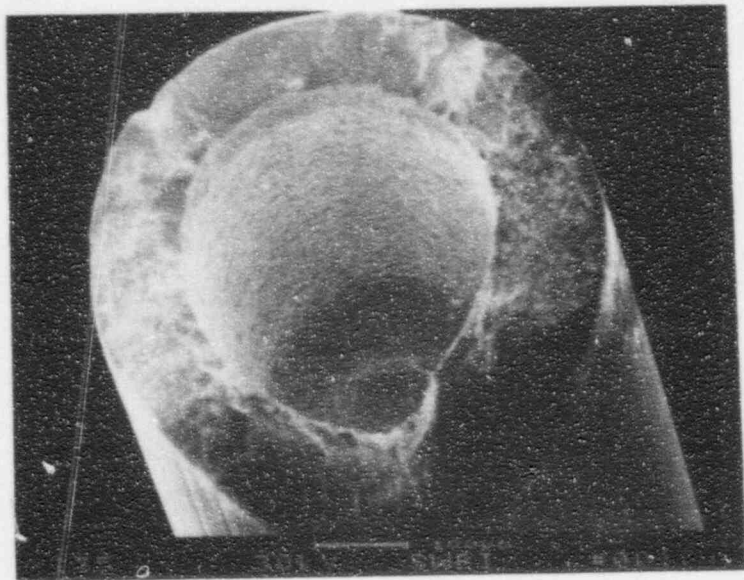
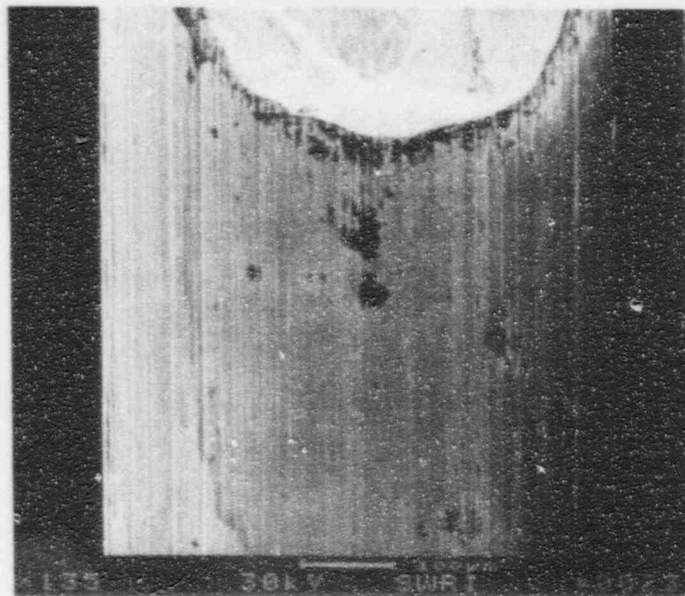
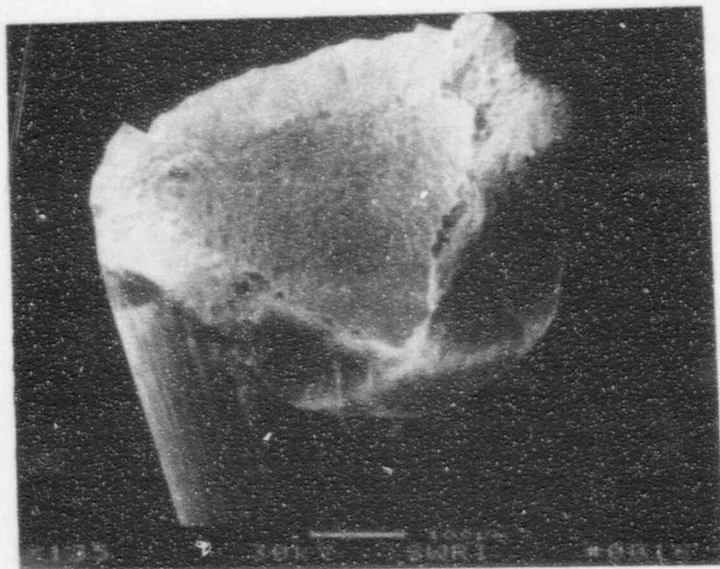
Figure B-42. SEM Fractographs of SwRI Wire No. 426-1 Showing Slant Fracture.

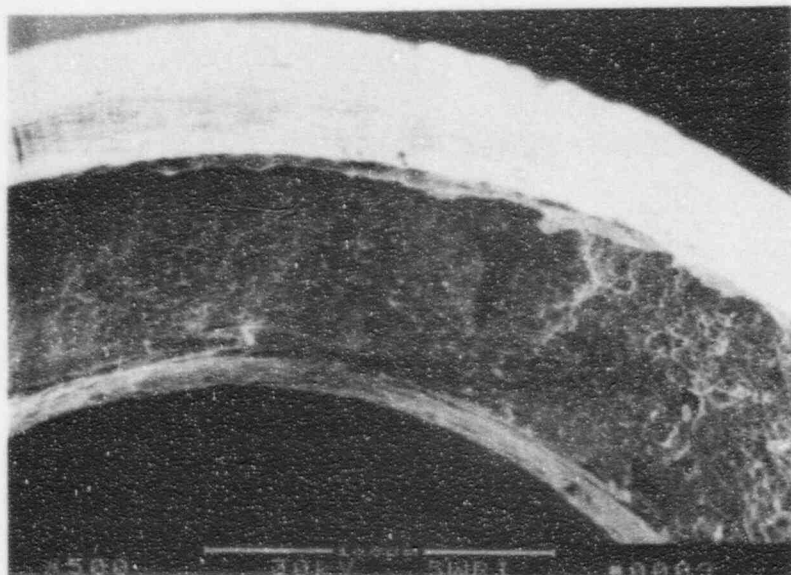
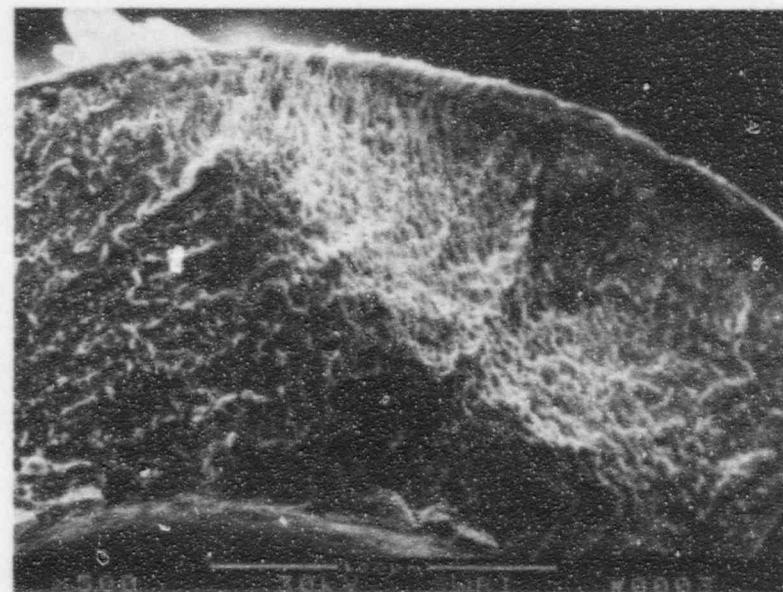
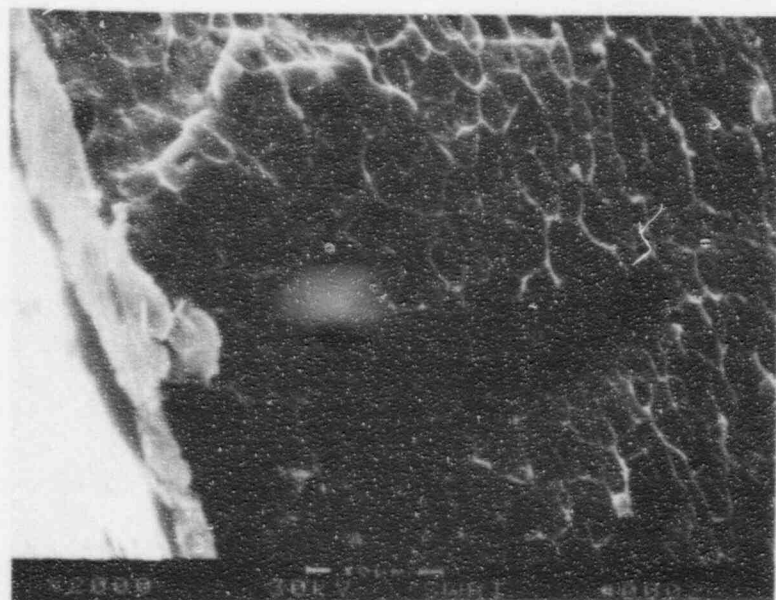
Figure B-43. SEM Fractographs Adjacent to the Thinned Section for SwRI Wire No. 426-1.

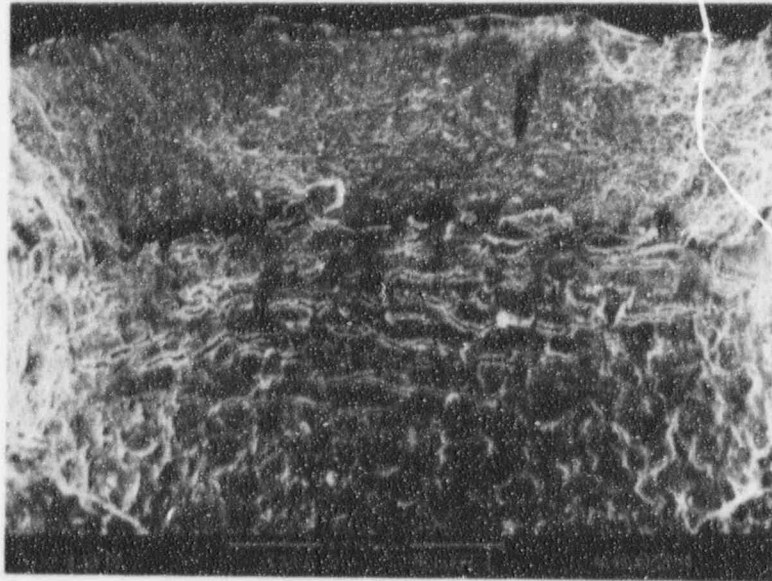
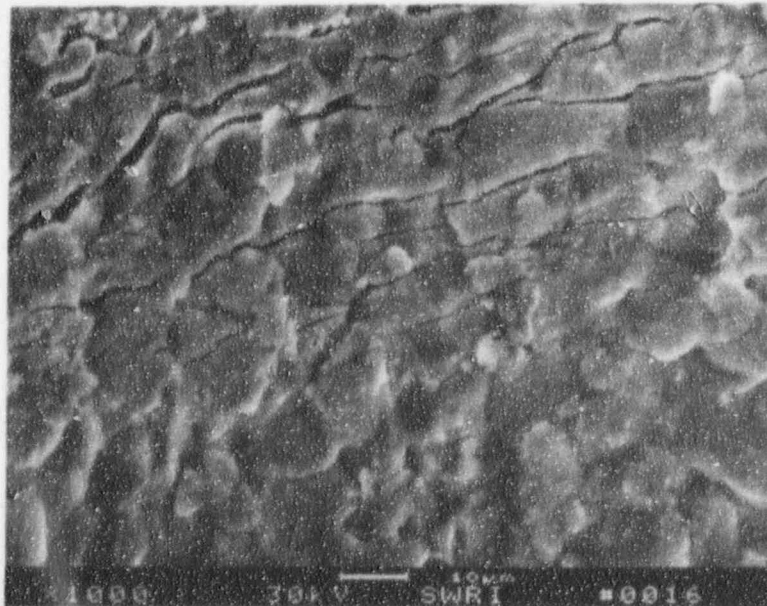
Figure B-44. SEM Photographs of the Cracked ID Scale at the Thinned Location for SwRI Wire No. 426-1.

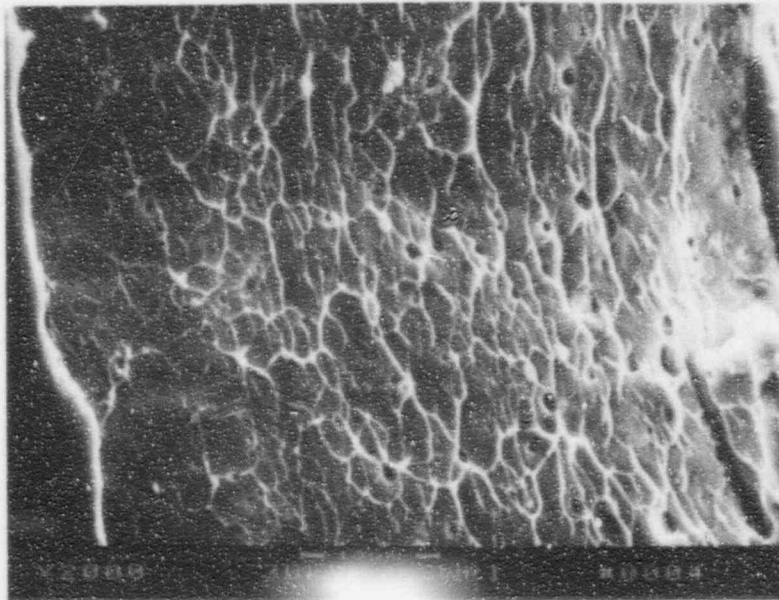
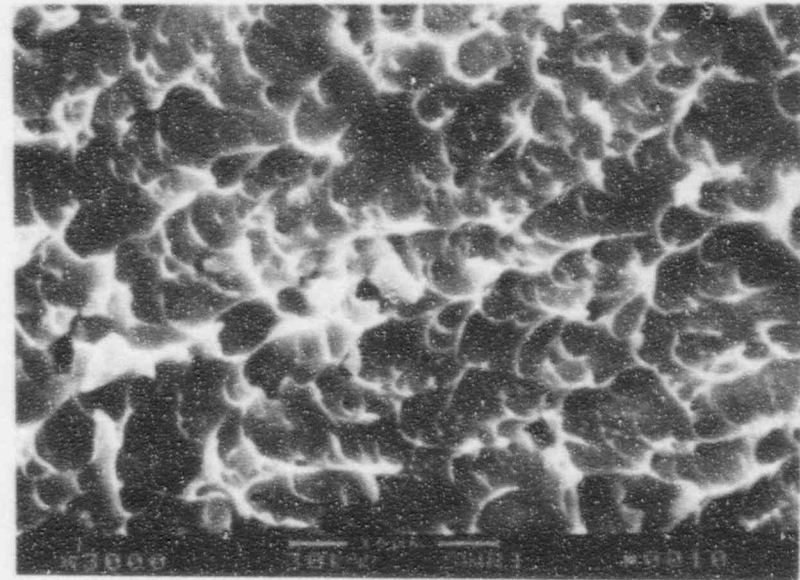
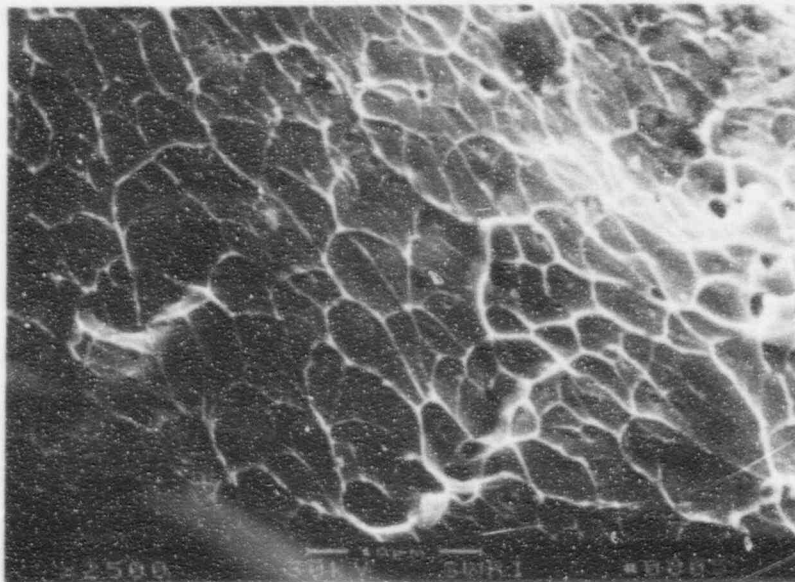
Figure B-45. SEM Fractographs at Locations A, B and C for SwRI Wire No. 426-1.

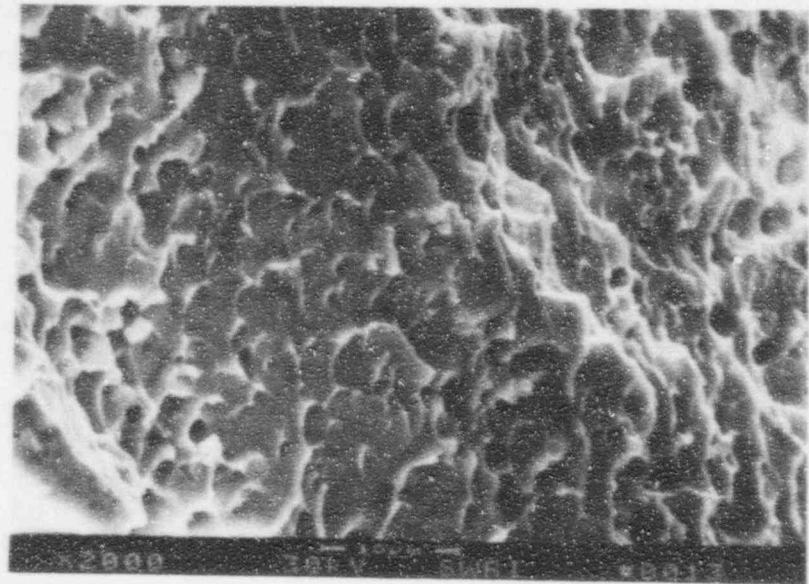
a) Location D

Figure B-46. SEM Fractographs at Locations D, E and F for SwRI Wire No. 426-1.

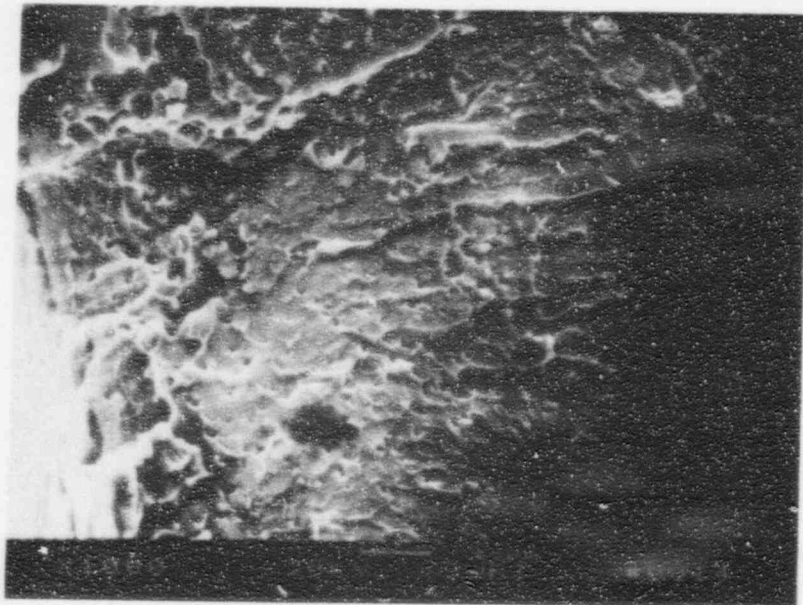
a) Location G

Figure B-47. SEM Fractographs at Locations G, H and I for SwRI Wire No. 426-1.

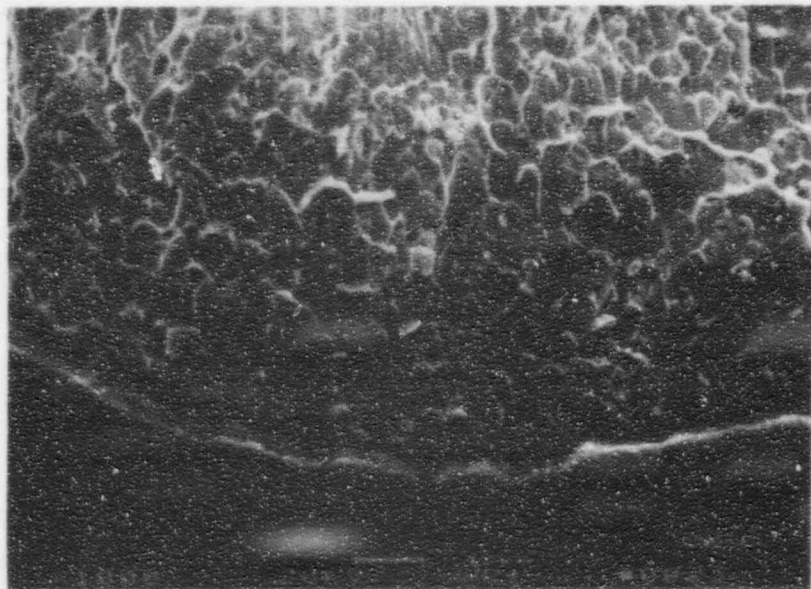
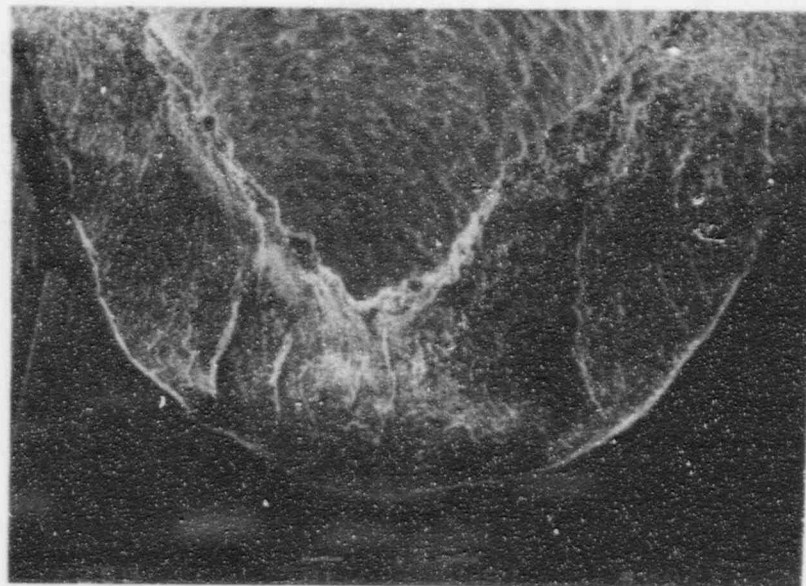
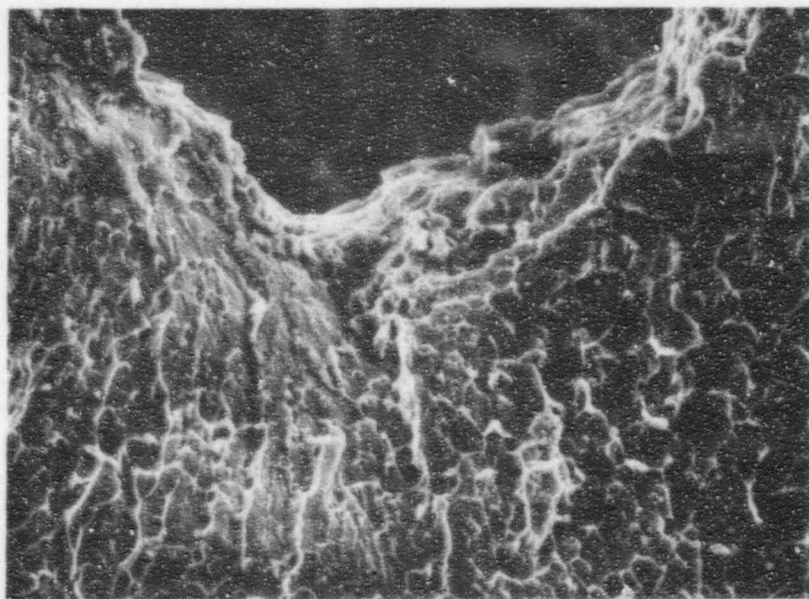
Figure B-48. SEM Fractographs of the Final Fracture on SwRI Wire No. 426-1.

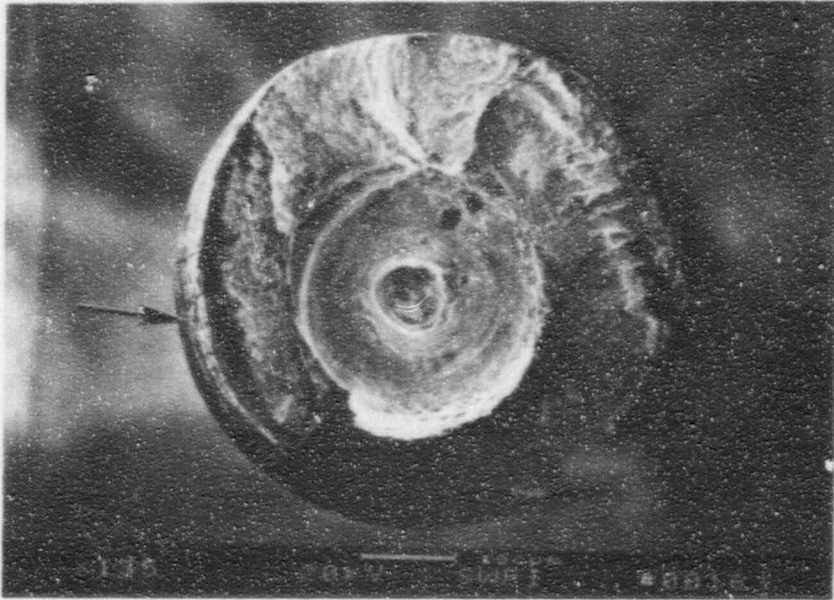
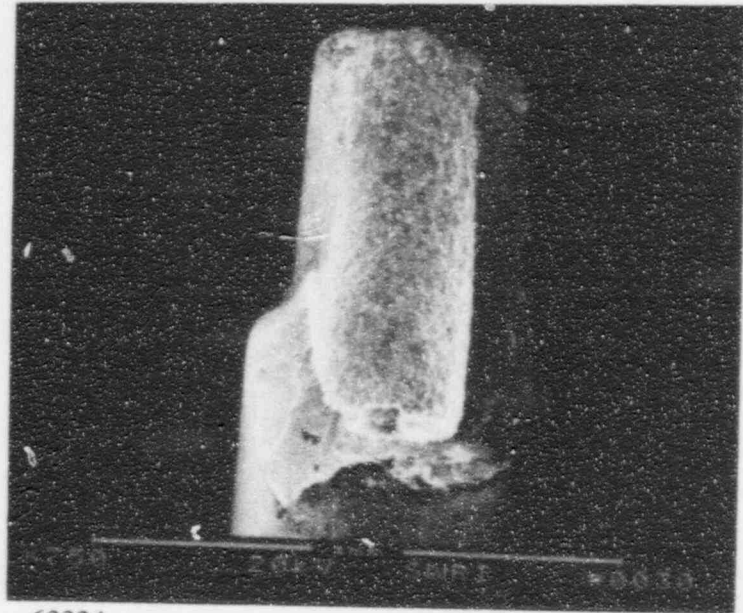
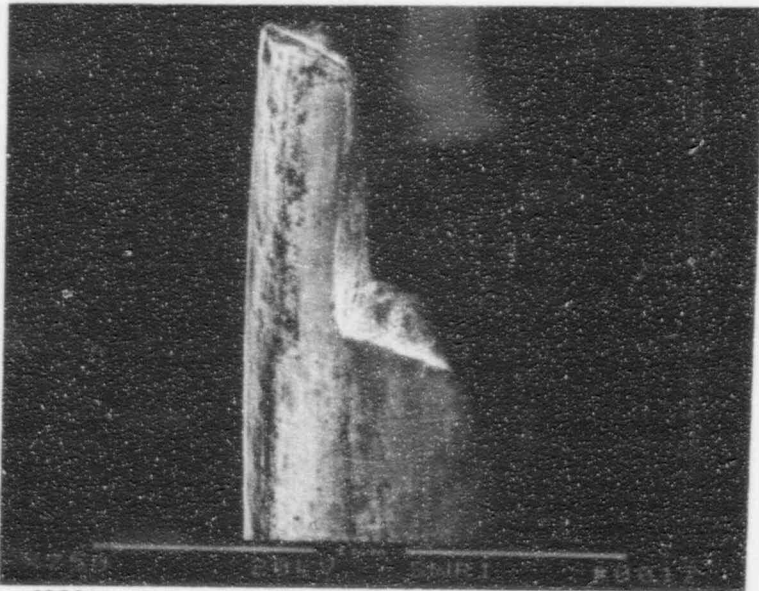
Figure B-49. SEM Fractographs for SwRI Wire No. 442.
Arrow shows yielded region.

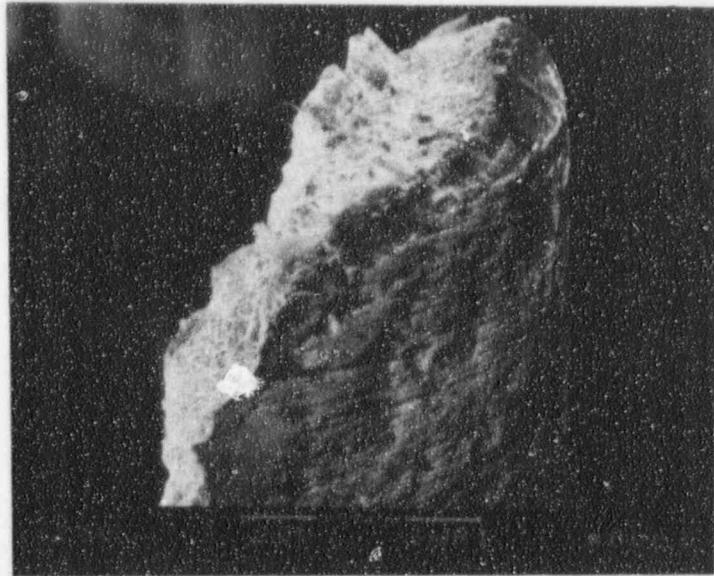
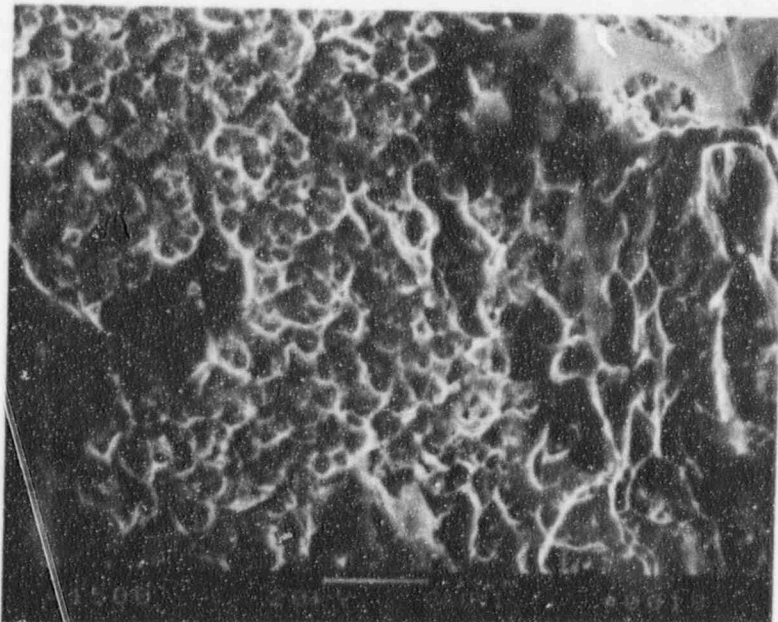
Figure B-50. SEM Photographs of the Yielded Region for SwRI Wire No. 442.

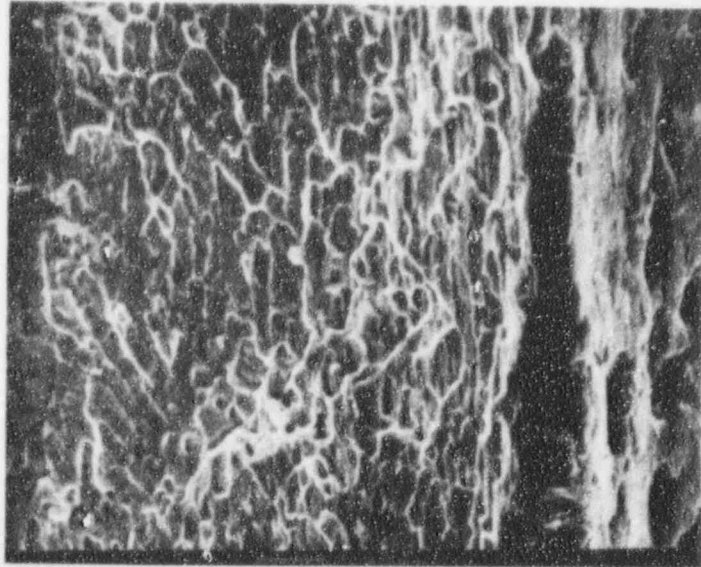
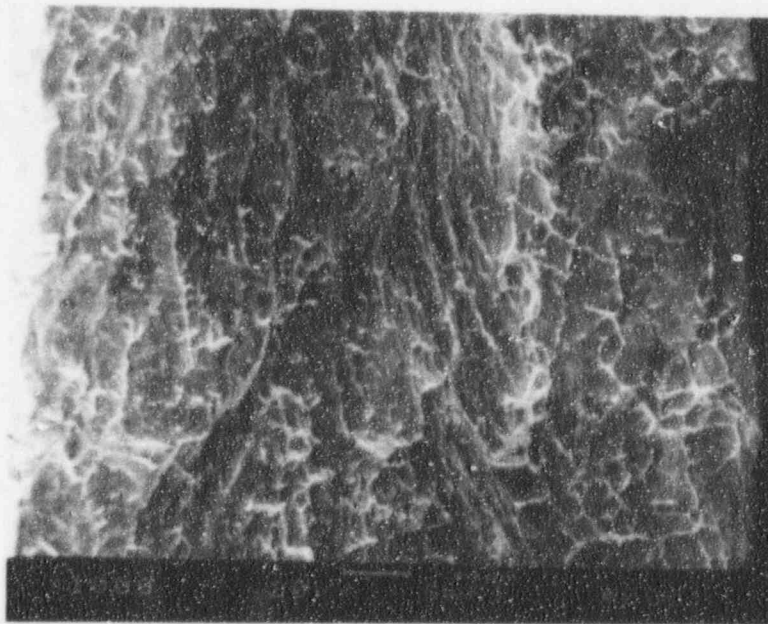
Figure B-51. SEM Fractographs of the Longitudinal Fracture Planes for SwRI Wire No. 442.

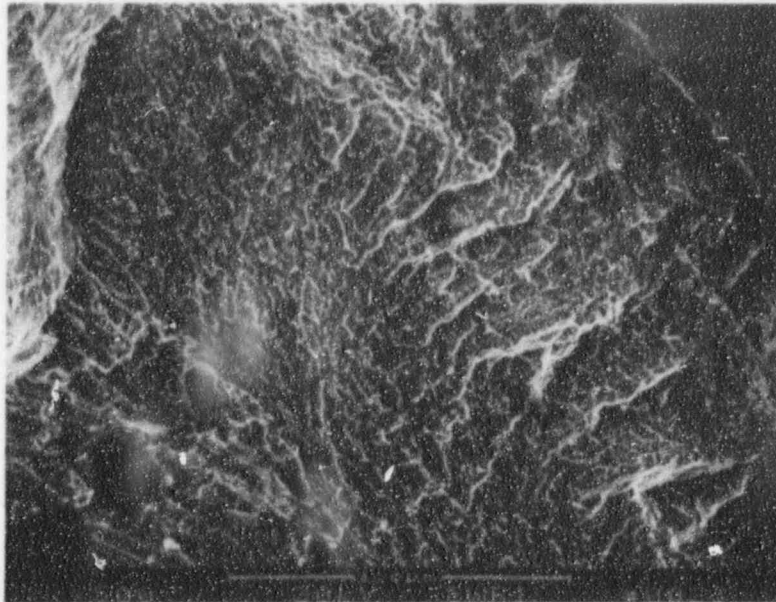
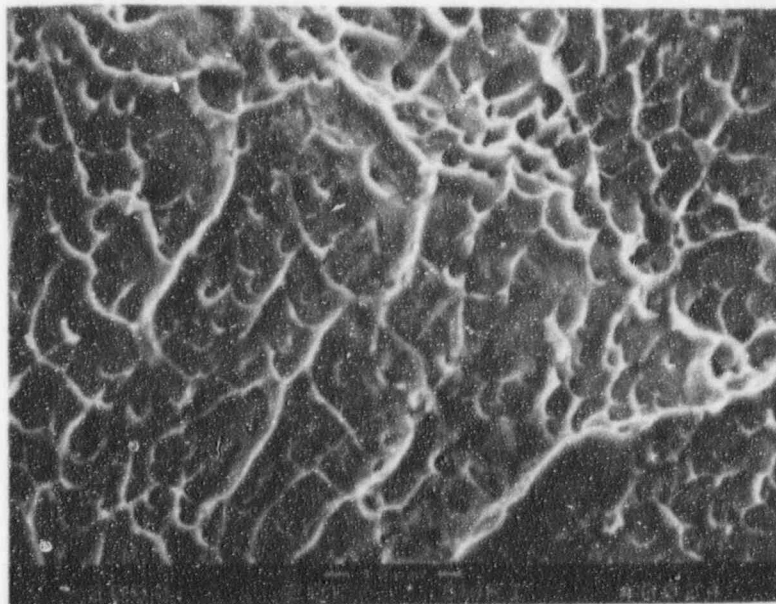
Figure B-52. SEM Fractographs of the Final Fracture Region for SwRI Wire No. 442.

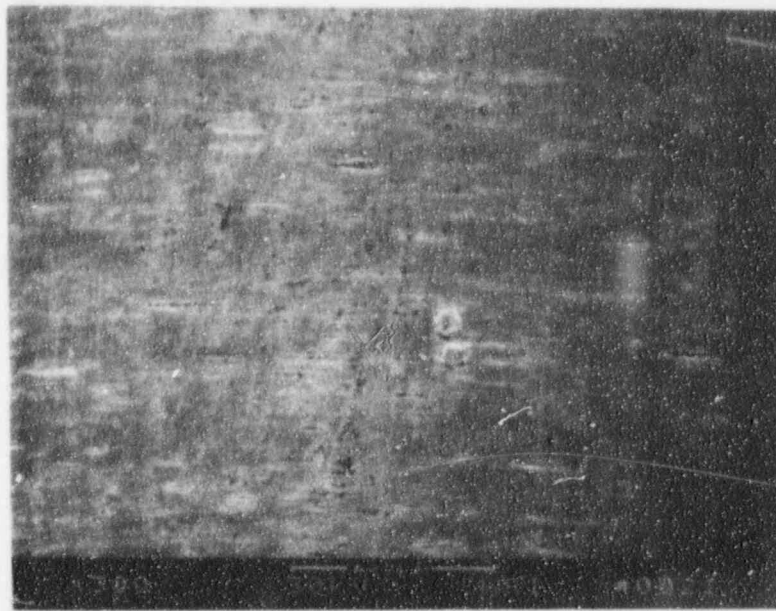
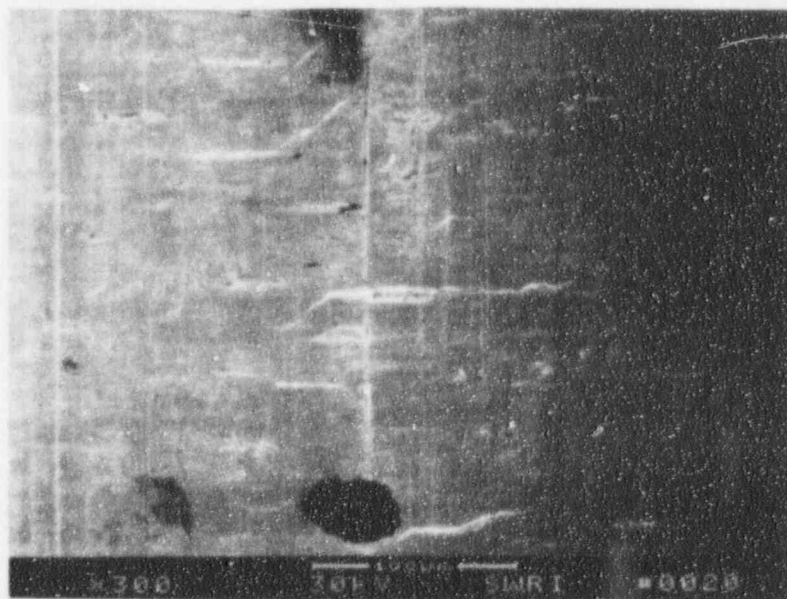
These two tests were performed in the optimization test series at the lowest charging potential. The specimens did not fracture but distinct microcracks developed, as shown in Figures D-1 and D-2. Cracks on the outside of the bends were relatively short and open [Figure D-1(a) and D-2(a)] while those on the inside were usually longer with 45° segments at the ends [Figures D-1(b) and D-2(b)]. It is evident that these charging conditions were insufficient to fully embrittle the specimens but that a degree of embrittlement did occur as evidenced by the cracking.

Figure D-1. SEM Photomicrographs from Surface of Hydrogen-Charged Bend Specimen. Test No. HC-2. Charging Conditions: -0.5V, 120 Min.

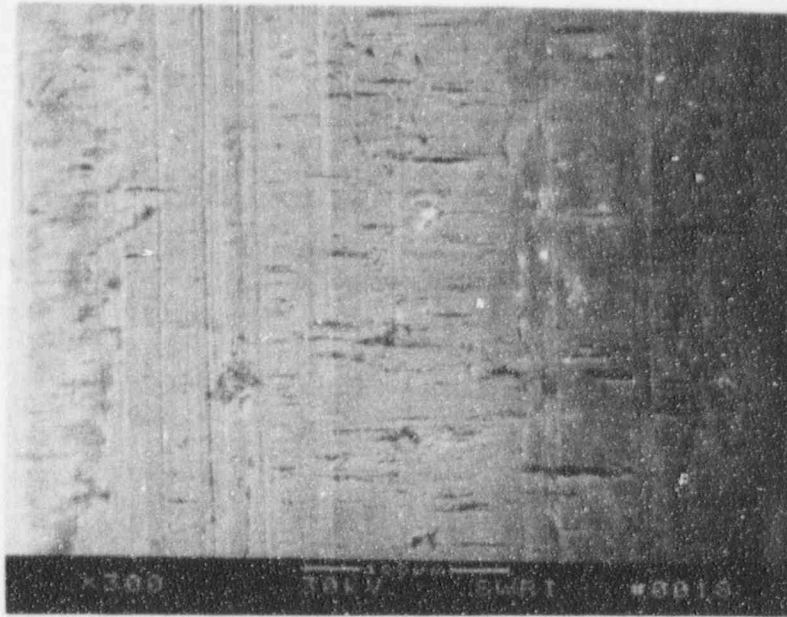
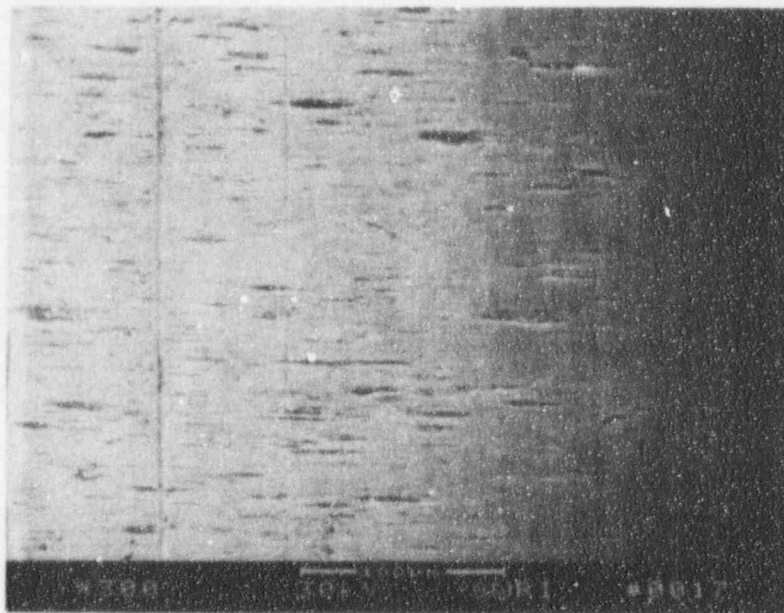
Figure D-2. SEM Photomicrographs from Surface of Hydrogen-Charged Bend Specimen. Test No. HC-3. Charging Conditions: -0.5V, 120 Min.

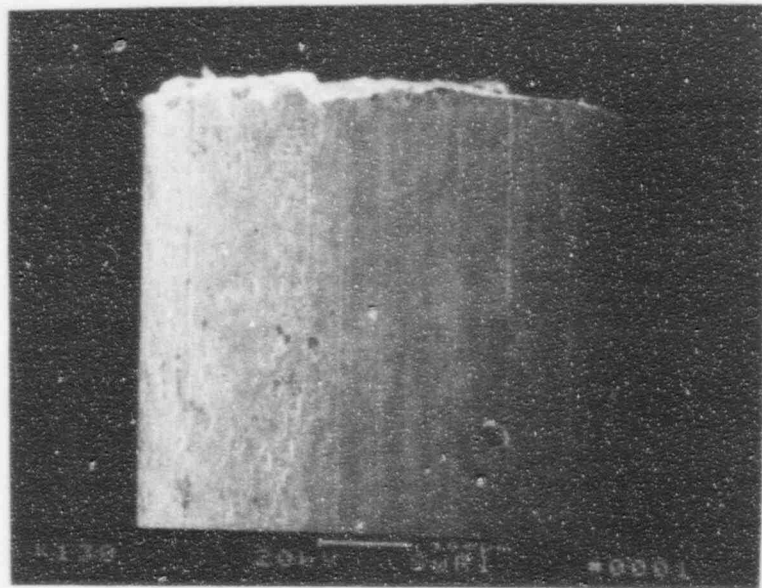
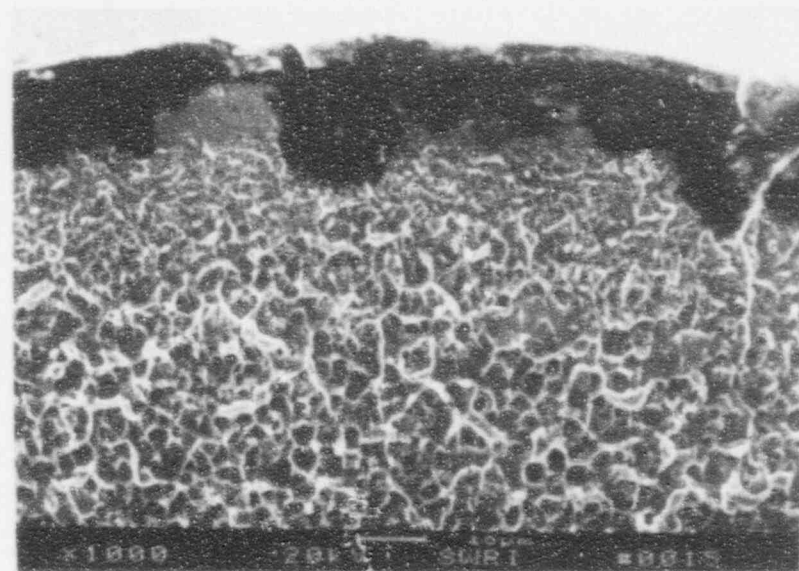
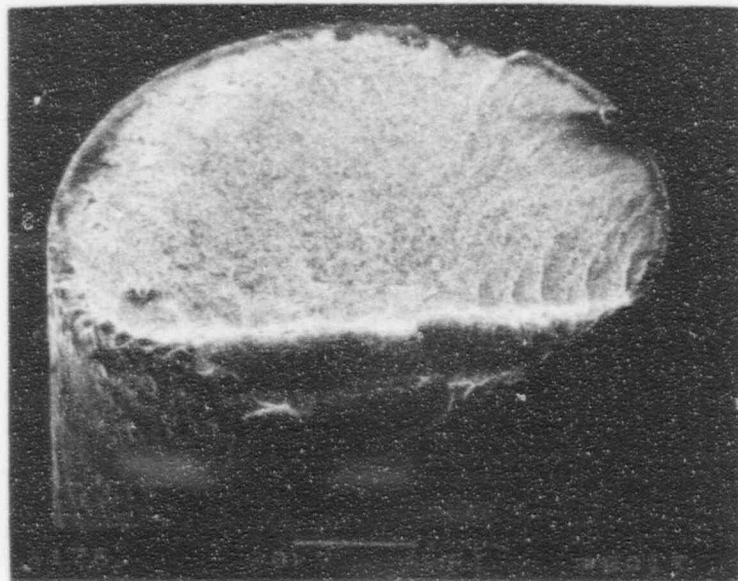
These tests represent two cases where charging was sufficient to induce complete fracture in the bend test. Test HC-4 was one of the triplicate tests with charging conditions of -1.0v and 120 min. The fractographic features consist of a flat fracture surface with fine-scale dimples and a thin featureless rim at the outer periphery, see Figure D-3. These features are essentially identical to those of Test HC-6, see Section 5.5.

Figure D-3. SEM Photomicrographs and Fractographs from Hydrogen-Charged Specimen. Test No. HC-4. Charging Conditions: -1.0V, 120 Min.

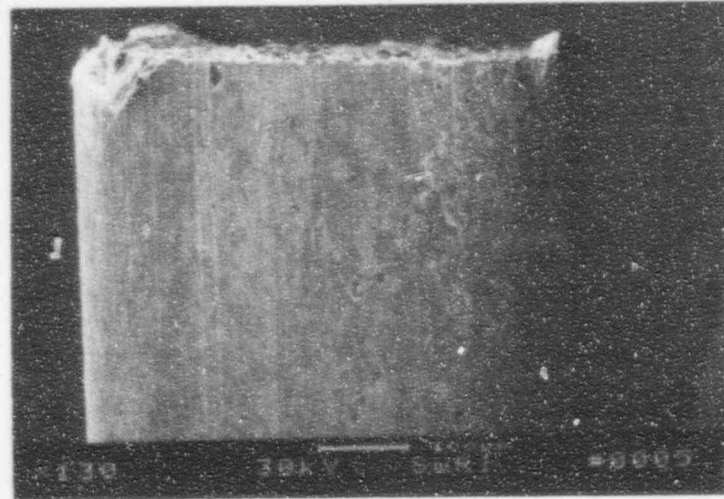
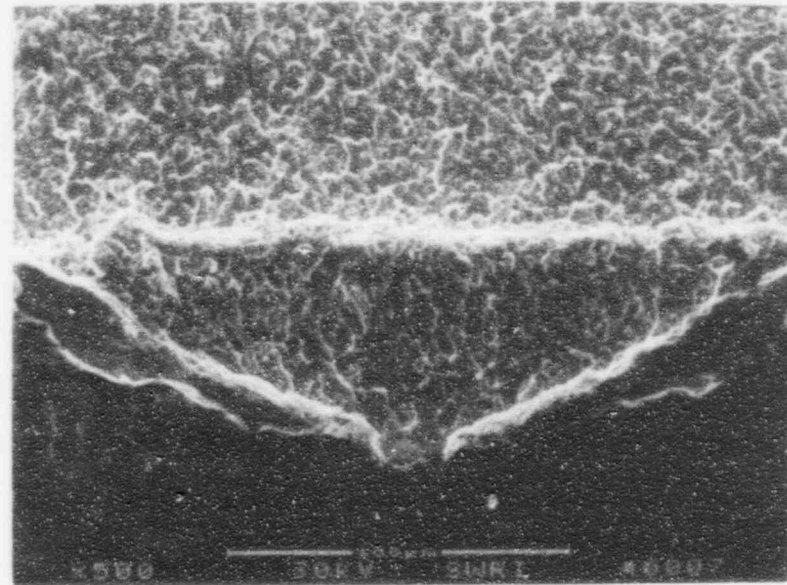
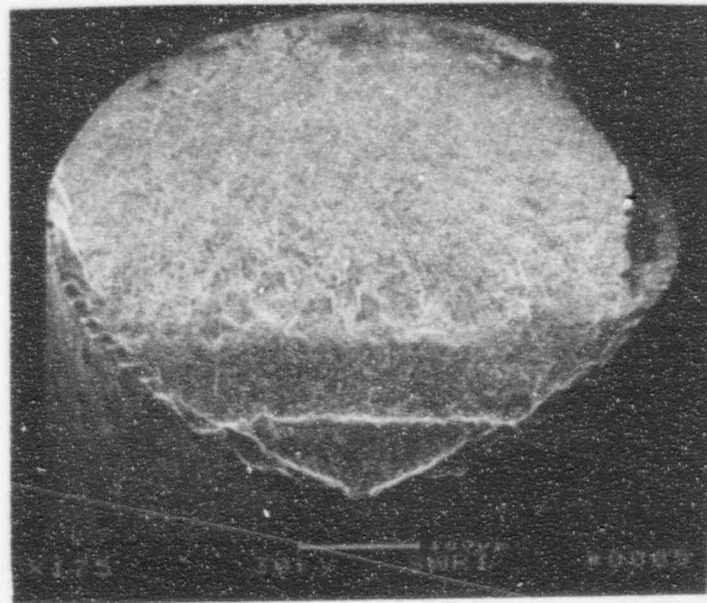
Test HC-7 was charged for a shorter period (100 min.) but still resulted in complete brittle fracture in the bend test. The fractographic features are shown in Figure D-4 and are essentially identical to those of Test Nos. HC-4 and HC-6.

Figure D-4. SEM Photomicrographs and Fractographs from Hydrogen-Charged Specimen. Test No. HC-7. Charging Conditions: -1.0V, 100 Min.
