NUREG/CR-6074
04-4448-010
Vol. 2

Sealed Source and Device Design Safety Testing

Technical Report on the Findings of Task 4

Investigation of Failed Nitinol Brachytherapy Wire

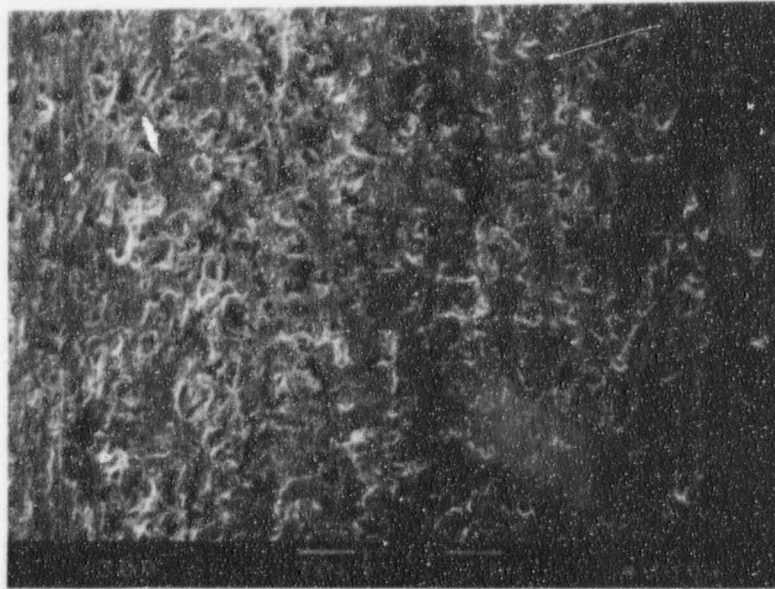
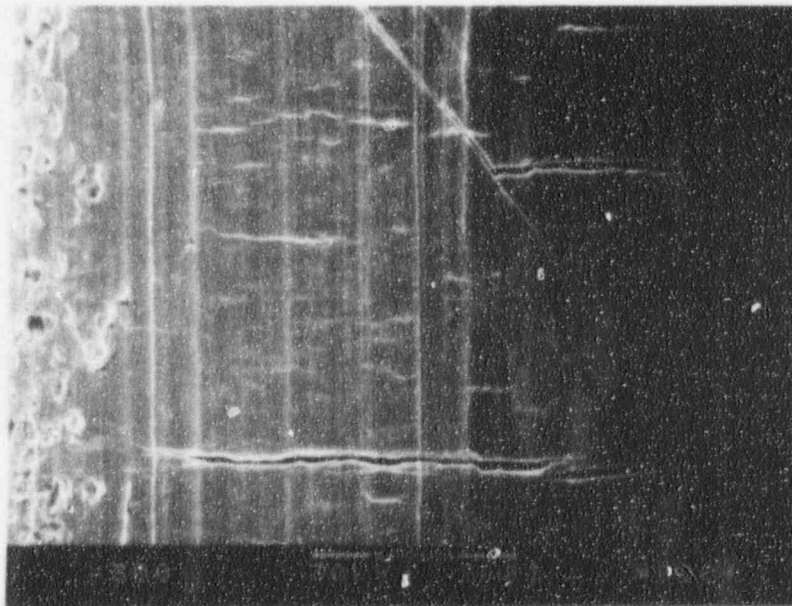
Test Nos. HC-5 was one of the triplicate tests performed with the maximum charging condition but it did not result in fracture of the specimen. Post-test SEM examinations, did however, reveal significant cracking on the inside of the bend as shown in Figure D-5(b). The cracking which developed in the bend test demonstrates that some degree of embrittlement did occur. Apparently, the charging condition varied slightly among the three specimens (HC-4, HC-5, and HC-6) so that Test HC-5 did not represent as high a degree of embrittlement as the other two tests.

Figure D-5. SEM Photomicrographs from Surface of Hydrogen-Charged Bend Specimen. Test No. HC-5. Charging Conditions: 1.0V, 120 Min.

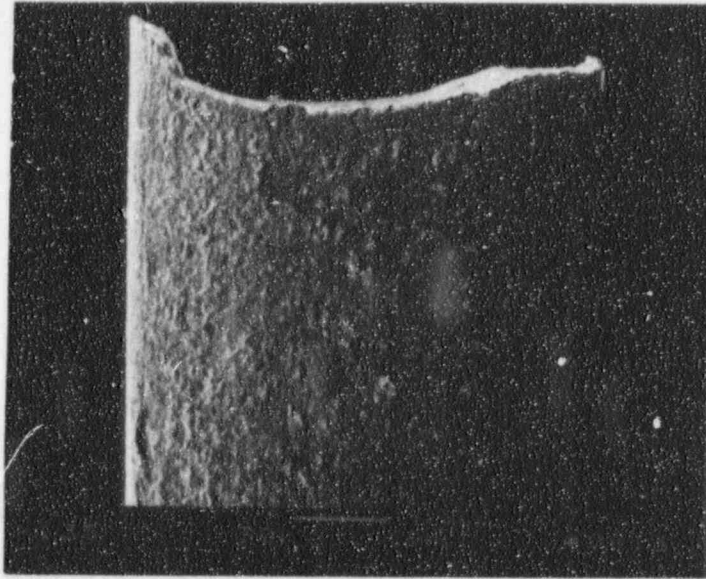
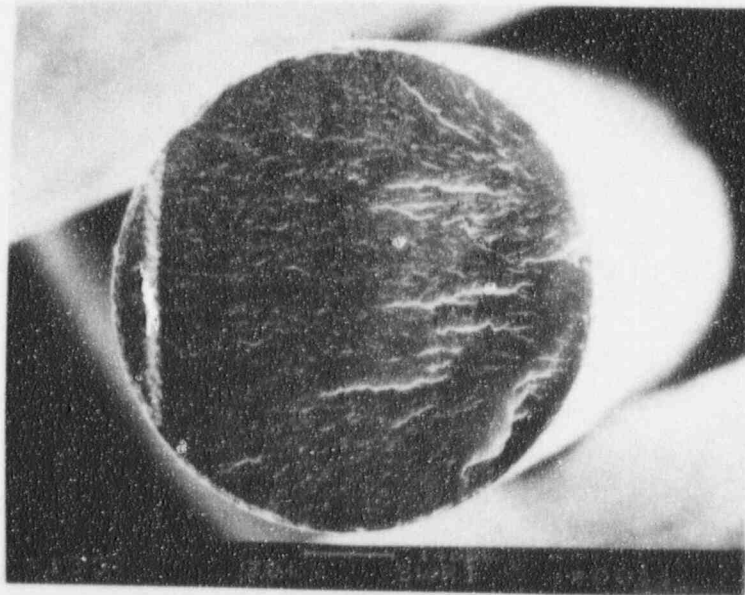
Reverse bending of the specimen after the initial test (Test No. HC-5R) resulted in complete brittle fracture. SEM fractographic from that fracture are shown in Figures D-6, D-7 and D-8. The specimen exhibited a flat fracture surface and uniform fine-scale dimples were evident throughout except for the initiation region [Figures D-6 and D-8]. The initiation zone exhibited a unique fine scale topography comprised of smooth features, ripples and very small tear dimples [Figure D-7].

Figure D-6. Fracture Surface of Hydrogen-Charged Bend Test Specimen. Test No. HC-5R. Charging Conditions: -1.0V, 120 Min. Reverse Bend After Initial test.

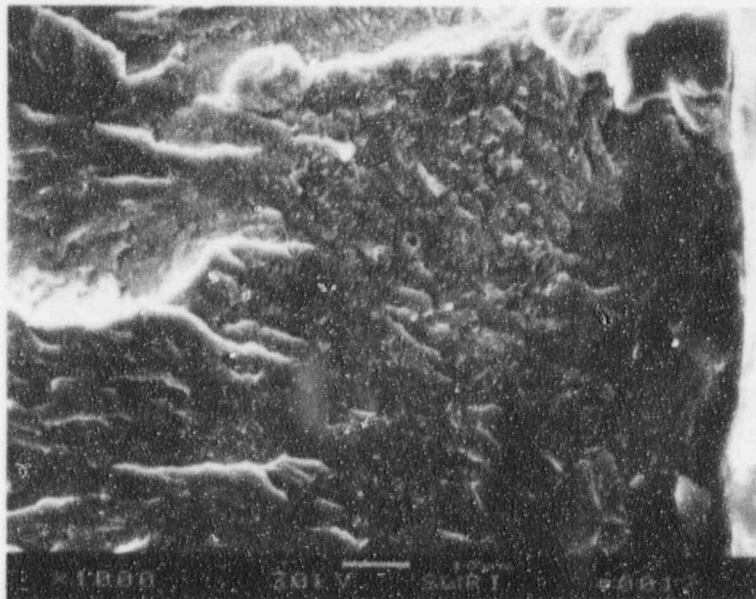
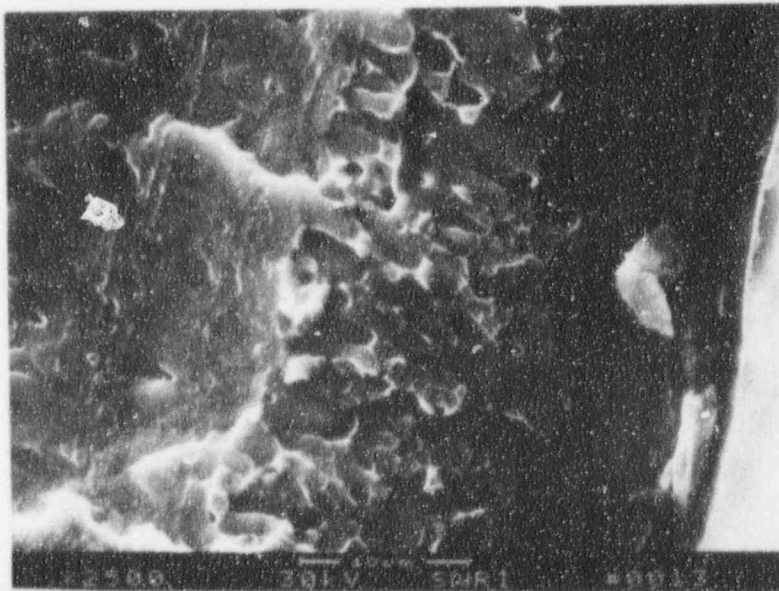
b) Two Locations At Edge Near Origin

Figure D-7. SEM Fractographs from Hydrogen-Charged Bend Test Specimens. Test No. HC-5R.

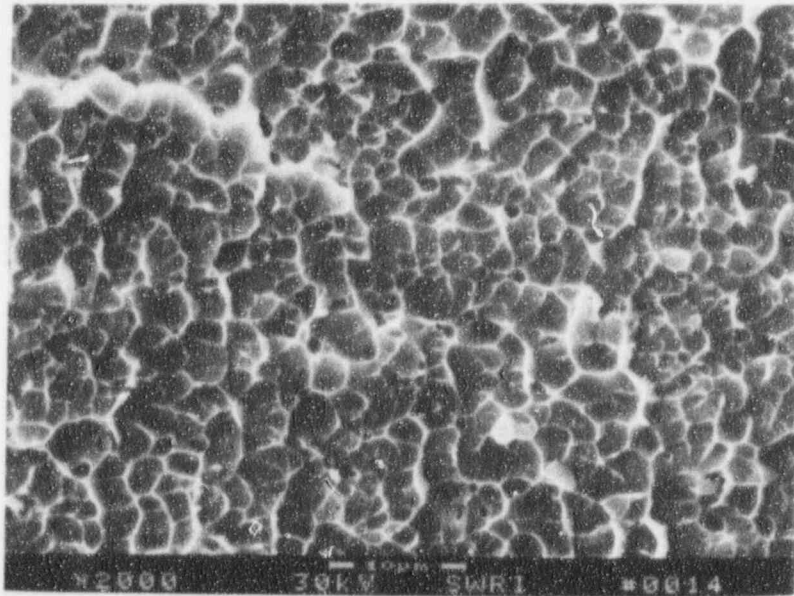
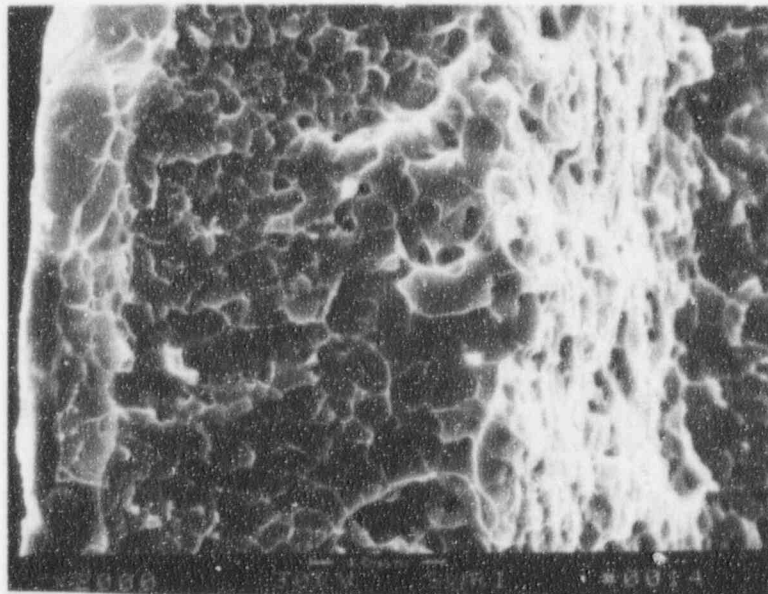
Figure D-8. SEM Fractographs from Hydrogen-Charged Bend Test Specimens. Test No. HC-5R.

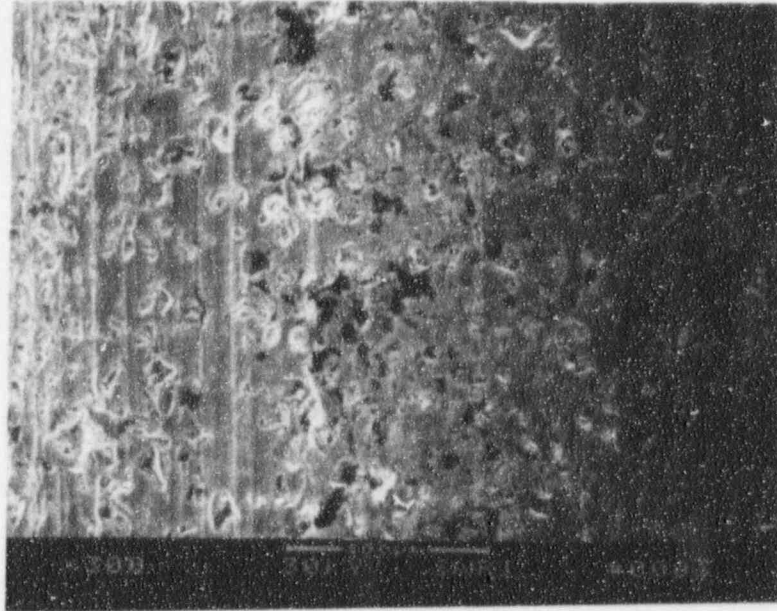
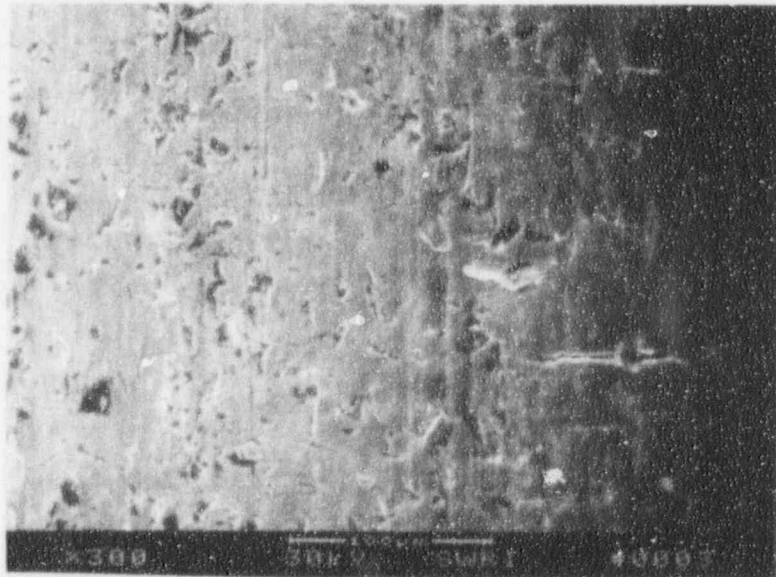
Test No. HC-8 involved a charging time of 80 min. and did not result in fracture. However, post-test SEM examinations showed subcritical cracking on the inside of the bend, as shown in Figure D-9(b). The cracking is less severe than that of Test HC-5. As in the case of Test No. HC-5, the cracking demonstrates partial embrittlement consistent with the less severe charging conditions.

Figure D-9. SEM Photomicrographs from Surface of Hydrogen-Charged Bend Specimen. Test No. HC-8. Charging Conditions: -1.0V, 80 Min.

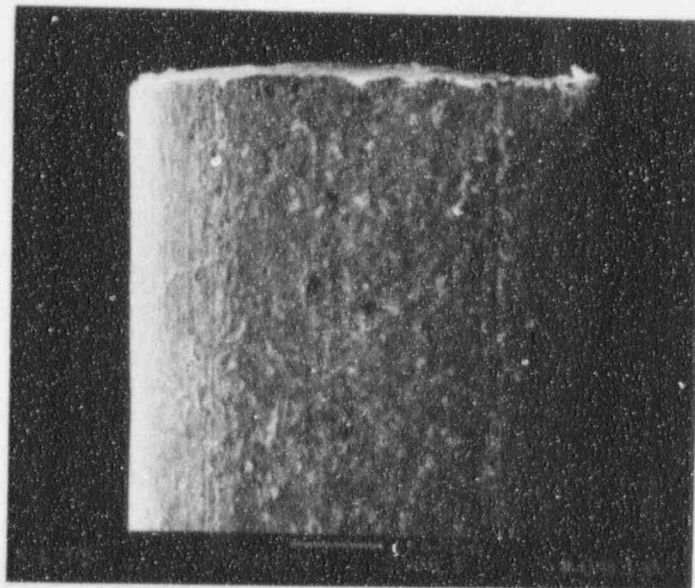
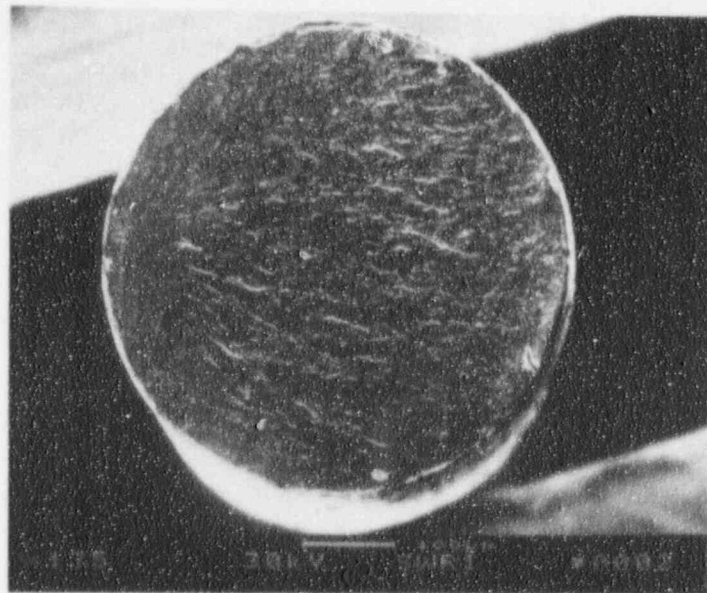
Reverse bending after the initial test (Test No. HC-8R) resulted in complete brittle fracture. SEM fractographs are shown in Figures D-10, D-11, and D-12. The fractographic features are essentially identical to those of Test No. HC-5R. The flat fracture and fine scale dimples are shown in Figures D-10(b) and D-12. Figure D-12 shows the initiation zone with the unique ripples and fine-scale tear dimples similar to those observed in Test HC-5R. It should be noted that the reverse bends of Test Nos. HC-5R and HC-8R were performed several days after the initial bend tests so that initial embrittlement may have decayed. A possible explanation of the fractographic features is that the failures initiated by slow tearing from the surface cracks in the early stages of the bend and that the final dimpled rupture occurred when the tearing reaches the critical crack size for fast fracture of the remaining section.

Figure D-10. Fracture Surface of Hydrogen-Charged Bend Test Specimen. Test No. HC-8R. Charging Conditions: -1.0V, 80 Min. Reverse Bend After Initial Tests.

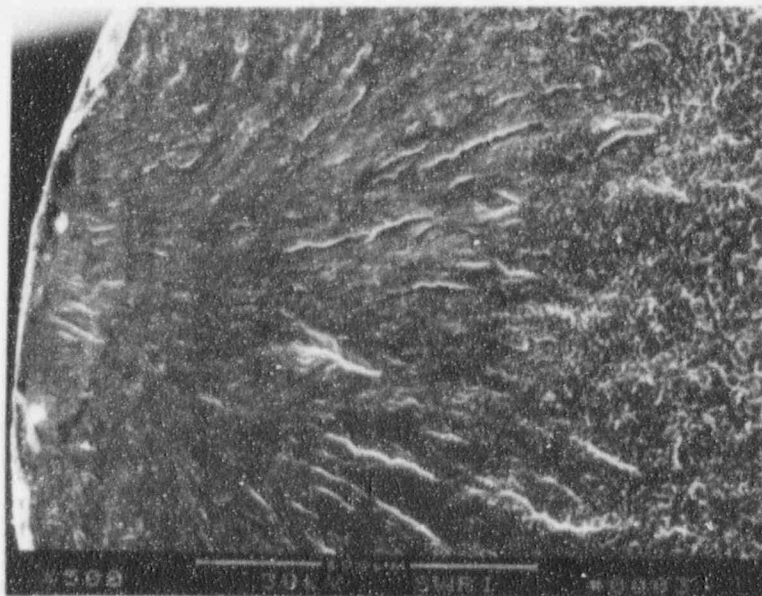
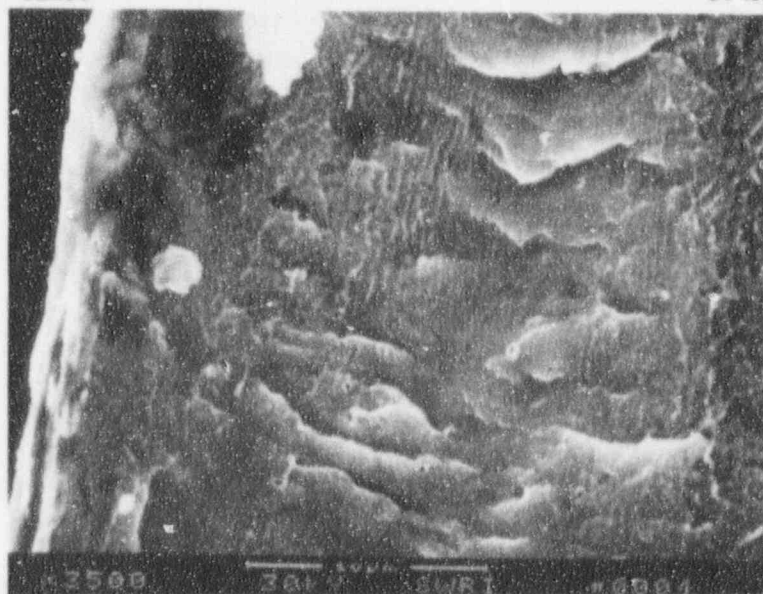
Figure D-11. SEM Fractographs from Hydrogen-Charged Bend Test Specimens. Test No. HC-8R.

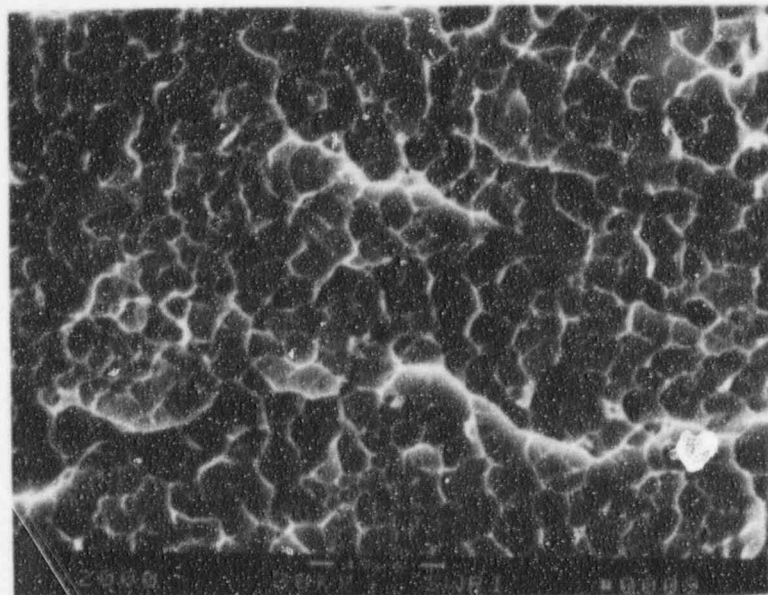
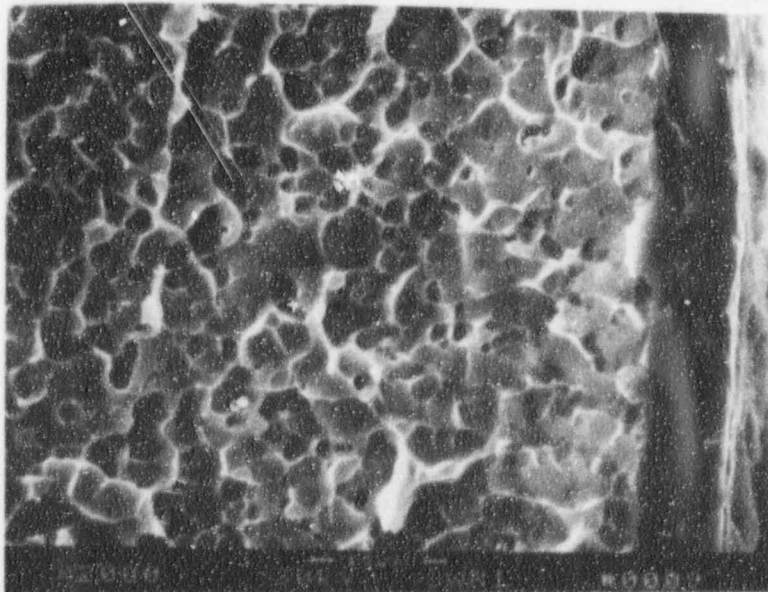
Figure D-12. SEM Fractographs from Hydrogen-Charged Bend Test Specimens. Test No. HC-8R.

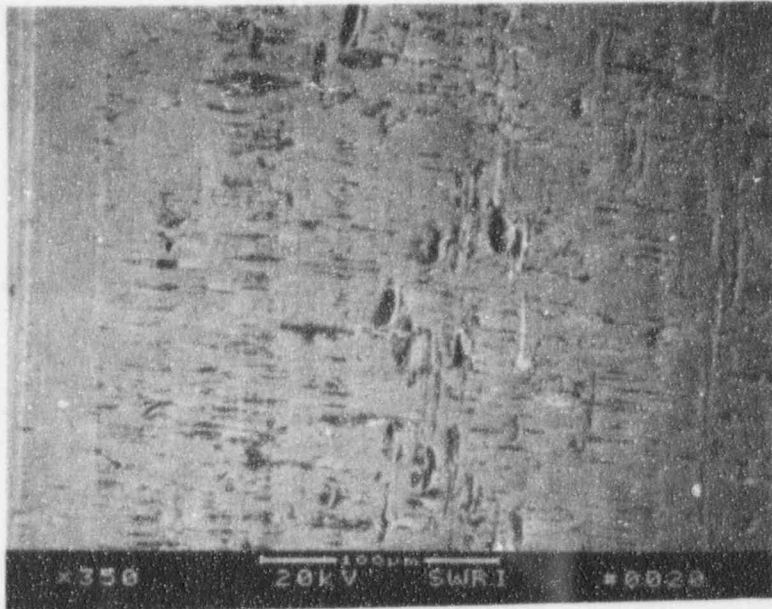
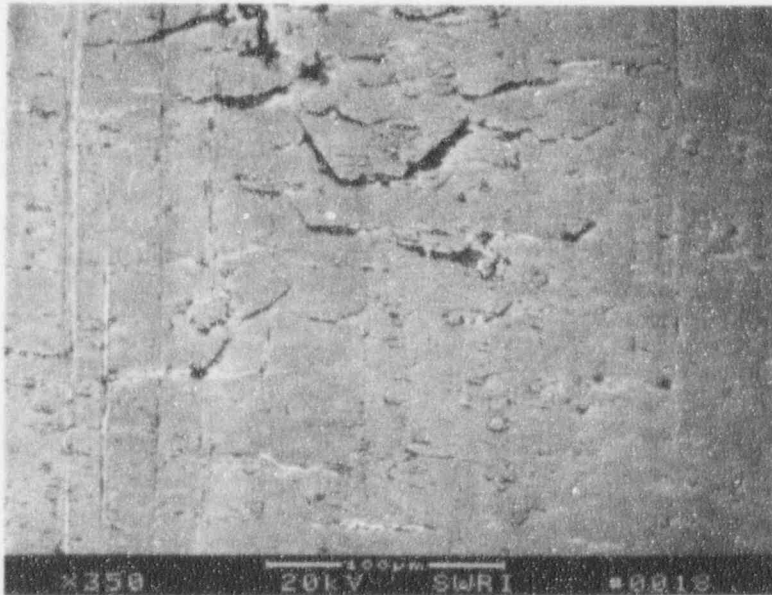
These tests represent cases where the bend tests were performed either after a 52-hour delay (HC-18, HC-19, HC-20) or after a 2-hour 450°F bake-out procedure (HC-21, HC-22, HC-23). None of these bend tests resulted in fracture indicating that the hydrogen embrittlement process is reversible. However, post-test SEM examinations revealed subcritical cracking at the bend as shown in Figures D-13 and D-14.

A possible explanation of this behavior is that the embrittlement in the outer layer involves a non-reversible mechanism so that a thin brittle shell remains after a delay time or bake out. Then, during the bend test, the thin shell could develop cracks which are not of a critical size for fracture of the more ductile core. A second possibility is that surface microcracks form during the charging process and that these cracks are not critical to fracture of this full cross section after time delay or bake-out. Further detailed studies of the hydrogen embrittlement process in Nitinol would be necessary to resolve these questions. Such testing is not relevant to the identification of the root cause of the sourcewire failures and is beyond the scope of this investigation.

Figure D-13. SEM Photomicrographs of Surface of Hydrogen-Charged Bend Test Specimen. Test No. HC-19. Charging Conditions: -1.0V, 120 Min.; Tested After 52 Hrs. At Room Temperature.

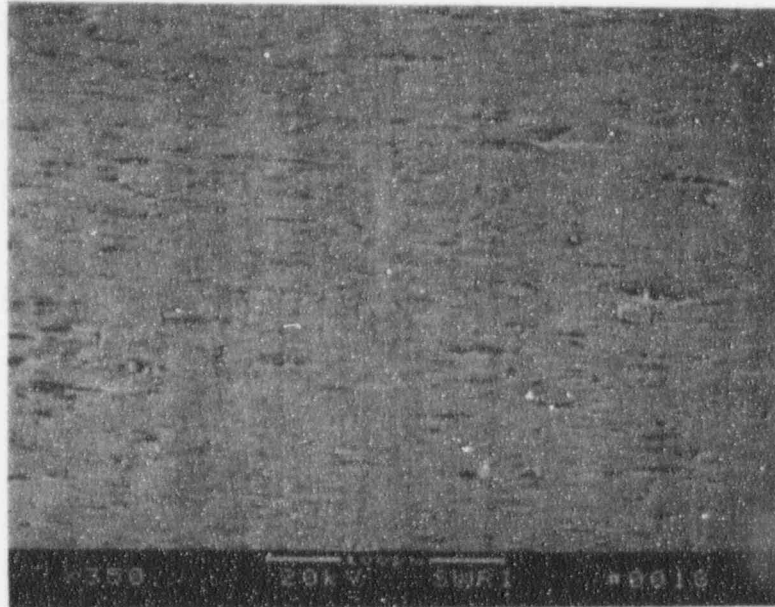
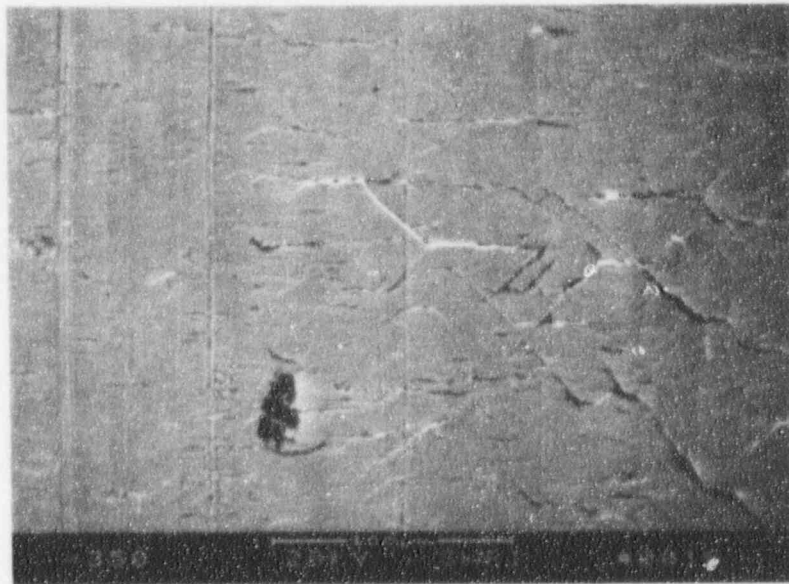
Figure D-14. SEM Photomicrographs of Surface of Hydrogen-Charged Bend Test Specimen. Test No. HC-21. Charging Conditions: -1.0V, 120 Min.; Tested After 2 Hrs. At 450°F.

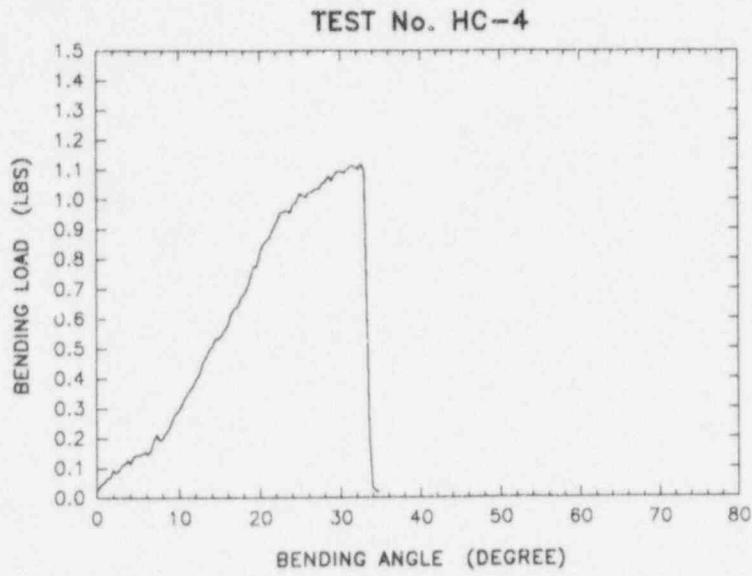
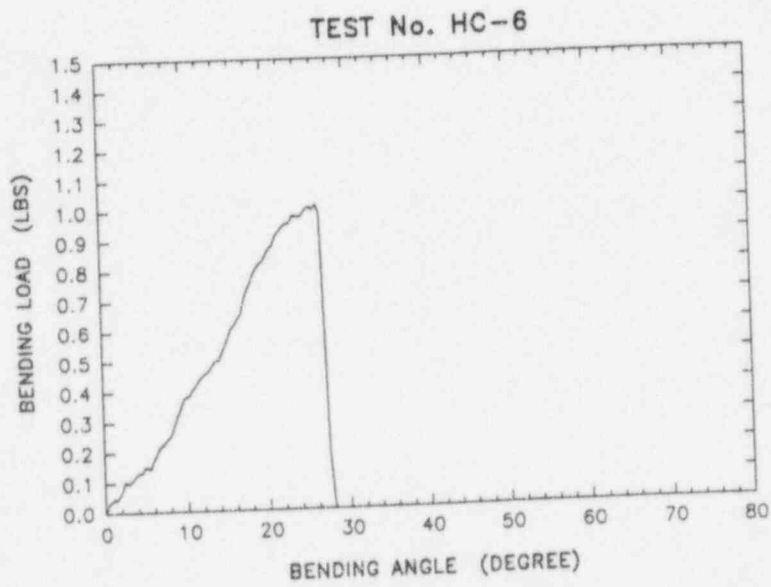
Figure E-2. Plot of Bending Load vs. Angle for Test No. HC-4 and HC-6.

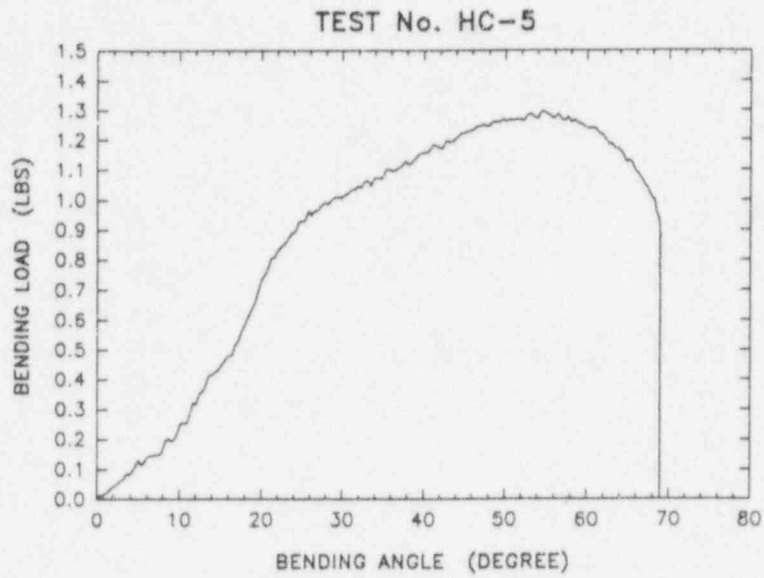
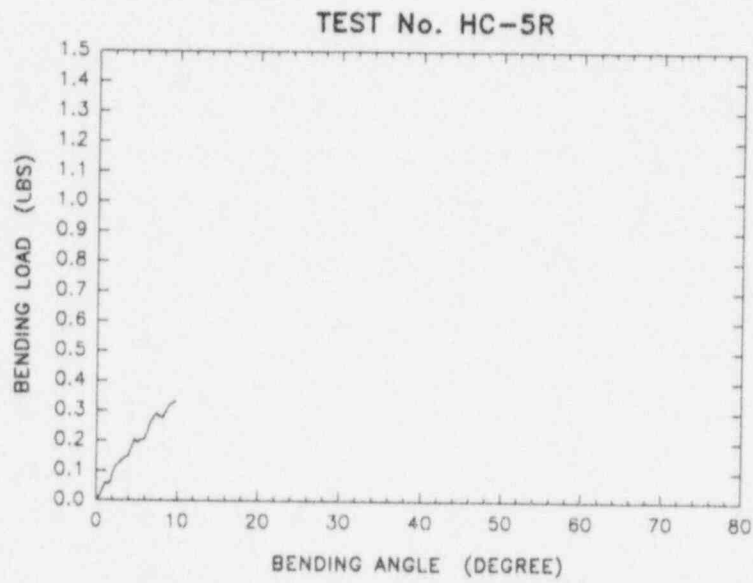
Figure E-3. Plot of Bending Load vs. Angle for Test No. HC-5 and HC-5R.

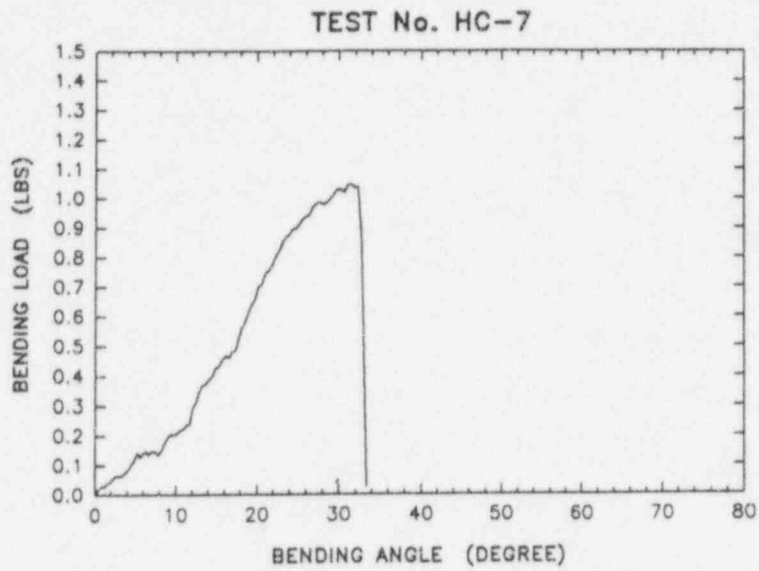
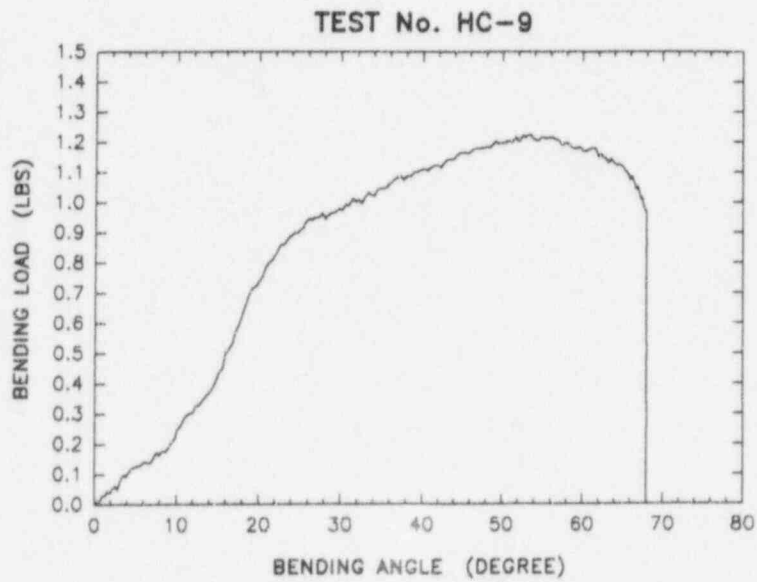
Figure E-4. Plot of Bending Load vs. Angle for Test No. HC-7 and HC-9.

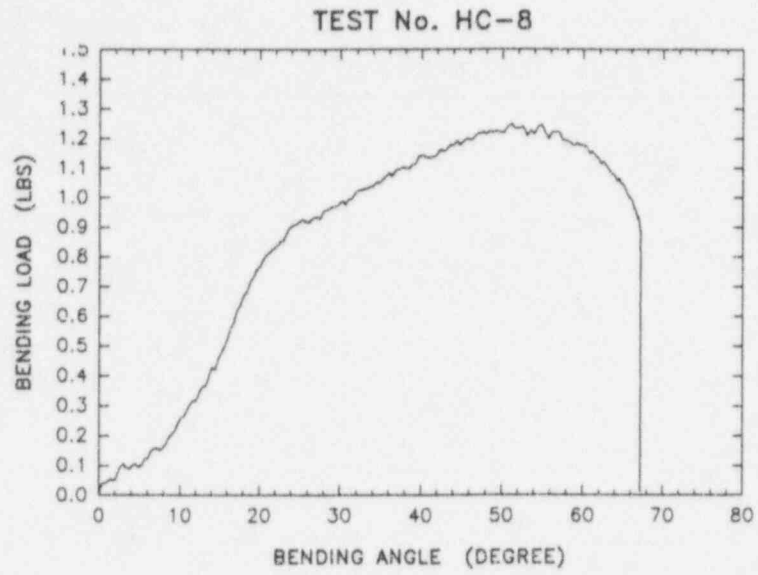
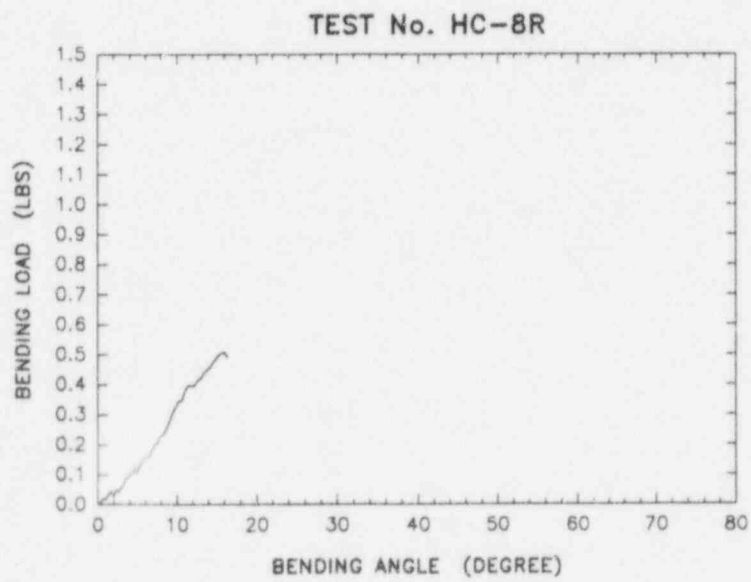
Figure E-5. Plot of Bending Load vs. Angle for Test No. HC-8 and HC-8R.

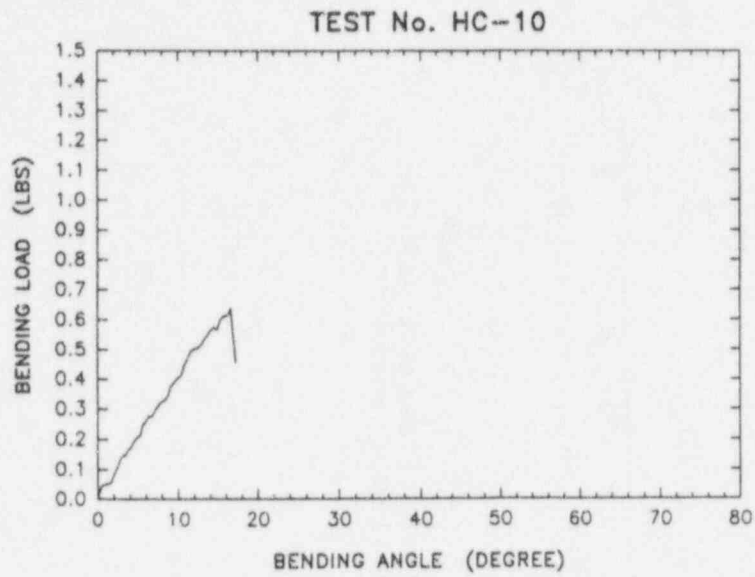
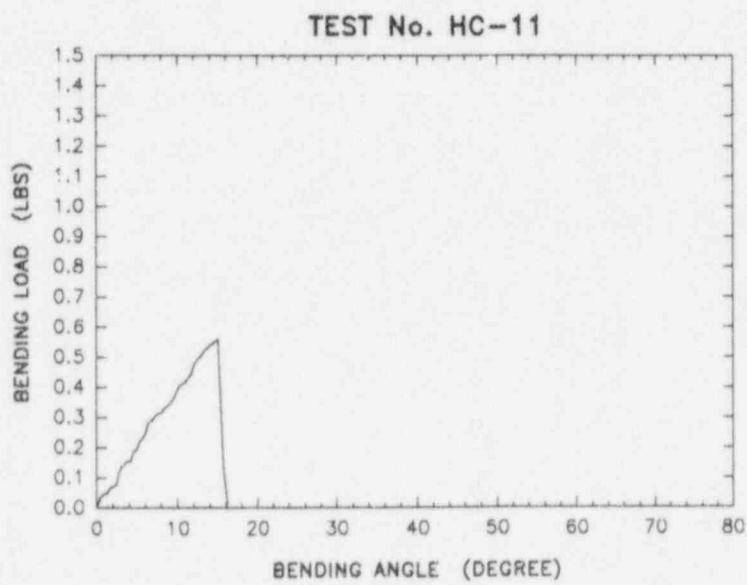
Figure E-6. Plot of Bending Load vs. Angle for Test No. HC-10 and HC-11.

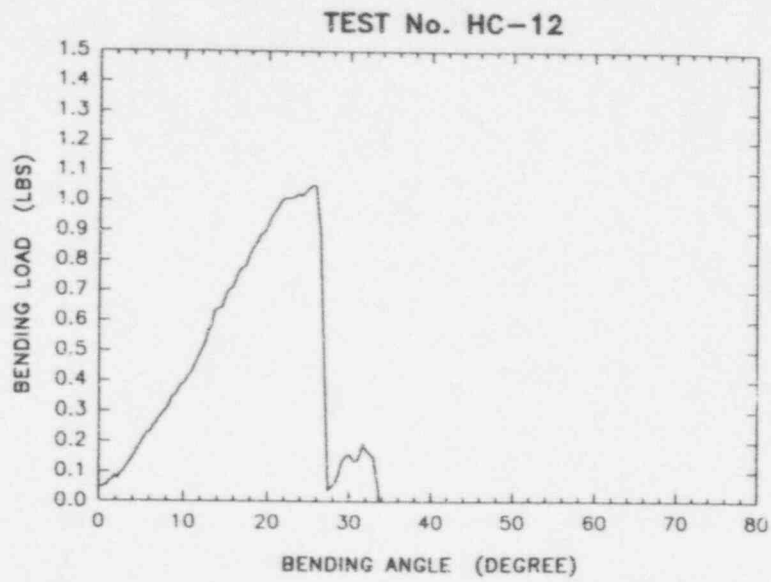
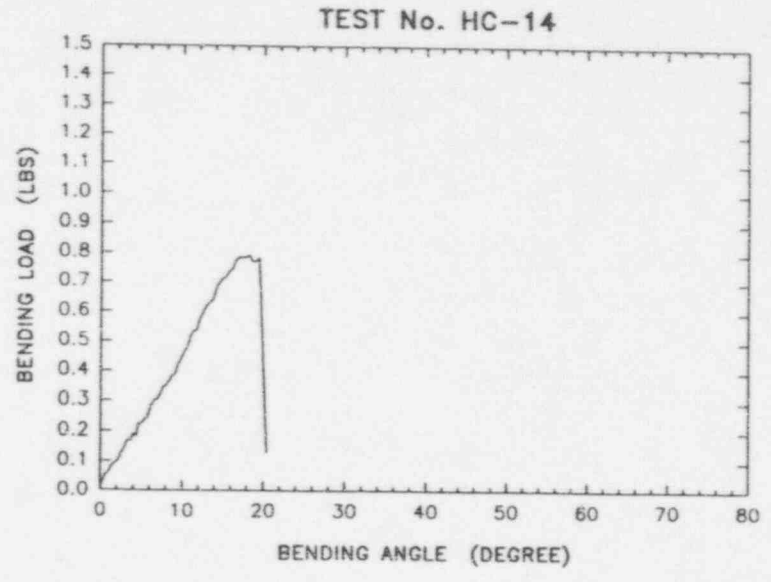
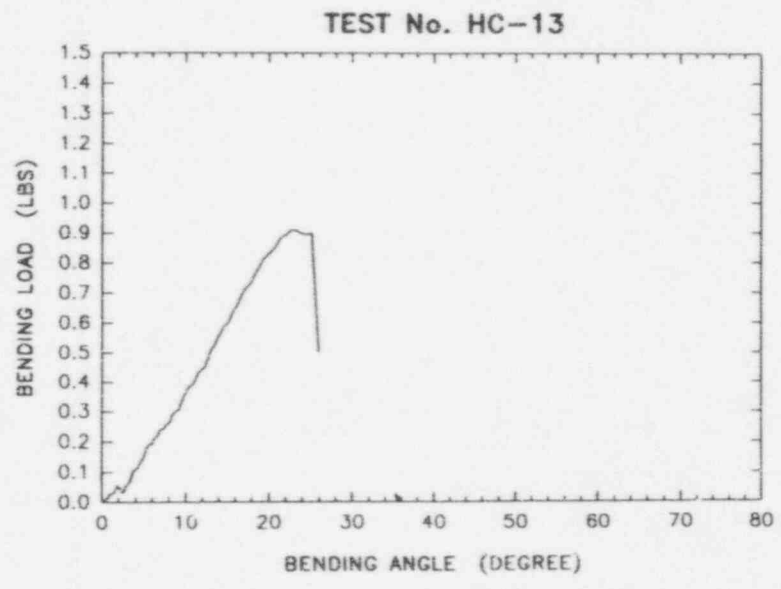
Figure E-7. Plot of Bending Load vs. Angle for Test No. HC-12, HC-13, and HC-14.

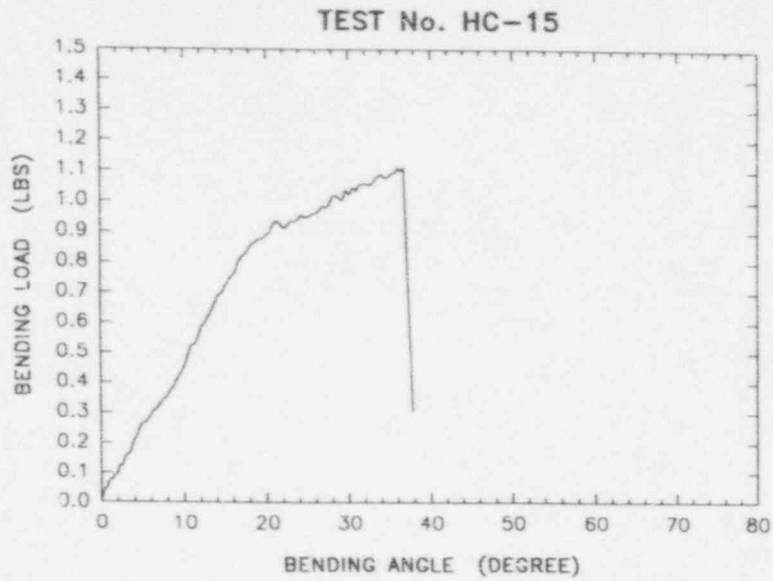
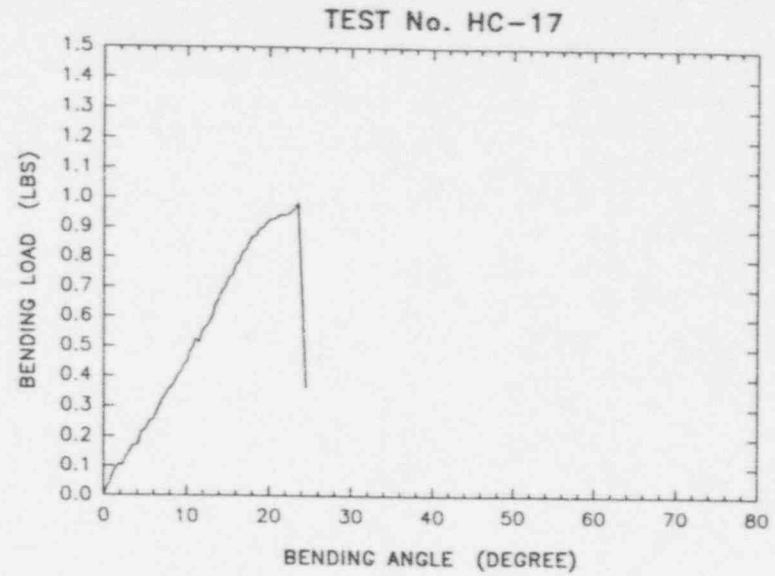
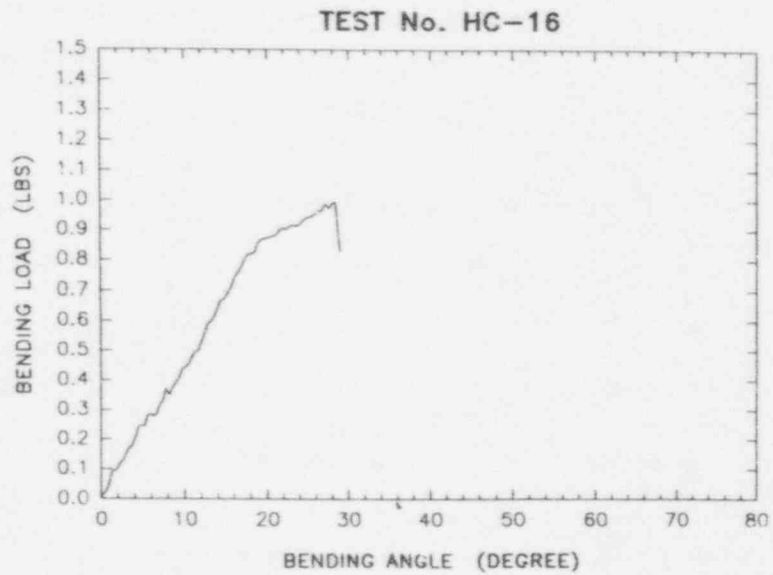
Figure E-8. Plot of Bending Load vs. Angle for Test No. HC-15, HC-16, and HC-17.

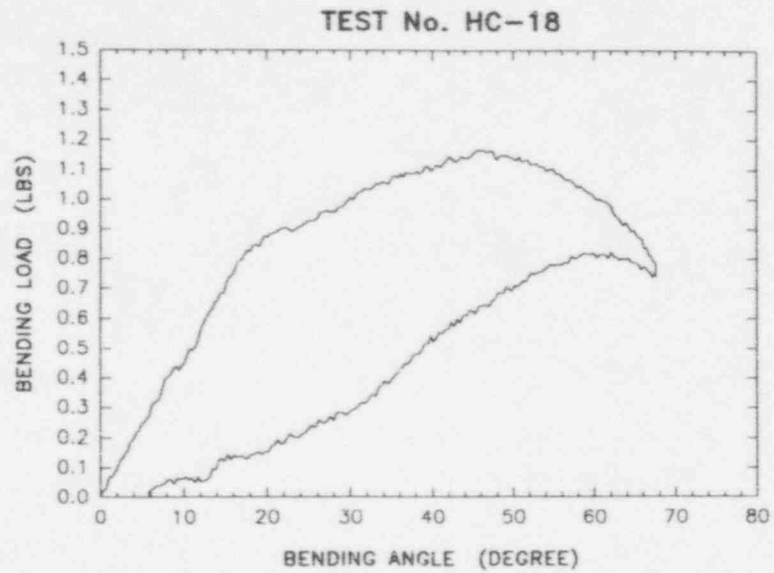
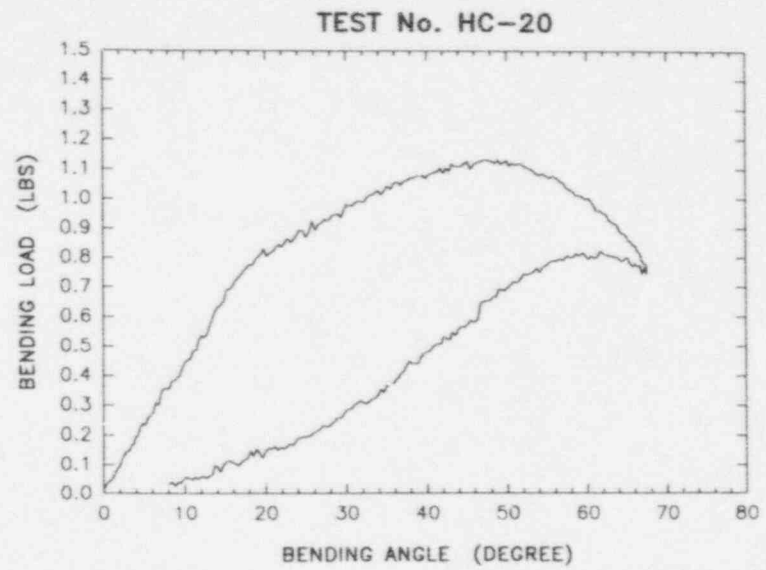
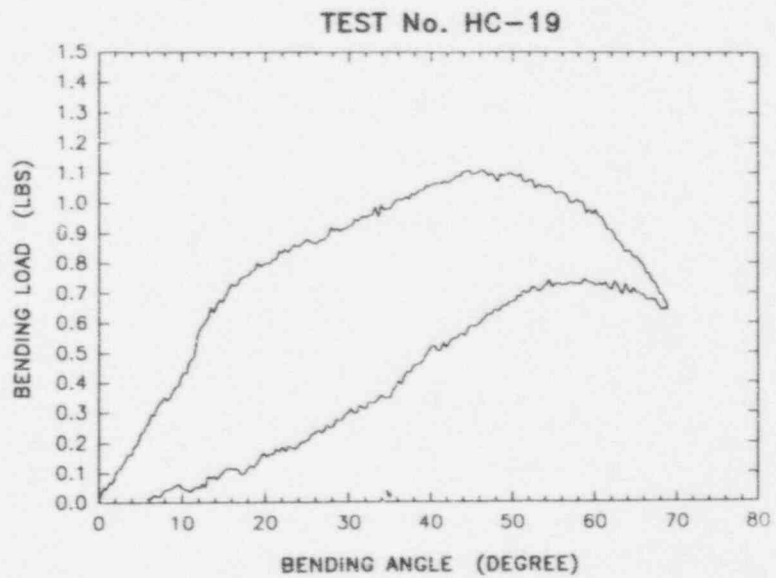
Figure E-9. Plot of Bending Load vs. Angle for Test No. HC-18, HC-19, and HC-20.

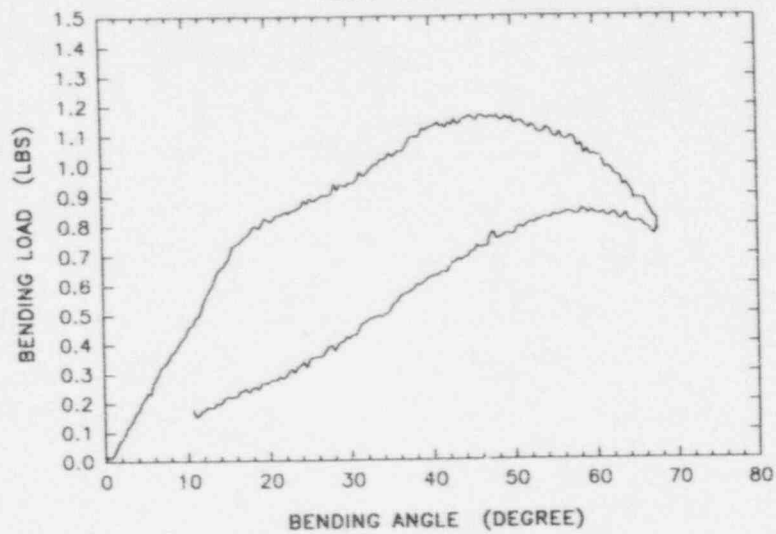
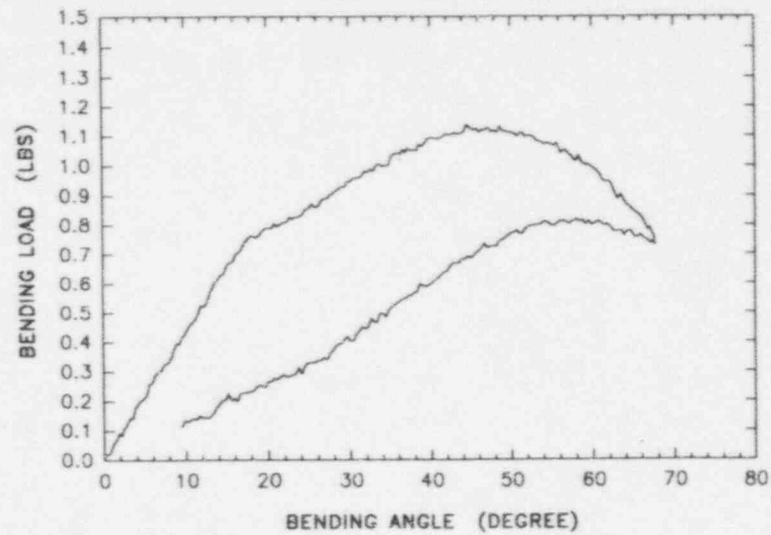
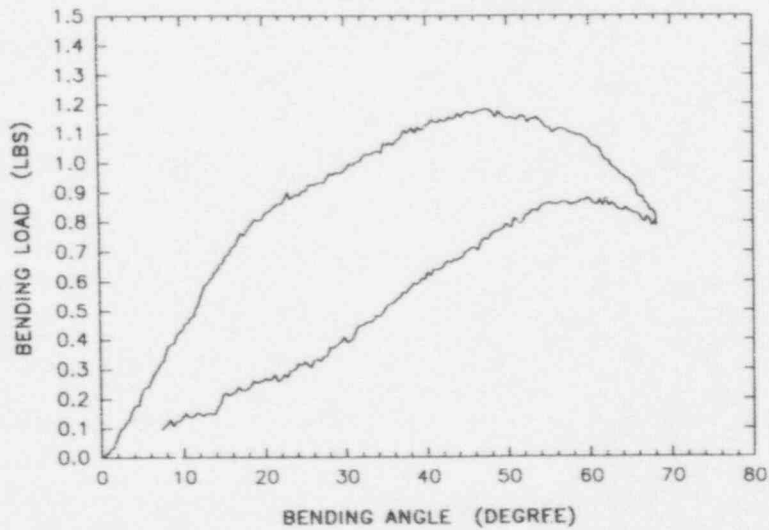
Figure E-10. Plot of Bending Load vs. Angle for Test No. HC-21, HC-22, and HC-23.
