LICENSEE EVENT REPORT (LER)

Facility Name (1) Quad Cities Unit One	Docket Number (2) 0   5   0   0   0   2   5   4	Page (3) 1   of   0   4
---	--	----------------------------

Title (4)  
The Technical Specification Required Pressure Was Not Met During Local Leak Rate Testing Due To A Procedural Deficiency

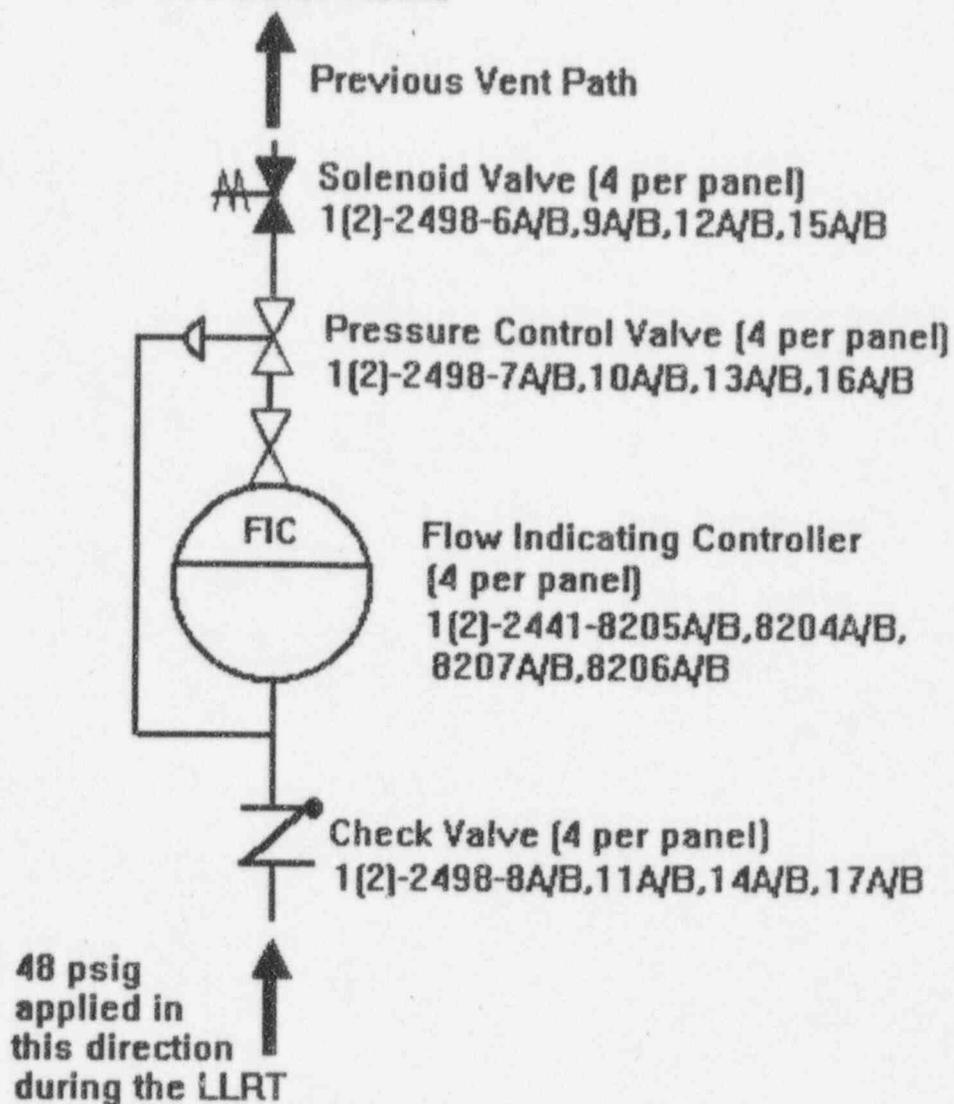
QCTS 0600-34 is currently performed when the CAM panel is in standby mode, which places the solenoids in a de-energized (closed) condition. When testing CAM check valves 1(2)-2498-8A/B, 11A/B, 14A/B, and 17A/B (which are internal to CAM panels 2251(2)-81A/B), the fittings at the calibration gas bottles are disconnected to provide a vent path. Solenoid valves [SOL] SO 1(2)-2498-6A/B, 9A/B, 12A/B, and 15A/B are also part of the same vent path (refer to Attachment A). During the performance of QCTS 0600-34, at least 48 psig of air pressure is applied to the outlet port of the solenoid (refer to Attachment B).

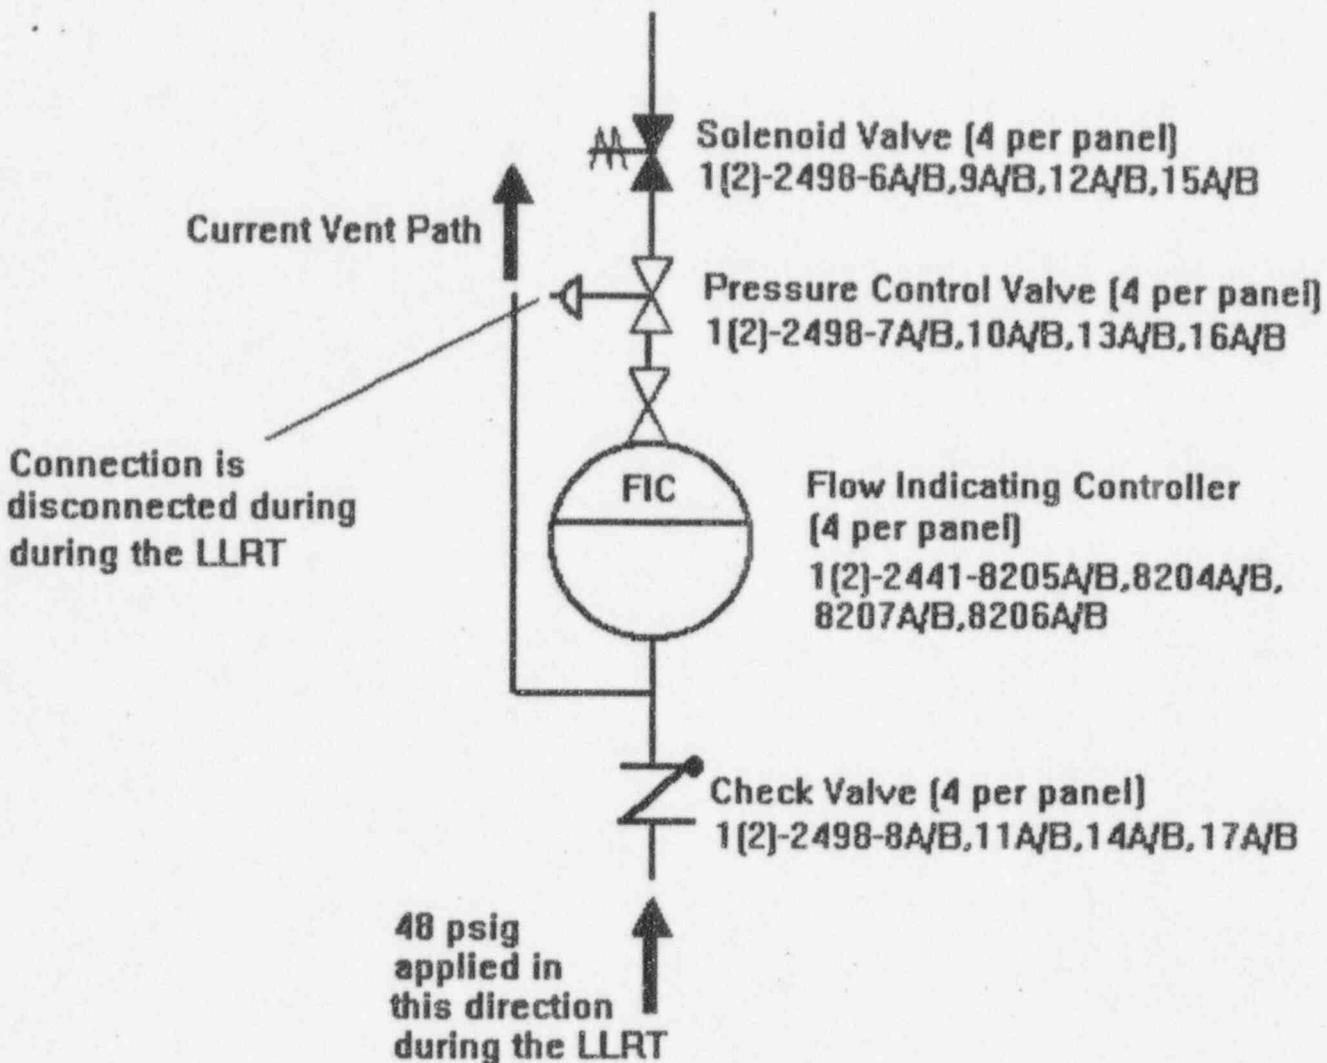
ATTACHMENT B

DE-ENERGIZED STATE FOR DIRECT ACTING SOLENOID  
(SO 1(2)-2498-6A/B, 9A/B, 12A/B, 15A/B)

1. Procedure QCTS 0600-34 will be revised to ensure an appropriate vent path exists when leak rate testing the 2251(2)-81A/B panels (NTS #2541809600801 Support Engineering). Due October 1, 1996.
