Duke Power Company
McGuire Nuclear Generation Department
12700 Hagers Ferry Road (MO01A)
Huntersville, NC 28078-8985

July 29, 1992

Subject: McGuire Nuclear Station, Unit 1
Docket Nos. 50-369
Gamma Plug Seal Weld Failure
Main Feedwater (CF)

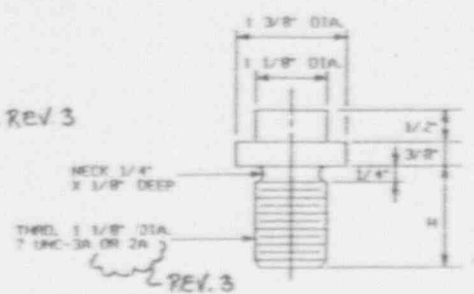
FIGURE 3
FOR USE WITH FIGURE 1
ACCESS AIDS

A 1-1/8 inch, seven thread per inch, non tapered solid plug is inserted into the inspection port (see attached drawing, MDS-EG-4). The plug is then seal welded to provide a leak tight joint. Since the strength of the threaded joint is not a function of the seal weld, the seal weld is categorized as a non-structural weld. The seal weld provides a sealing surface and keeps the non-tapered threaded plug from backing out.
