U.S. NUCLEAR REGULATORY COMMISSION

Report No: 50-341/96004

Facility: Enrico Fermi, Unit 2

Enrico Fermi, Unit 2
NRC Inspection Report 50-341/96-04

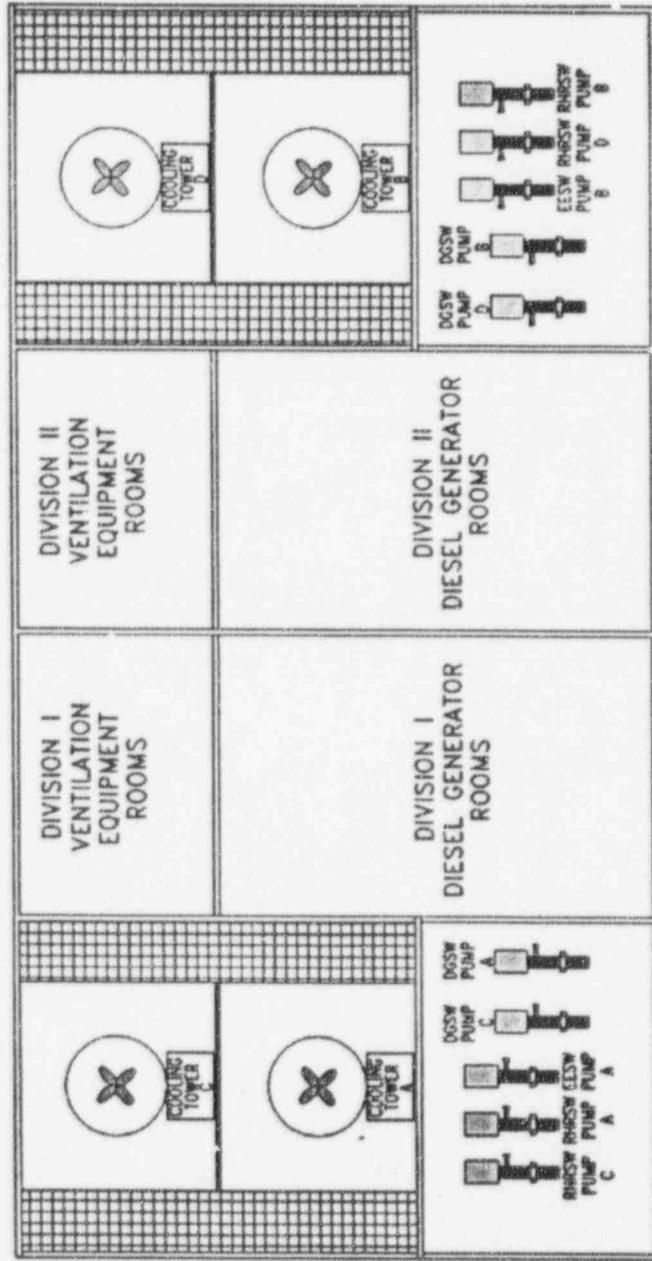
Simplified RHR Complex Layout

- ◆ Effects Of Sub-Freezing Temperatures In Air Space Above Reservoir And Below Pump Room Floors
 - ◆ DGSW Check Valve Back Leakage
 - + Pump Column Designed To Drain Upon Stopping Pump
-
-

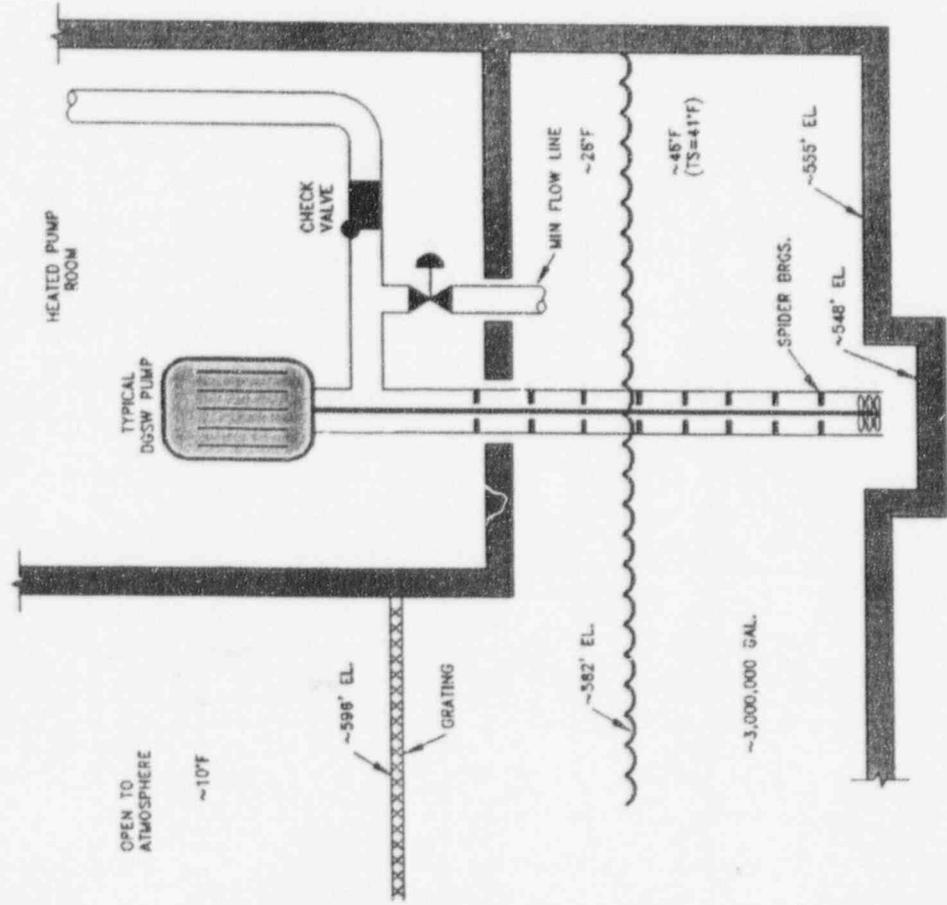
Simplified RHR Complex

- ★ Cause Of DGSW Pump 'C' Inoperability
 - ◆ Initial Pump Shaft Binding Caused By Ice Formation On Pump Bearing
 - ◆ Subsequent Pump Problems Caused By Ice Blockage In Pump Column Or Casing
 - ★ Significant Conclusions
 - ◆ Other Similarly Designed SW Pumps Were Susceptible To This Common Cause Failure Mechanism
 - ◆ Design Inadequacies In RHR Complex Design
-
