SUBJECT: MEETING SUMMARY OF OCTOBER 27, 1992, ON THE SHROUD ACCESS COVER AT  
HATCH UNIT 2 AND POST-MEETING ACTIONS (SAC No. M84756)

PLANT HATCH UNIT TWO  
SHROUD SUPPORT PLATE ACCESS HOLE COVER CRACKING

# ***Access Hole Cover Examinations at Plant Hatch - Unit 2***

HATCH 2  
ACCESS HOLE COVER  
EVALUATION

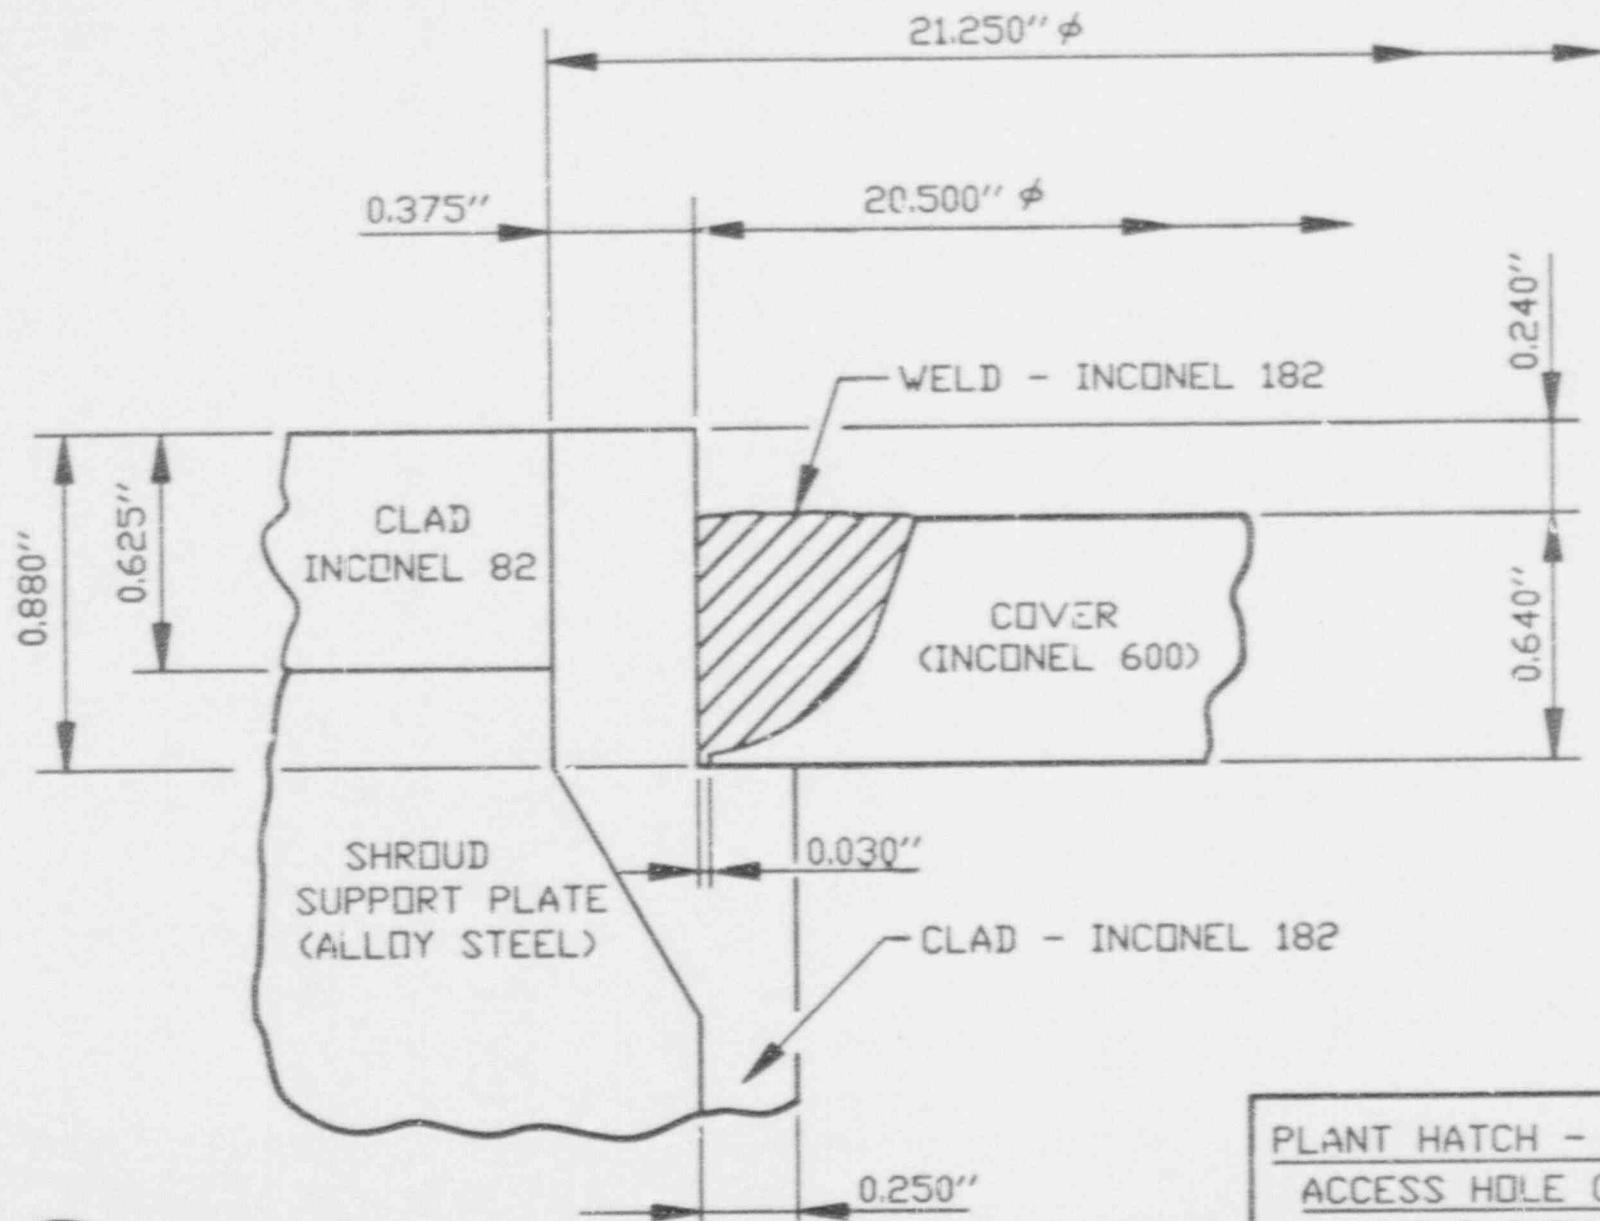
PLANT HATCH - UNIT 2  
ACCESS HOLE COVER  
WELD DETAIL

- I. TWO ACCESS HOLE COVERS LOCATED AT 0° AND 180°  
APPROX. 18" DIRECTLY BELOW RECIRC SUCTION NOZZLES

- II. EACH COVER IS INCONEL 600 -- 5/8" THICK, 20" DIAMETER

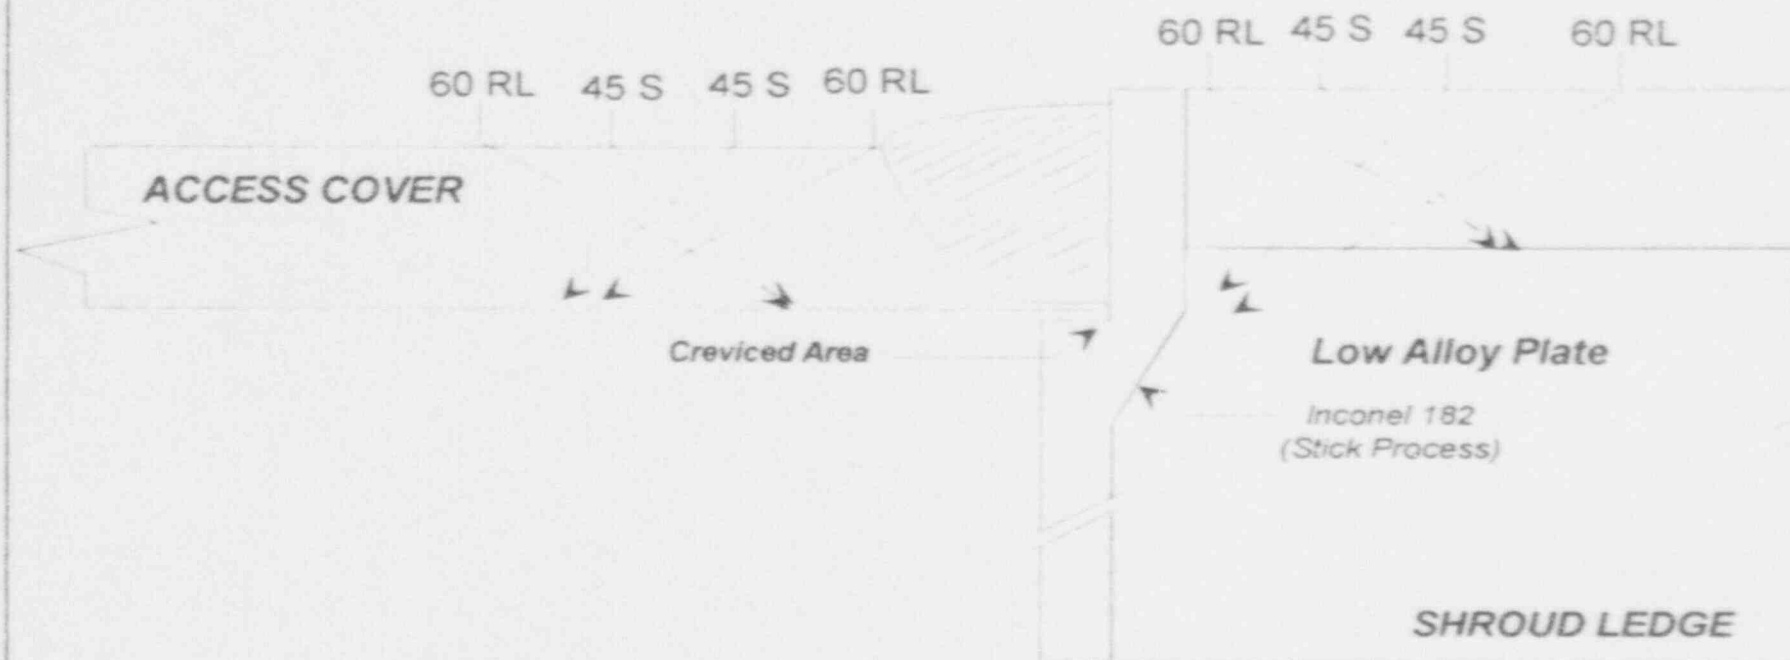
Cross-Sectional View

- Examination technique utilized to detect radial and circumferential cracking
  - Examine from cover and shroud ledge side
  - 45 degree shear and 60 degree RL for weld and base metal interrogation
- Techniques qualified based on actual cracked specimens
  - Visual confirmation
  - Circumferential and radial cracks
- Remote automated exams
  - New scanner and technique for improved accuracy
  - Utilized proven *Smart 2000* data acquisition system

- 0° cover shows no reportable indications
- 180° cover has 2 circumferential planar indications
  - Indication 1 is from 25° to 135°
  - Indication 2 is from 215° to 335°
    - No axial exam on ledge side from 335° to 25° & from 135° to 215° due to RPV and Shroud wall
  - Indication location verified by ultrasonic landmarks and design dimensions
  - Indication has characteristics similar to IGSCC
    - Facetted appearance
    - Strong echo-dynamic pattern
- No radial cracking detected

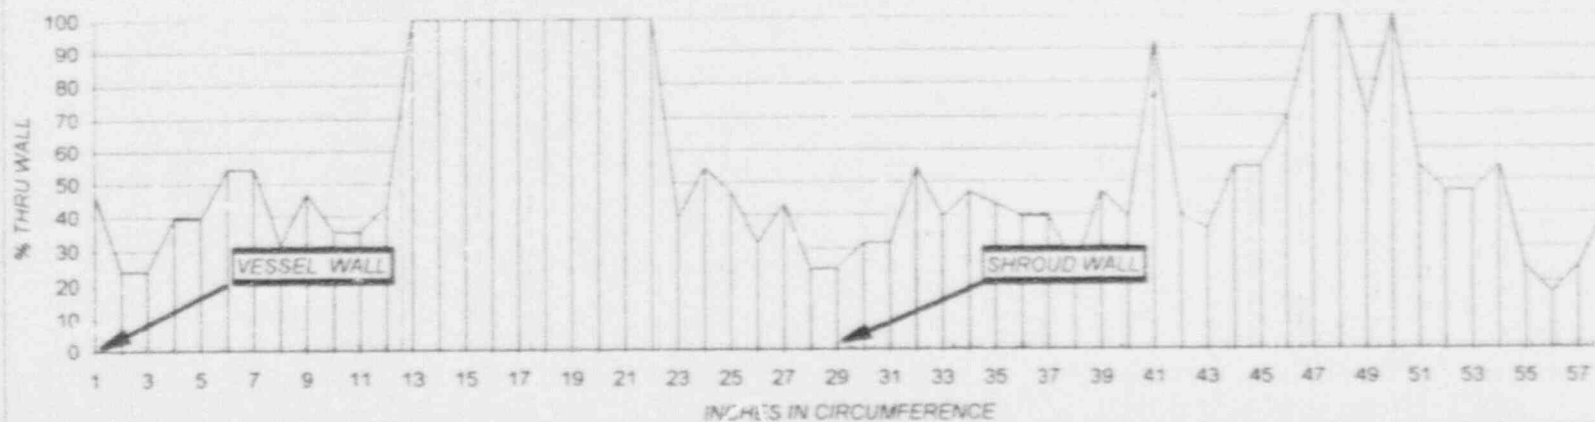
180 DEGREE ACCESS COVER (SHROUD SIDE) THRU WALL LAYOUT MAP

- Cracking can not be confirmed from Cover side
- Crevice area not detected
  - Interface recorded with beam propagating thru crevice area
- Patterns of thru-wall are not consistent
- No areas of pop-thru detected by Visual examination
- First thin cover p. with only one cover cracked

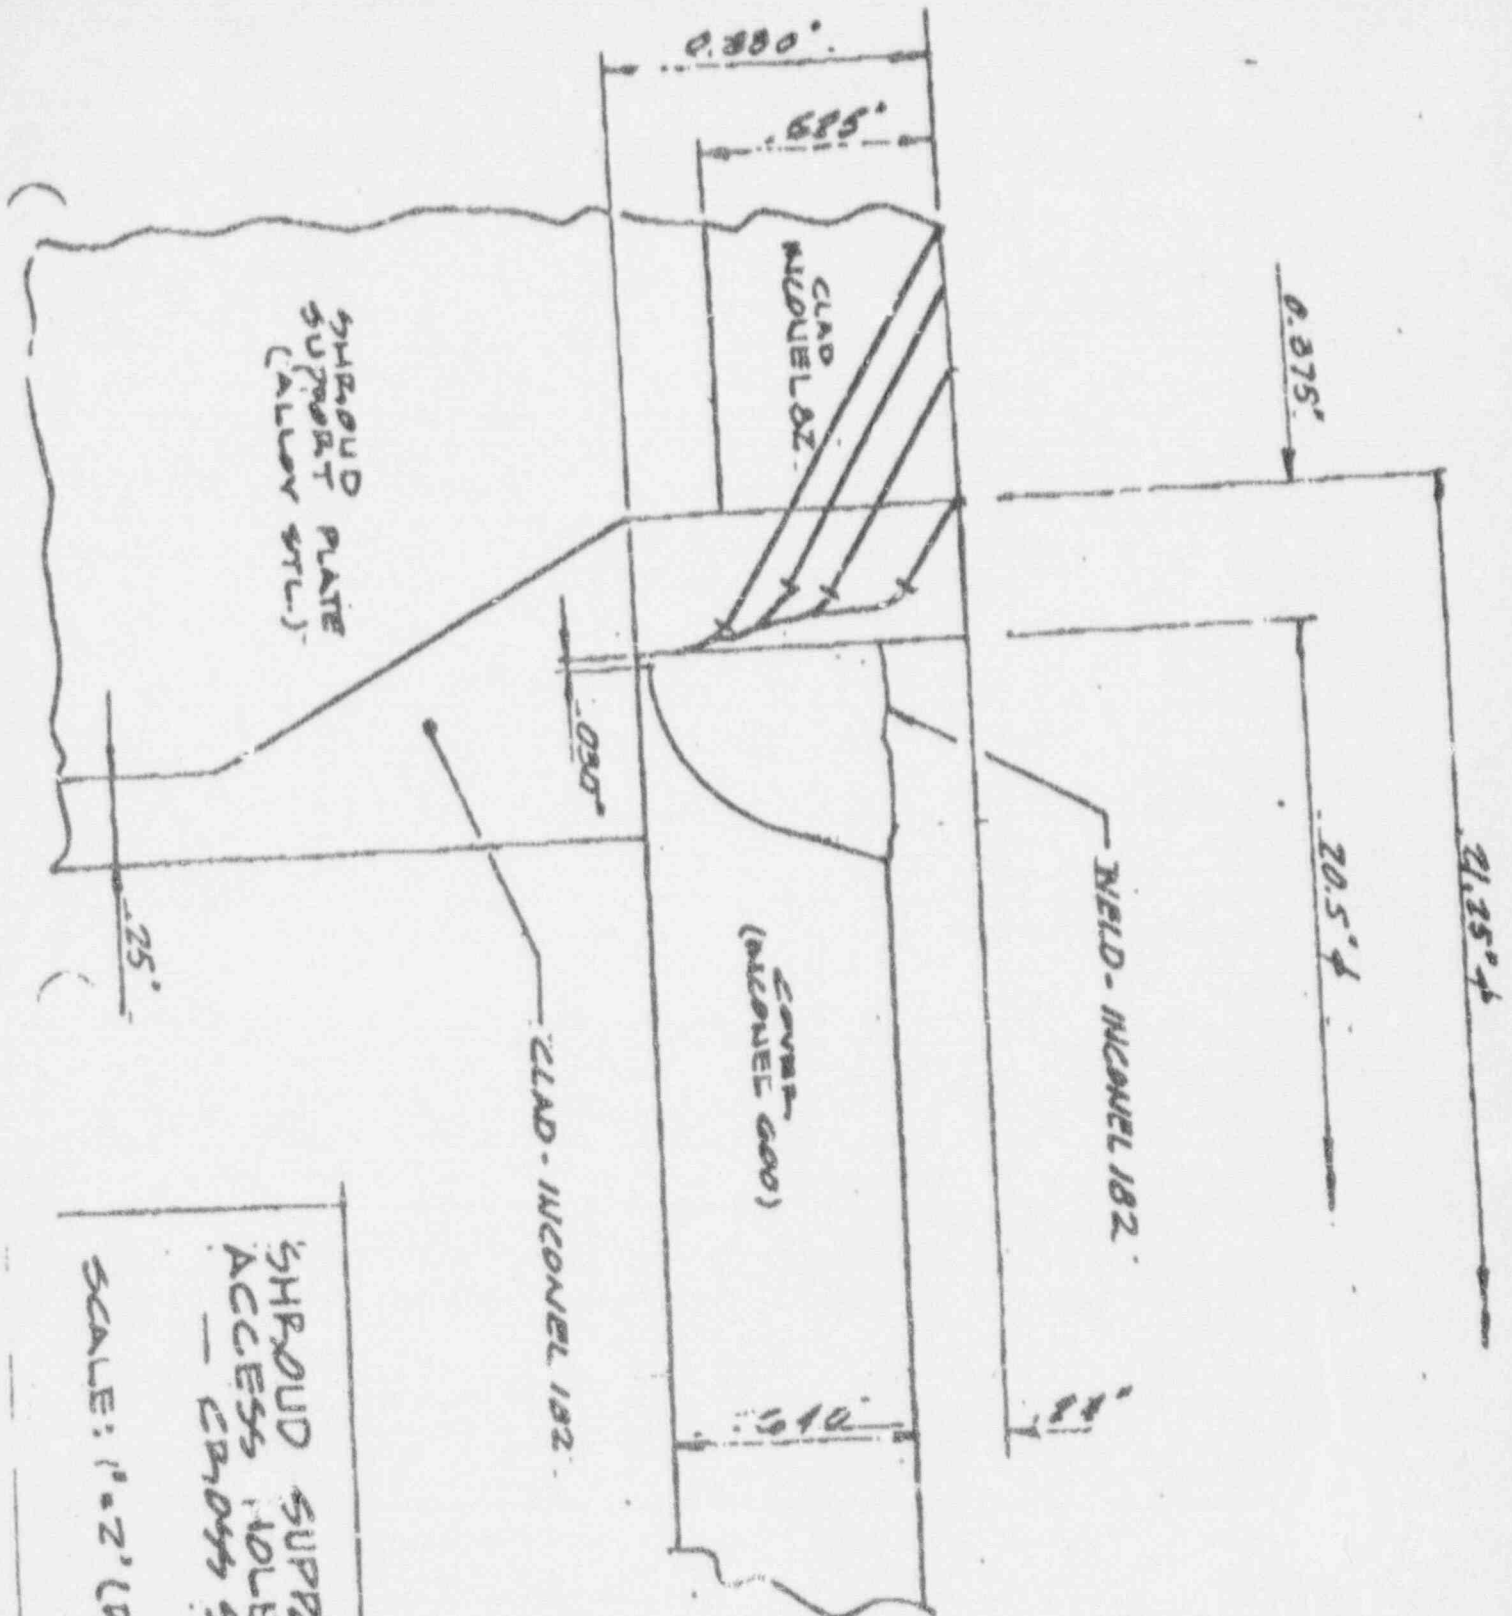
SHOULD SUPPORT PLATE  
ACCESS HOLE COVER  
— CH0045 SECTION —

- 0 CRACK INDICATION IN THE ACCESS HOLE COVER NOT A PRESSURE BOUNDARY CONCERN, BUT CAN BE EVALUATED WITH SIMILAR STRUCTURAL MARGIN CRITERIA.
- 0 CIRCUMFERENTIAL CRACKING IN THE WELD NOT CONSIDERED A SAFETY ISSUE. REVIEWED WITH THE NRC IN THE PAST.
- 1 AHC SEPARATION CAN BE READILY DETECTED BY SIL 462 SYSTEM RECOMMENDATIONS.
- 0 CRACK INDICATIONS ARE CIRCUMFERENTIAL, ENTIRELY IN THE LEDGE. NO RADIAL CRACKING OBSERVED. AVERAGE LIGAMENT THICKNESS APPROXIMATELY 0.26 INCH WITH THE CRACK OFFSET AT LEAST 1/8 INCH FROM THE WELD INTERFACE.

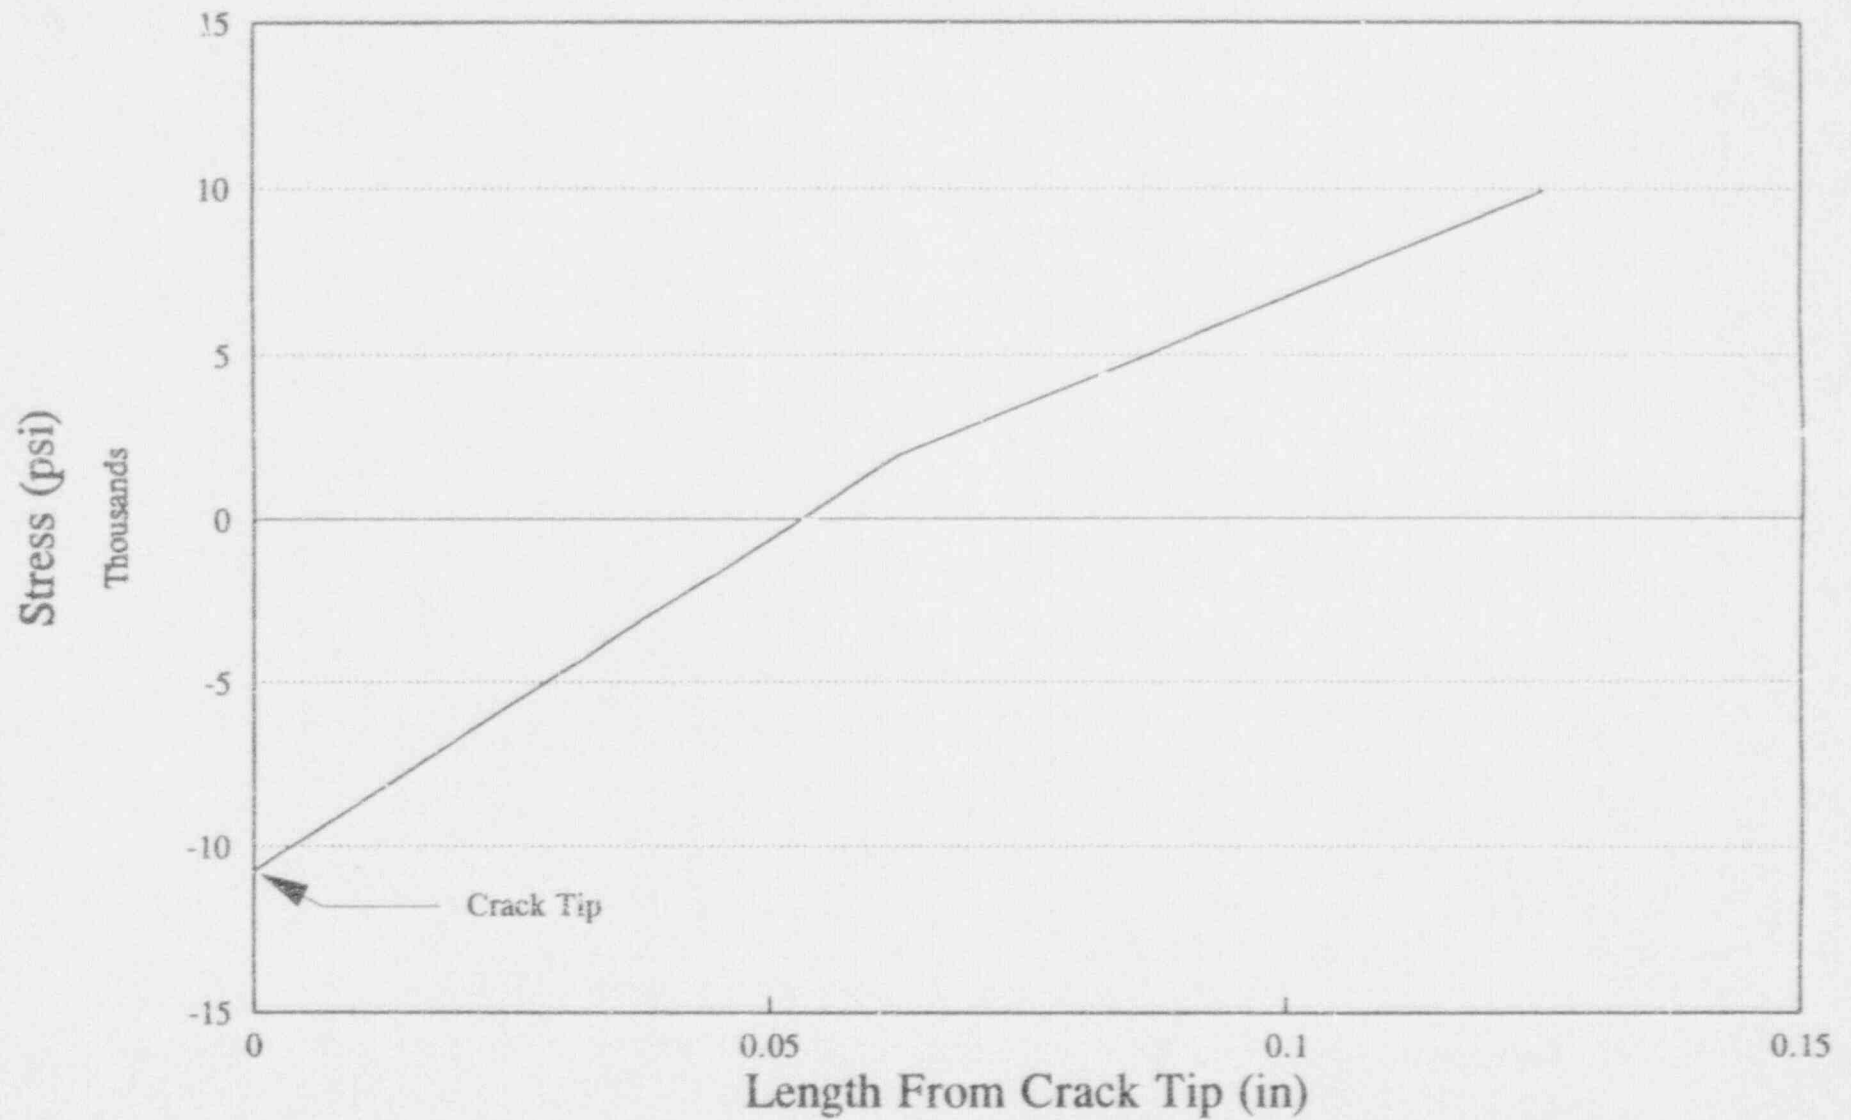
# Horizontal Ligament FEM Axial Stress Distribution

- 0 EVEN AFTER ACCOUNTING CRACK GROWTH AND INCLUDING THE STRUCTURAL MARGIN OF 3.0, THE REQUIRED LIGAMENT IS 0.14 INCH. THE AVAILABLE AVERAGE LIGAMENT OF 0.26 INCH IS WELL IN EXCESS OF THE REQUIRED VALUE.

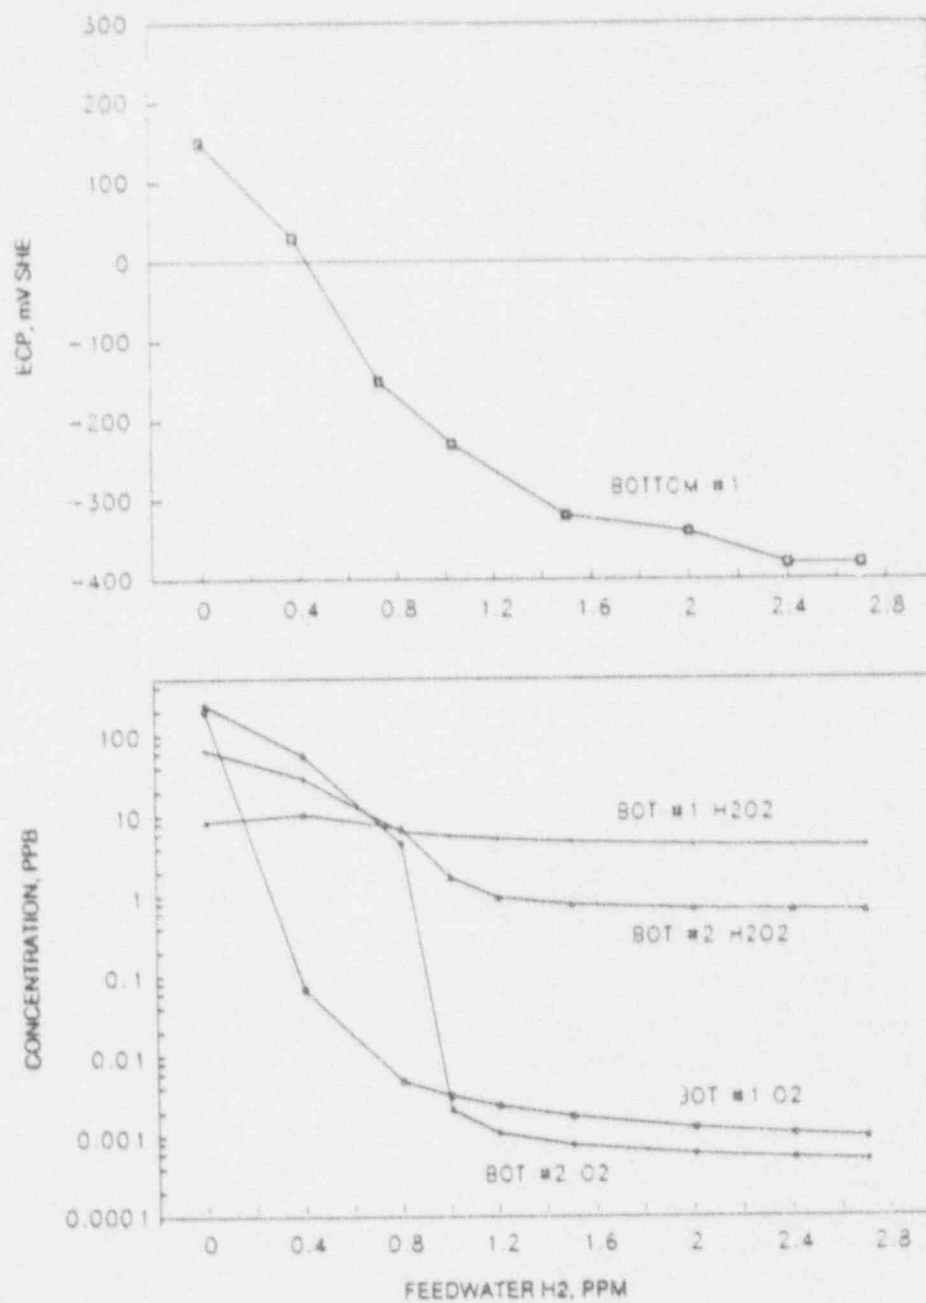
Figure C-8. Measured ECP and Calculated Oxygen and Peroxide at Bottom Electrode Positions

- 0 IGSCC CRACK GROWTH RATE IS A STRONG FUNCTION OF WATER CHEMISTRY - CONDUCTIVITY AND ECP.
- 0 HATCH 2 WATER CHEMISTRY HAS BEEN EXCELLENT DURING THE LAST FUEL CYCLE
  - + WEEKLY AVERAGE WATER CONDUCTIVITY HAS BEEN LESS THAN 0.2 MICROSIEMEN/CM FOR OVER 95 PERCENT OF THE TIME
  - + PLANT HAS BEEN OPERATING UNDER HYDROGEN WATER CHEMISTRY WITH 0.6 PPM FEEDWATER HYDROGEN INJECTION
- 0 BASED ON LOWER PLENUM ECP MEASUREMENTS DONE AT FITZPATRICK (SIMILAR TO HATCH 2), ECP BELOW THE AHC AT 0.6 PPM FEEDWATER HYDROGEN INJECTION LEVEL IS -100 mV.
- 0 CRACK GROWTH RATE AT -100 mV ECP IS PREDICTED TO BE 16 TIMES LOWER THAN THAT UNDER NORMAL WATER CHEMISTRY (+100 mV) GIVING A RATE OF 1.2 MICROINCH / HOUR. THIS GIVES AN INCREMENT OF 15 MILS IN THE NEXT 12000 HOURS.
