FACILITY: Three Mile Island, Unit No. 1 (TMI-1)

SUBJECT: SUMMARY OF MEETING WITH GPUN ON JUNE 28 and 29, 1982
CONCERNING GPUN'S STEAM GENERATOR RECOVERY PROGRAM

**TMI-1 OTSG Status
and
Repair Process Description**

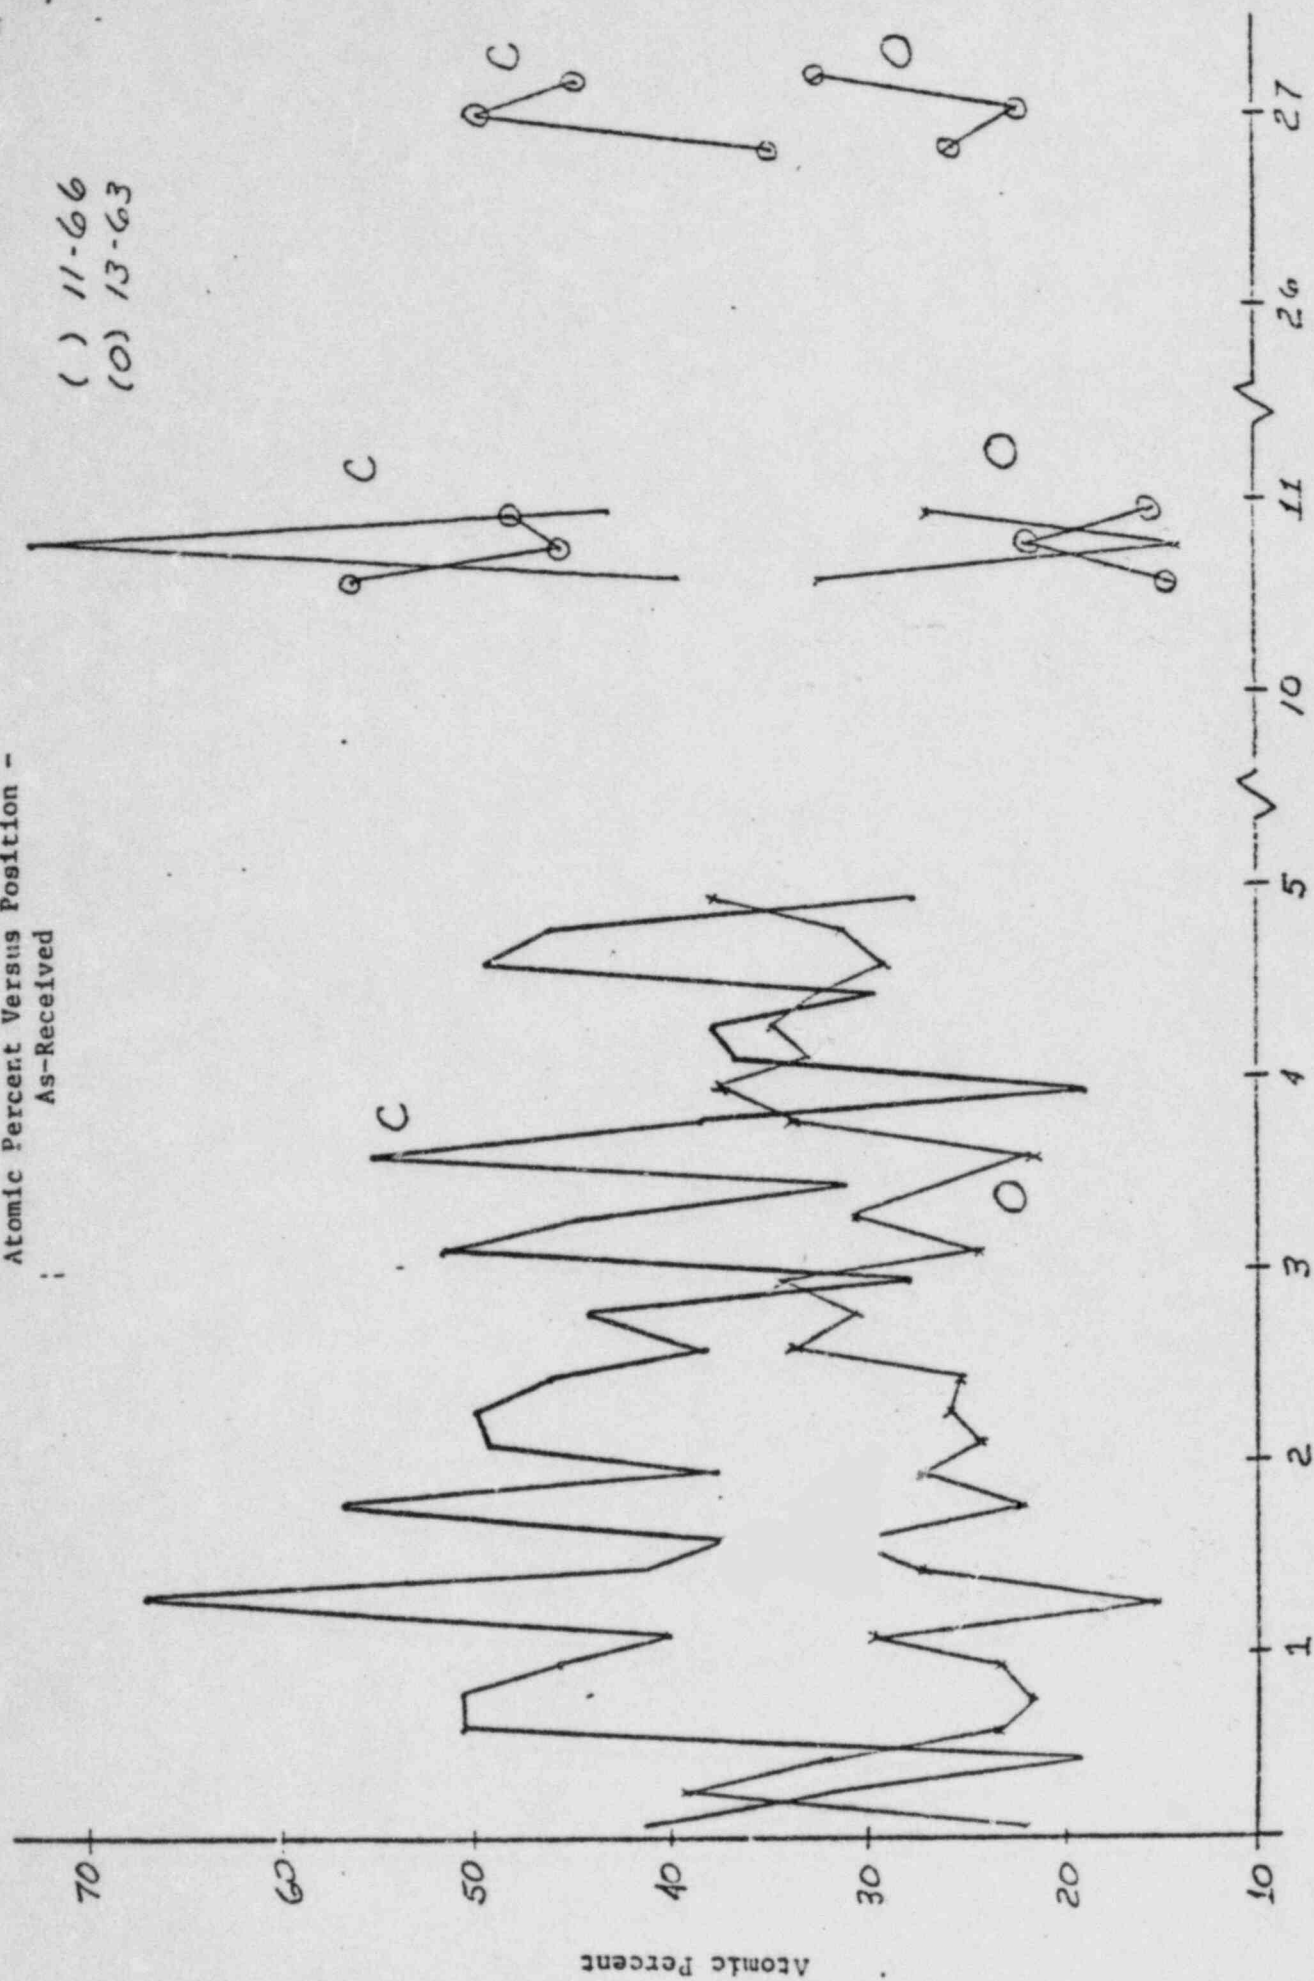
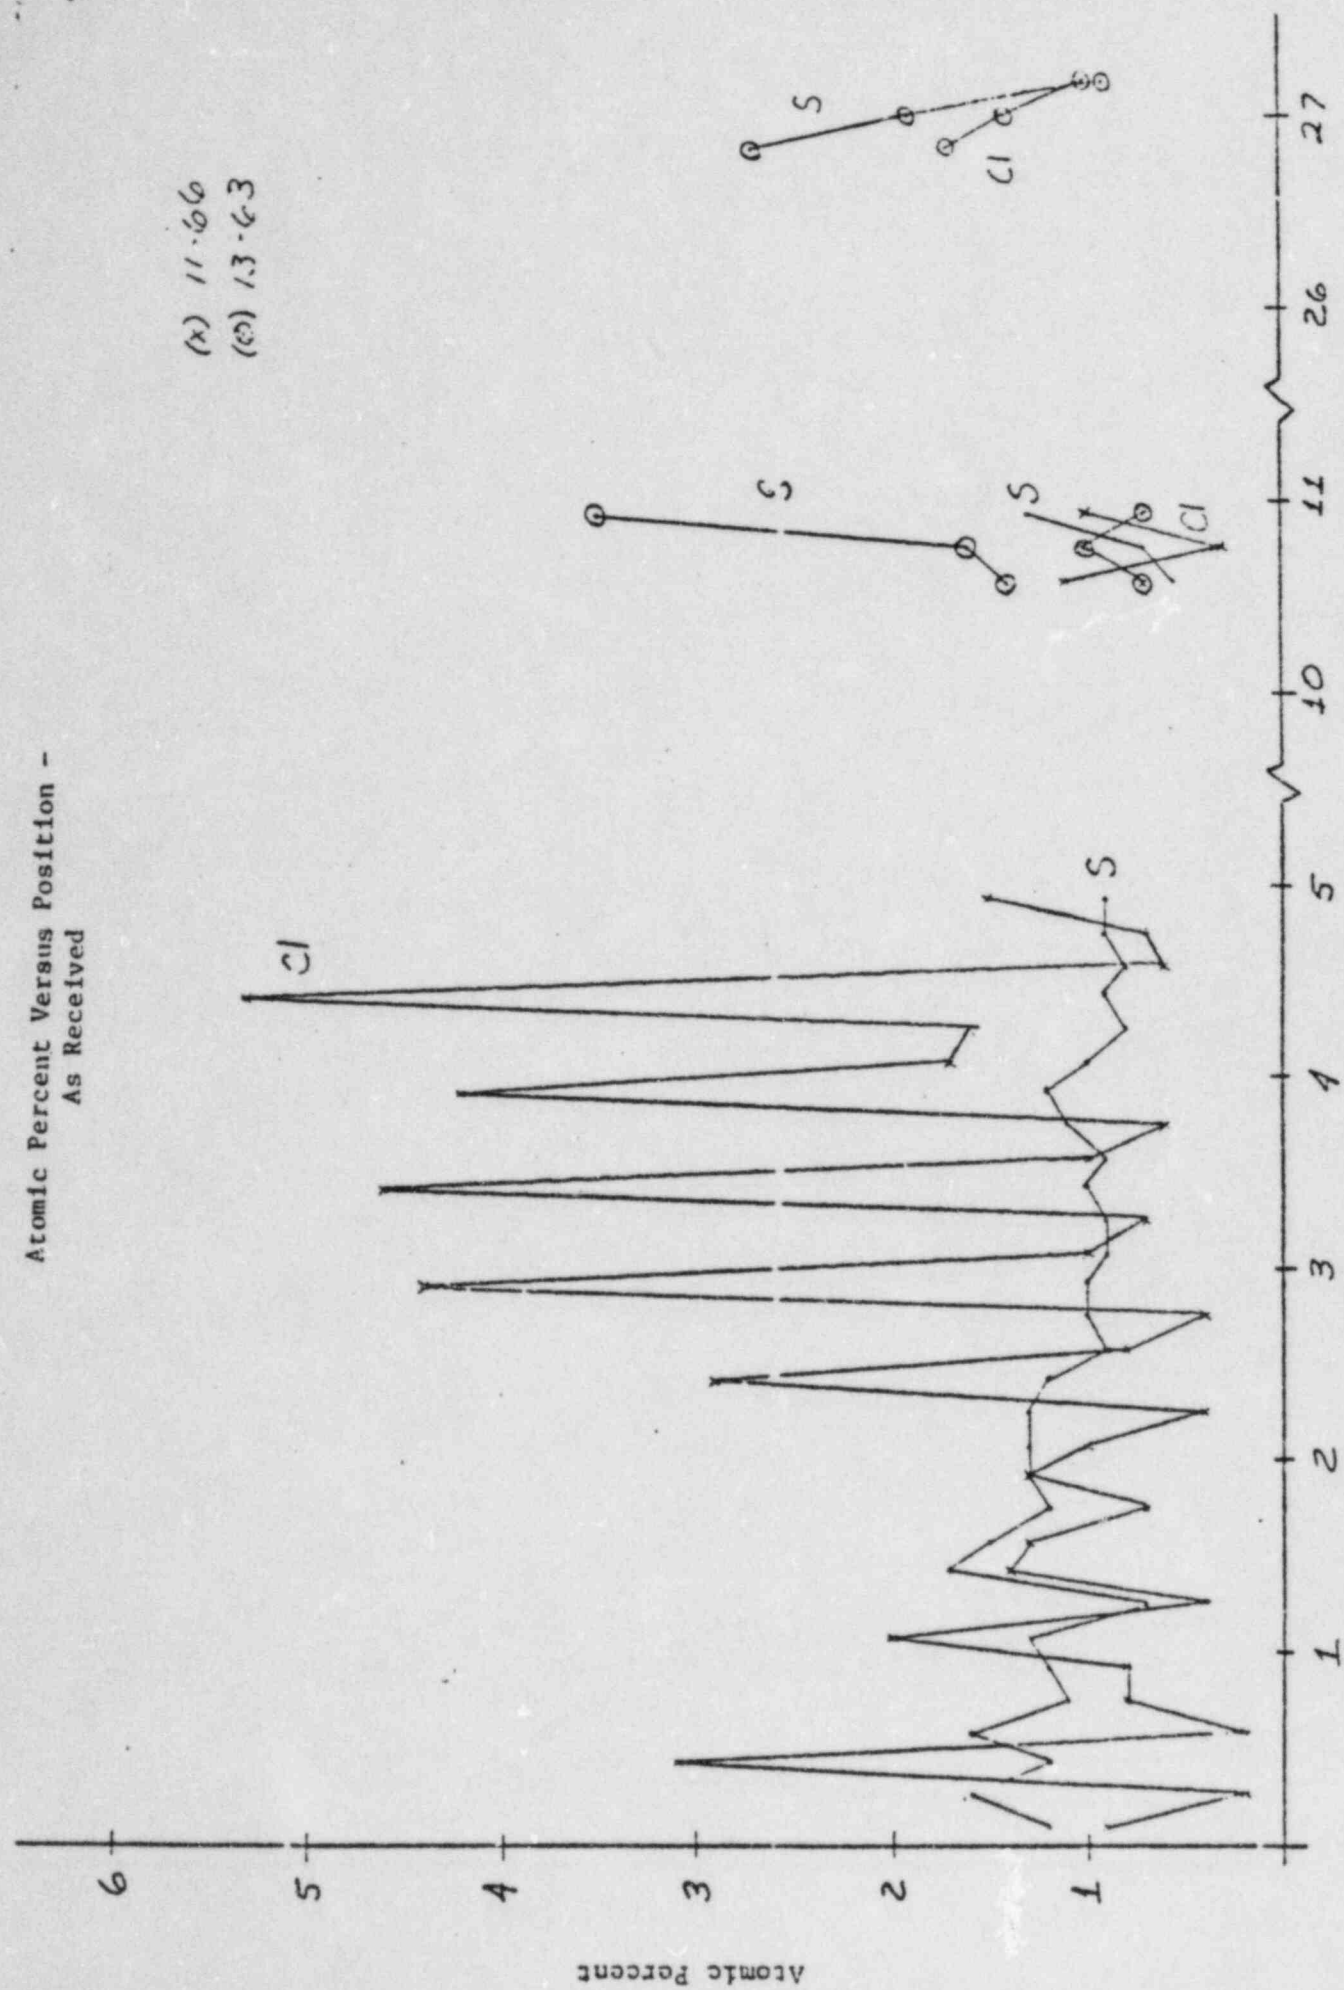
Atomic Percent Versus Position -
As-Received

PHOTOMICROGRAPH OF THROUGH WALL IGC IN
SPECIMEN C FROM TUBE A-146-6

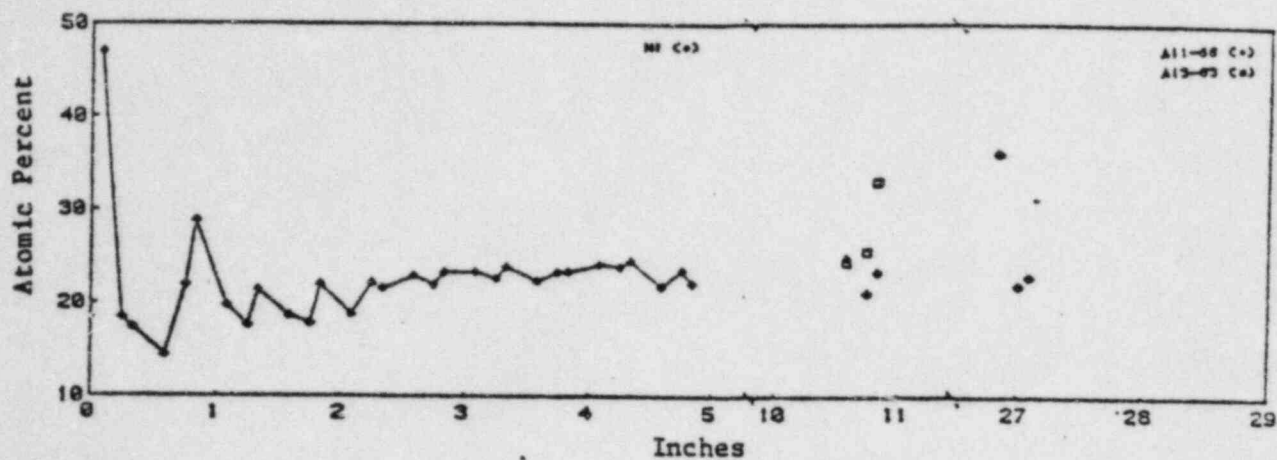
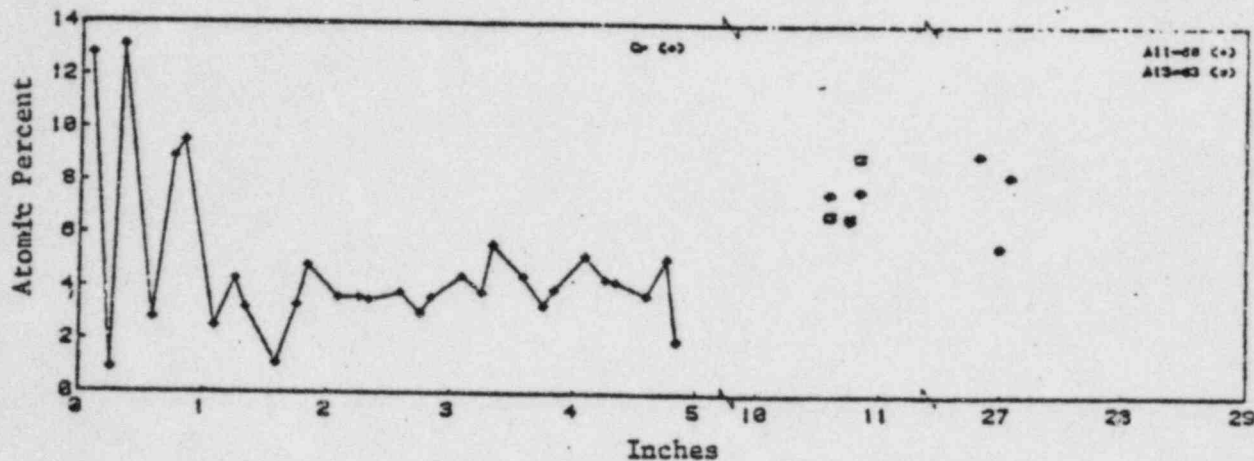
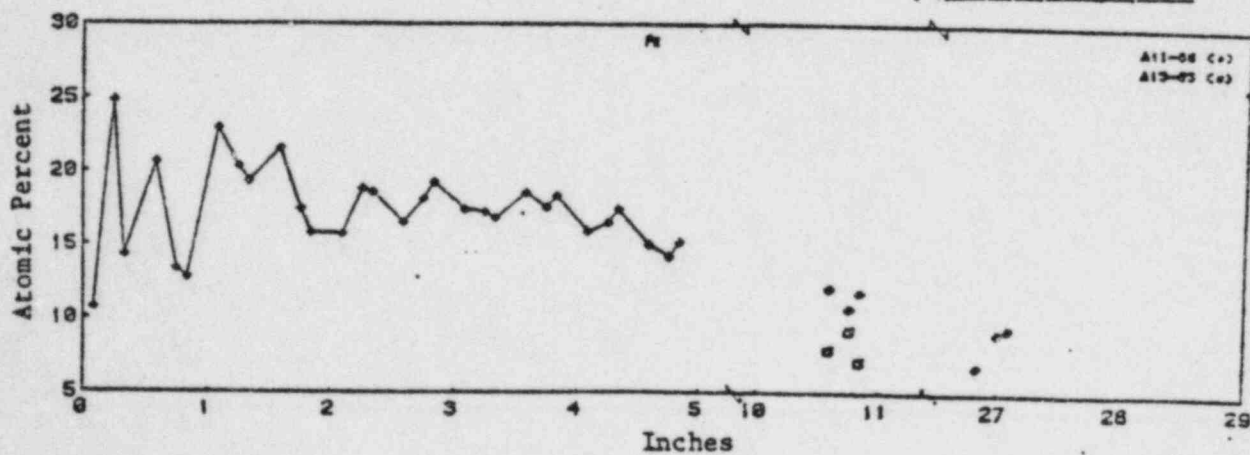
Figure 2.8.1 Concentrations of Nickel, Chromium, and Iron as a Function of Distance From the Top

- o CHROMIUM LEVELS IN THE GRAIN BOUNDARIES VARY FROM 8 WT. % TO 20 WT. % INDICATING SOME AREAS ARE HIGHLY SENSITIZED
- o THE INCONEL MICROSTRUCTURE APPEARS TYPICAL FOR STEAM GENERATOR TUBING WITH DISCRETE CHROMIUM CARBIDE PARTICLES IN THE GRAIN BOUNDARIES

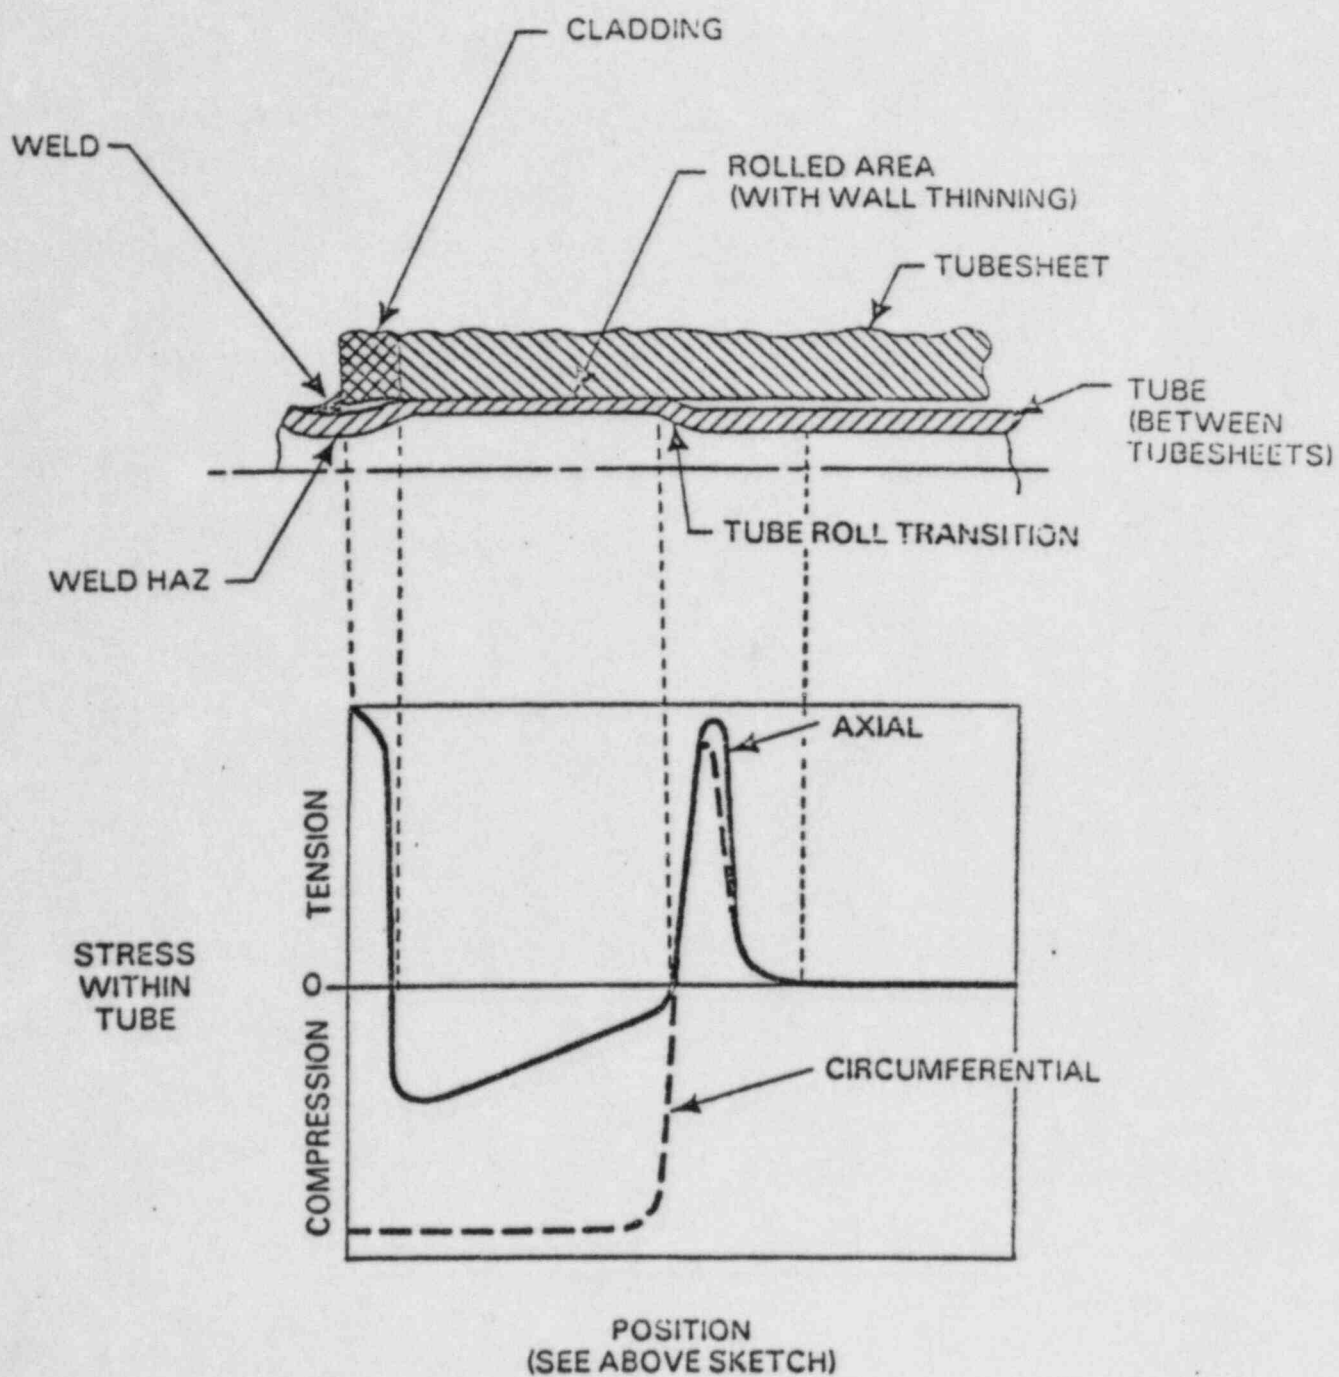
FIGURE VIII-1

- o CARBON APPEARS AS THE MAJOR CONTAMINANT ON FRACTURE SURFACES. SULFUR AND CHLORINE ARE PRESENT AS SECONDARY CONTAMINANTS
- o RESIDUAL STRESS MEASUREMENTS SHOW A PEAK AT THE ROLL TRANSITION AND A UNIFORM DISTRIBUTION THROUGH THE ROLL REGION.

TUBE/TUBESHEET ROLLED/WELDED JOINT
ESTIMATED DISTRIBUTION OF TUBE RESIDUAL STRESSES

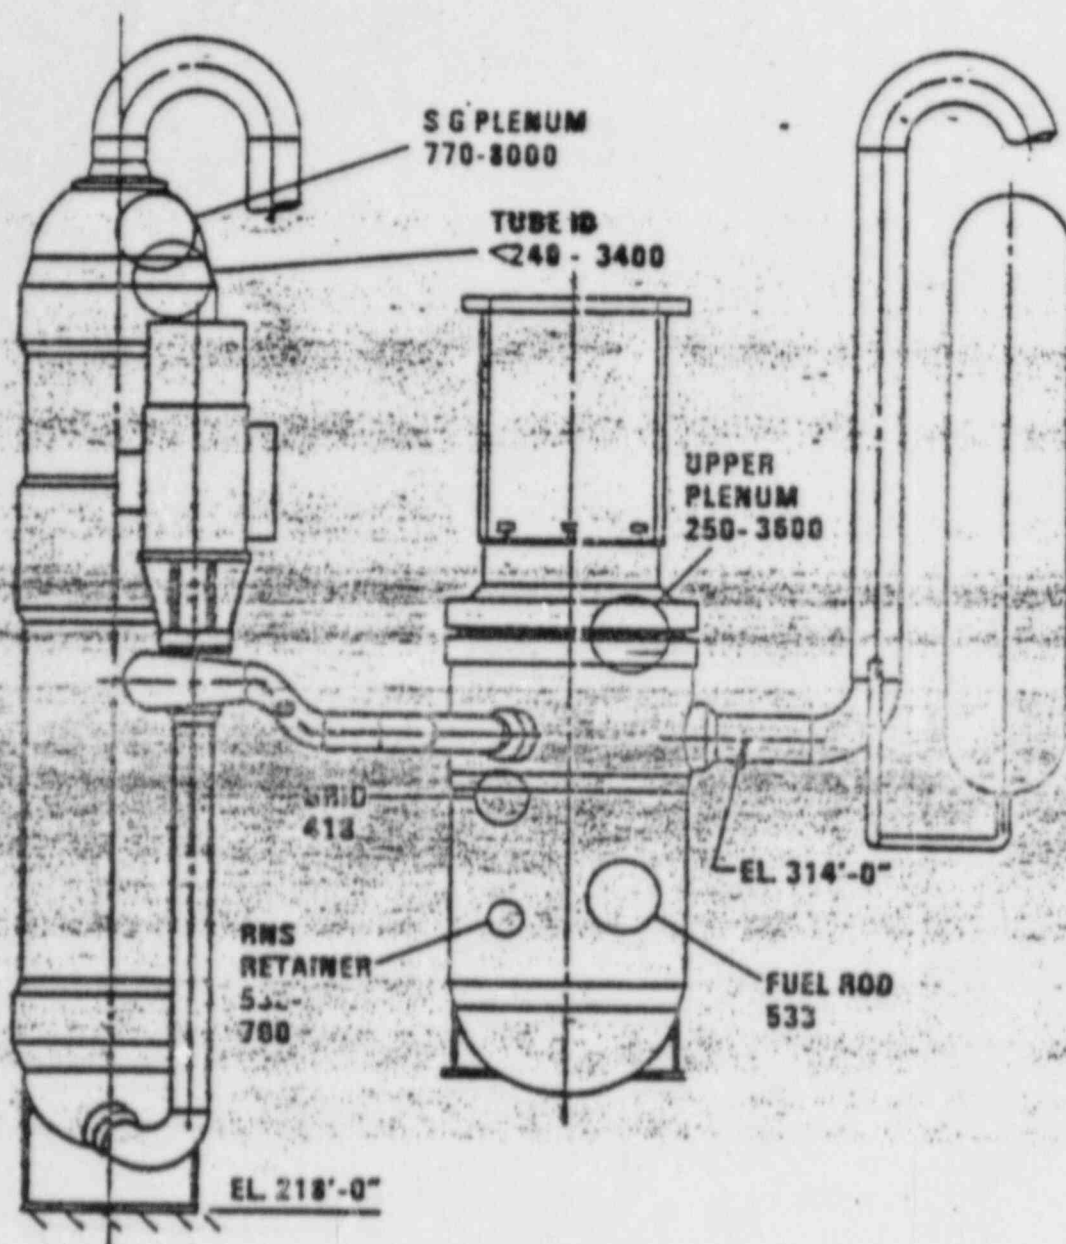
RCS Inspection Results - Sulfur Levels ($\mu\text{g}/\text{ft}^2$)

NO CRACKING OR DEFECTS ATTRIBUTABLE TO
SULFUR ASSISTED STRESS CORROSION CRACKING

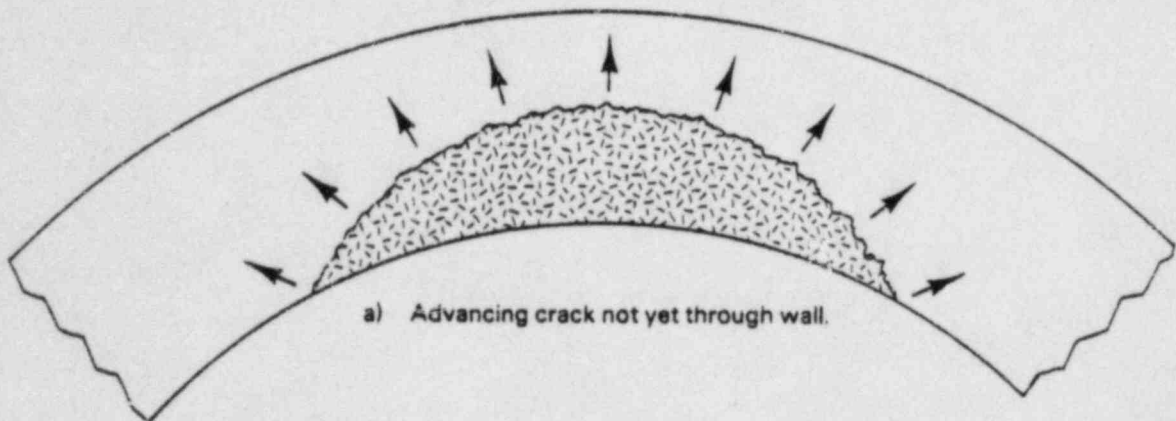
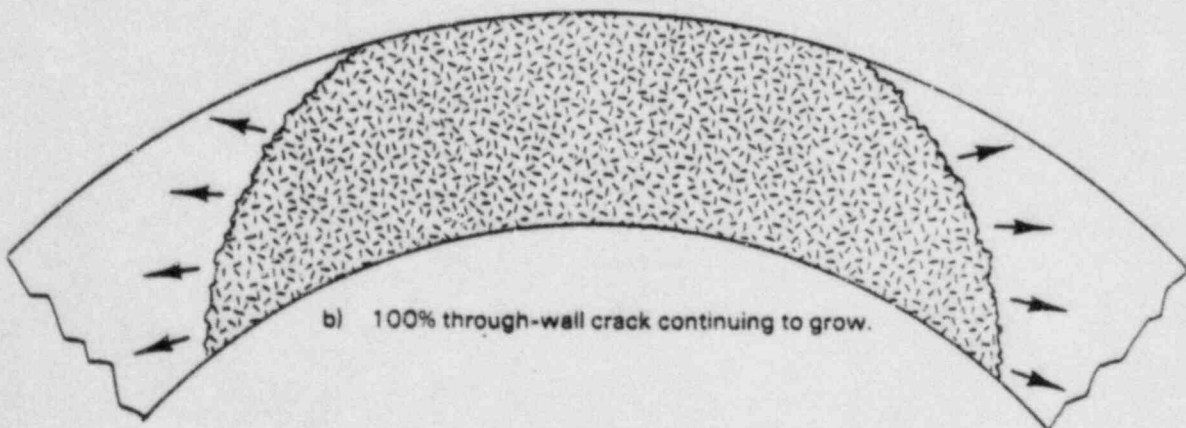
SKETCH OF TYPICAL CRACK SHAPES

a) Advancing crack not yet through wall.

b) 100% through-wall crack continuing to grow.

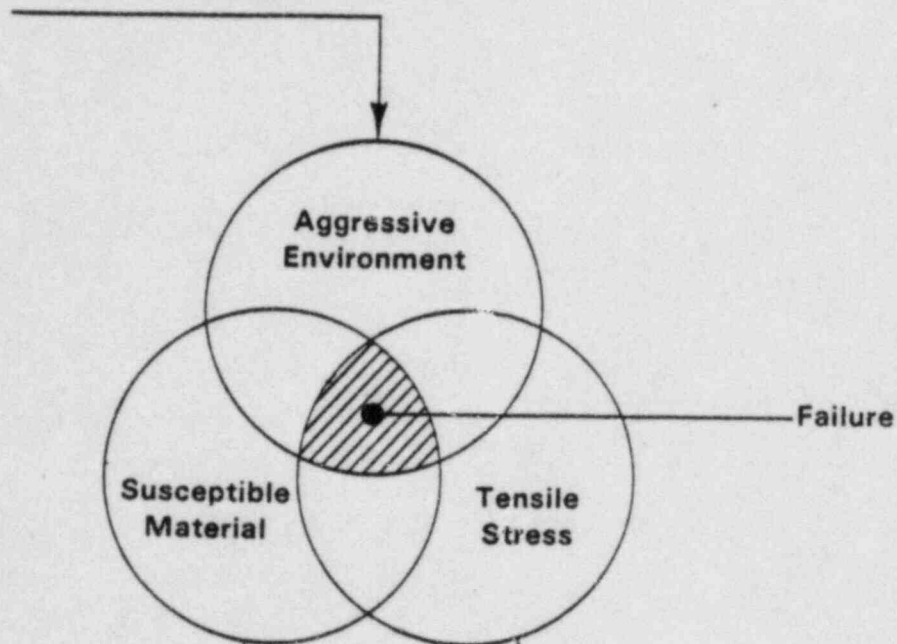
Intergranular Stress Corrosion Cracking

- Sulfur in the primary coolant as high as several ppm.
- Solution hydrogenated and heated
- Solution cooled and oxygenated
- Aggressive reduced sulfur species

- Inconel 600
- Mill annealed at $\sim 1900^{\circ}\text{F}$ /stress relieved at $\sim 1150^{\circ}\text{F}$
- Grain boundary chromium less than 10%

- Cracks oriented circumferentially
- Calculated residual axial stresses high in the seal weld heat affected zone and vicinity of the roll transition
- Applied axial tensile stress during cooldown and at cold shutdown

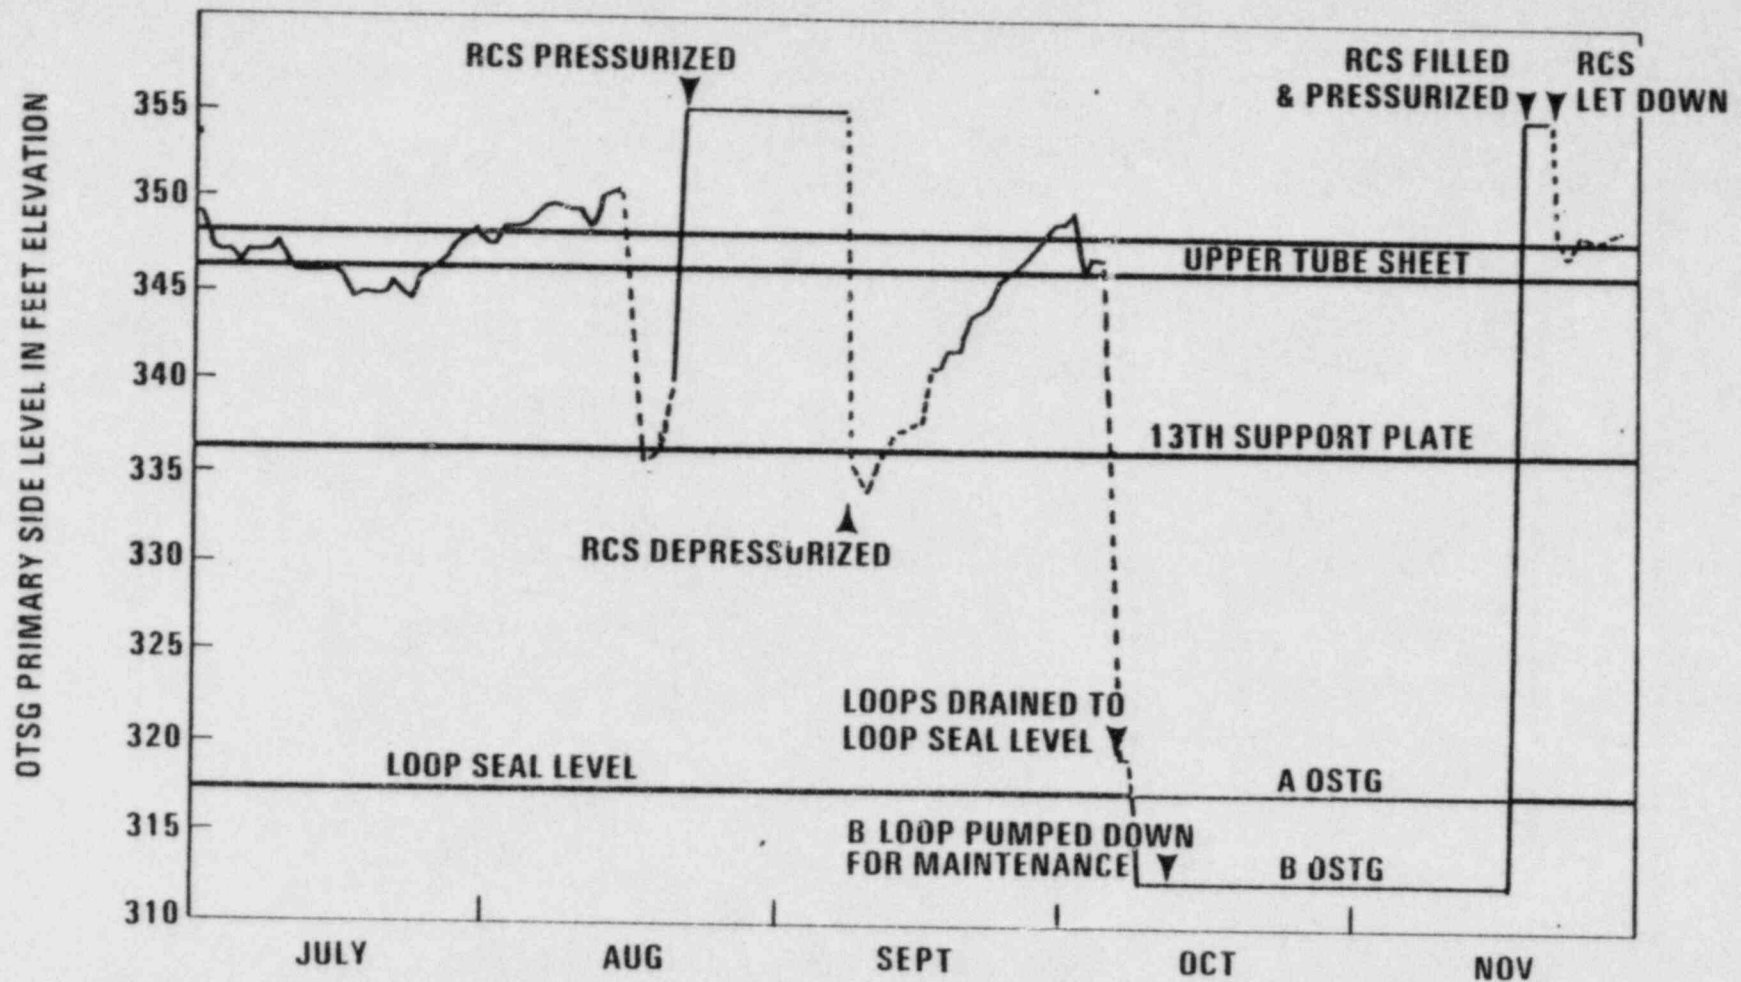
OTSG Level July 1981 — November 1981

DOTTED LINE MEANS ESTIMATED LEVEL
VENTING ARRANGEMENT CAUSES UP TO 27" ERROR

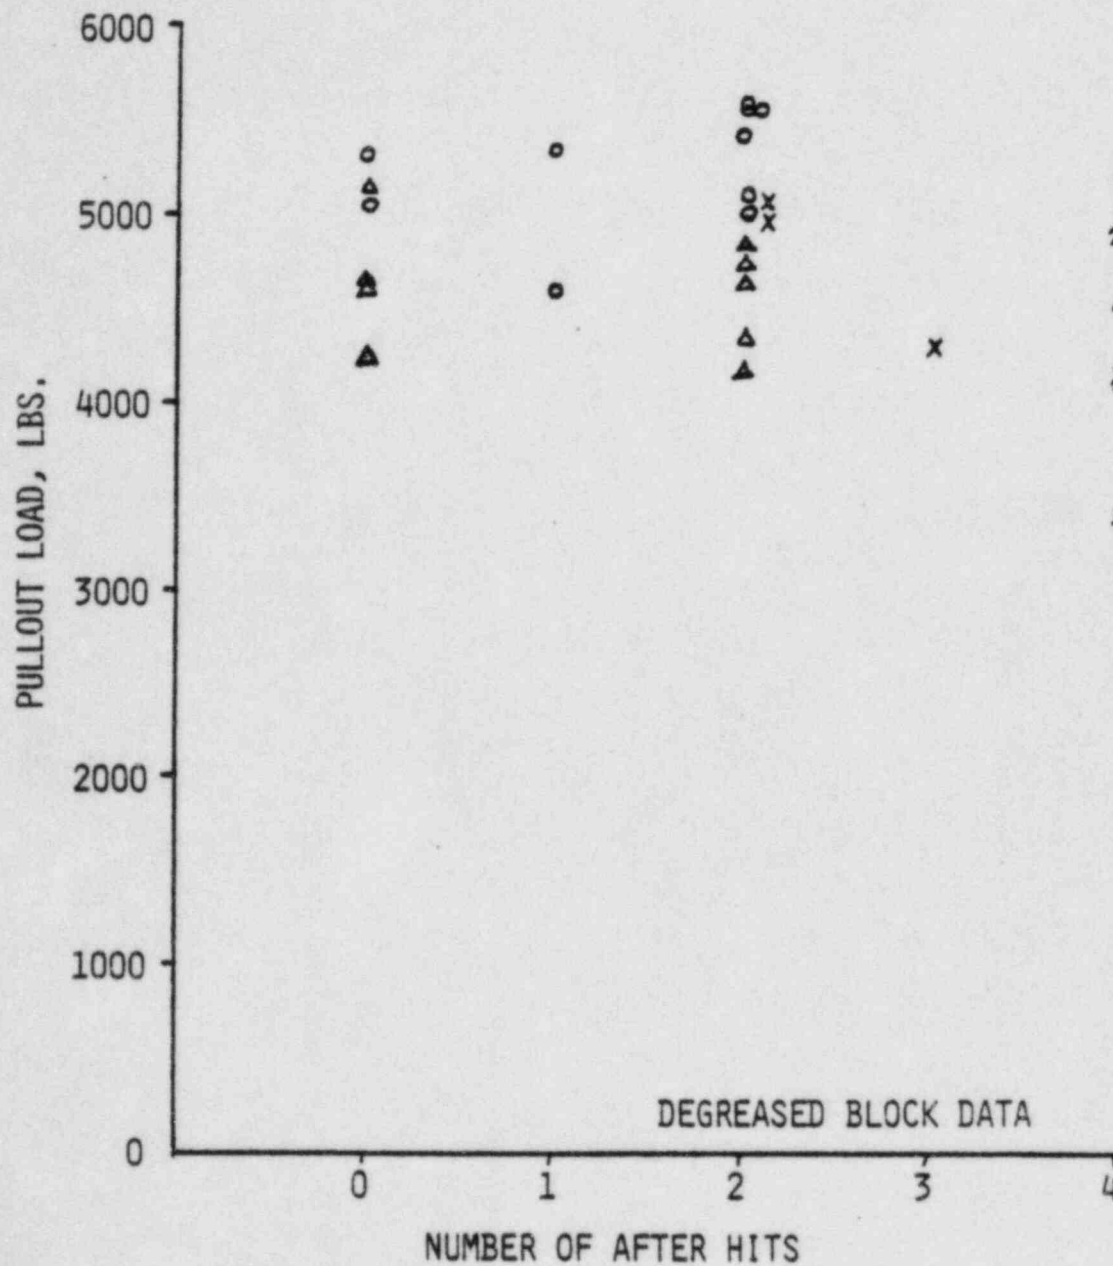
EFFECT OF AFTER HITS ON PULLOUT LOAD
20/14-8" EXPANSION

- △ TUBE YIELD 46.1 KSI
- TUBE YIELD 57.0 KSI
- × TUBE YIELD 60.9 KSI
