UNITED STATES OF AMERICA
NUCLEAR REGULATORY COMMISSION
ATOMIC SAFETY AND LICENSING BOARD

In the Matter of
LONG ISLAND LIGHTING COMPANY
(Shoreham Nuclear Power Station,
Unit 1)

Docket No. 50-322-OL
LBP-85-18
June 14, 1985

PARTIAL INITIAL DECISION
ON EMERGENCY DIESEL GENERATORS

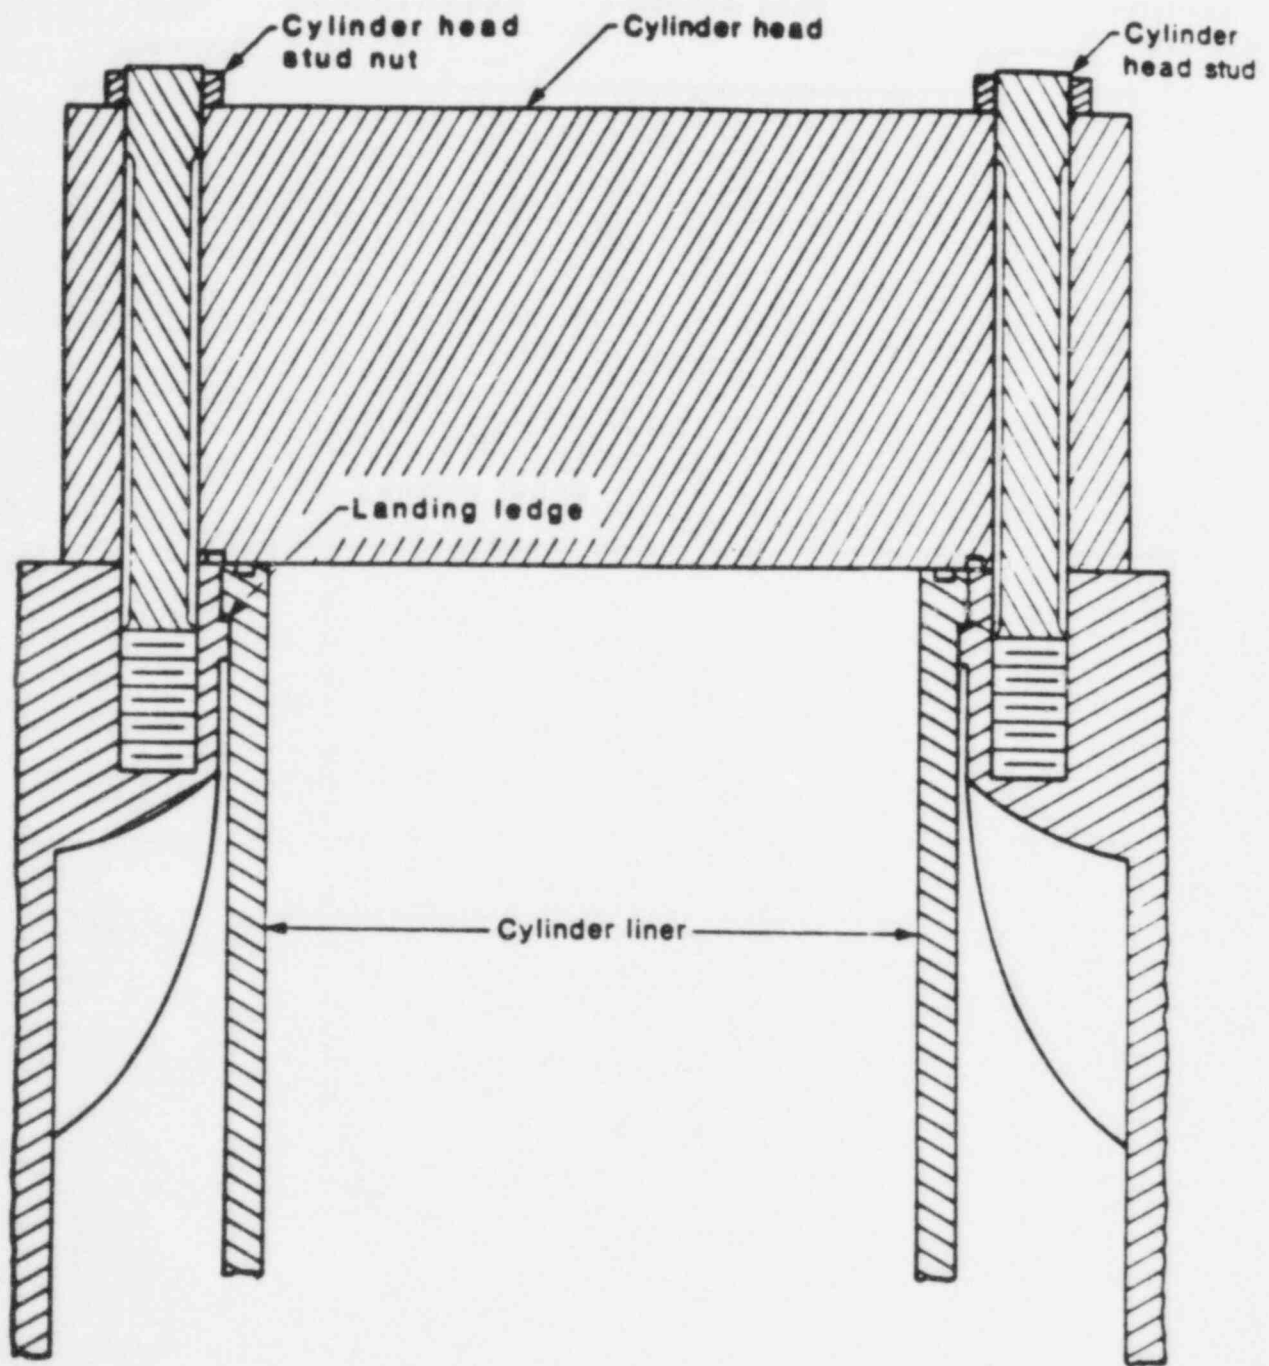
Figure 1.

B-3. The function of the cylinder blocks is to form the framework of the liquid-cooled engine, provide passage for coolant and support for the cylinder liners and cylinder heads and to restrain the forces generated by gas loads. McCarthy et al., ff. Tr. 24,372, at 8. The configuration for one cylinder liner and head is illustrated in LILCO Exhibit B-7 (Figure 1, attached), and plan views of block tops, showing
