SUBJECT: PALO VERDE SALP INPUT

MULTIPLE EQUIPMENT FAILURES FOLLOWING LOAD REJECT
AND REACTOR TRIP
EVENT FOLLOWUP REPORT 89-038
50.72 #14912, 14927, AND 1493E
EVENT DATE- 3/3/89
PLANT-PALO VERDE UNIT 3
PROJECT MANAGER-M. DAVIS
COGNIZANT ENGINEER- J. THOMPSON

TITLE: Atmospheric Dump Valve Deficiencies

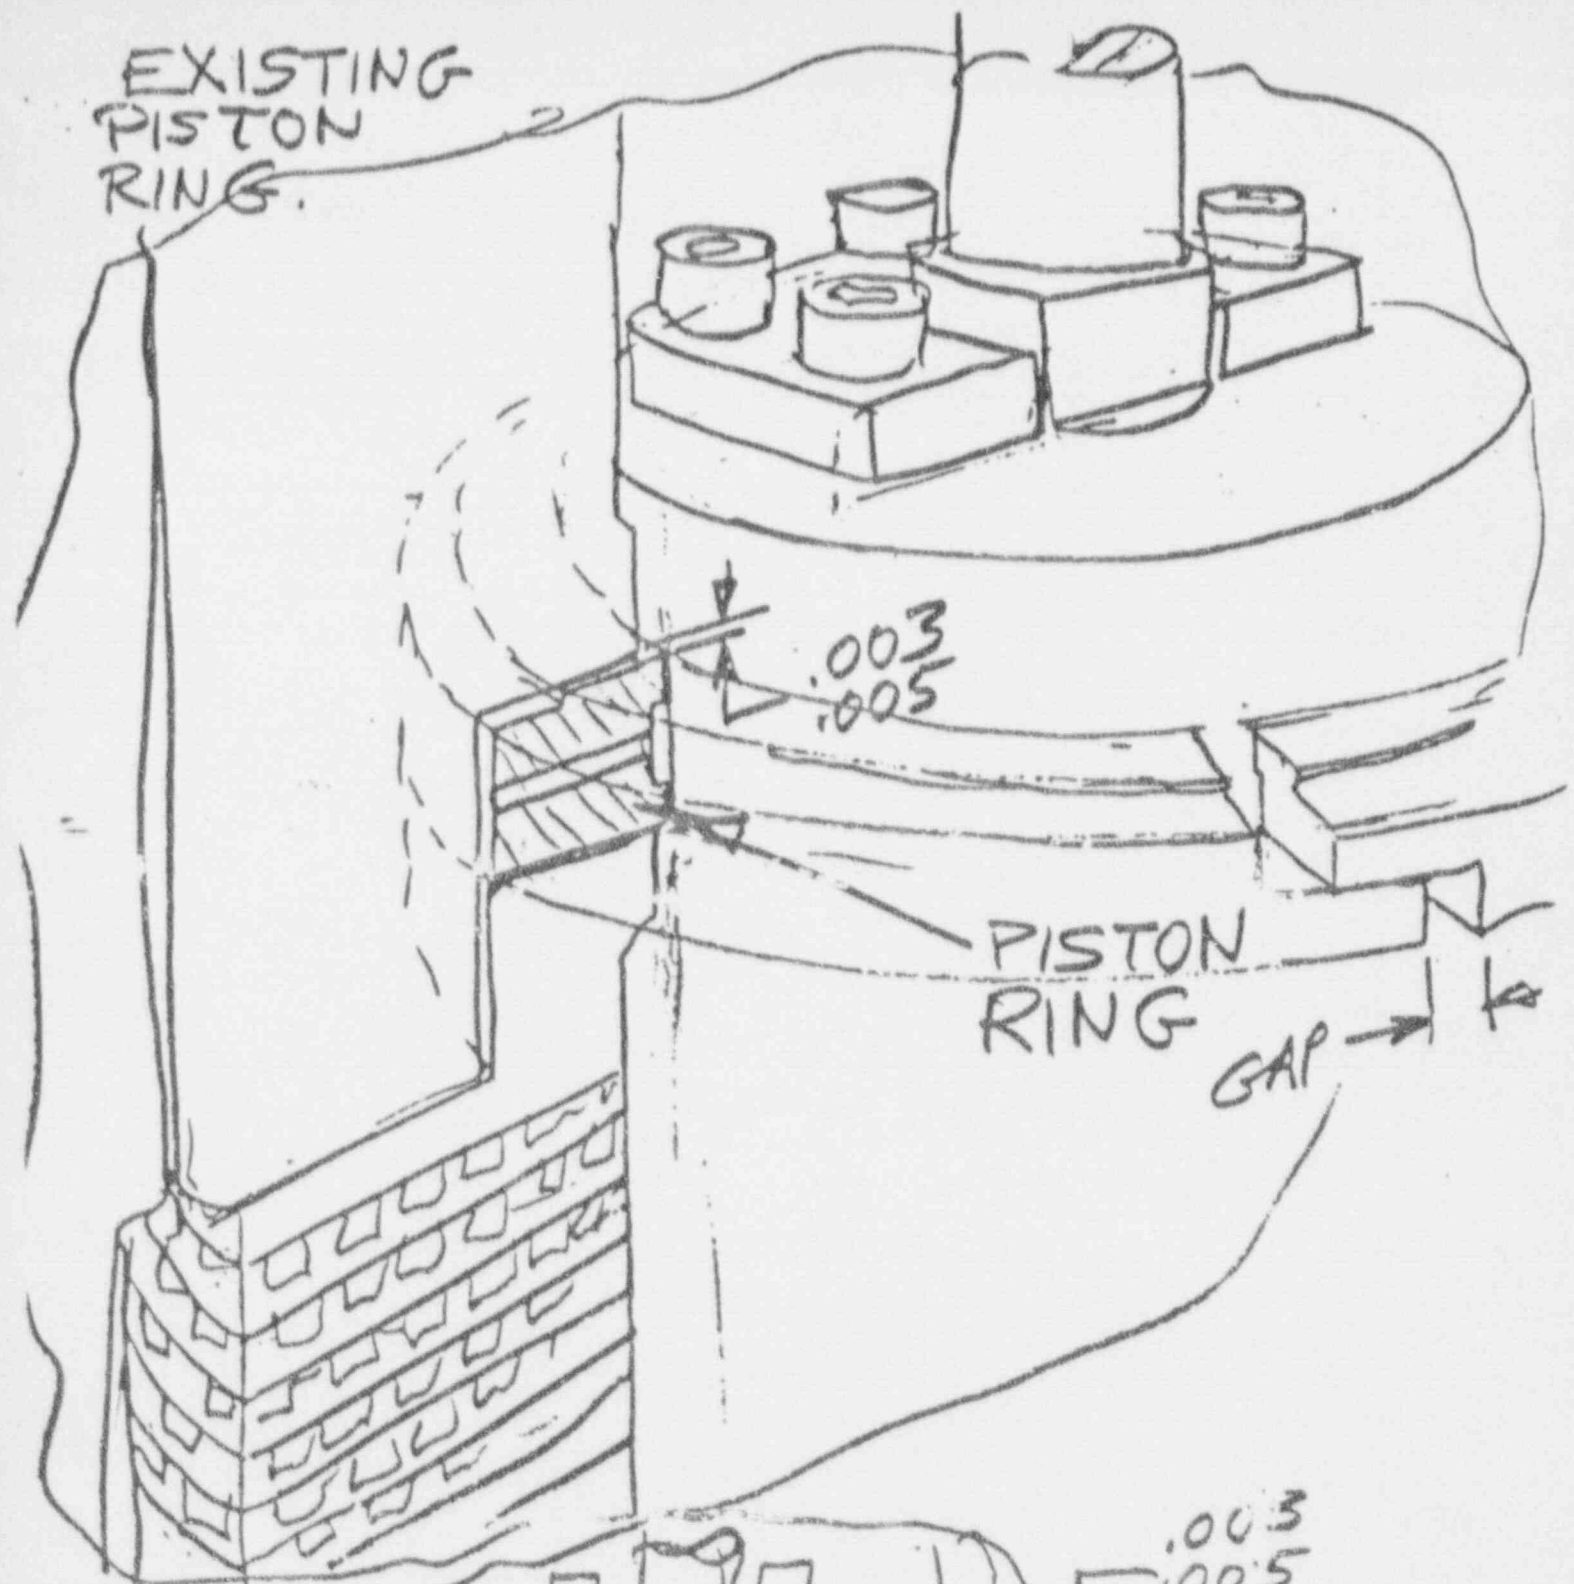
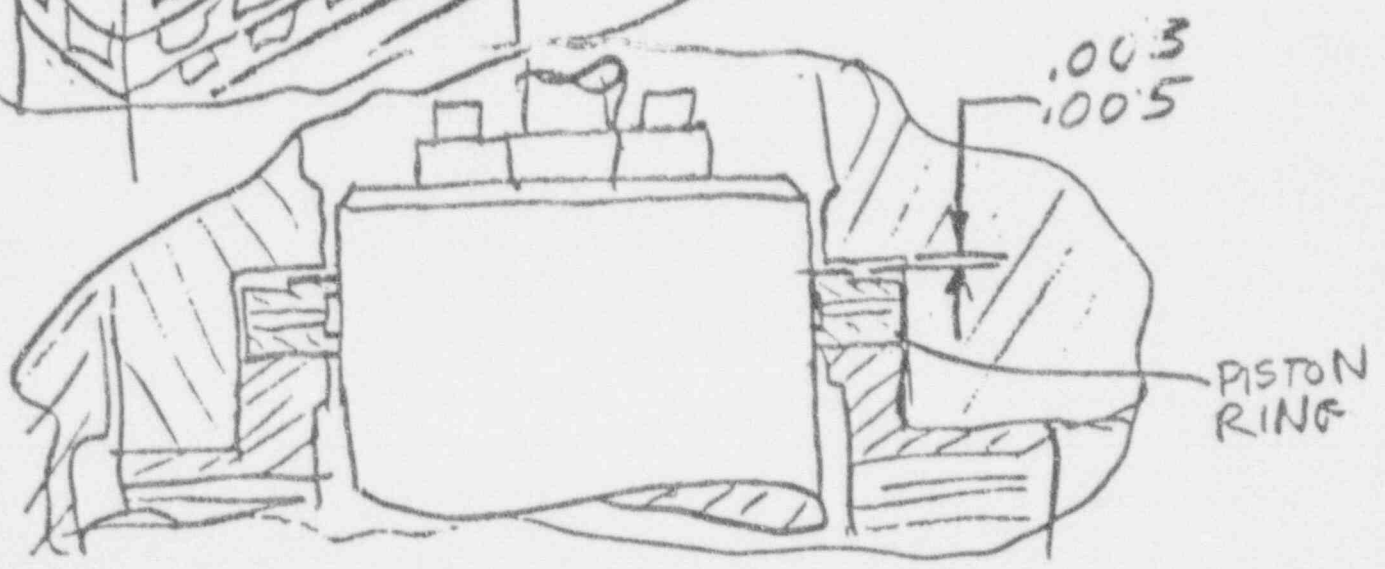
EXISTING
PISTON
RING.

As noted above, the cause of failure is not known. The condition cannot be made to occur on demand and in fact appears randomly. Our speculation is that pipe scale and other dirt particles get into the piston ring cavity and prevent the ring from sealing. Until the recent Palo Verde testing in March 1989, we have been unable to verify that an excessive bonnet pressure existed.

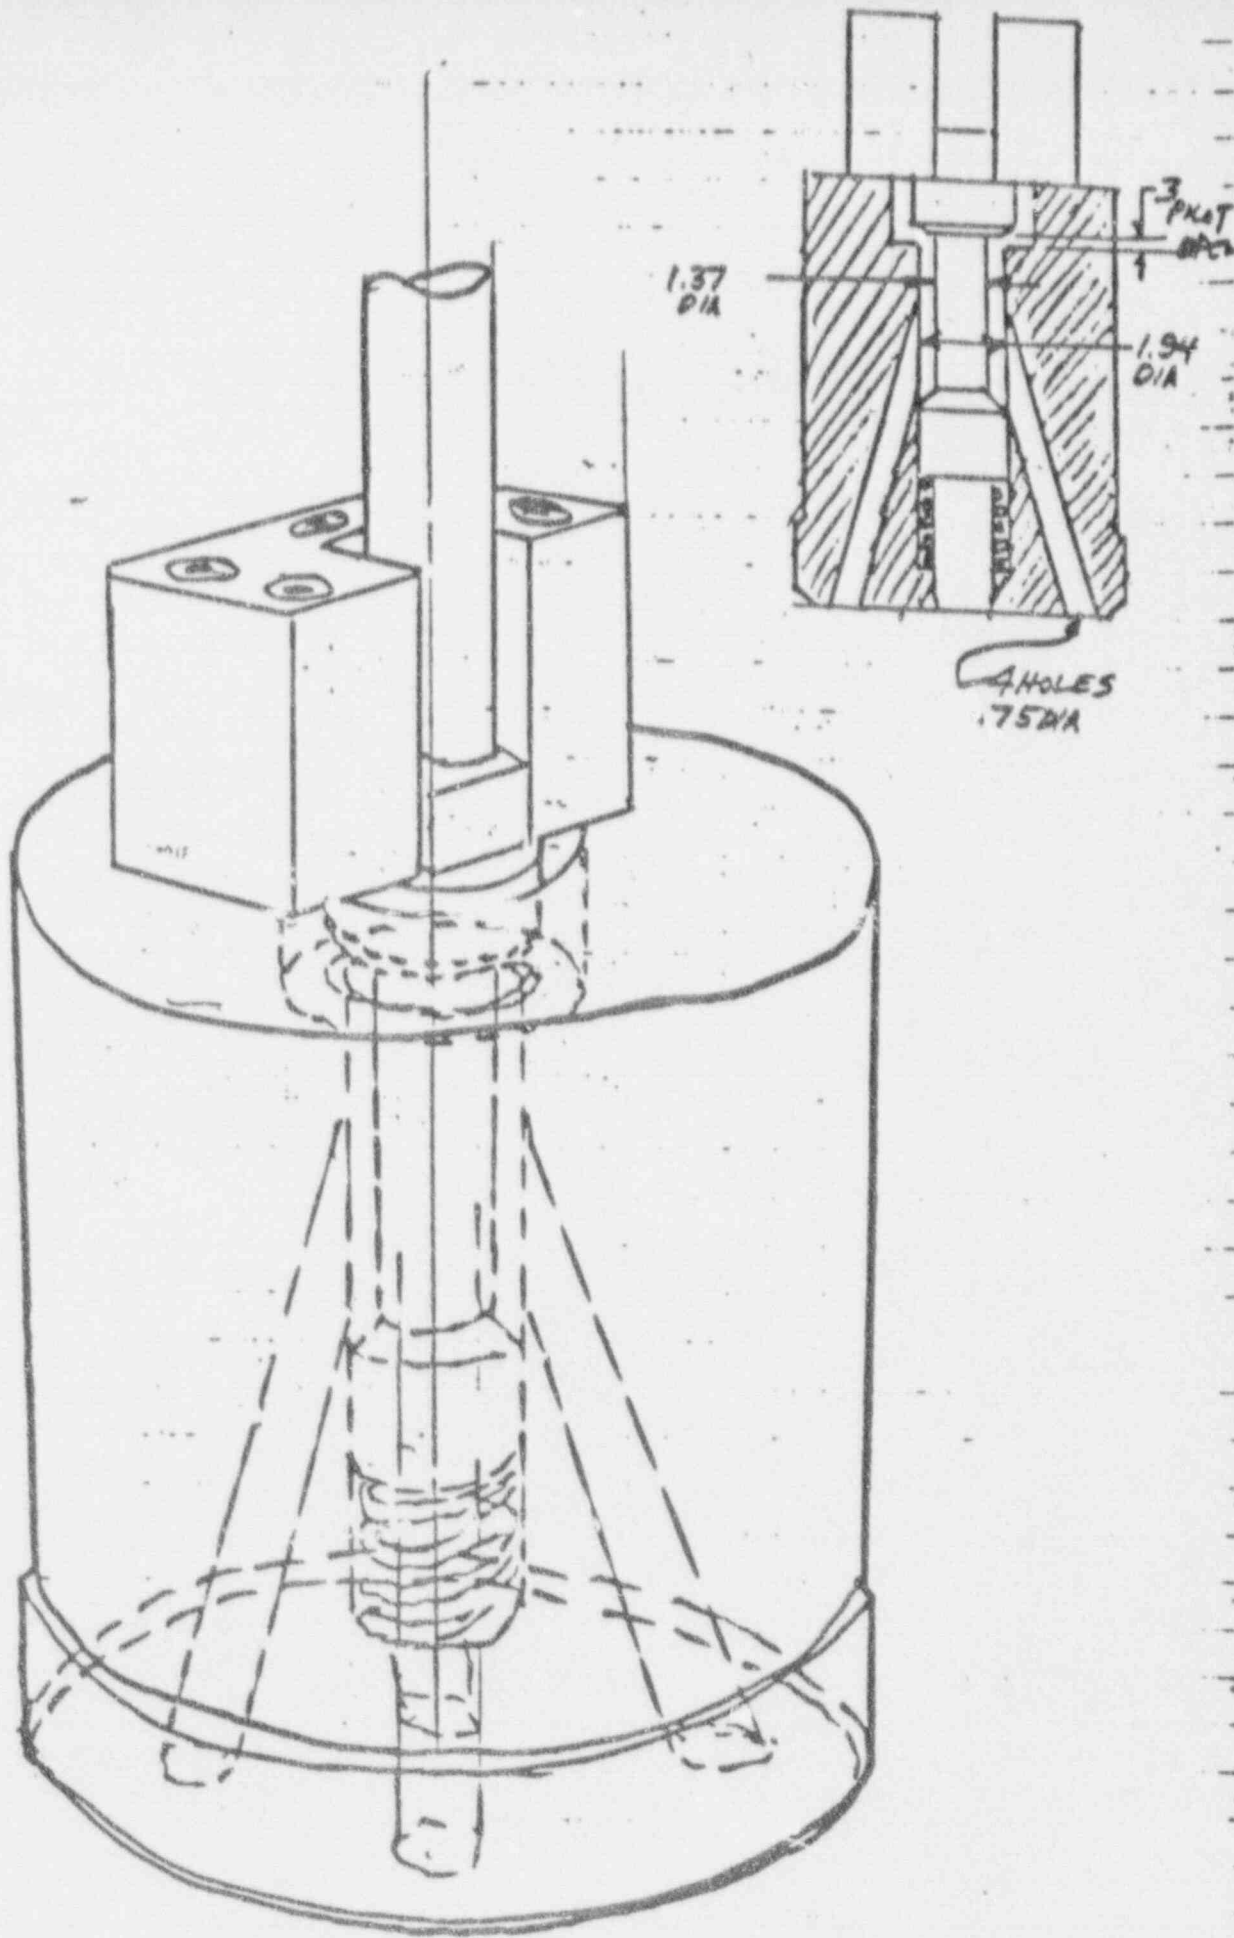
APS TEST

TESTING RUN WITH 1170 PSI INLET PRESSURE
