EVALUATION OF LEAK IN
OYSTER CREEK CORE SPRAY SYSTEM

TR-092
(REV 0)

January 15, 1993

GPU Nuclear
1 Upper Pond Road
Parsippany, New Jersey 07054

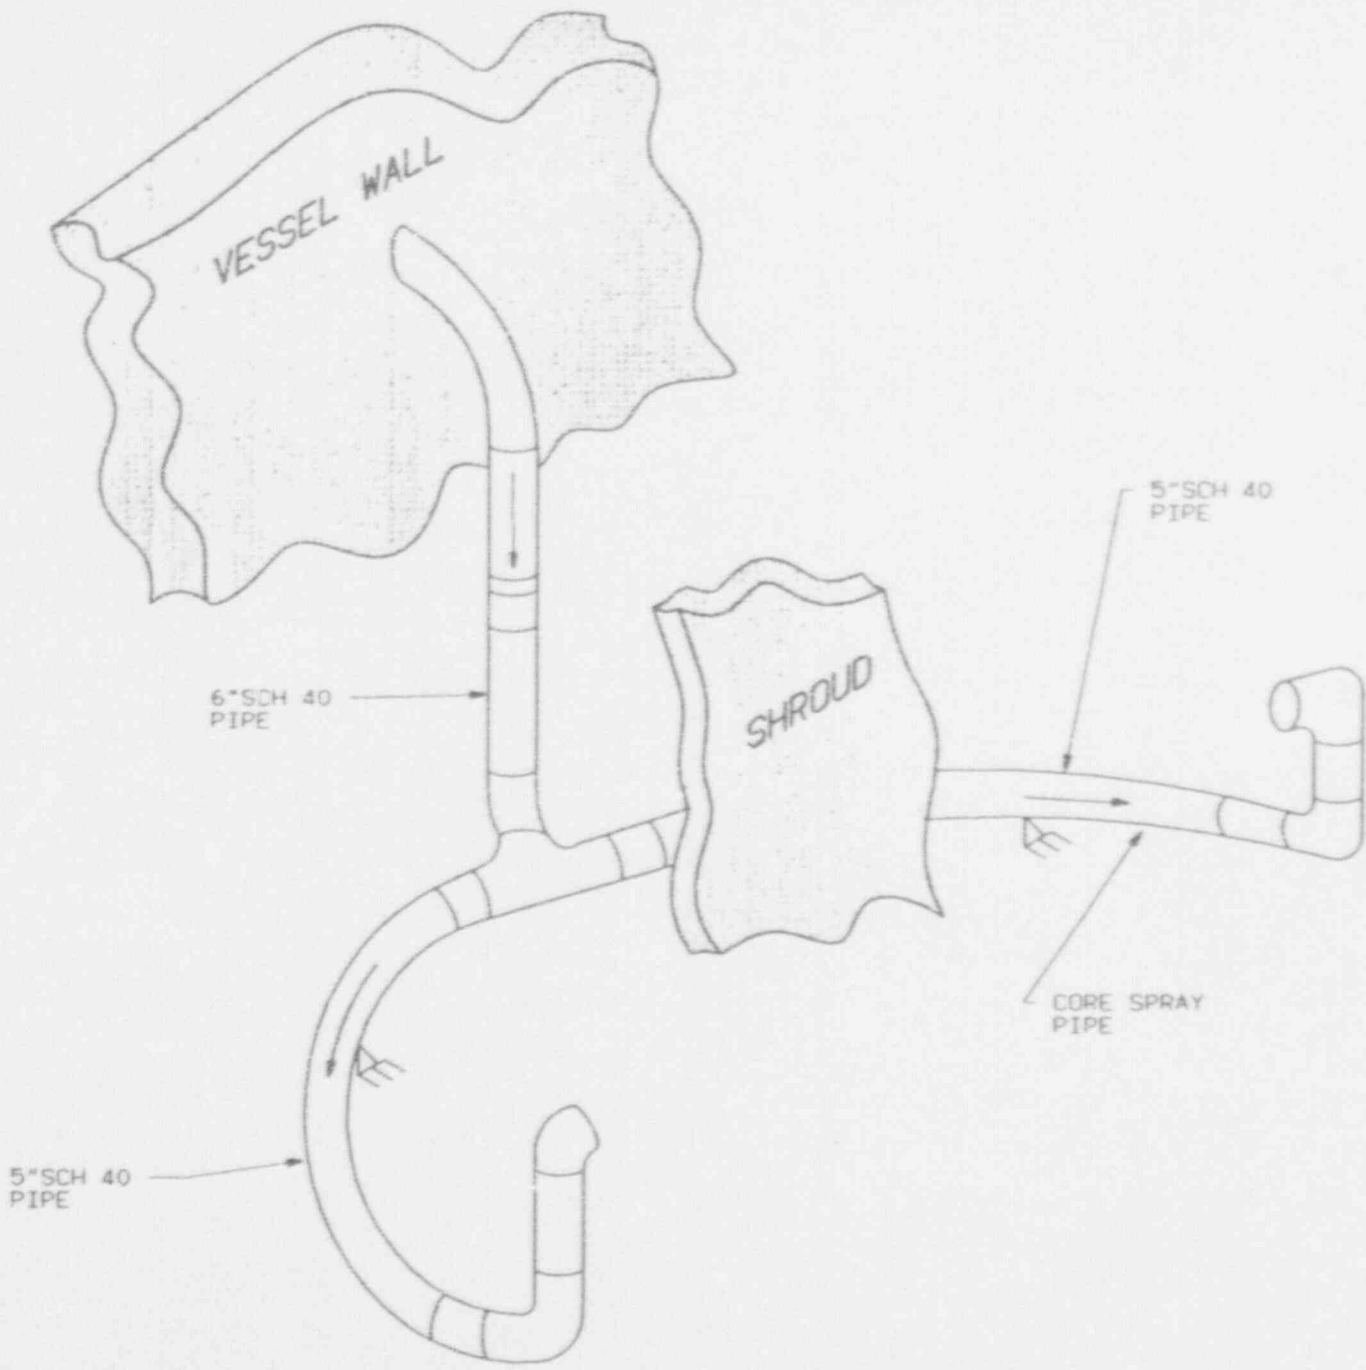
FIGURE 1 CORE SPRAY LOWER PIPING UNIT

During the Oyster Creek 14R refueling outage In-Service Inspection (ISI) of the reactor vessel internals, a leak was detected in the core spray system I piping between the vessel wall and core shroud in the annulus area (Figure 1). The leak was detected during an air test on system I when bubbles were observed coming from a weld on the down leg portion of the annulus piping (Figure 2). A video camera was able to determine that the leak was coming from a weld defect in a fillet weld on a pipe coupling.

core shroud where the 5 inch pipe is welded to the shroud (Figure 1). The annulus piping was assumed to be built-in at the core spray nozzle and upper core shroud and supported in the vertical direction only at the pipe supports attached to the outside diameter of the shroud.

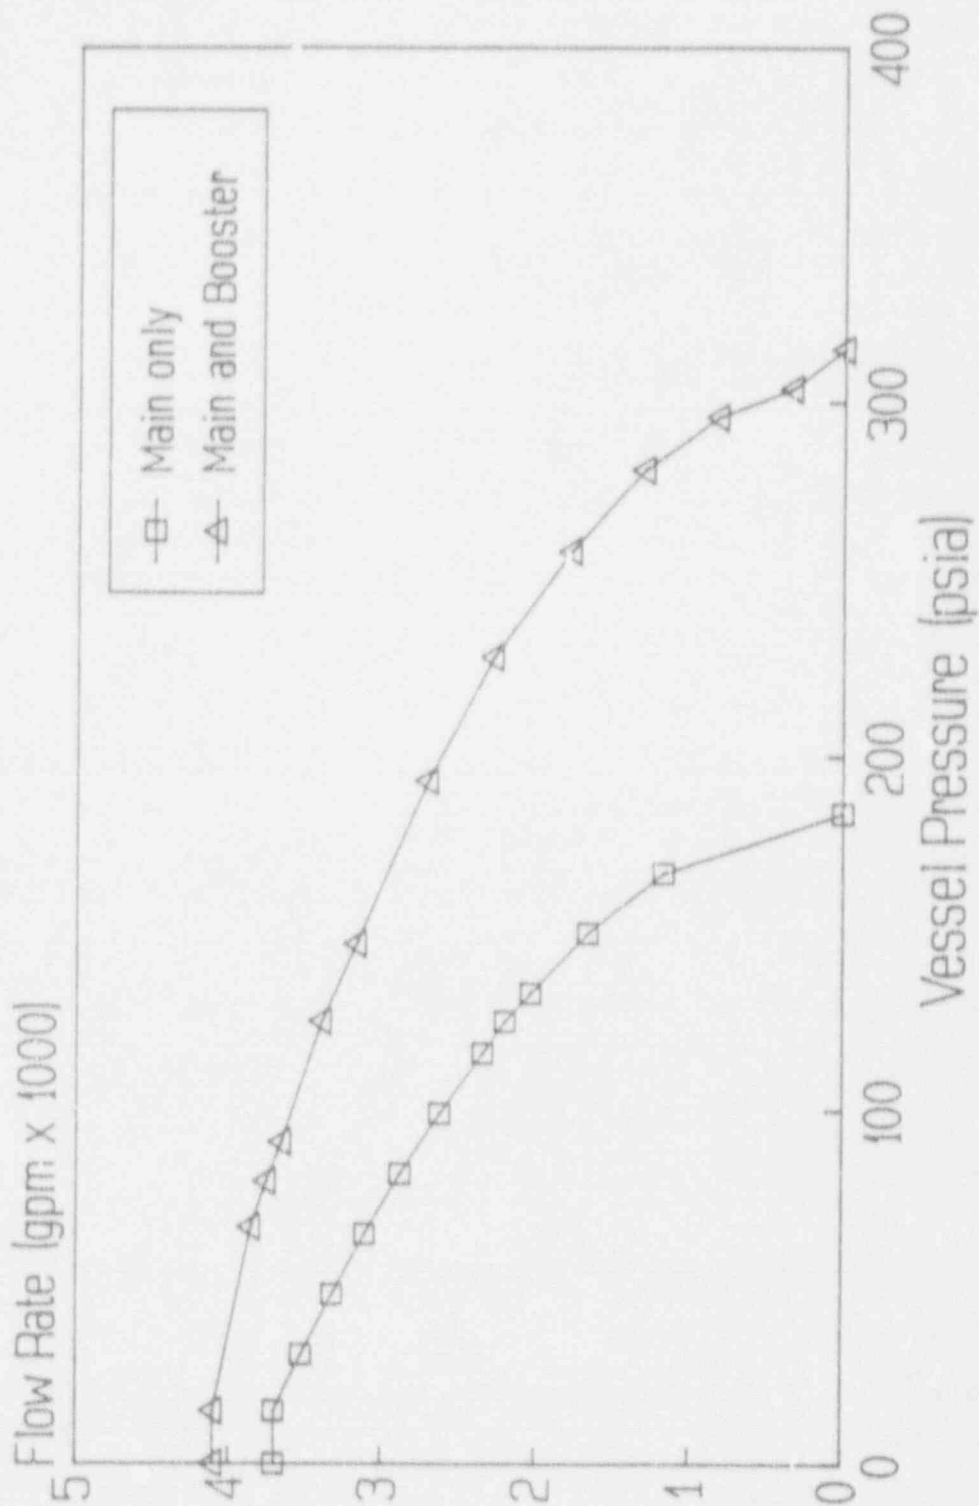
Figure 4

Each of Oyster Creek's two core spray systems contain a core spray sparger, two main pumps and two booster pumps. The current ECCS analysis¹ for OC is based upon a core spray flow of 3400 gpm (1 main and 1 booster pump) from one system and 2200 gpm (1 main pump) from the other system at a vessel pressure of 110 psig. To compensate for a previously found crack in the sparger, the flow requirements for system II are 3640 gpm when the system is the two pump contributor and 2360 gpm if it is the single pump contributor. Based on core spray system tests, the actual flow rates exceed the design basis by 500 gpm for system I and 300 gpm for system II. The curve of flow versus pressure used in the ECCS analysis is shown in figure 4.

Core Spray System Flow Rates Used in ECCS Analysis
