RADIOLOGIC AND ENGINEERING ASSESSMENT

DOE ID NO.: GJ-13012-VL  
ADDRESS: 237 NORTH SPRUCE STREET

JUNE 1985

BENDIX FIELD ENGINEERING CORPORATION  
P.O. Box 1569  
Grand Junction, Colorado 81502

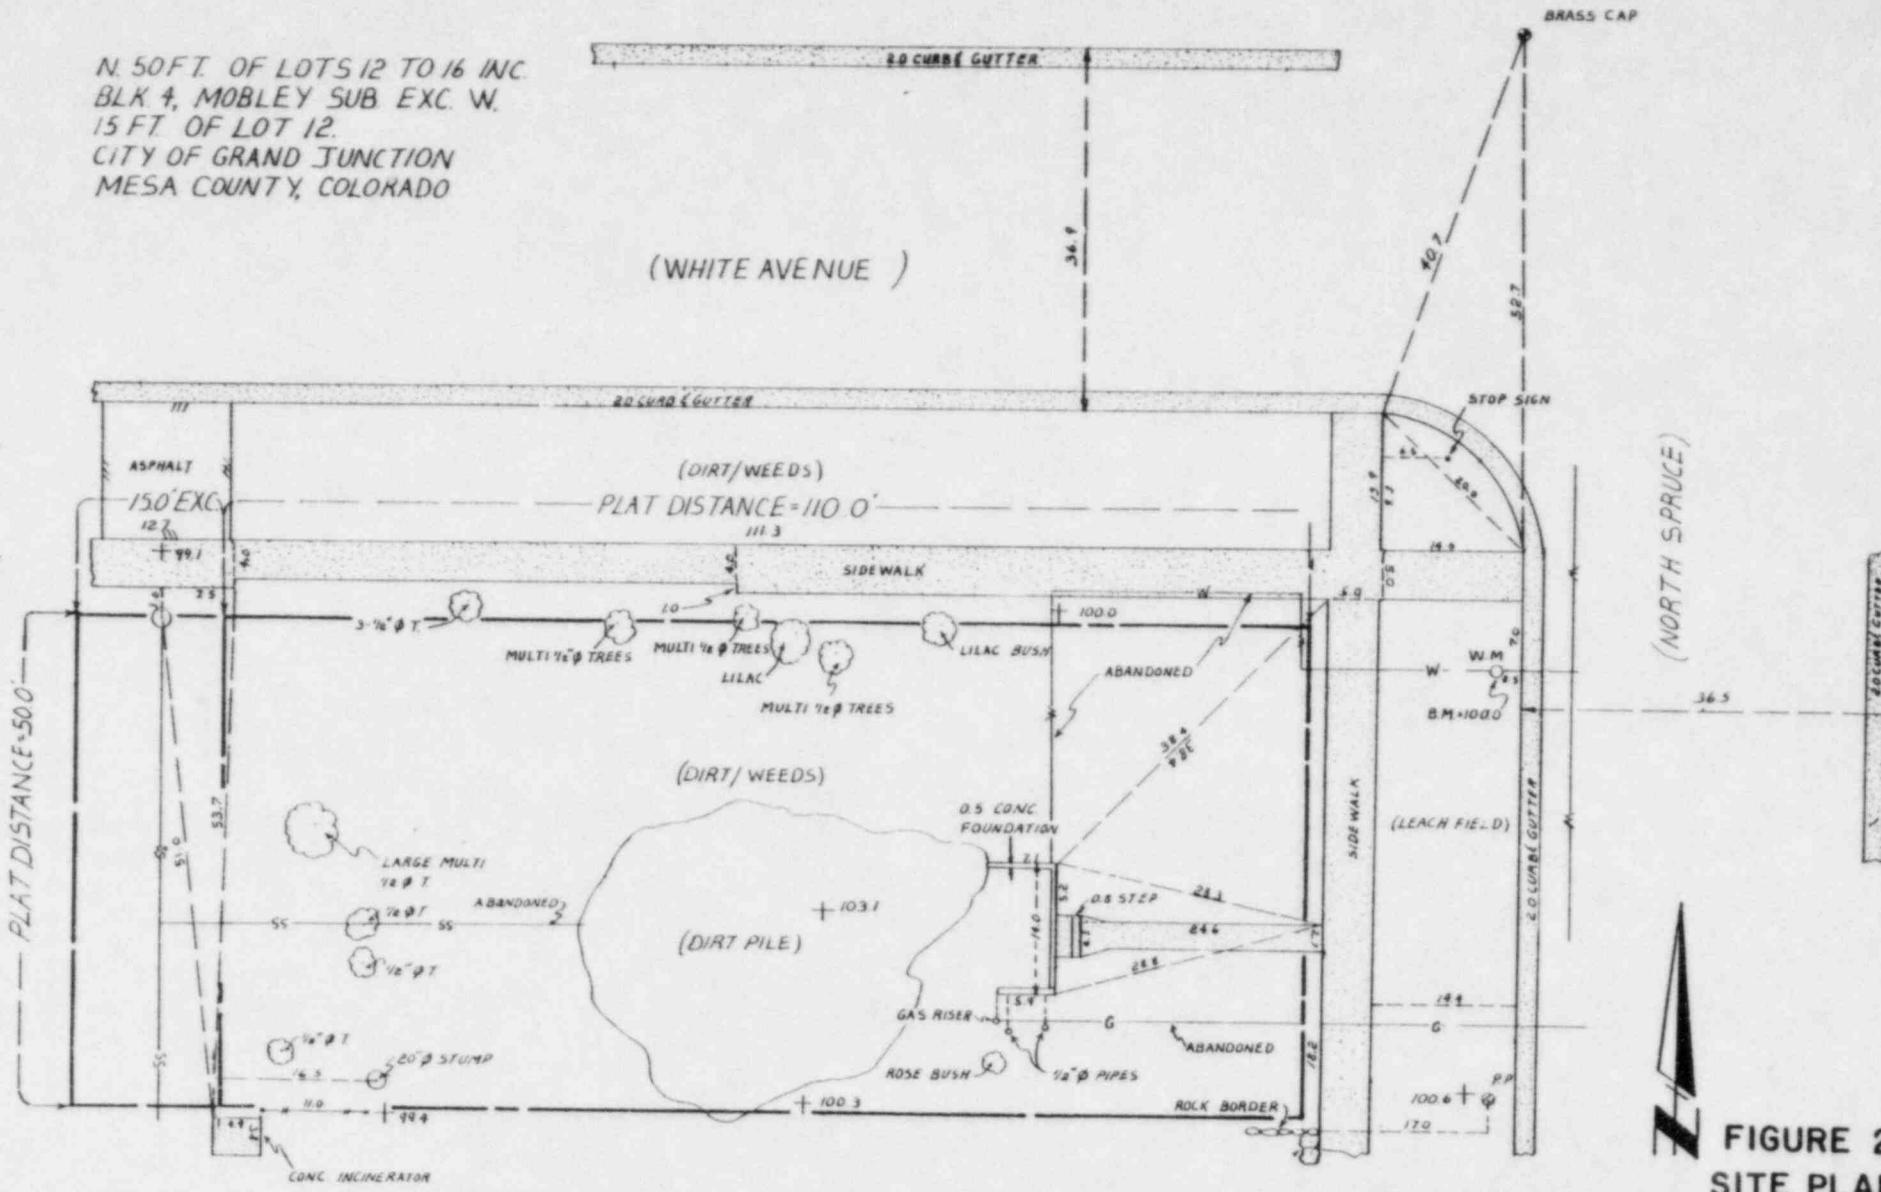
**FIGURE 2.2**  
**SITE PLAN**

A concrete foundation and a portion of a sidewalk (demolished residence) occupy this site. Utilities, landscaping, and other special features of this property are included in Appendix Figure 2.2.

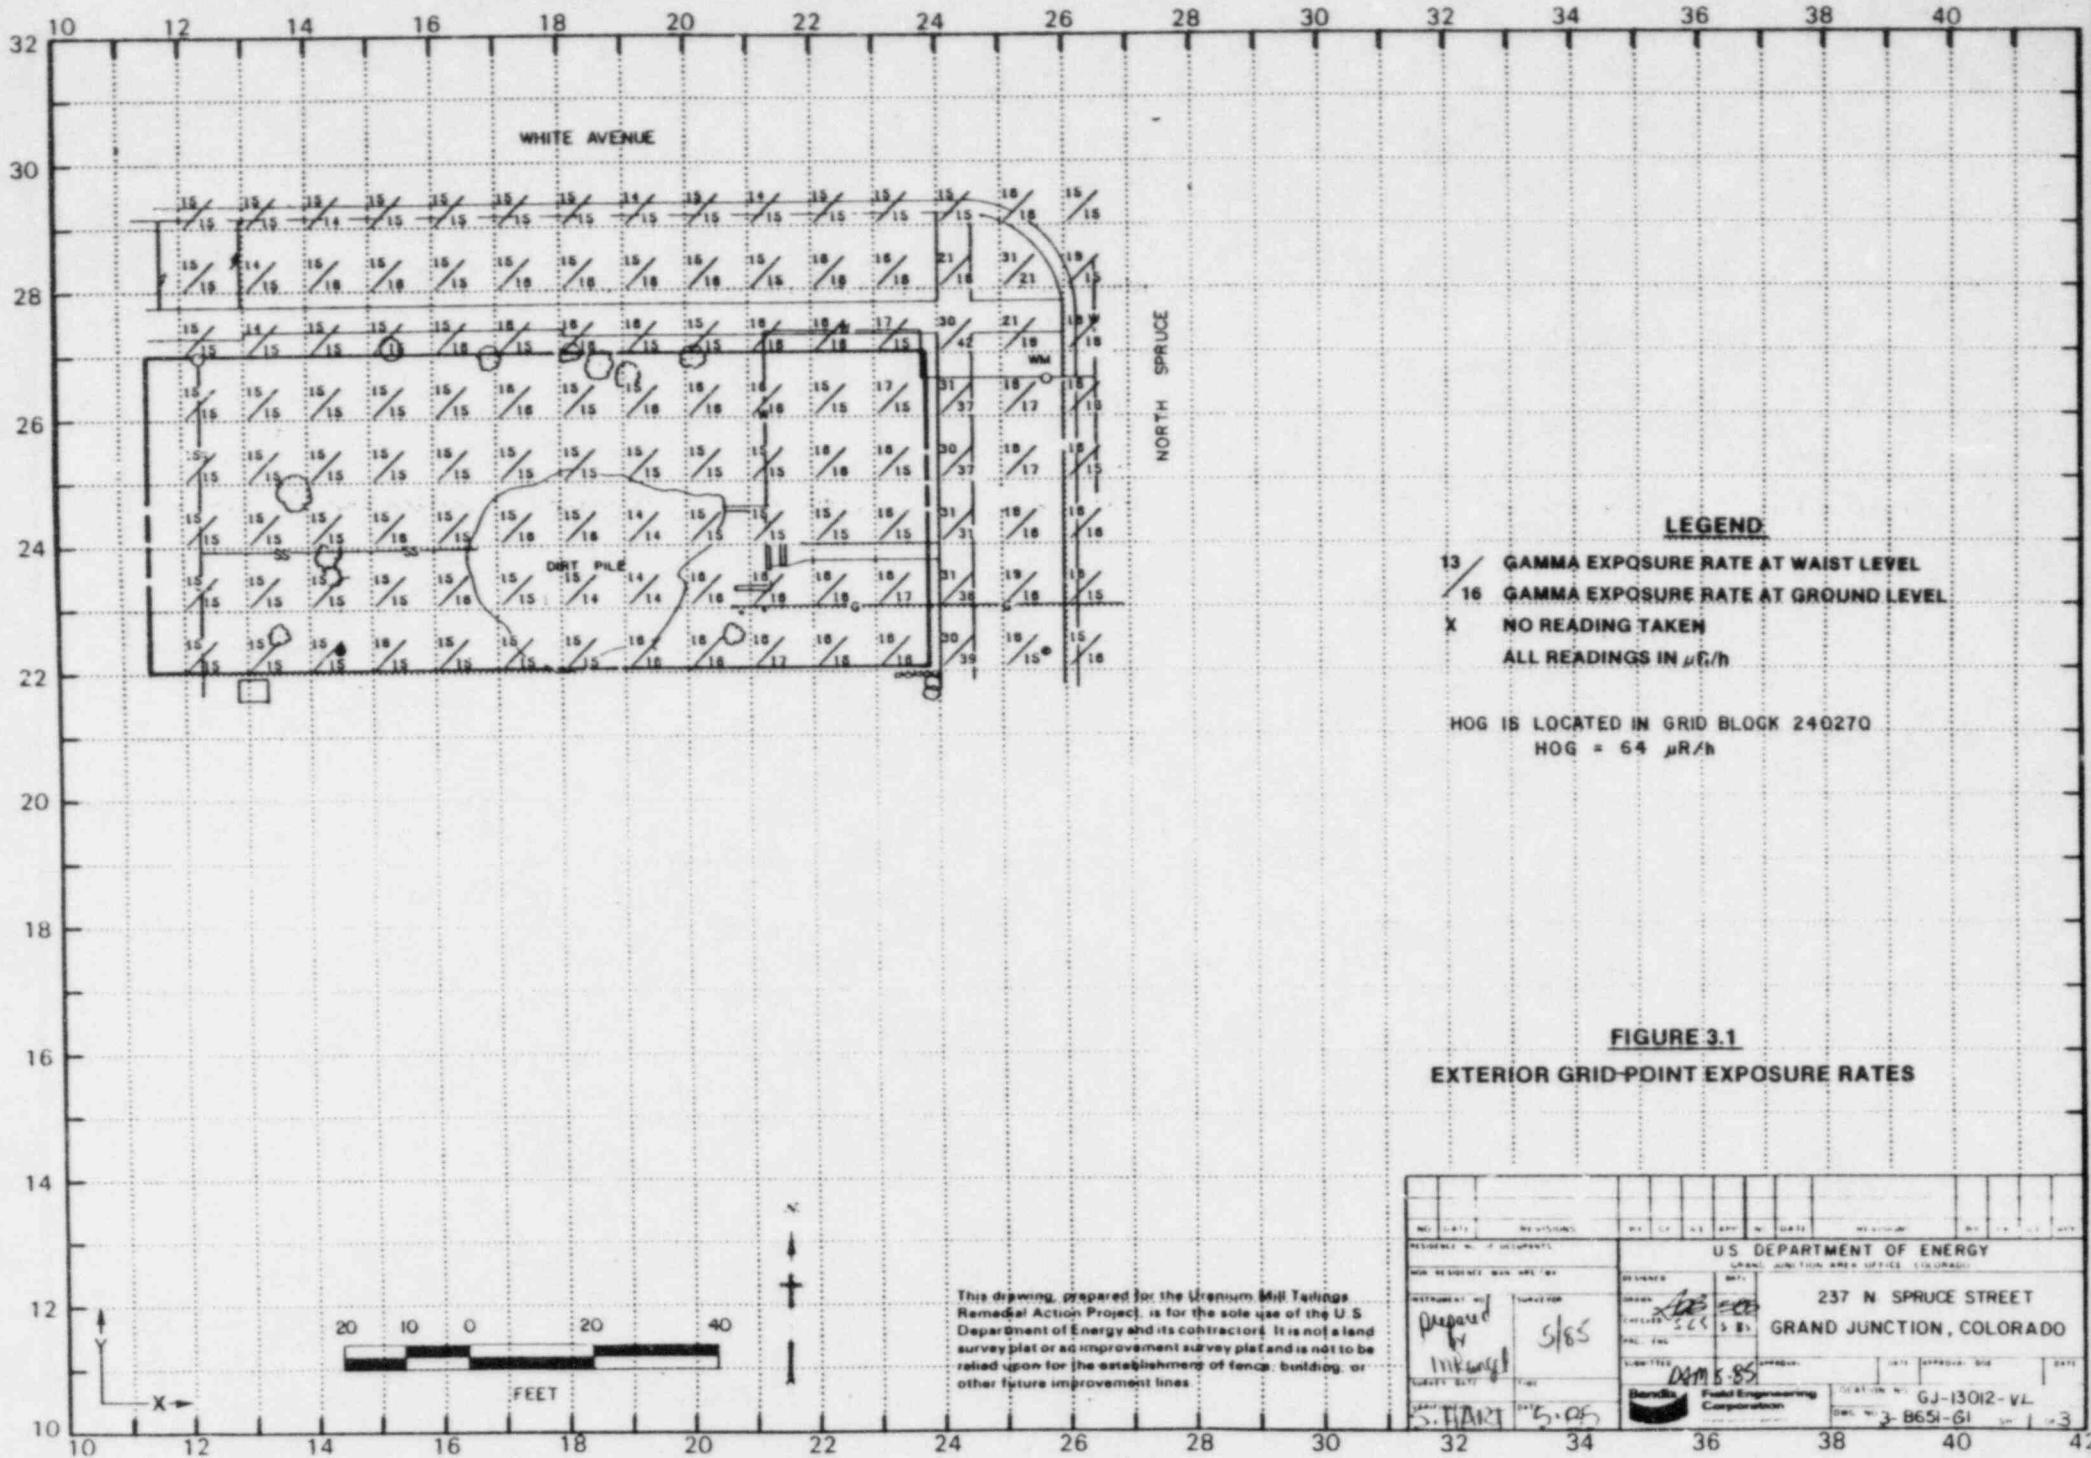
**FIGURE 3.1**  
**EXTERIOR GRID-POINT EXPOSURE RATES**

Exterior radium-concentration measurements are presented in Appendix Table 3.1. Grid-point survey results are shown in Appendix Figure 3.1.
