# **Draft Radiological and Engineering Assessment**

Vicinity Property No. DUR 202

THE RADIOLOGICAL AND ENGINEERING ASSESSMENT

DURANGO PROPERTY

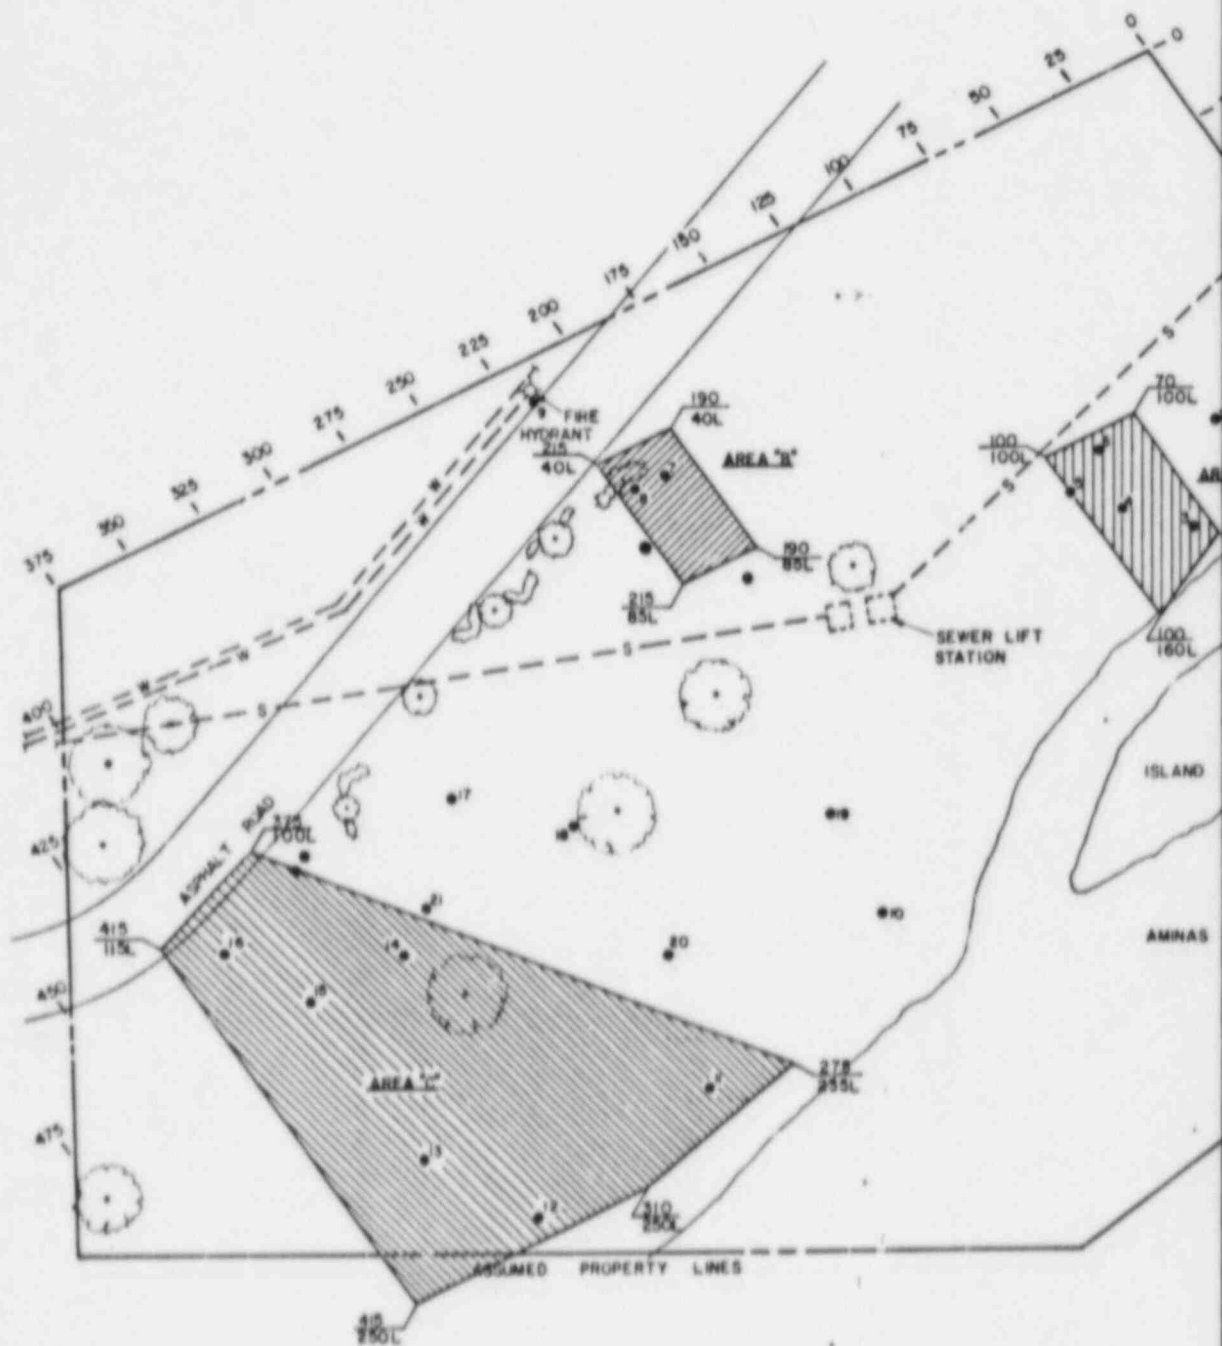
Contamination was found in 9 of the 21 holes augered. The location and depth of the contamination is described in Table 3.1 and is shown in Figure 3.1.

HOLE	CONTAMINATION DEPTH
1	None
2	None
3	0-36"+*
4	0-24"+*
5	None
6	12-30"+*
7	0-12"+*
8	None
9	None
10	None
11	12-24"
12	0-18"
13	None
14	0-12"
15	0-12"
16	0-18"
17	None
18	None
19	None
20	None
21	None

- EXCAVATE AREA "A" TO A DEPTH OF 30 INCHES.
- BACKFILL EXCAVATED AREA WITH COMMON FILL AND REGRADE TO ORIGINAL CONDITION.

- REMOVE AND REPLACE TREE WITH SAME TYPE AND SIZE AS APPROVED BY CONTRACTOR'S REPRESENTATIVE.
- EXCAVATE AREA "B" TO A DEPTH OF 6 INCHES.
- BACKFILL EXCAVATED AREA WITH COMMON FILL AND REGRADE TO ORIGINAL CONDITION.

- REMOVE AND REPLACE TREE WITH SAME TYPE AND SIZE AS APPROVED BY CONTRACTOR'S REPRESENTATIVE.
- EXCAVATE AREA "C" TO A DEPTH OF 12 INCHES. CONTRACTOR'S REPRESENTATIVE TO RESURVEY. IF FURTHER CONTAMINATION EXISTS, EXCAVATE AS DIRECTED BY CONTRACTOR'S REPRESENTATIVE.
- BACKFILL EXCAVATED AREA WITH COMMON FILL. TOP WITH 6 INCHES OF AGGREGATE BASE COURSE IN ASPHALT AREA.
- REPAVE ASPHALT AREA WITH 4 INCH THICK ASPHALT.
