UNITED STATES OF AMERICA  
NUCLEAR REGULATORY COMMISSION

Briefing on Davis Besse

Docket No. 50-346

Location: Washington, D. C.  
Date: Wednesday, July 24, 1985

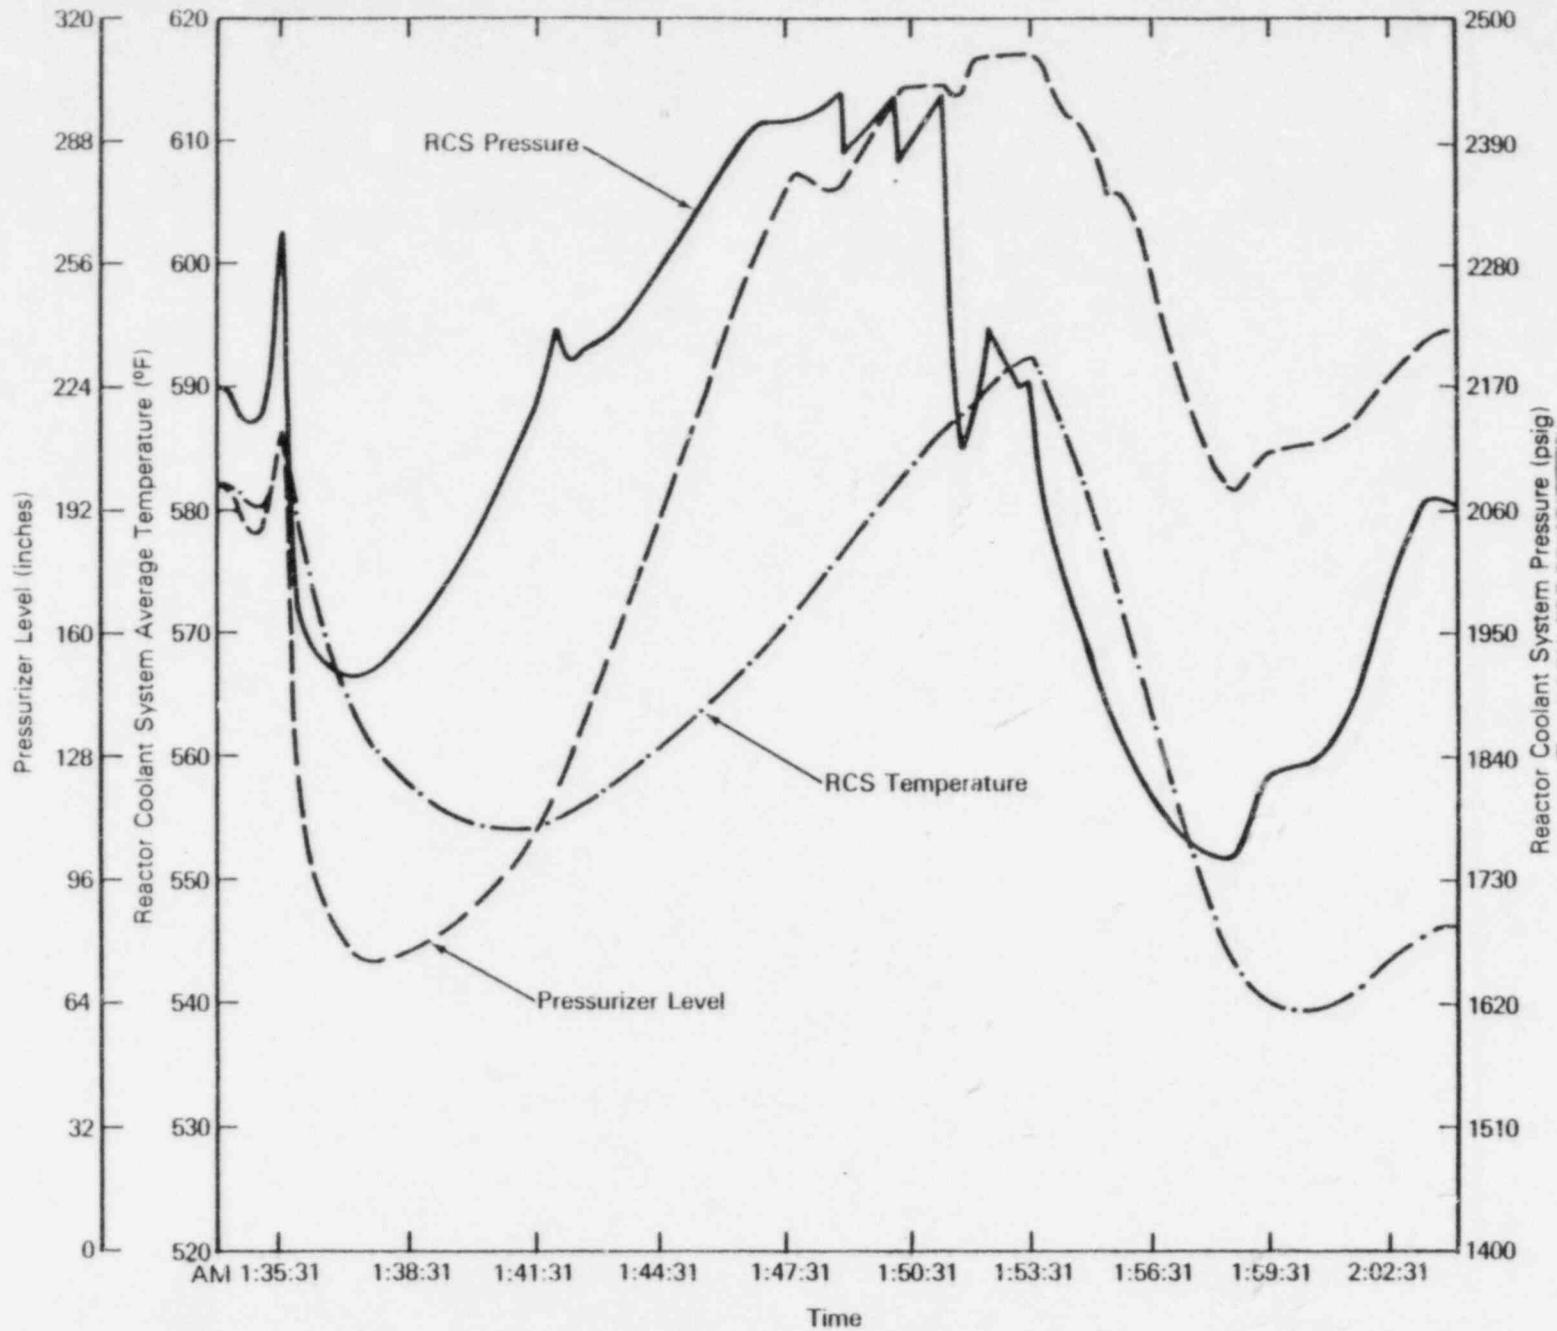
Figure 3.1 Reactor Coolant System and Pressurizer Response as a Function of Time, June 9, 1985

The sequence of events listed in Table 3.1 is based on the plant process computer printouts (alarm and sequence of events) and the data acquisition display system (DADS) computer printouts. The trends of important primary and secondary coolant system parameters are shown in Figures 3.1 through 3.3 as a function of time. Figure 3.1 shows the reactor coolant system pressure, average temperature, and the pressurizer level. Figures 3.2 and 3.3 show the pressure, level and flow for each of the two steam generators.

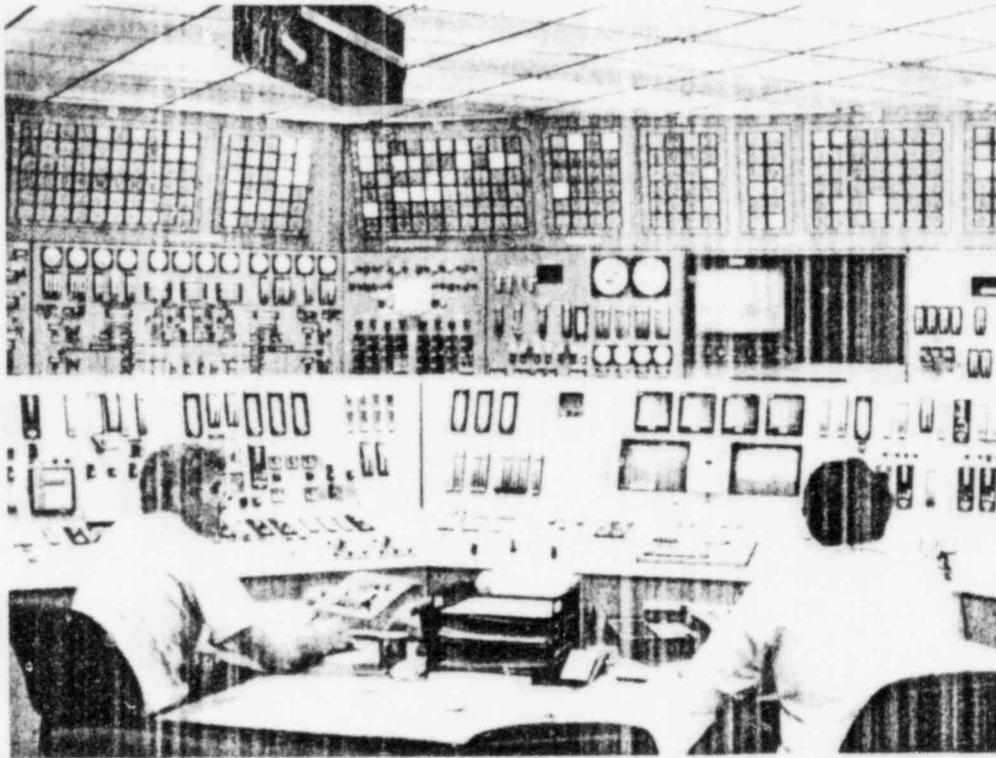
Figure 3.4 Davis-Besse Control Room

The assistant shift supervisor entered the control room (shown in Figure 3.4) and was examining one of the consoles when he noticed that main feedwater flow was decreasing and that the No. 1 main feedwater pump had tripped. Since the No. 2 feedwater pump was in manual control, it could not respond to the integrated control system demand automatically to increase feedwater flow.

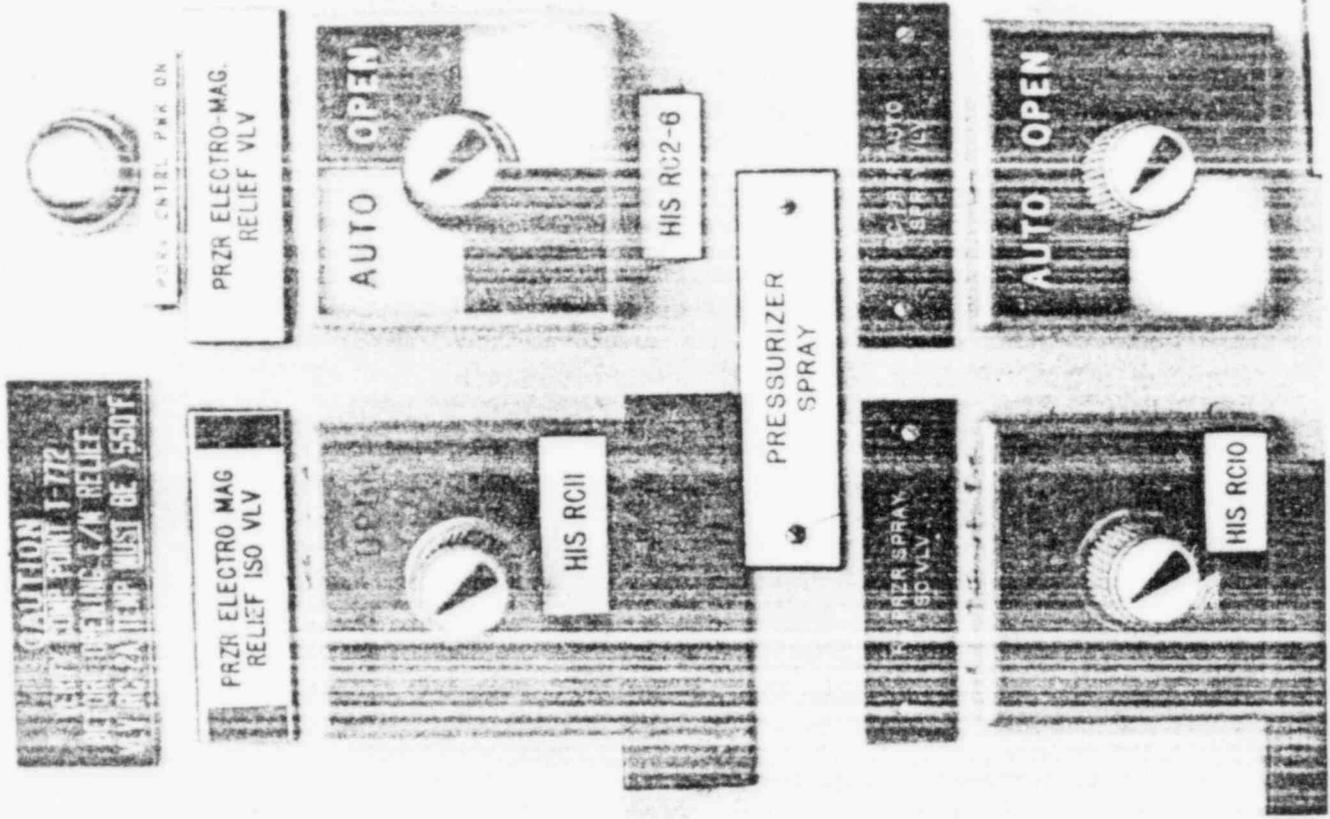
Figure 3.11 Control Station for Pressurizer PORV

The primary-side operator returned to his station and began monitoring the pressure in the pressurizer, which was near the PORV setpoint (2425 psig). The PORV then opened and he watched the pressure decrease. The indicator in front of him signaled that there was a closed signal to the PORV and that it should be closed (Figure 3.11). The acoustic monitor installed after the TMI accident was available to him to verify that the PORV was closed, but he did not look at it. Instead, he looked at the indicated pressurizer level, which appeared steady, and based on simulator training, he concluded that the PORV was closed.

Shown in Figure 3.11, the indicators for the PORV include: control power available light (blue), automatic (white), PORV open (red), PORV close (green), lock open (amber). The PORV open/close lights are operated by a limit switch operated by the PORV solenoid plunger (i.e., the output of the electric solenoid; the

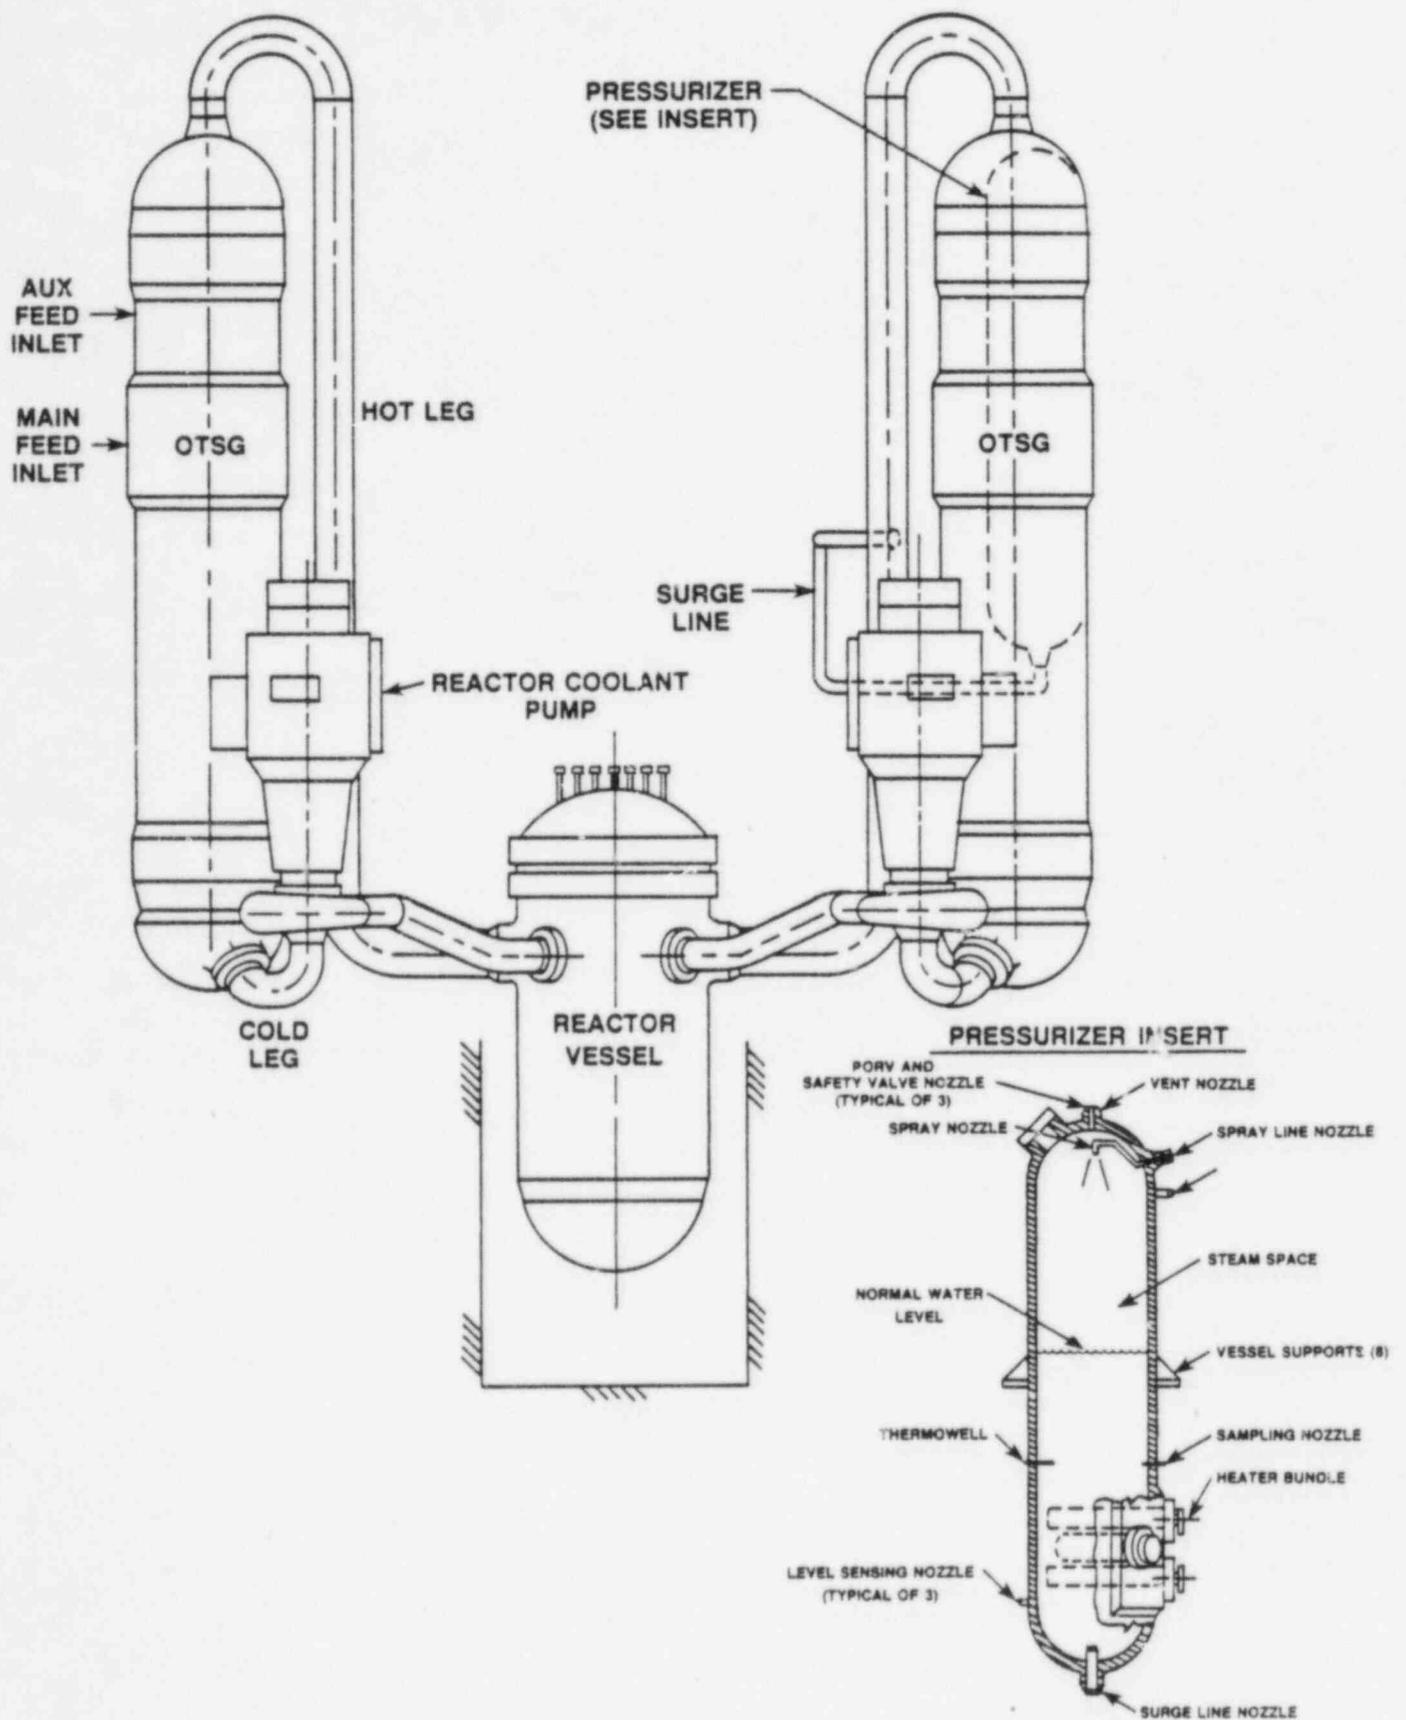
Figure 4.1 Davis-Besse Nuclear Steam Supply System

The Nuclear Steam Supply System (NSSS) for the Davis-Besse plant was supplied by the Babcock & Wilcox Company. The NSSS, shown in Figure 4.1, consists of two heat transport loops with each containing a hot leg, a once-through steam generator (OTSG), and two cold legs. Water from the OTSG is returned to the reactor vessel by the reactor coolant pumps, with one pump located in each cold leg. Reactor coolant system (RCS) pressure is maintained by an electrically heated pressurizer that is connected to one of the hot legs. During normal operations, the pressurizer contains a 700-cubic foot steam bubble that exerts a pressure of approximately 2150 psig on the RCS. Protection against overpressurization is provided by the pilot operated relief valve (PORV) and two code safety valves. The pilot operated relief valve discharges to a quench tank. The two code safety valves discharge directly to the containment building.

At the top of the pressurizer as shown in Figure 4.1, there are two code safety valves which vent directly to the containment atmosphere, a high-point vent line, and the pilot operated relief valve (PORV) with its associated upstream block valve.

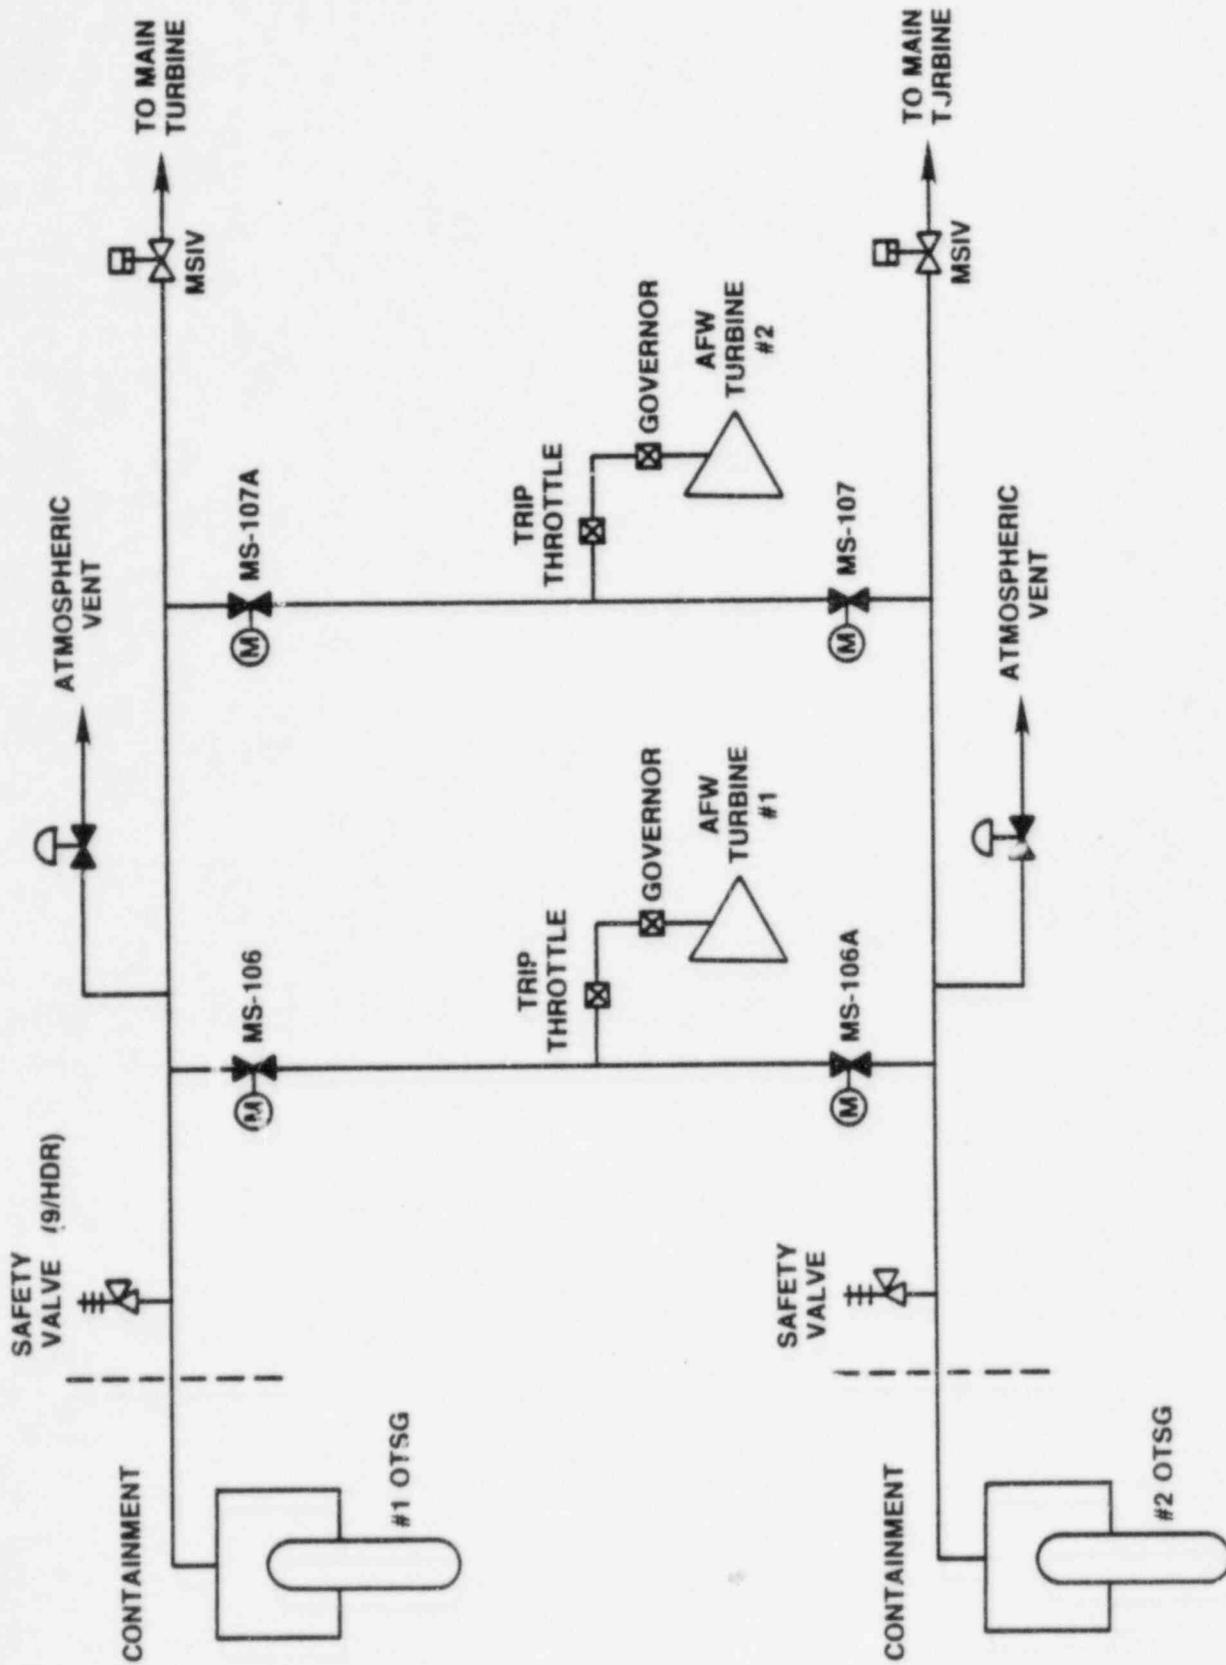
Figure 4.2 Main Steam System

The main steam system functions to deliver superheated steam from the steam generators (OTSGs) to the main turbine and required plant auxiliaries. As shown in Figure 4.2, the system begins with the outlet piping from the steam generators and passes through the containment building to the main steam isolation valves (MSIVs). Protection against overpressurization for the steam generators is provided by 18 code safety valves (9 per steam generator) located on the system piping upstream of the MSIVs, and two atmospheric vent valves (one per steam generator) which act as relief valves. The atmospheric vent valves are controlled by the integrated control system (ICS) and aid in controlling steam pressure if a large transient occurs when the unit is in service, if condenser vacuum is lost, or if the MSIVs are closed. Connections upstream of each main steam isolation valve supply steam to the redundant turbine-driven auxiliary feedwater pumps. Either system header is capable of supplying either turbine; however, the auxiliary feedwater pump turbine normally receives steam from its associated steam header.

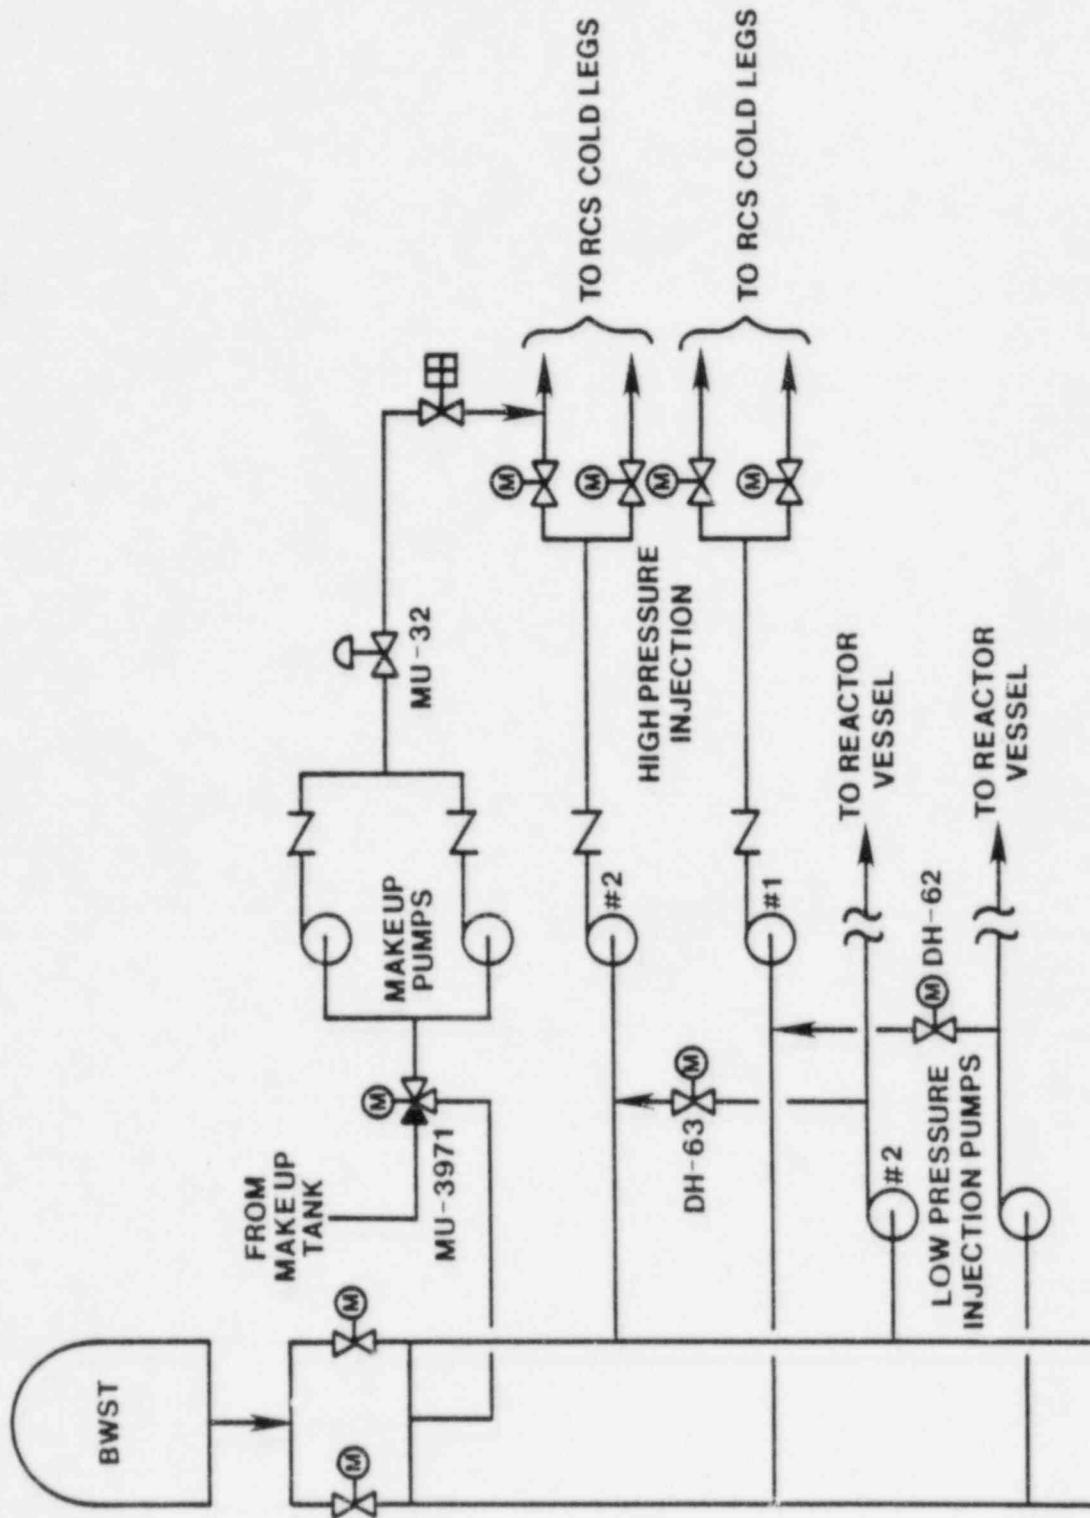
Figure 4.5 Makeup/HPI Cooling System

The low pressure injection (LPI) pumps are also a part of the emergency core cooling systems. The LPI pumps receive a suction from the BWST and discharge via the decay heat removal coolers (not shown in Figure 4.5) into the reactor

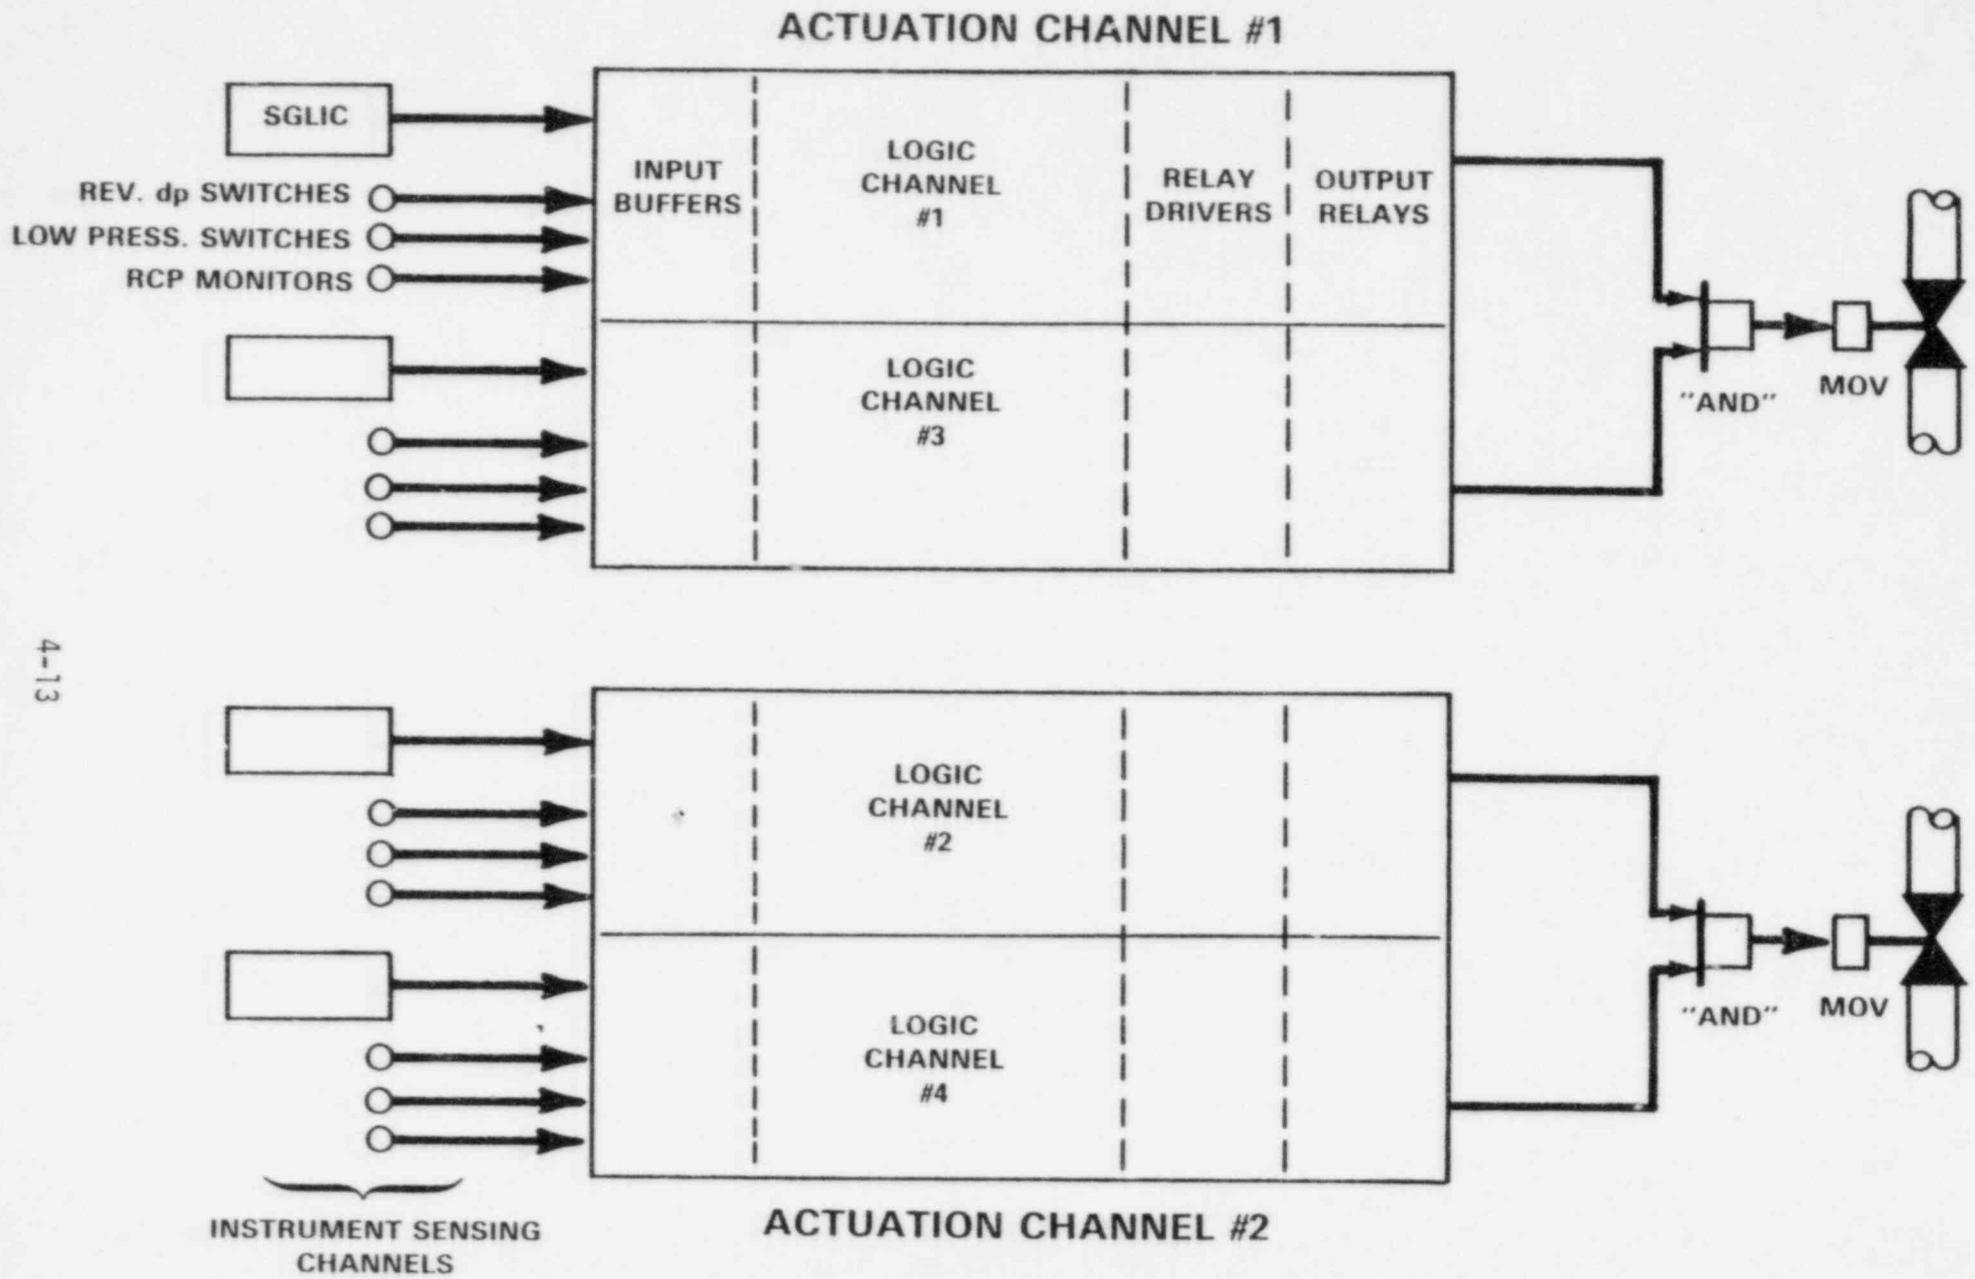
Figure 4.6 SFRCS Block Diagram

Figure 4.6 depicts the channelization of the SFRCS. There are two Actuation Channels, each of which contains two identical logic channels. Within each Actuation Channel, one logic channel is ac powered and the other logic channel is dc powered. The field wiring at the actuated equipment is such that generally both logic channels must "trip" (i.e., a two-out-of-two AND logical arrangement) to actuate most equipment, which is referred to as a "full trip." However, some equipment is actuated by a "half trip" (i.e., only one logic channel of an actuation channel has tripped). For example, the atmospheric steam vent valves are closed by "half trips."
