OMAHA PUBLIC POWER DISTRICT
FORT CALHOUN STATION

Steam Generator Tube Rupture Incident
Final Report

June 1984

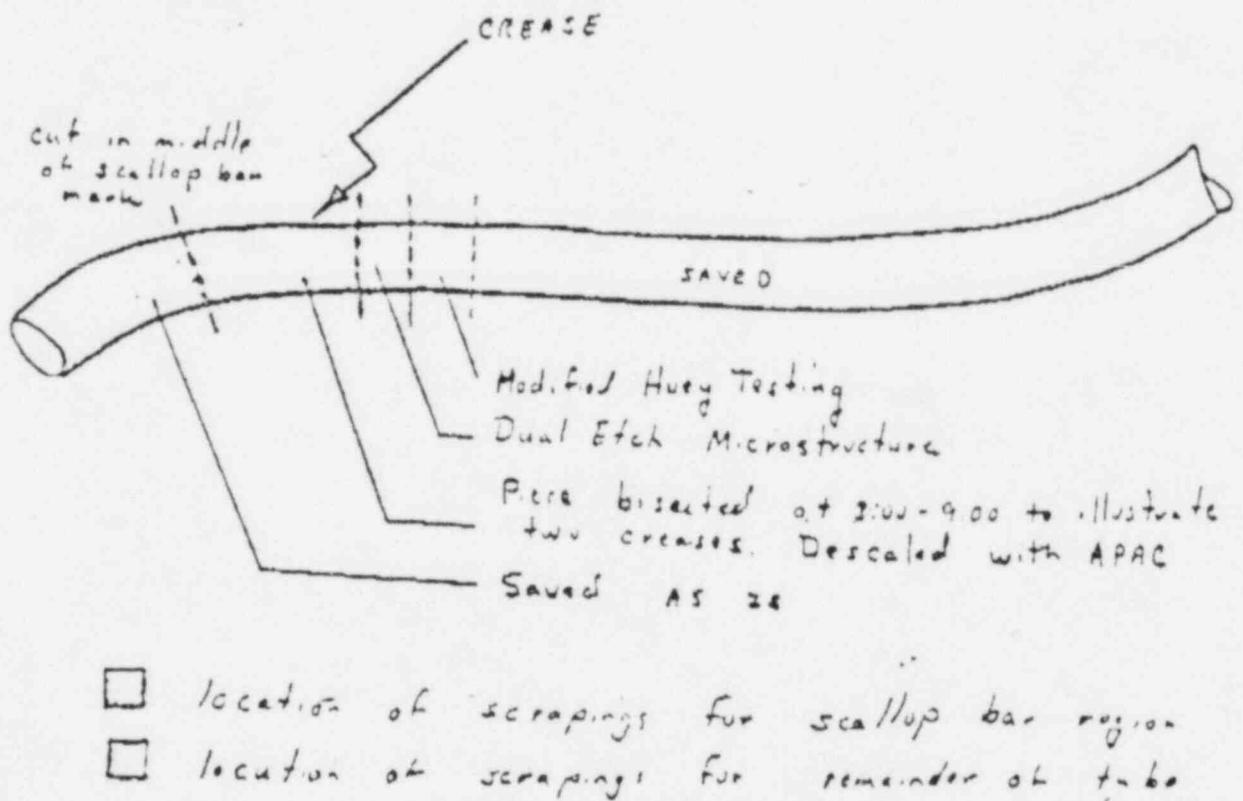
Figure 5 - Disposition of Pieces from Tube L29R86, Section 13A

Figure 5 illustrates the sectioning of tube section 13A to provide samples for subsequent examinations. These samples were removed for dual etch microstructure characterization, modified Huey testing, and surface examination. Prior to the sectioning, samples of the deposits were collected for chemical analysis. The locations of scrapings for chemical analysis are also illustrated in Figure 5.

One section from tube specimen 13A was chemically descaled using APAC, a standard two step descaling solution. The piece chosen was from the middle of one scallop bar to just past the kink in the tube, as shown in Figure 5. The purpose was to establish whether defects other than the kink/crease existed, and if so to correlate them to the previously observed eddy current indications. Once descaled, the specimen was examined at 5-40X under a microscope. Whereas only one crease was visible on the exterior surface of the tube, two creases were observed on the inside diameter. The shallower of the two creases corresponded to the location of the scallop bar. The distance between the two creases also matched the distance between the two eddy current signals. No other externally or internally visible defects were identified.
