ARKANSAS POWER AND LIGHT ARKANSAS NUCLEAR ONE - UNIT 1 CONTROL ROOM DESIGN REVIEW FINAL SUMMARY REPORT HUMAN ENGINEERING DISCREPANCIES VOLUME 2 AUGUST 14, 1985

Category 1 HEDs (42 HEDs)

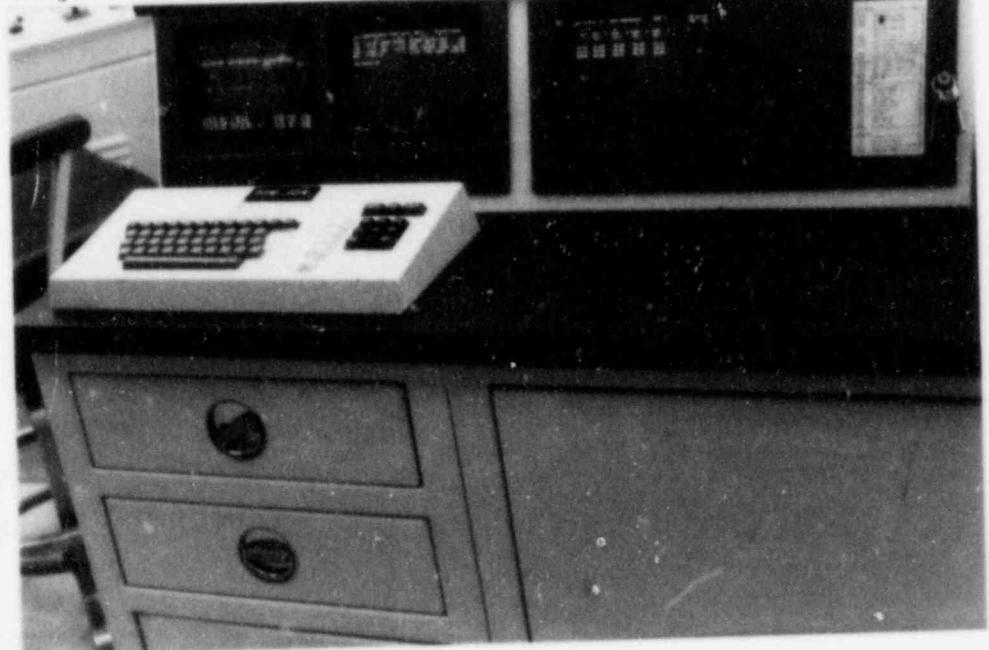
The computer console is seldom used by the operator and is intended as a stand-up work station. It is primarily used to define trend points which takes very little time at the keyboard. Therefore, as a stand-up console, leg and foot room are adequate.

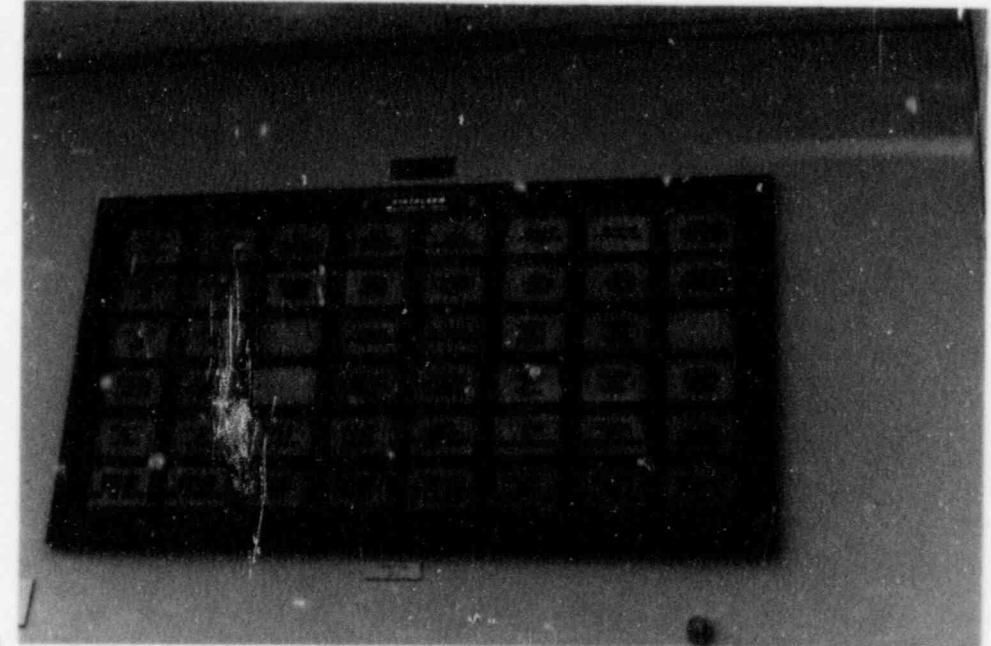
The type styles are all basic block fonts and are easily readable by the plant operators. Therefore, no additional action to address this HED is planned. However, if the annunciator windows are changed due to other HED's, the type styles will be made the same for all modified windows.

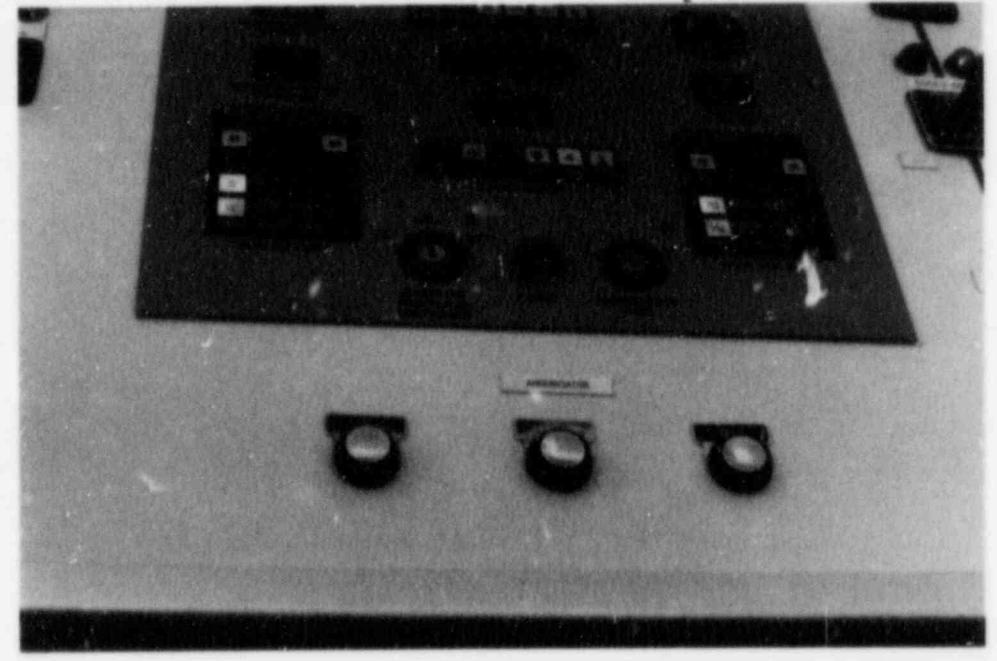
The annunciator controls are labeled and are used quite frequently by the plant operators. The use of a coding scheme for easy recognition is not useful since the operators are very familiar with these controls. Since a change is not justified, no further action to address this HED is planned.

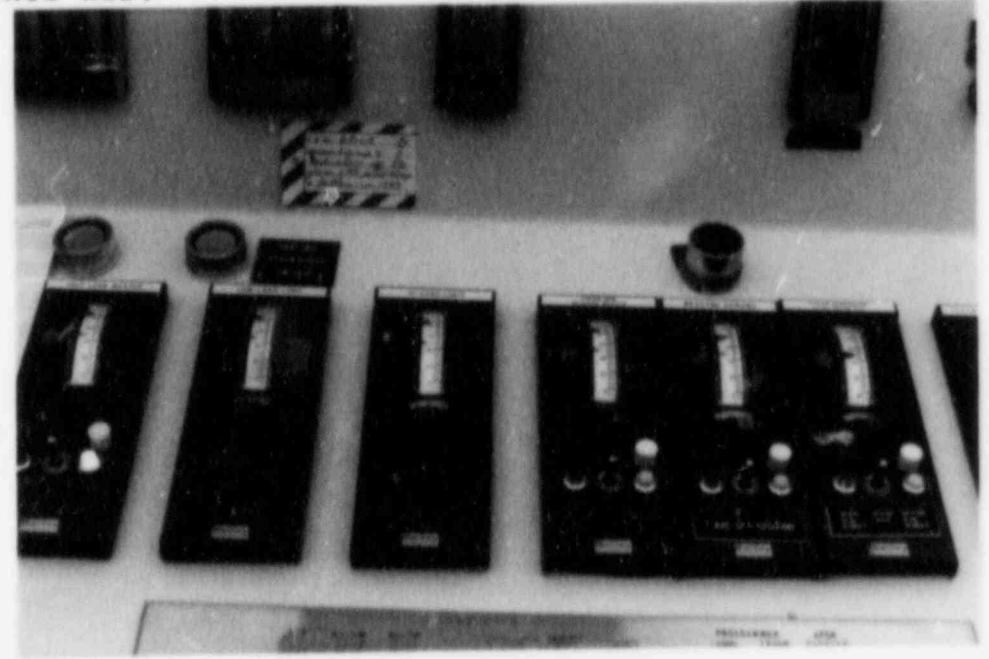
These controls do occasionally result in "overshooting" a desired value, but the consequence is not significant. The operator simply readjusts the control until the desired value is achieved. These controls have not resulted in operational problems and therefore do not warrant a design change to correct this HED.

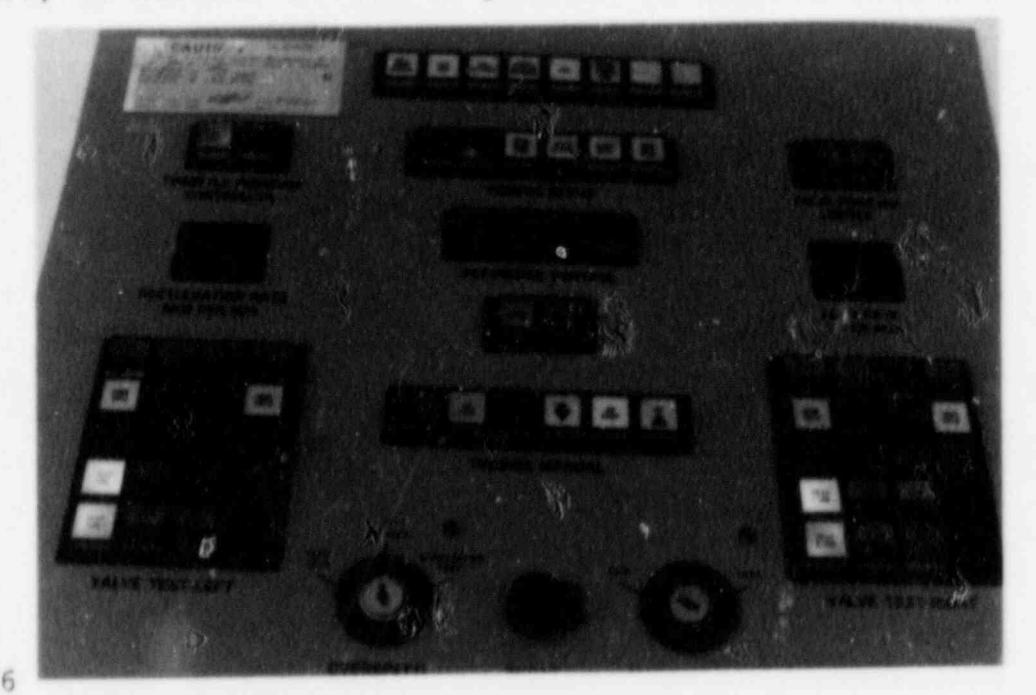
The panel insert that has the legend pushbuttons and legend indicator lights is part of vendor supplied controls for a particular piece of equipment. The operator procedure for use of this panel insert gives sufficient guidance on operation of the panel such that operator confusion is not a problem. Therefore, no further action is planned to address this HED.

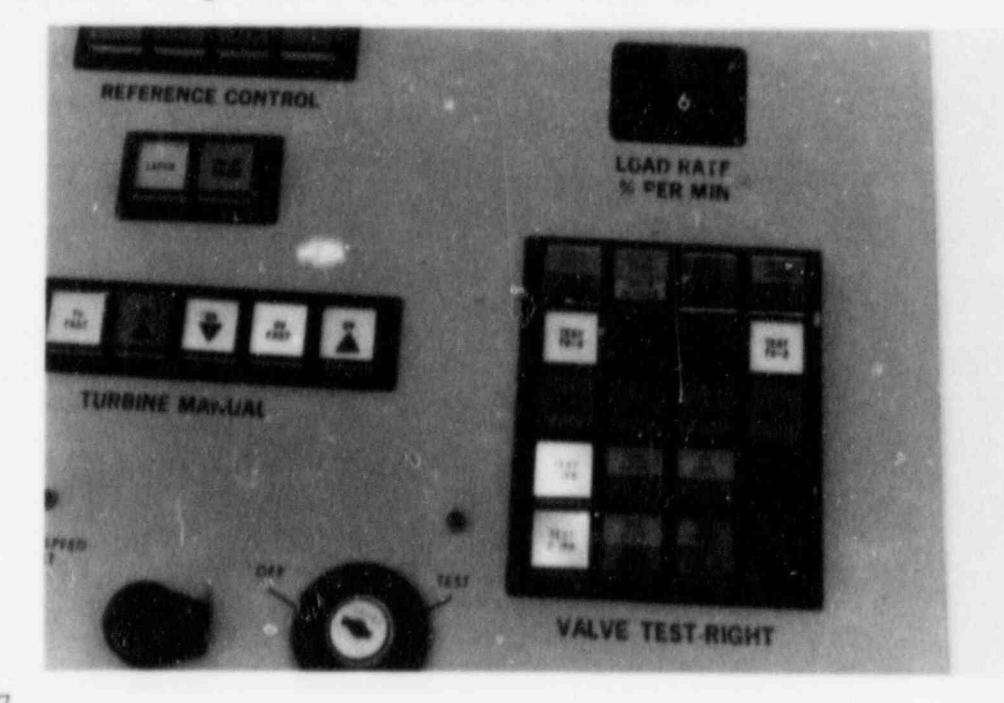
Although the contrast between the lettering and the pushbutton background is not high, the legends are readable under the existing control room lighting conditions. Therefore, no further action is planned to address this HED.

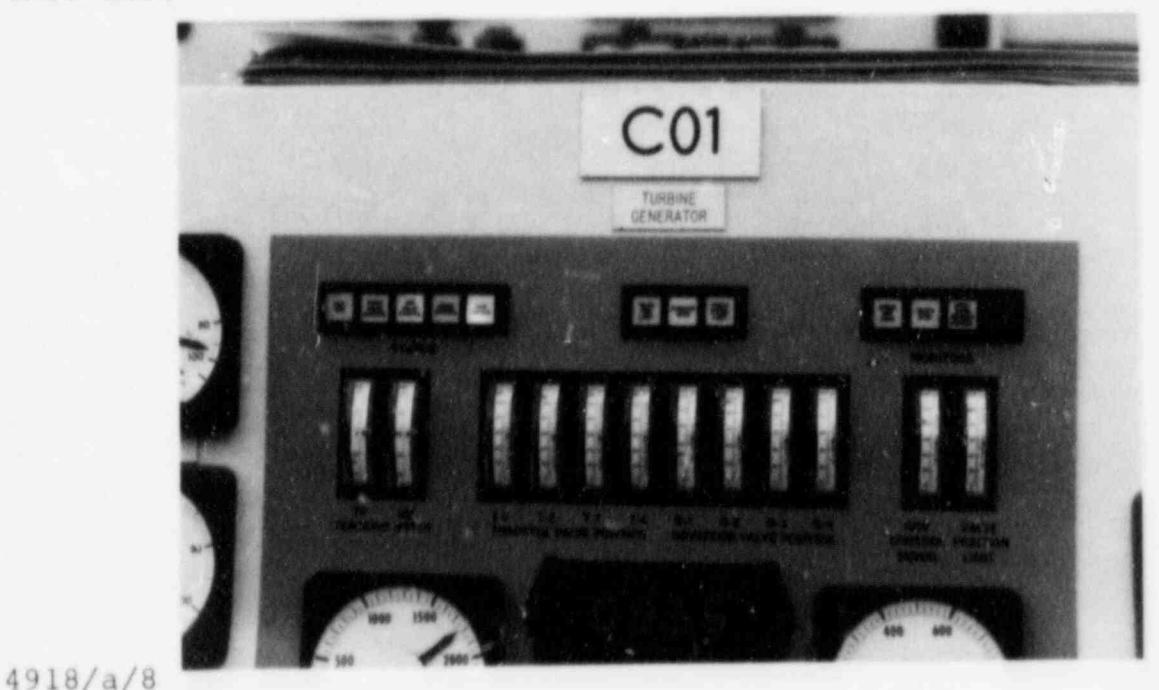
Although there are more than three lines of lettering on the referenced legends, they are not difficult to read. Also, the information provided in these four lines is important to the operator. Therefore, no further action is planned to address this HED.

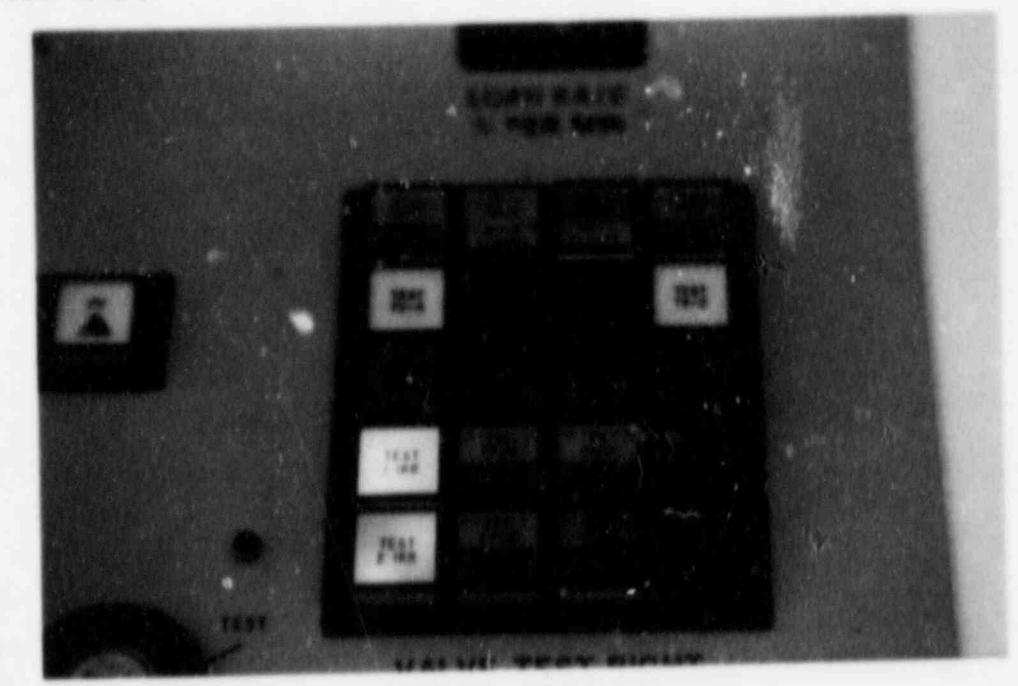
Although a raised barrier is not utilized for pushbuttons located side-by-side, they do have a grid barrier between each of the pushbuttons such that only one button can be depressed by a single finger. Therefore, no further action is planned to address this HED.

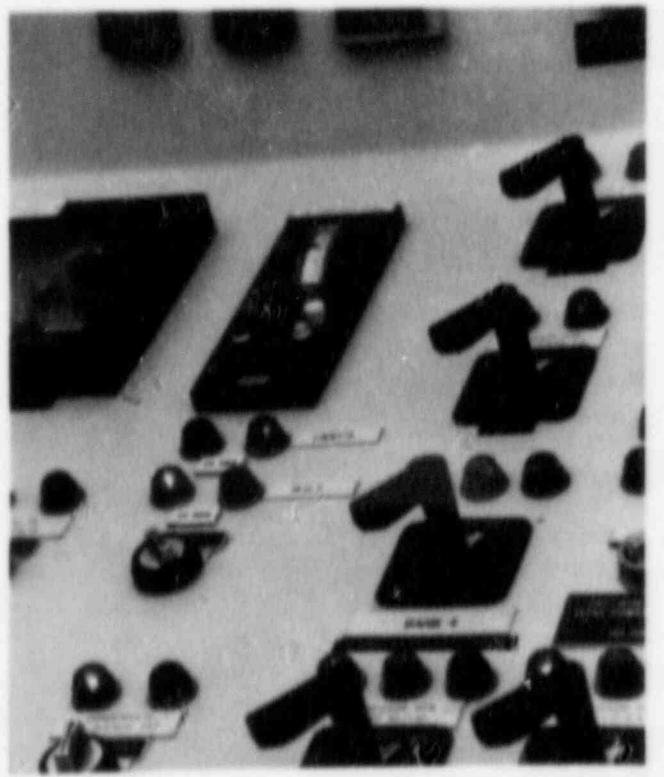
The identified displays are not difficult to read since the operator normally leans slightly to operate controls on the benchboard and/or to observe displays. Therefore, since the displays are easily read, no further action is planned to address this HED.

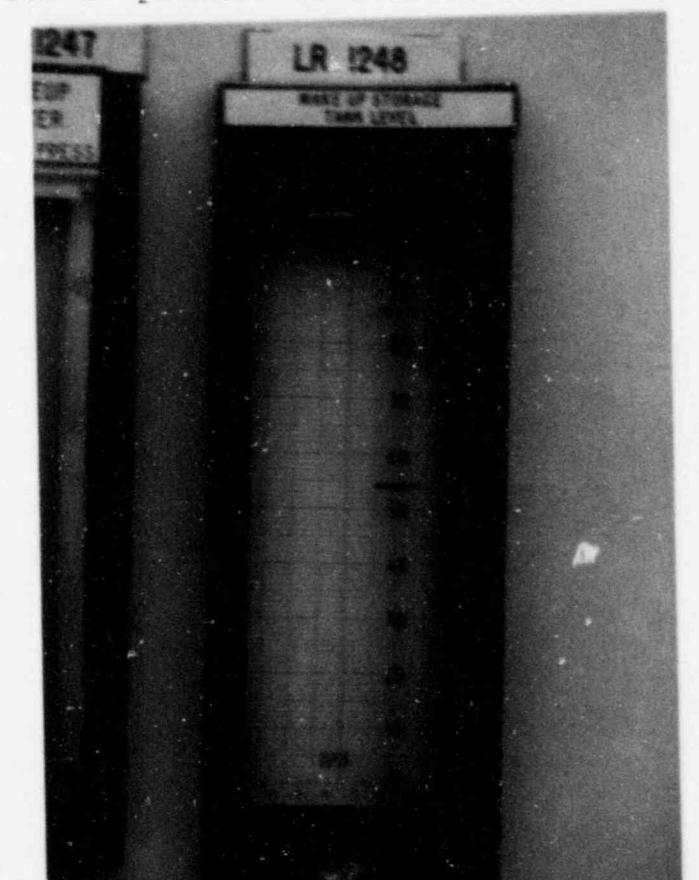
The trend recorders are checked daily by the shift administrative assistant to assure that adequate markings are maintained. This procedure has been adequate to assure valid markings and will be continued. Due to the use of this administrative procedure, the condition observed was not permanent and no further action is planned to address this HED.

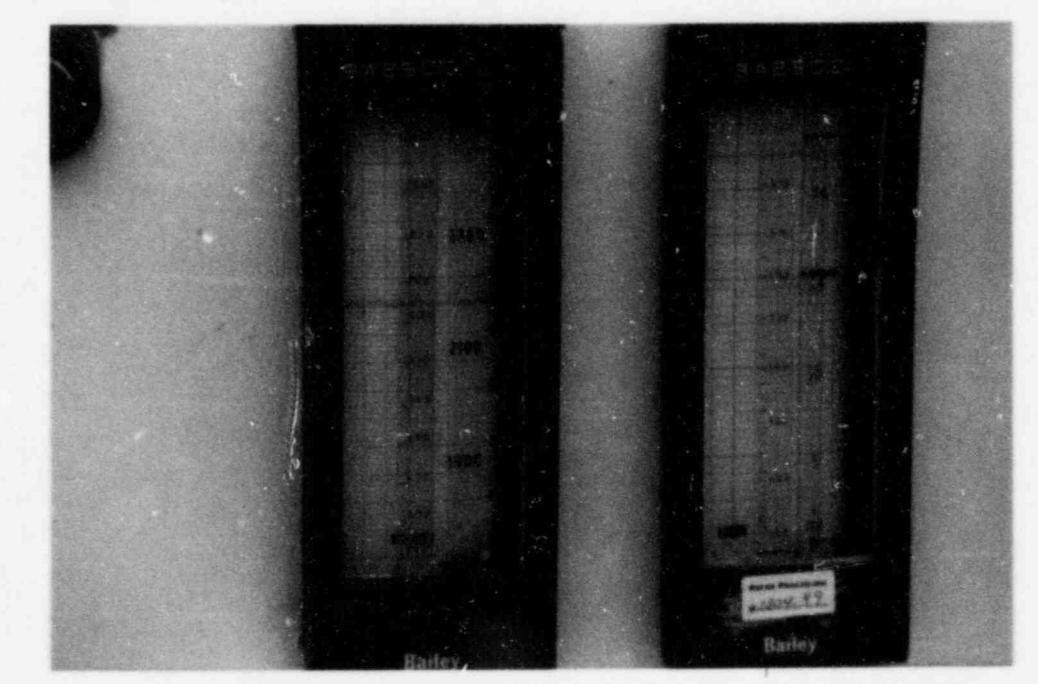
The scale superimposed on the face of the reactor coolant pressure indicators provides an operator aid for determining subcooling margin. The lettering is intentionally small to prevent obscuring the primary display information of pressure. Furthermore, the primary display for subcooling margin is provided on a separated dedicated display for the operator's use. Therefore, since the purpose of the superimposed scale is purely as an operator aid, serves as a backup to a dedicated display and is not difficult to read, no further action is planned to address this HED.

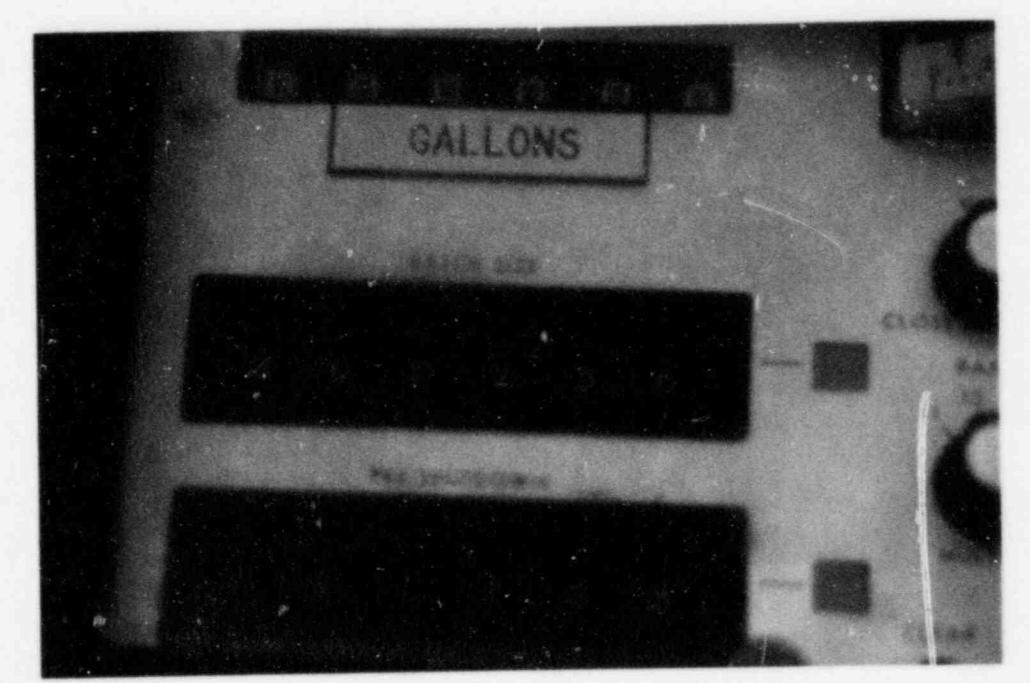
The drum type counters have the capability to display up to six digits but the measured variable does not exceed four digits in actual use. Therefore, the displayed variable is within the 0700 guideline for not utilizing commas for separation. Furthermore, the plant operators report no difficulty in using the subject drum counter. Based on the lack of a justification for making a change, no further action is planned to address this HED.

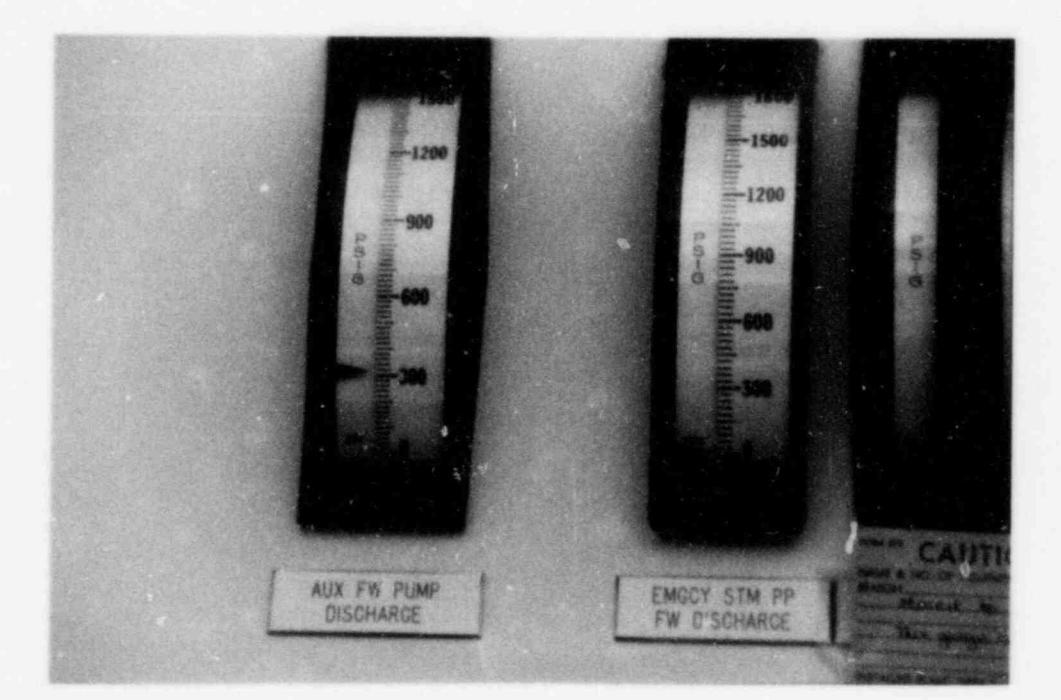
The identified displays (except for the core flood tank level indicators) are all used for general monitoring and are not intended for accurate reading. The displays provide sufficient information for the operator's needs and, therefore, a change is not justified. No further action is planned to address this HED.

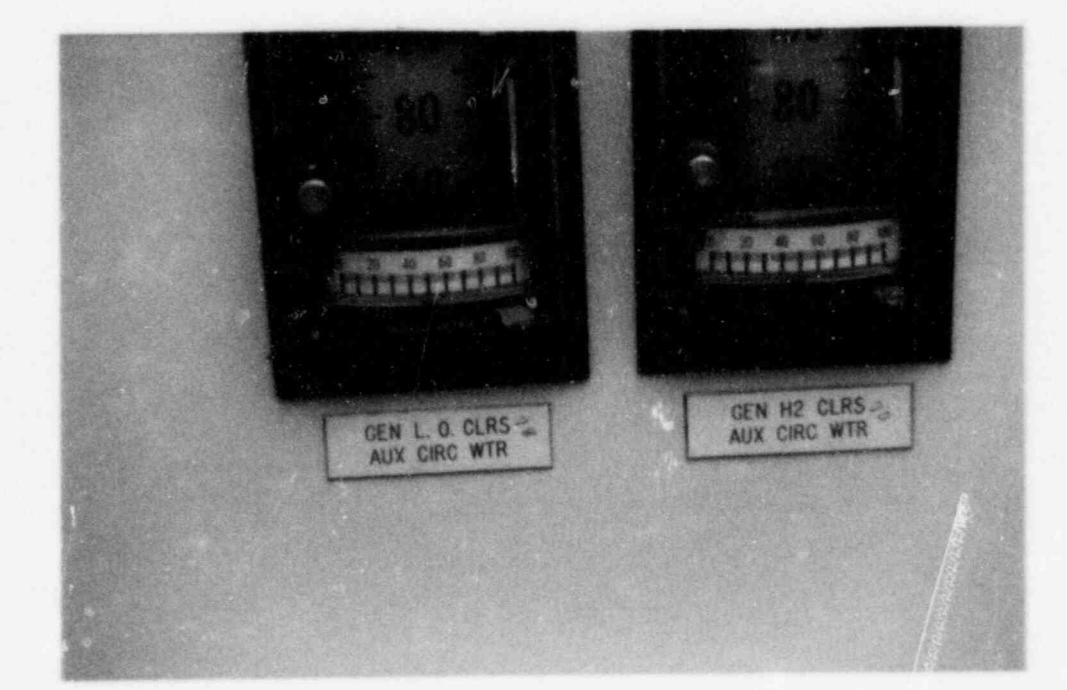
The identified displays are easily read by the operator even when the pointer tip overlaps minor markings on the display. These indicators are primarily for observation that a change in the measured variable is occuring and not for indication of a discrete value. Therefore, since a change is not justified, no further action is planned to address this HED.

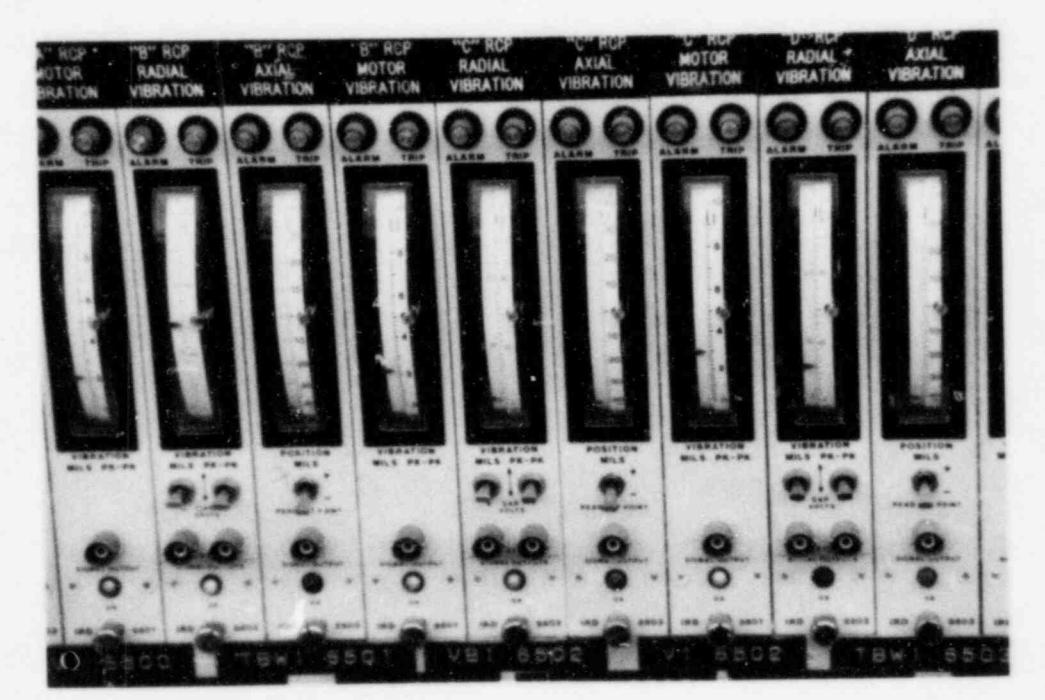
A review of the graduation markings on the identified displays verified that they were all easily read since the graduation heights do vary. The application of the checklist guideline was misinterpreted. Therefore, since a change is not appropriate, no further action is planned to address this HED.

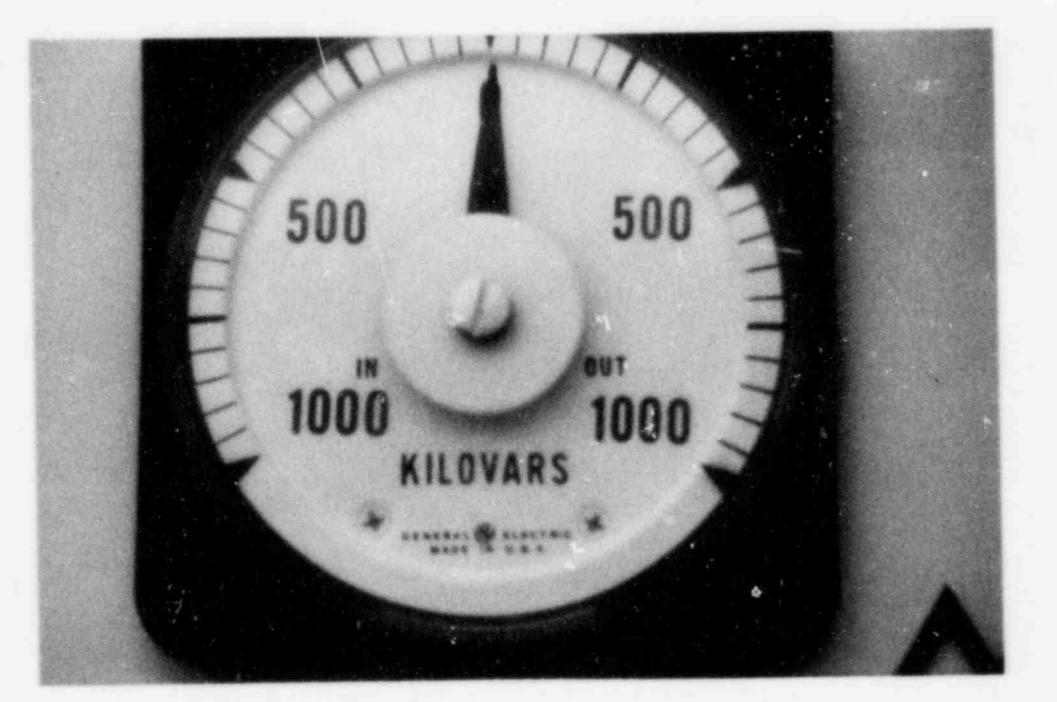
The identified displays are all special application meters that do not lend themselves to the 0700 guideline for clockwise motion to indicate increasing values. They are designed to provide the operator with the information needed in a format that is easily read. A change to try to meet the 0700 guideline would create a confusing and difficult to read display. Therefore, no further action is planned to address this HED.

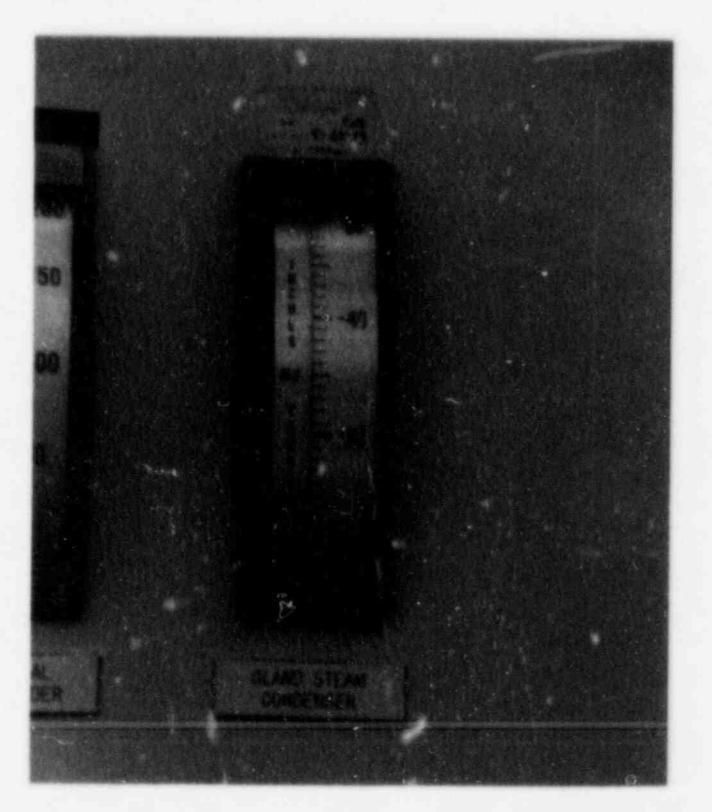
The identified displays are all special application meters that do not lend themselves to the 0700 guideline for upward motion to indicate increasing values. They are designed to provide the operator with the information needed in a format that is easily read. A change to try to meet the 0700 guideline would create a confusing and difficult to read display. Therefore, no further action is planned to address this HED.

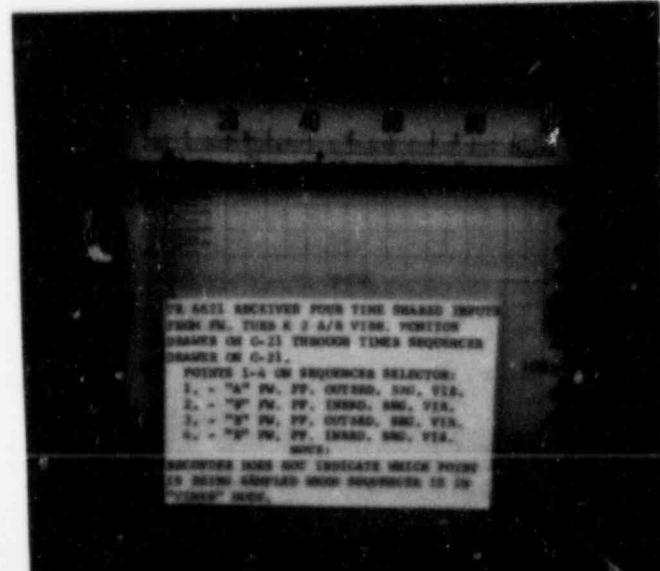
TR-6612	(Panel	C-12)
TR-6501	(Panel	C-13)
TR-2890	(Panel	C-19)
TR-2808	(Panel	C-19)
TR-3629	(Panel	C-19)
TR-3651	(Panel	C-19)

Therefore, based on the control room relabeling program and the above described design change evaluations, the discrepancies will be corrected as appropriate.

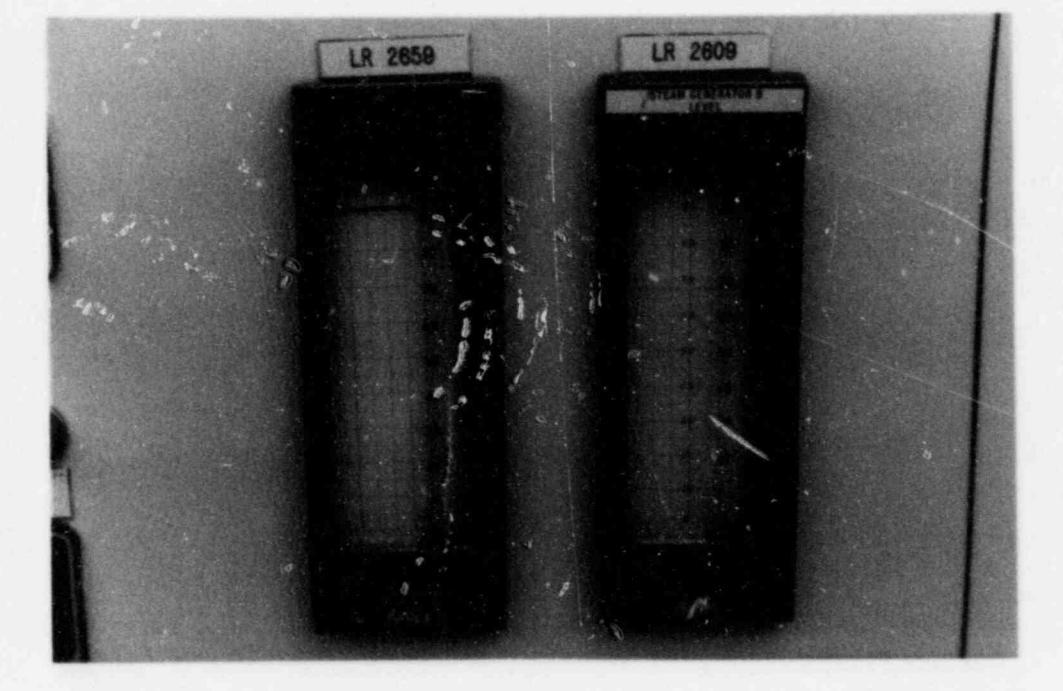
trending any of several computer points. They are provided with labels that have temporary marker type labeling written in by the plant operators. This arrangement provides the needed flexibility for these addressable trend recorders.

The other trend recorders identified will be evaluated during the comprehensive control room relabeling program to assure that adequate parameter identification is provided. Therefore, the discrepancies will be or have been corrected.

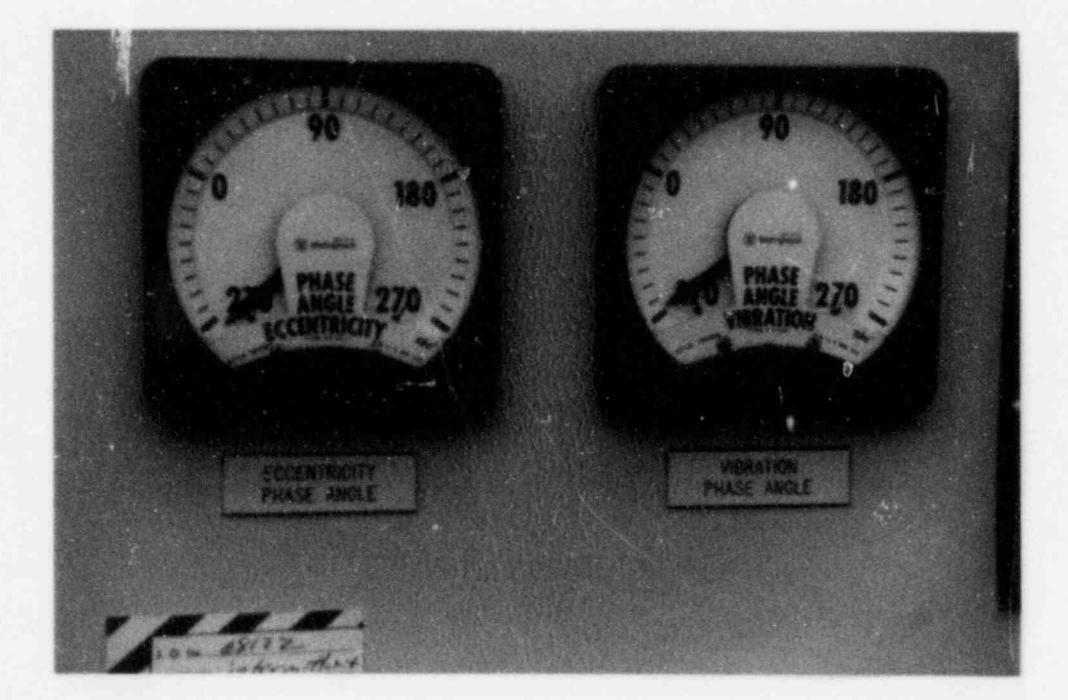
The identified displays are not utilized by the control room operators. They are used for turbine-generator diagnostics by the vendor representatives and maintenance personnel and are special application meters that do not lend themselves to the 0700 guideline. Therefore, no further action is planned to address this HED.

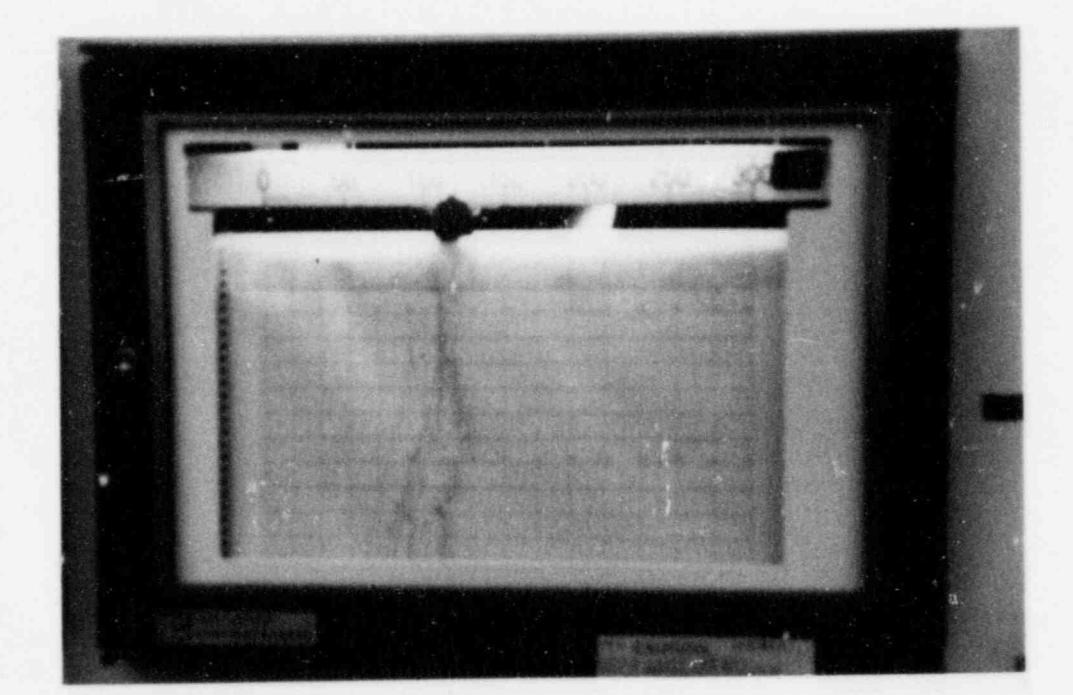
The identified multi-point recorders are all discrete type recorders and not pen type recorders. Therefore, the HED does not apply. Each of the multi-points are appropriately identified by a letter designator in accordance with 0700 guidelines. No further action is planned to address this HED.

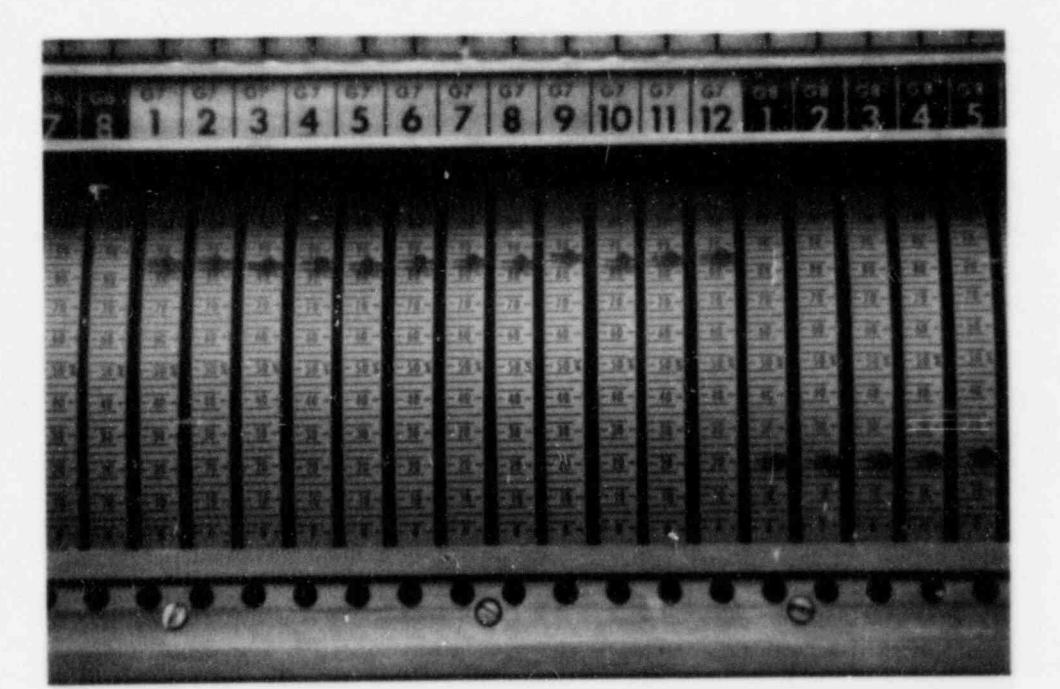
The identified display is provided to give the operator a general idea of the relative location of the control rods and is not used for determining exact or discrete values. Therefore, the complex pointer shape and overlapping with the scale marks and numbers does not impact the operators ability to obtain the desired data. Based on the lack of justification for a change, no further action is planned to address this HED.

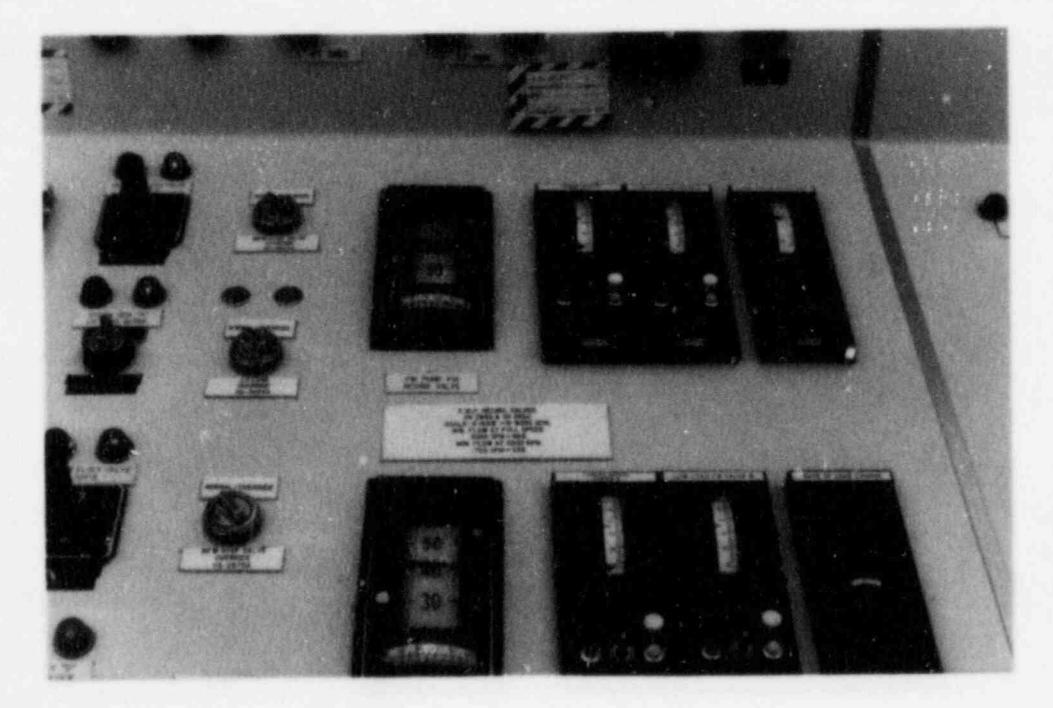
The Bailey meters do have black on a gray background, but they are easily readable by the plant operators. Based on a lack of justification, no further action is planned to address this HED.

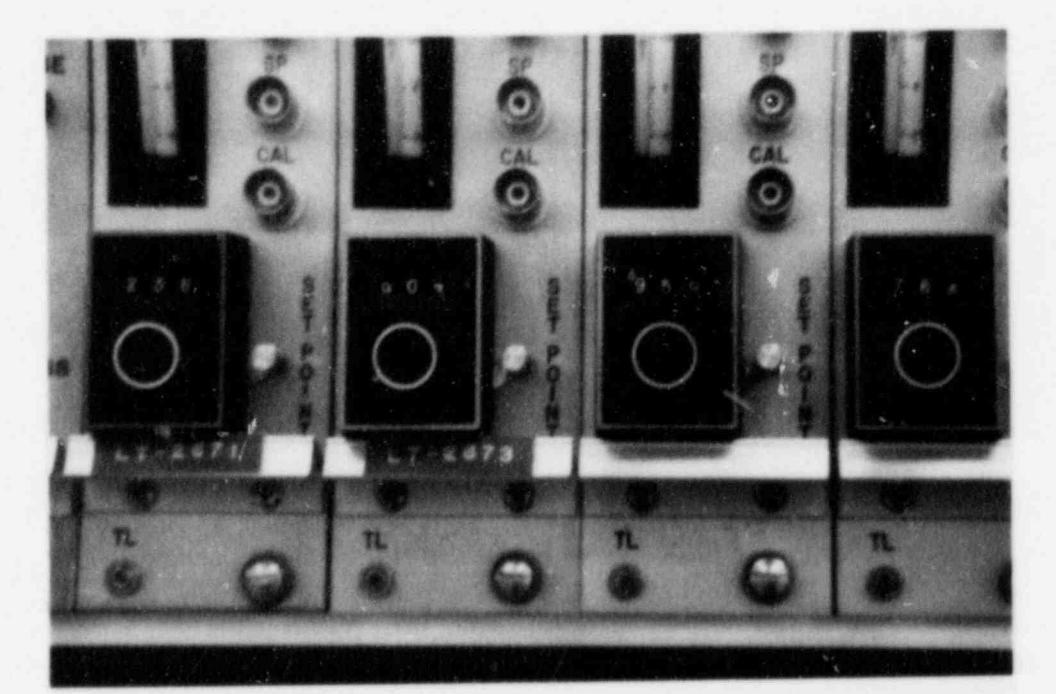
The identified drum counters are easily read and provide sufficient information for the operators needs. Modifying them to snap action type displays would be of no benefit to the plant operators. Based on a lack of justification for change, no further action is planned to address this HED.

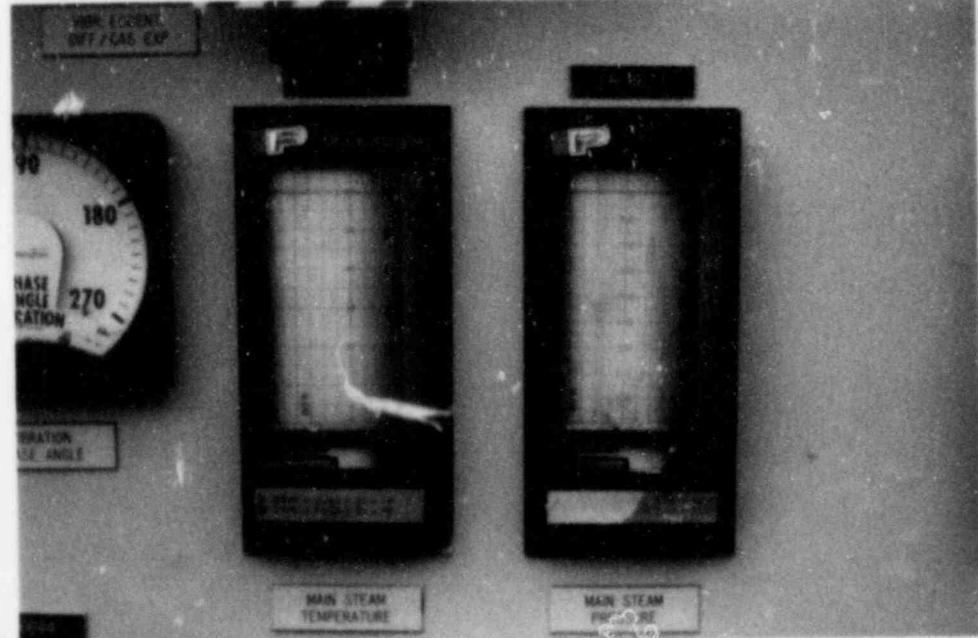
The controls and displays on C-Ol and C-ll are intended to work together. Therefore, the location of the identified displays on C-11 was intentional such that they can be viewed from Panel C-Ol where related controls are located. No further action is planned to address this HED.

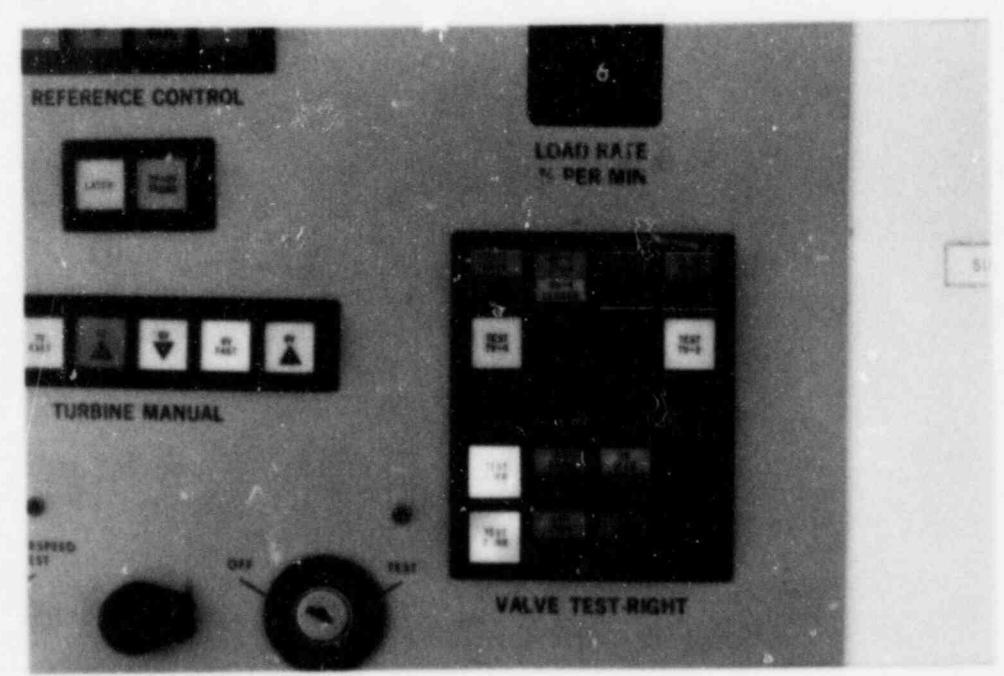
The arrangement of the legend lights and legend buttons on the turbine control panel mimics the physical arrangement of the turbine valves. Therefore, the arrangement is logical from a physical representation viewpoint rather than from an alphabetical viewpoint. No further action is planned to address this HED.

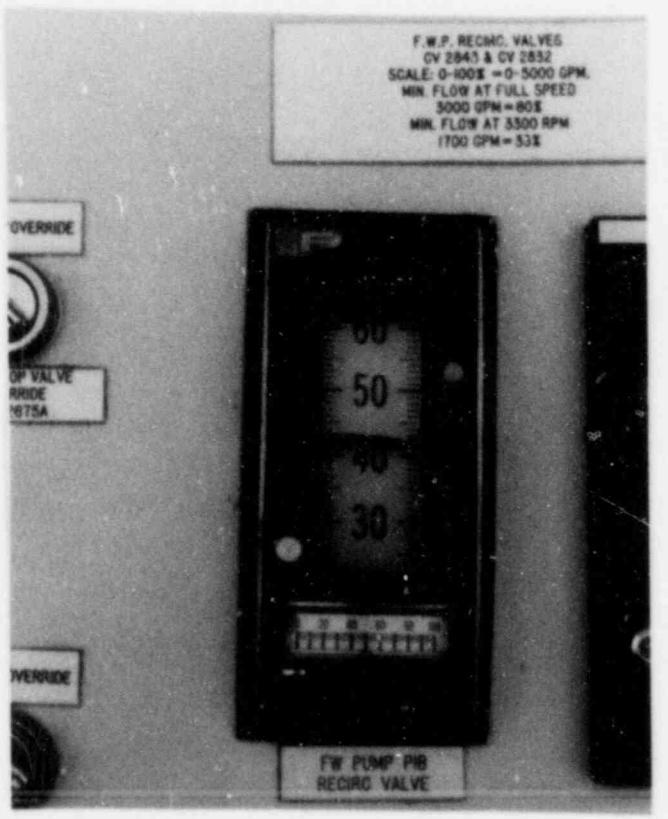
The feedwater pumps are on Panel C-03 which is where the recirc valve controls are located. Some of the feedwater pump auxiliary systems are controlled from C-02. Therefore, the location of the identified controls is appropriate for the purpose they serve.

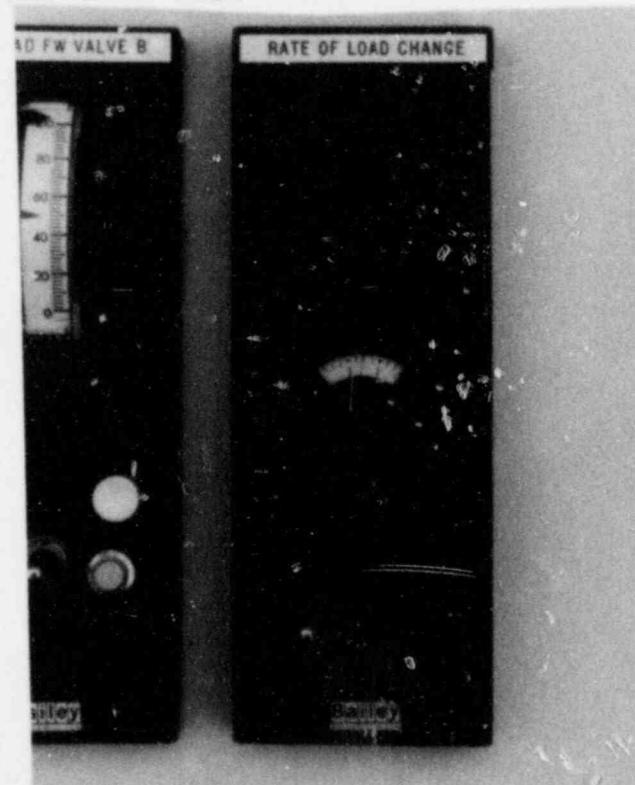
The identified controller is clearly labeled to show the purpose and has not created operator confusion in the present location. Since the existing arrangement is not troublesome for the operators and operator training adequately covers the operation of this control, relocation could result in operator confusion due to negative training transfer. Therefore, due to a lack of justification for a change, no further action is planned to address this HED.

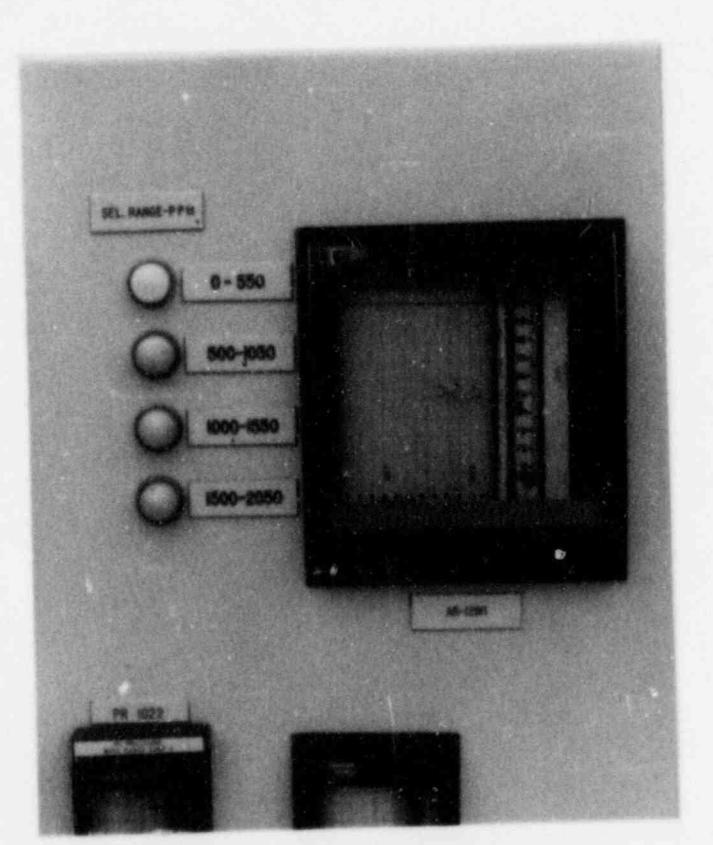
The identified recorder is not utilized in conjunction with the operation of the letdown controls. It is primarily a monitoring display not directly associated with control devices. The current location provides for convenient viewing and does not create operator problems. Therefore, no further action is planned to address this HED.

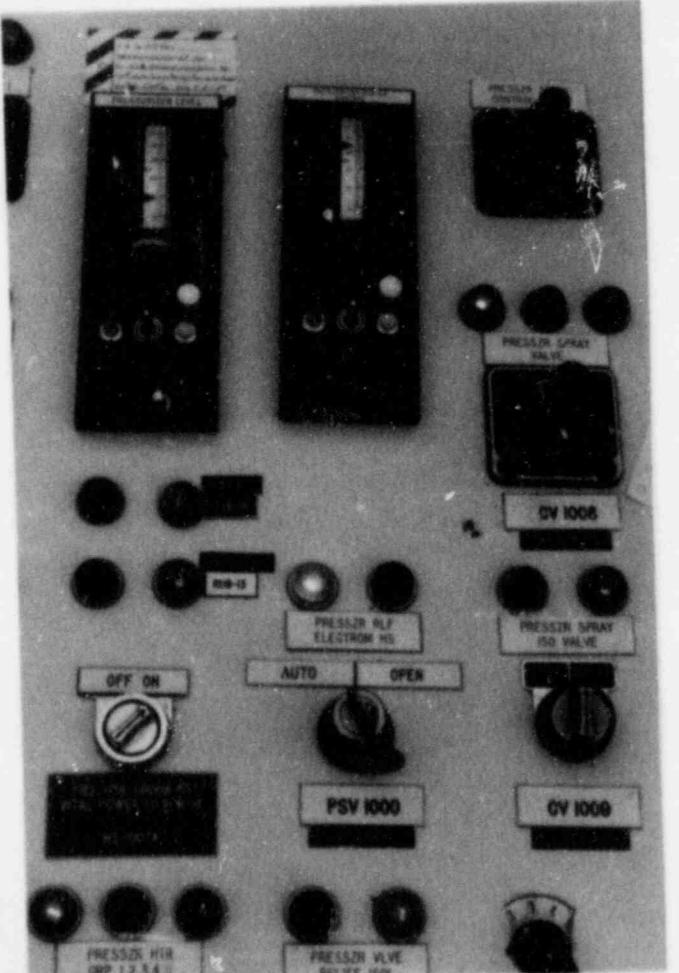
The pressurizer level controller (LIC-1000) is not functionally associated with the pressurizer spray valve control (CV-1008). Therefore, no further action is planned to address this HED.
