ARKANSAS POWER AND LIGHT ARKANSAS NUCLEAR ONE - UNIT 1 CONTROL ROOM DESIGN REVIEW FINAL SUMMARY REPORT HUMAN ENGINEERING DISCREPANCIES VOLUME 2 AUGUST 14, 1985

Category 1 HEDs (42 HEDs)

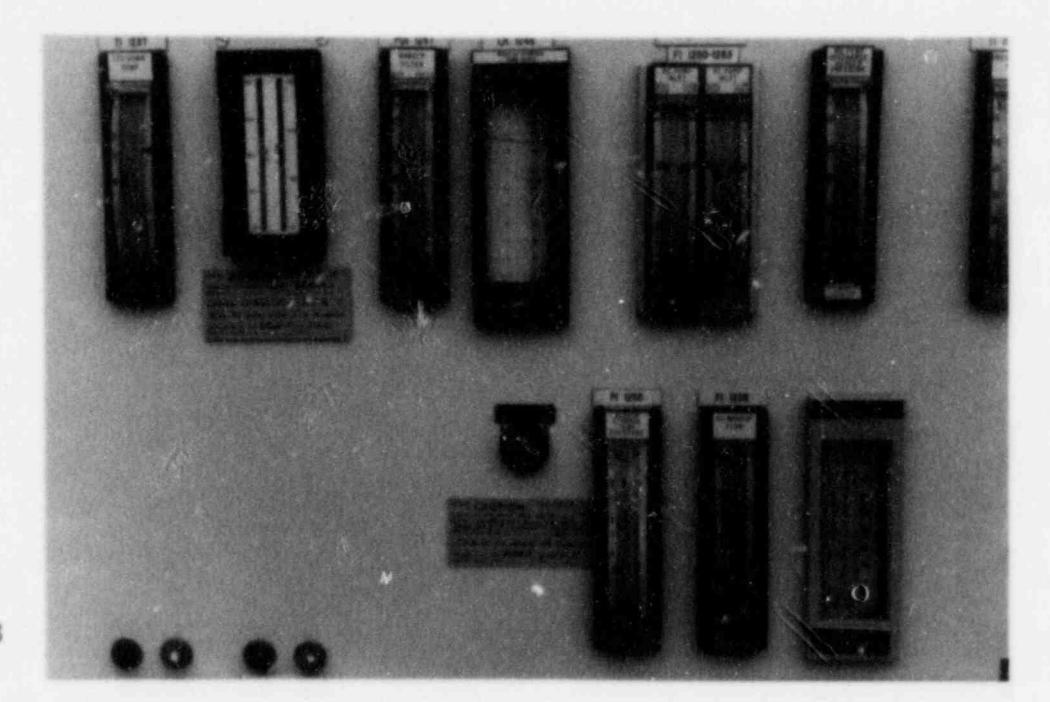
The identified displays are not used for comparison purposes (i.e., mass balance checks) since they are not accurate enough for that purpose. They are used in conjunction with controllers located below the displays such that the existing location is appropriate. Therefore, no further action is planned to address this HED.

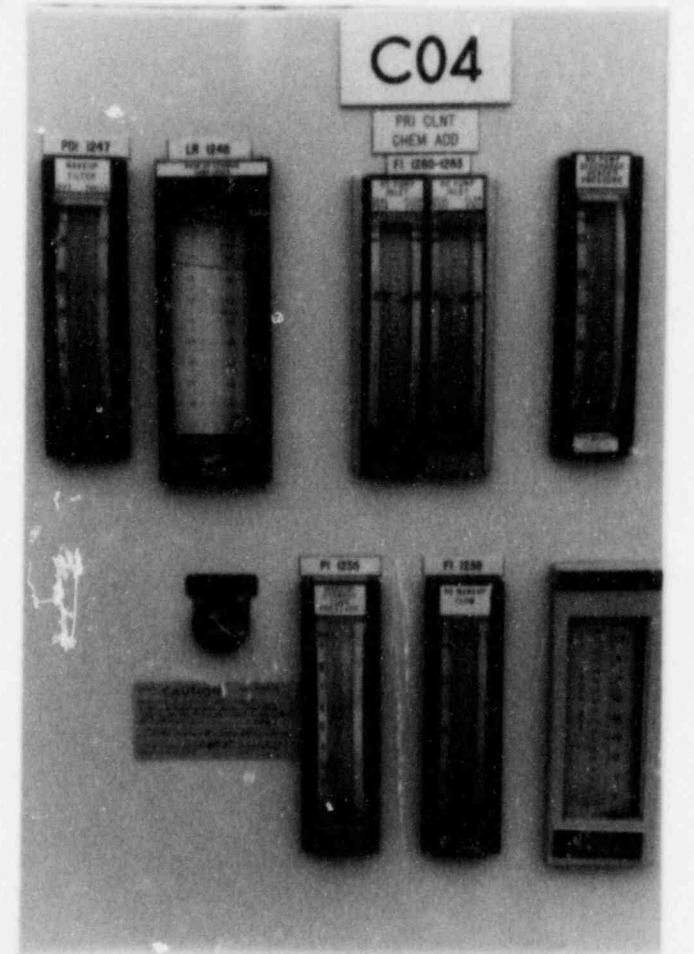
The identified non-adjacent indicators are not related. Therefore, no further action is planned to address this HED.

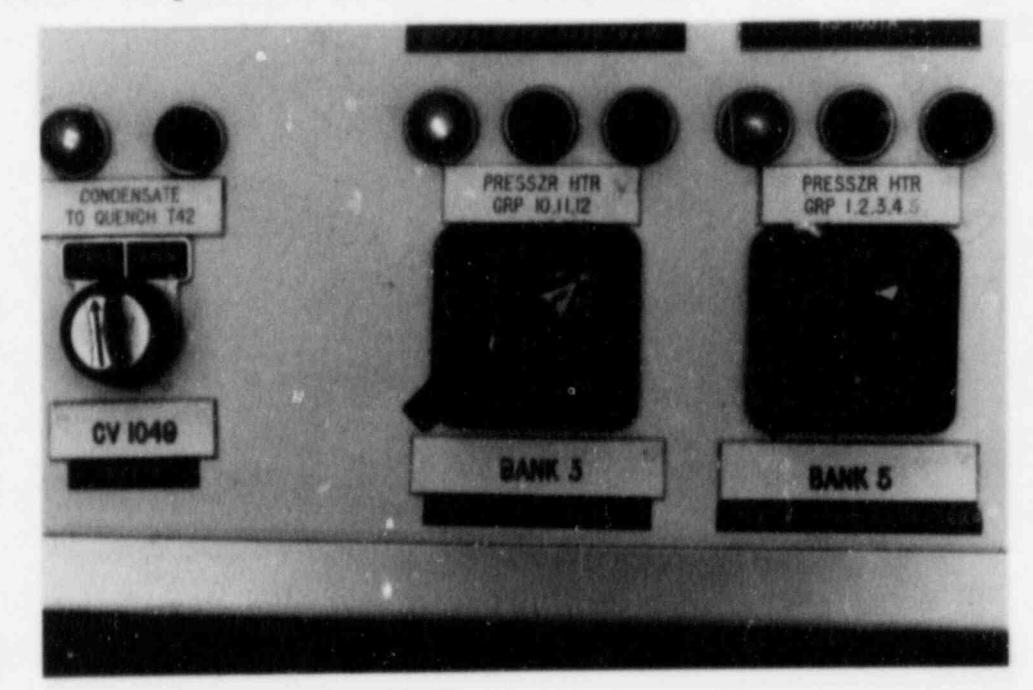
The identified J-handle controls are not operated simultaneously and are not located such that inadvertent actuation is a problem. The controls are easily accessible even though they violate the 3 inch minimum separation. Therefore, due to a lack of justification for change, no further action is planned to address this HED.

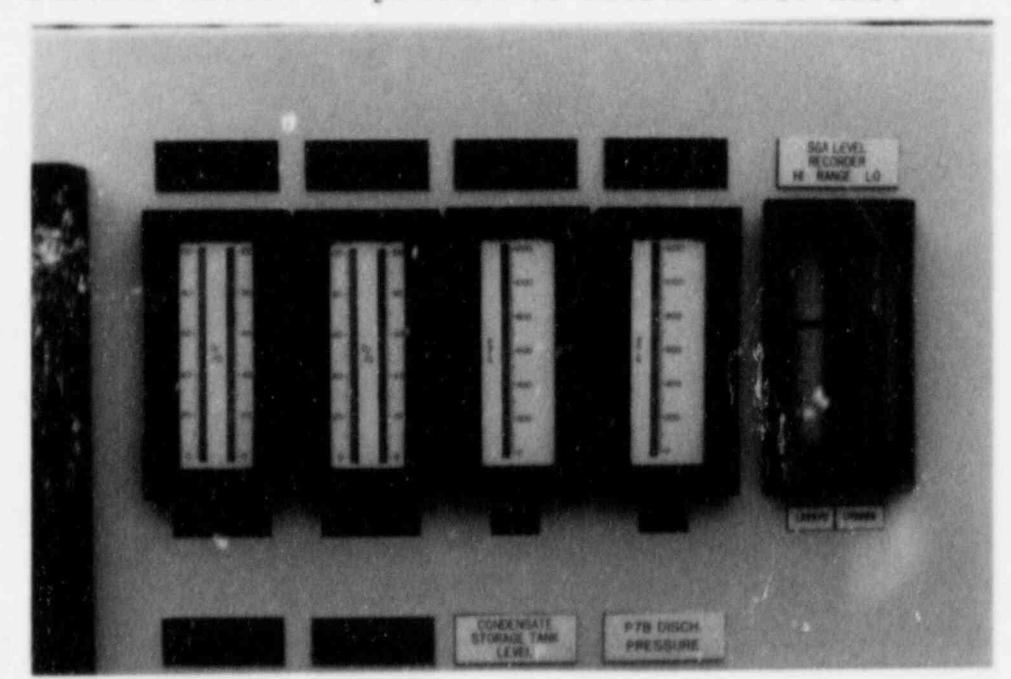
The steam generator level recorders and level meters are not used for comparison purposes. The level meters are used to get a reading of the level on an instantaneous basis while the recorders are used to get a trend of the level changes over a period of time. Therefore, due to a lack of justification for change, no further action is planned to address this HED.

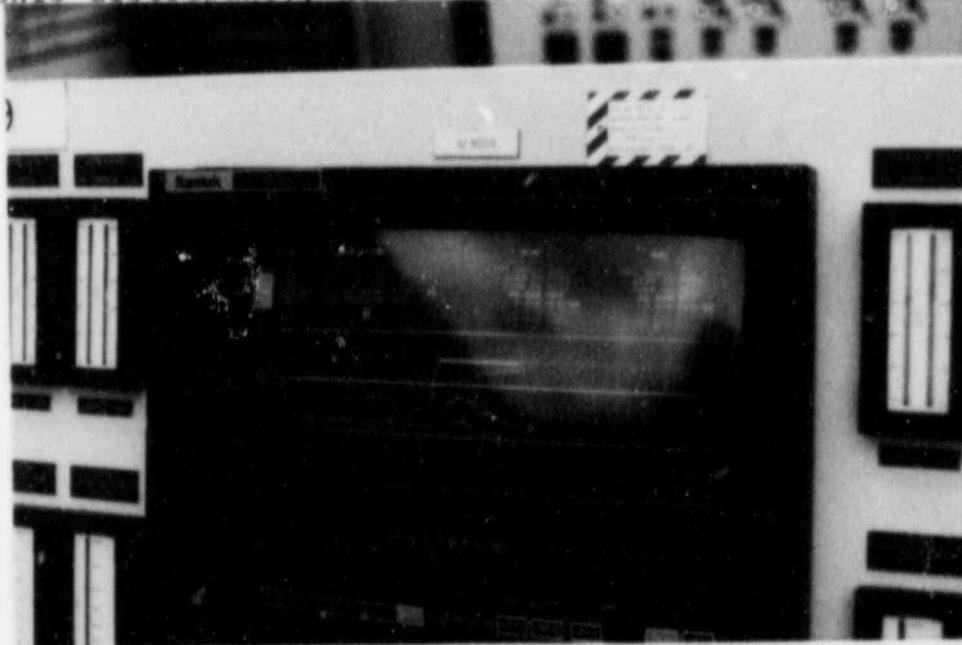
The original plant design had the "A" emergency feedwater pump supplying the "B" steam generator and the "B" emergency feedwater pump supplying the "A" steam generator. Due to this arrangement the steam generator components were arranged in reverse alphabetical order to correspond to the plant layout. Since that time, the emergency feedwater system has been redesigned and the emergency feedwater pumps supply both steam generators. Therefore, the reason for the reverse orientation of the steam generator components on the C-09 has been eliminated. However, due to the fact that the instrumentation is consistently arranged in reverse alphabetical order for the steam generators and due to the major panel rearrangement necessary to correct this discrepancy, no further action is

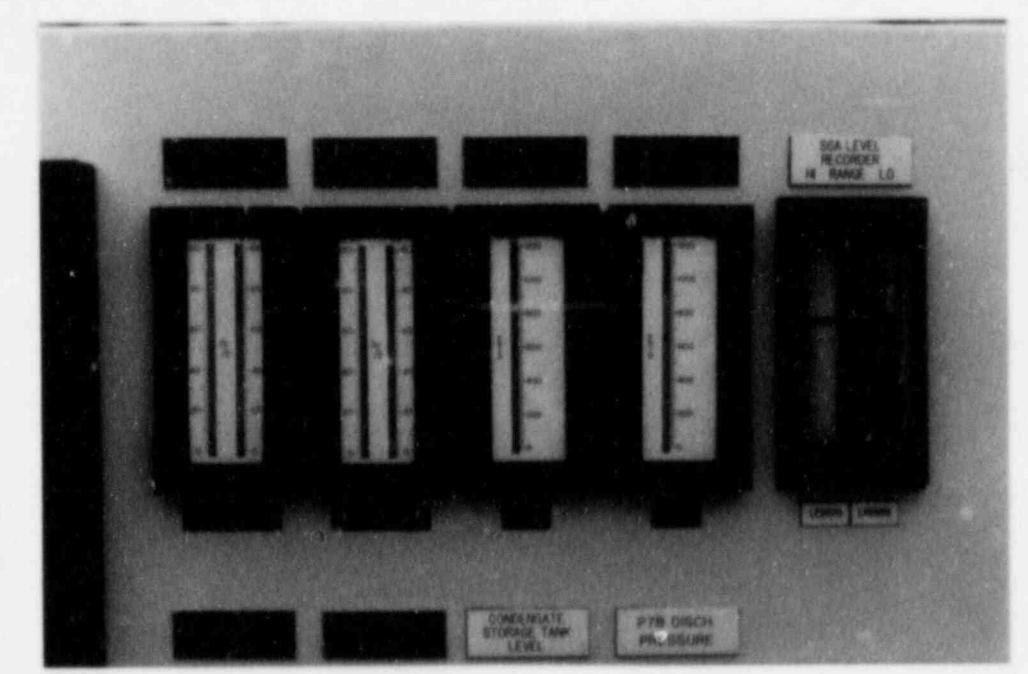
The use of mirror imaging on panel C-09 was done to make the comparison of indicators easier when standing in front of the SPDS display. The operator uses the SPDS display as a center point and reads outward to his left and right to get information on the steam generators and EFW pumps. This arrangement is considered beneficial by the plant operators. Therefore, due to a lack of justification for change, no further action is planned to address this HED.

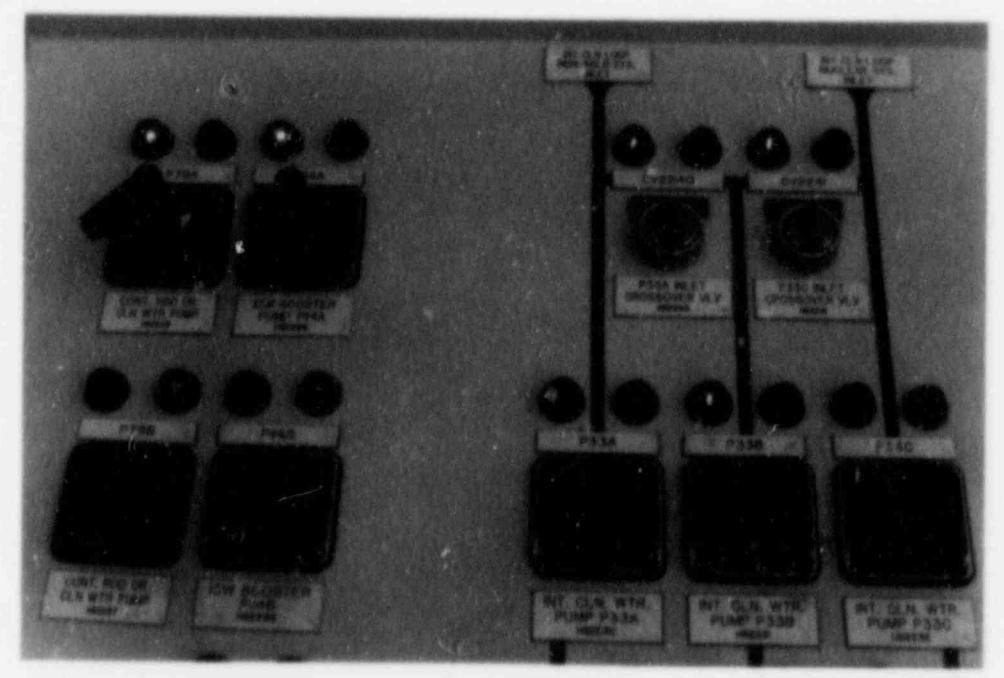
The identified J-handle controls are not operated simultaneously and do not cause operator difficulty in using them. They are arranged to facilitate mimics and to optimize use of the limited available space. Therefore, due to a lack of justification for change, no further action is planned to address this HED.

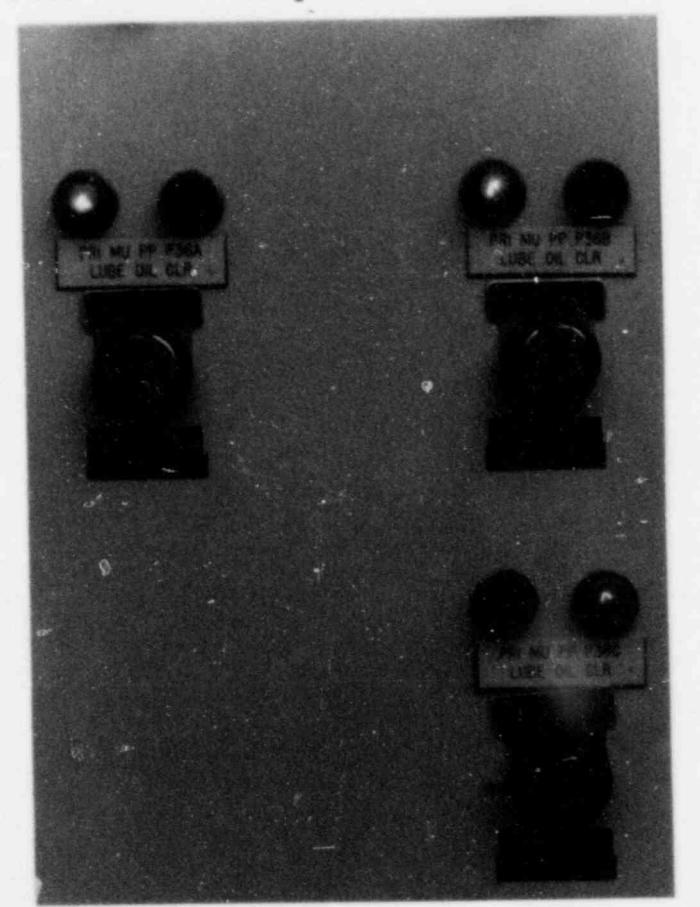
The identified components are arranged in left to right and top to bottom sequence. The arrangement does not present any difficulty for the operator to locate or actuate these controls. Therefore, due to a lack of justification for change, no further action is planned to address this HED.

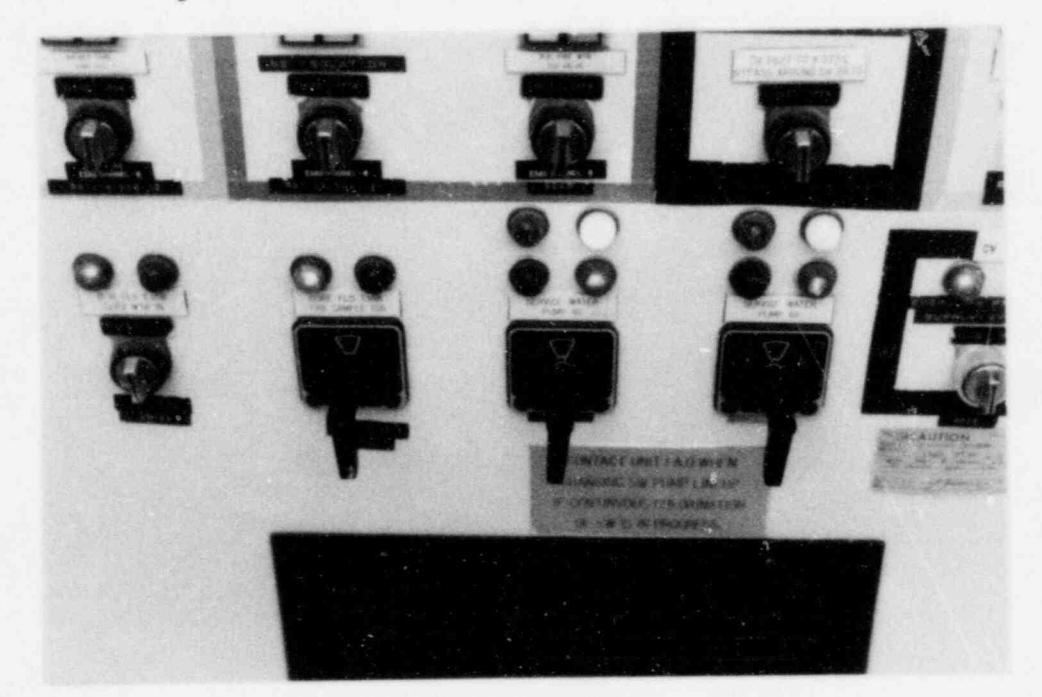
The subject service water pump controls are not used very often by the plant operators. Therefore, being located low on the panel does not create undue difficulty for actuation and no further action is planned to address this HED.

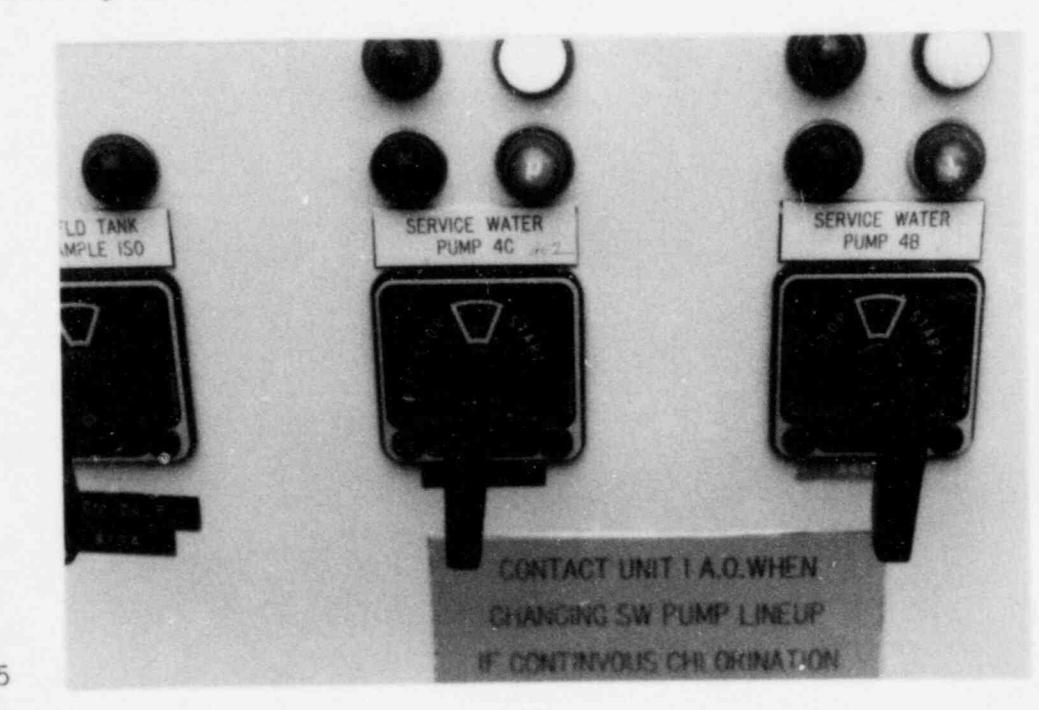
The "B" pumps for the service water and HPI system are the "swing" pumps and are consistently located to the right of the "dedicated" pump controls. Therefore, for these pumps, the existing arrangement is logical to the plant operators. The HPI block valve controls, however, will be evaluated for possible arrangement.

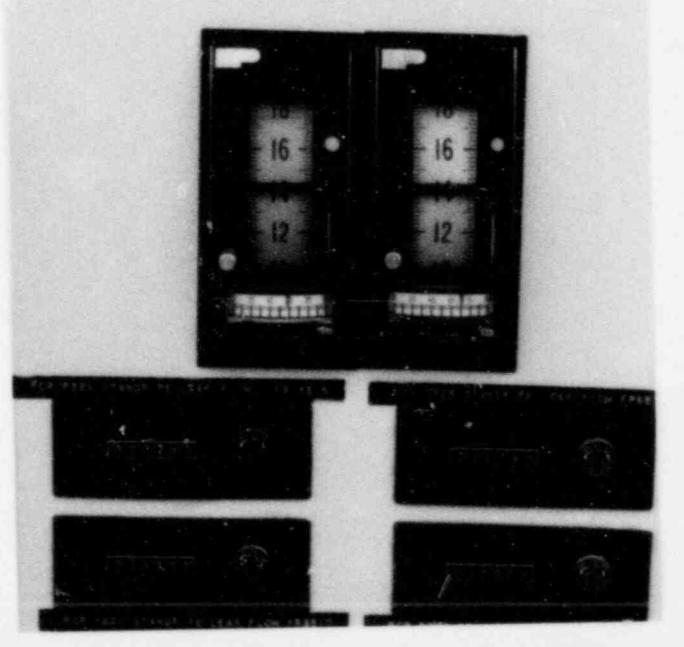
R.C. leak pump and R.C. leak pump alternator controls are separated from RCP instrumentation and located within S.G./FW instrumentation on panel C-13.

The identified components are not associated with the ICS section of the panel. However, the components will be evaluated for possible relocation to Panel C-12 from Panel C-13.

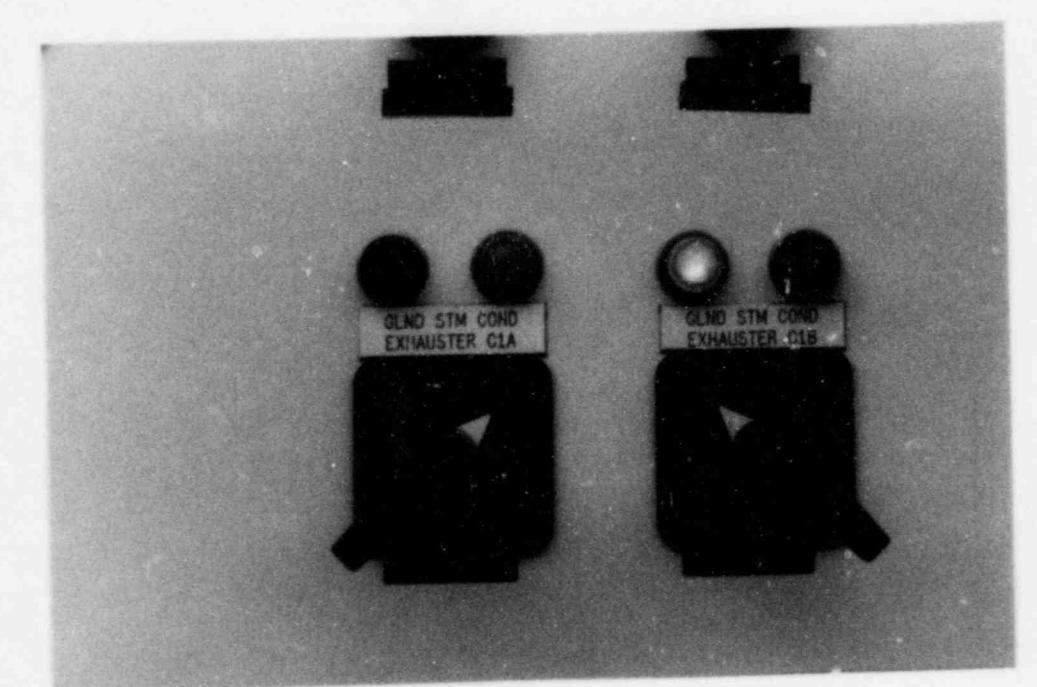
Water box vacuum pump and gland steam condenser exhauster controls violate minimum separation distance and are not spring return. May cause interference.

The identified J-handle controls are not operated simultaneously and do not cause operator difficulty during operation. Therefore, due to a lack of justification for change, no further action is planned to address this HED.

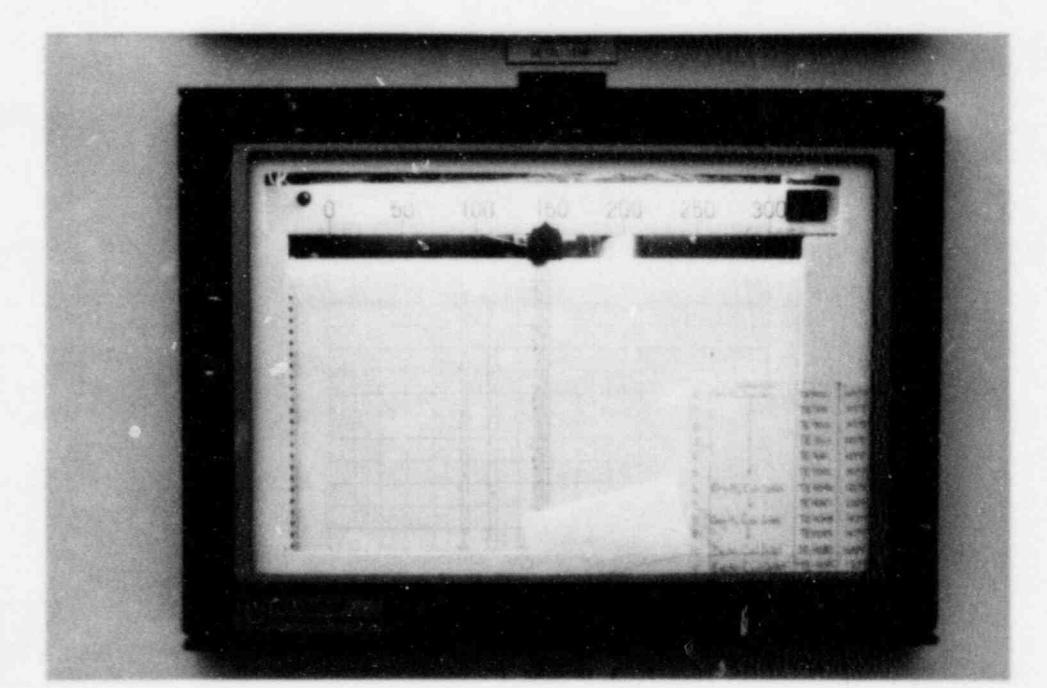
The identified recorder is not required to be visible from panel C-Ol since the recorded parameters are primarily associated with controls on C-19. Furthermore, the recorder is used for trending of data that is not needed as immediate feedback for operation of controls. Therefore, due to the limited space available on the control panels and the lack of need for immediate feedback from this recorder, the present location is appropriate. No further action is planned to address this HED.

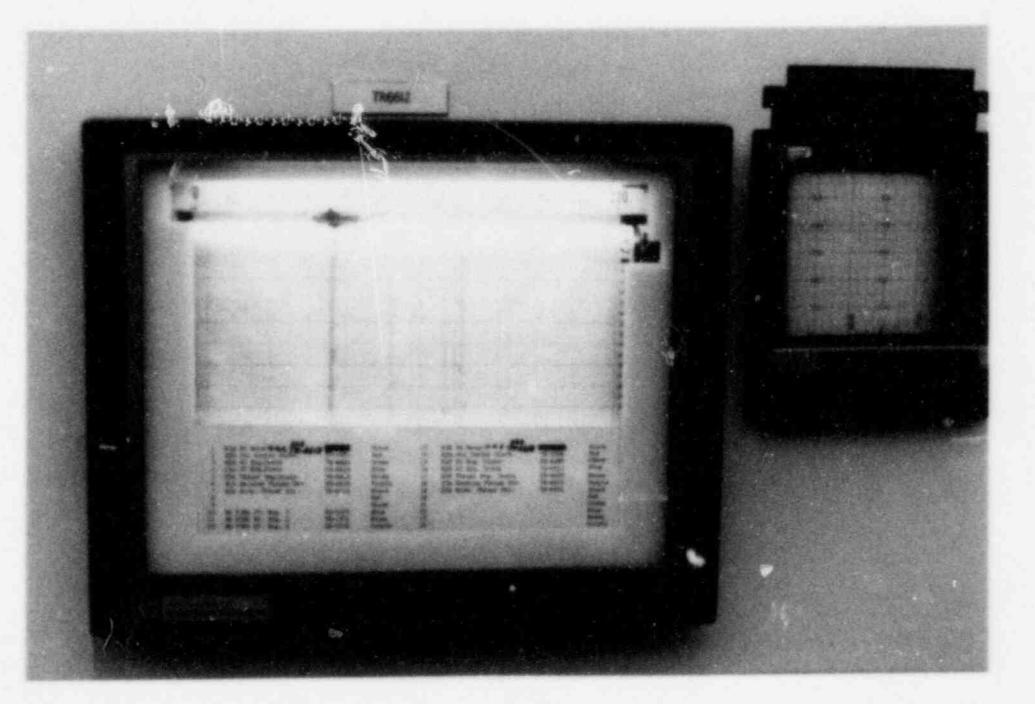
The identified recorders are not required to be visible from panel C-02 since the operation of controls on C-02 do not rely on feedback from these recorders. The recorder TR-6612 is located appropriately for the intended use. The recorder TR-6613 is not used by the plant operators and is to be evaluated for deletion per HED No.: QS:A4.9-1.064. Therefore, due to a lack of justification for change, no further action is planned to address this HED.

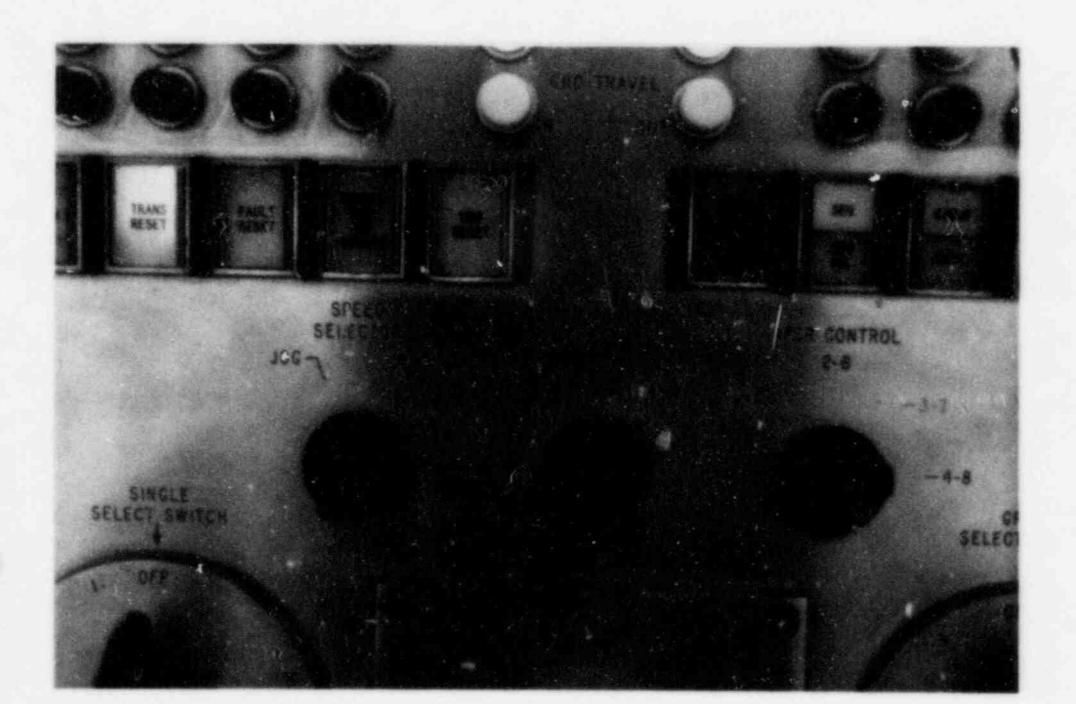
The identified control is not used routinely by the plant operators in conjuction with the group average indication meters. The back panel rod position is the source of rod position information relied upon by the operators which is readily visible and the association is clear through operator training. Therefore, due to a lack of justification for change, no further action is planned to address this HED.

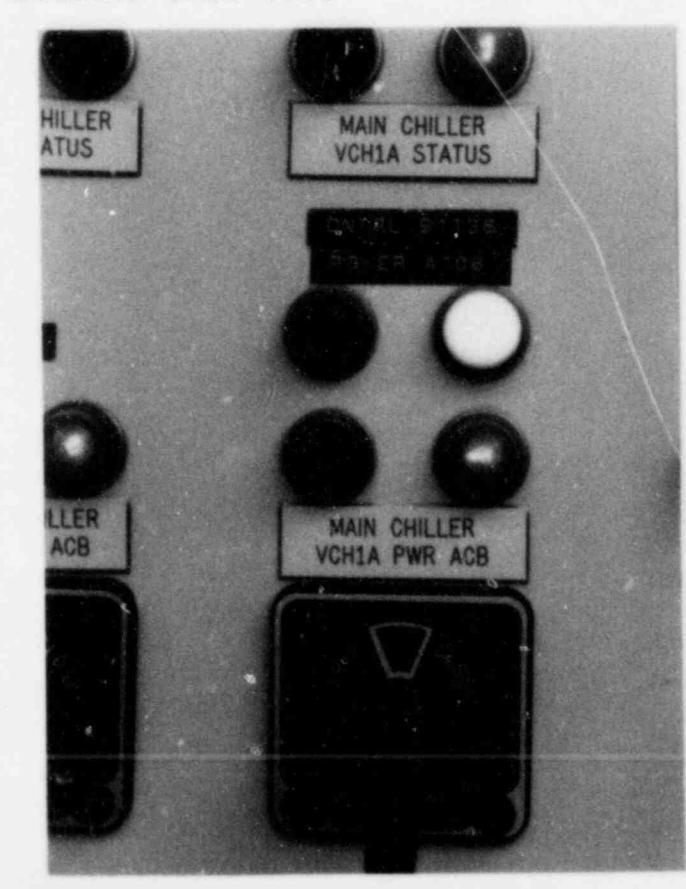
The identified lights are not labeled since they are arranged as part of the standard convention for breaker indicators such that operators know what they mean. It would not add to the meaning of the light to label them since their color and arrangement meets the standard convention. Therefore, no further action is planned to address this HED.

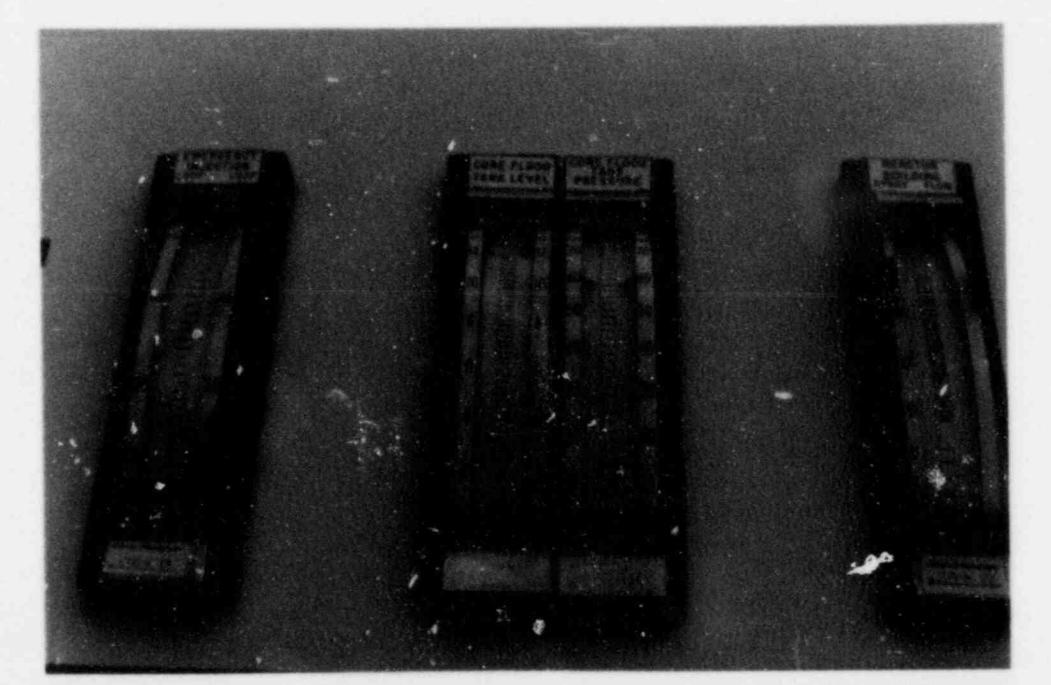
Top row of meters on C-16/C-18, used in control operations, is too high on panel and cause parallax problem.

The identified meters have been or will be corrected as follows:

- The emergency injection, reactor building spray flow, and decay heat removal flow meters were replaced with "sigma" type meters that are less susceptible to parallax since they have flat display faces. This design change was initiated prior to the evaluation of this HED are part of AP&L's on-going commitment to the practical application of human factors's principles. Therefore, this part of the HED has been corrected by a design change.
- The core flood tank level and pressure displays are to be evaluated for possible replacement.
- The reactor building pressure meter does not require accurate readings that would be impacted by parallax. Therefore, the existing meter is acceptable and no further action is planned to address this part of the HED. (See HED VL:1-1.005)
