Sealed Source and Device Design Safety Testing

Technical Report on the Findings of Task 4

Investigation of a Failed Brachytherapy Needle
Applicator

Prepared by
S. J. Lukezich

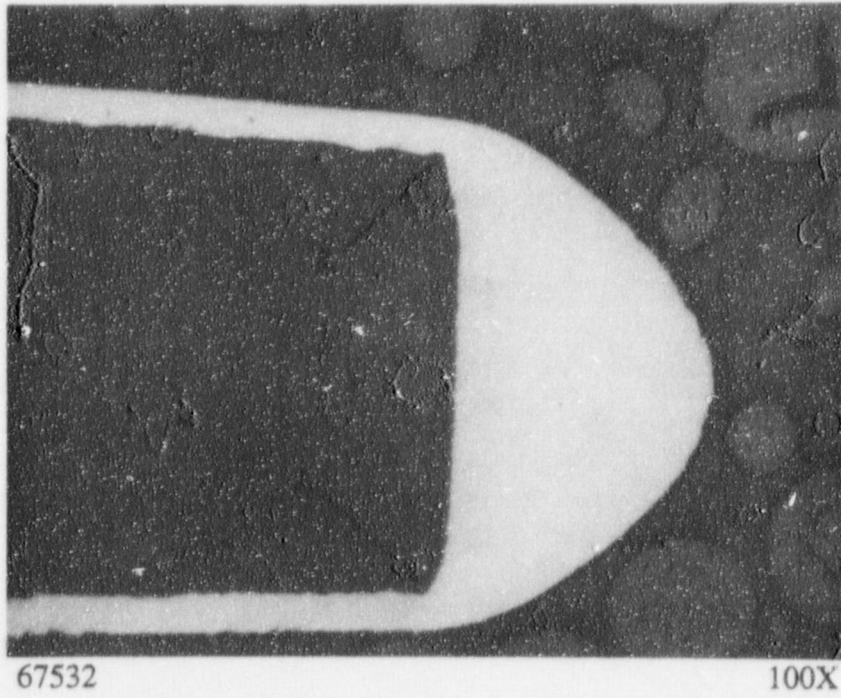
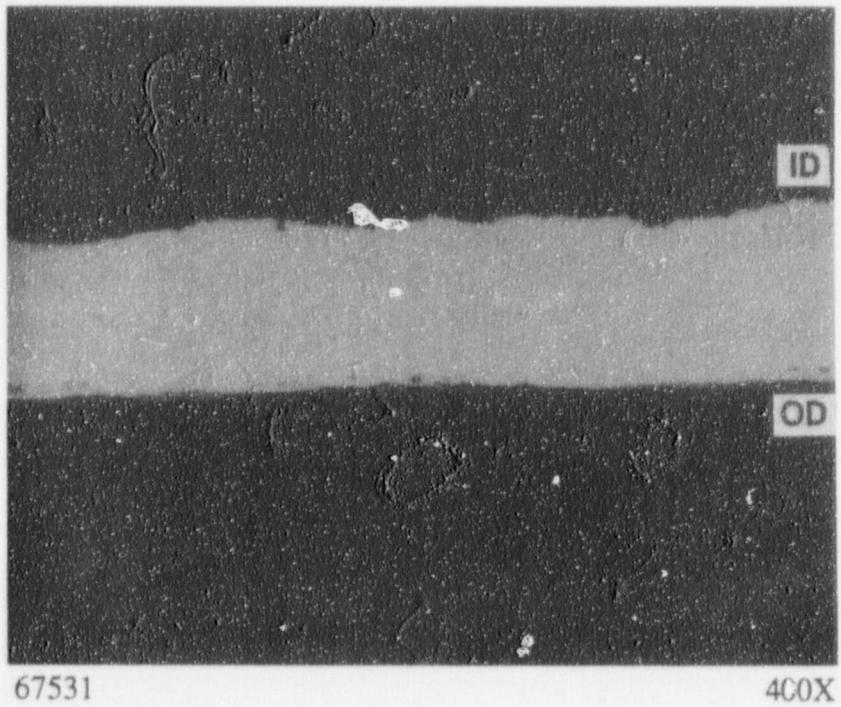
Cross sections of the tip of the Subject Applicator and the wall thickness near the tip and 4 cm from the tip of the needle are shown in Figures 2-21 and 2-22. The tip of the needle is solid, and forms a nearly square corner with the remaining tube on the ID of the needle (Location A in Figure 2-21a). The ID surfaces of the needle both near the tip and at 4 cm from the tip are rough, which is consistent with the recast appearance observed during the examination with the SEM. The roughness associated with the recast surface finish causes the wall thickness of needle to fluctuate slightly, a feature which will be discussed in more detail in Section 2.4. The OD surface of the needle, particularly at 4

Figure 2-21. Subject Applicator. Unetched cross section of a) the tip, and b) the wall of the needle adjacent to the tip.

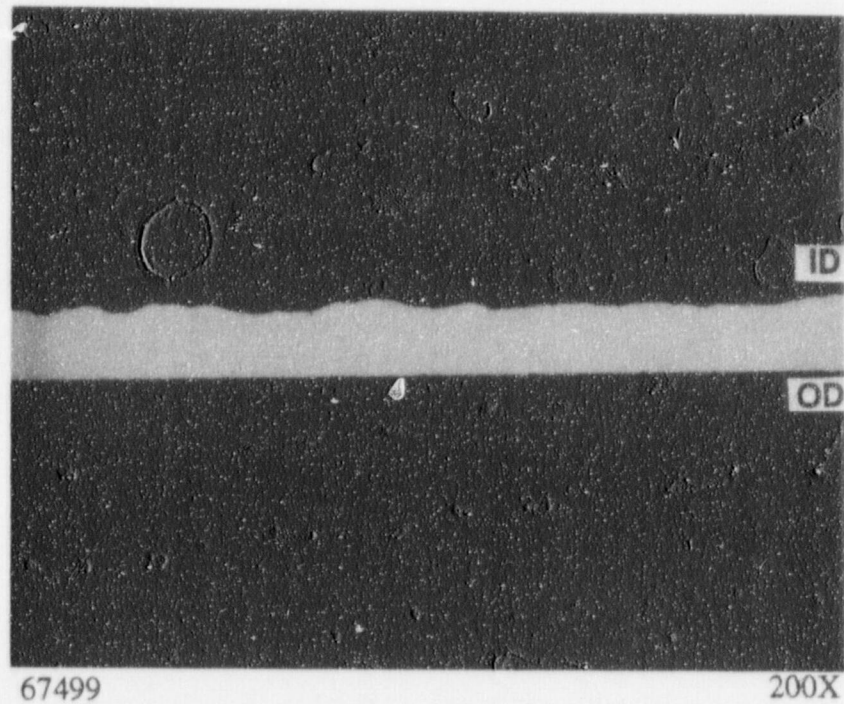
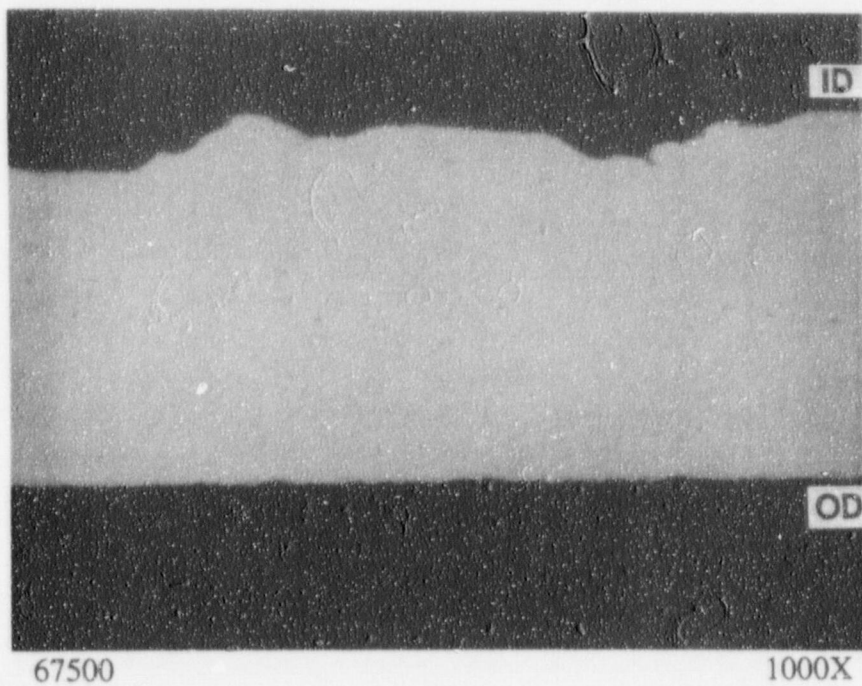
Figure 2-22. Subject Applicator. Unetched cross section of the wall of the needle at a location 4 cm from the tip.

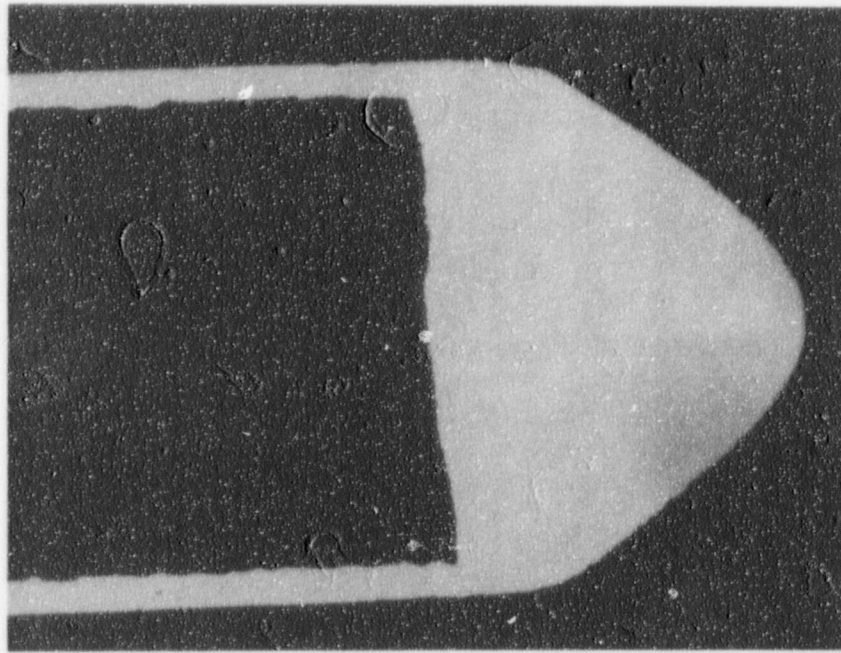
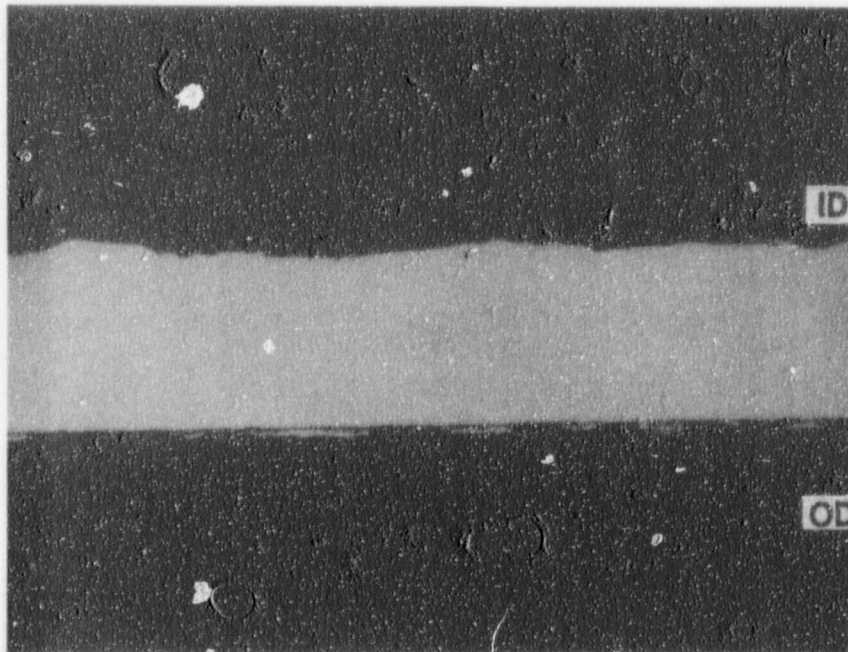
Cross sections of the tip of the Unused Applicator and the wall thickness near the tip and 4 cm from the tip of the needle are shown in Figures 2-23 and 2-24. The transition from the tip to the inside diameter of the needle is nearly a square corner, as was the case for the Subject Applicator. The ID surface is relatively rough, which is again consistent with the recast appearance described earlier. The OD surface appears relatively smooth even at the highest magnifications used, except for several isolated circumferential scratches near the tip itself. These scratches penetrate to 10% or less of the wall thickness and are not expected to impact the performance of the needle since it is expected that the tip would provide mechanical support (stiffening) if a bending load were applied to this region of the needle.

Figure 2-23. Unused Applicator. Unetched cross section of a) the tip, and b) the wall of the needle adjacent to the tip.

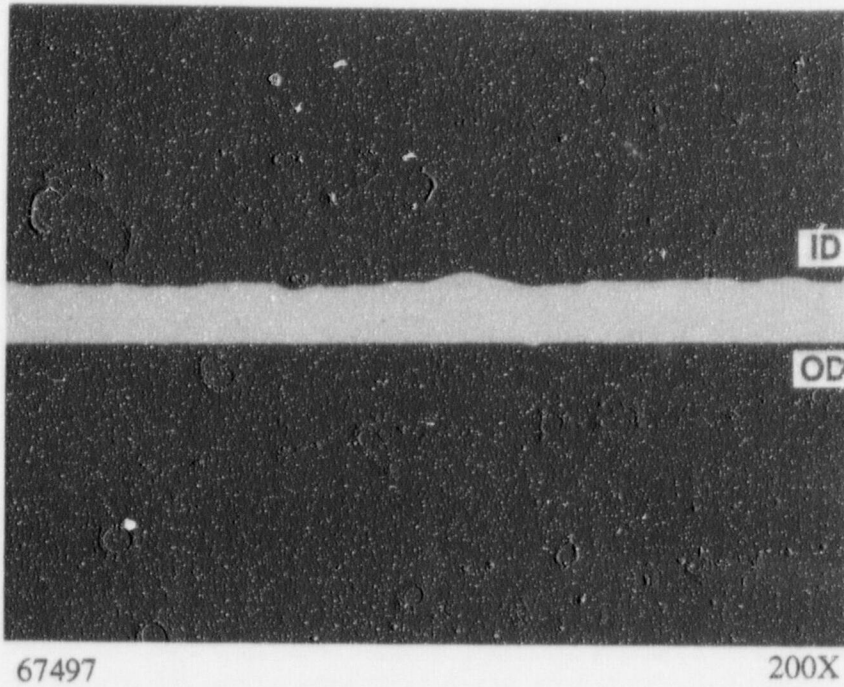
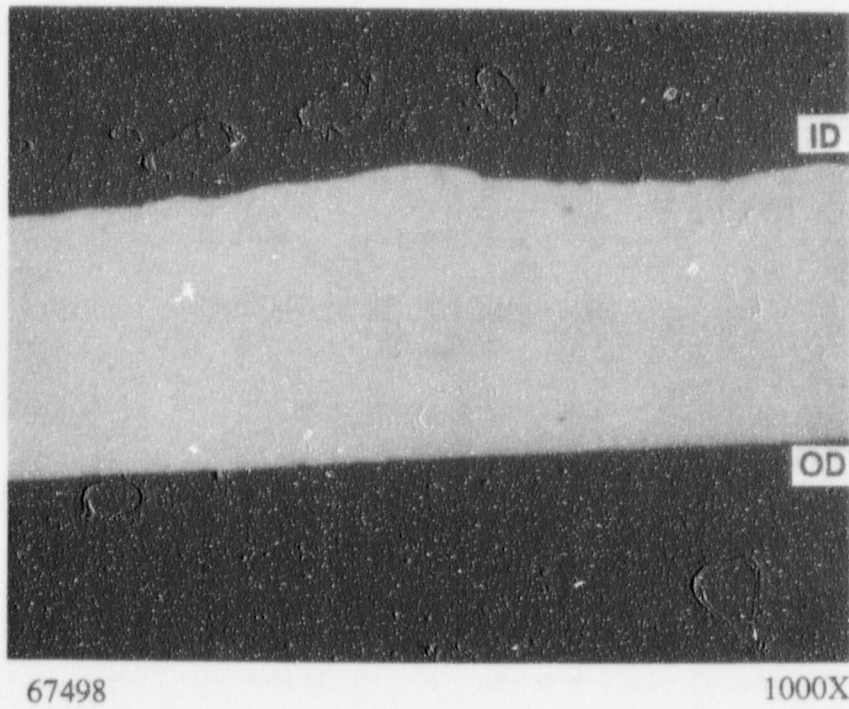
Figure 2-24. Unused Applicator. Unetched cross section of the wall of the needle at a location 4 cm from the tip.

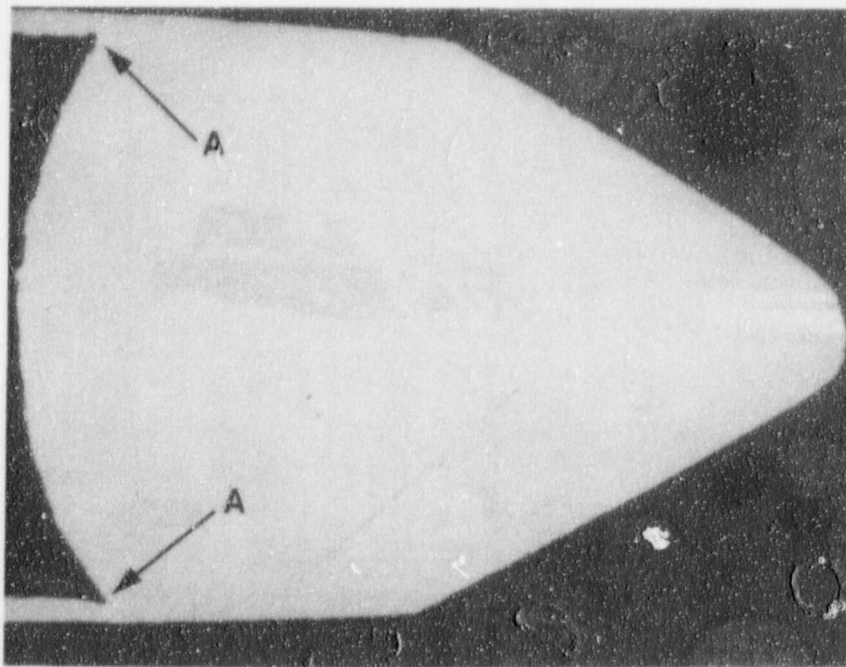
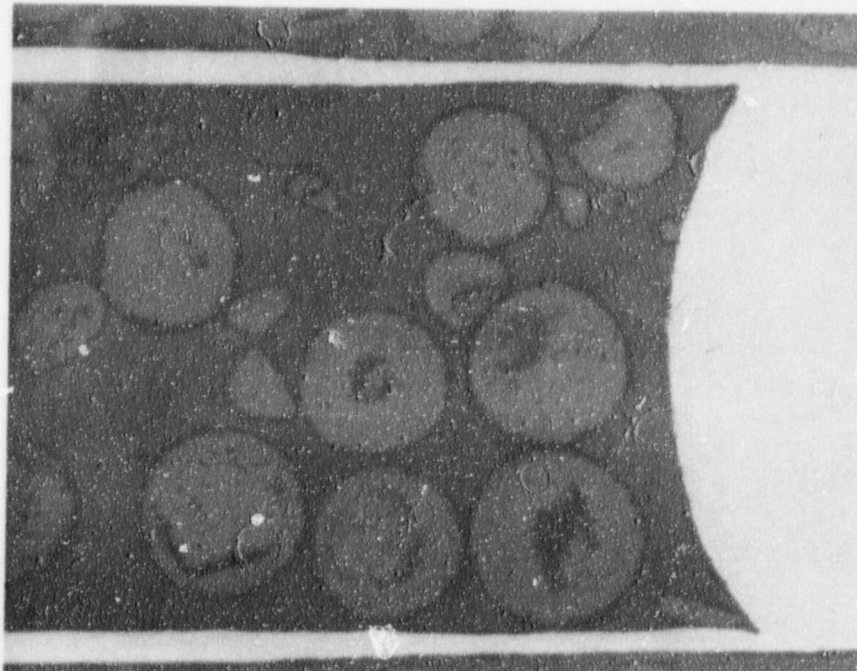
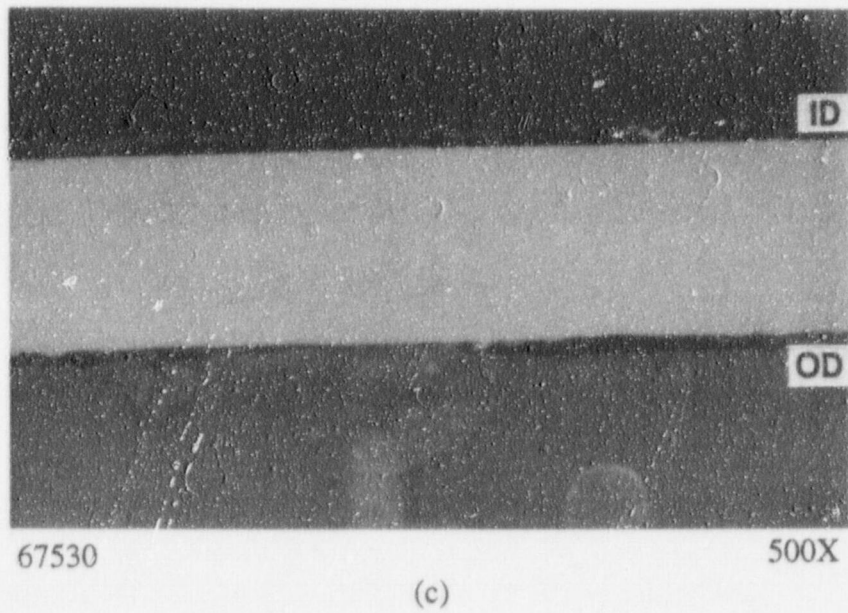
Cross sections of the tip of the Raw Applicator and the wall thickness near the tip and 4 cm from the tip of the needle are shown in Figures 2-25 and 2-26. This needle is from a different manufacturing lot than the Subject and the Unused Applicators, and numerous differences were observed. The tip of the needle is larger and more elongated, and the transition from the tip to the inside diameter of the needle forms angles of less than 90° (Location A in Figure 2-25a). Within the first 7 mm adjacent to the tip of the needle the wall thickness was less than for the rest of the needle as a result of the grinding to finish the tip (Figure 2-25b). Both the ID and OD surfaces are very smooth, resulting in a uniform wall thickness over the remaining length of the needle. No scratches or other surface distortions are present which would be expected to impact the performance of the needle even if it were subjected to high levels of bending stress.

The Raw Applicator was found to have an average wall thickness of 1.9 mils with a range of 1.8-2.2 mils. This excludes measurements from the first 7 mm immediately adjacent to the tip of the needle, where the wall thickness had been reduced to as little as 0.8 mils as a result of grinding of the OD surface during the fabrication of the tip (Figure 2-25b). The uniformity of the wall thickness over the remainder of this needle was better than for the previous two needles, with the maximum variation from the average thickness at any location being +/- 0.1 mils. This improved uniformity is a result of the significantly smoother ID surface which was produced on this needle. The potential affect of the reduced wall thickness for the short distance immediately adjacent to the tip of the needle is unknown.

Figure 2-25. Raw Applicator. Unetched cross section of (a) and (b) the tip, and (c) the wall of the needle adjacent to the tip.

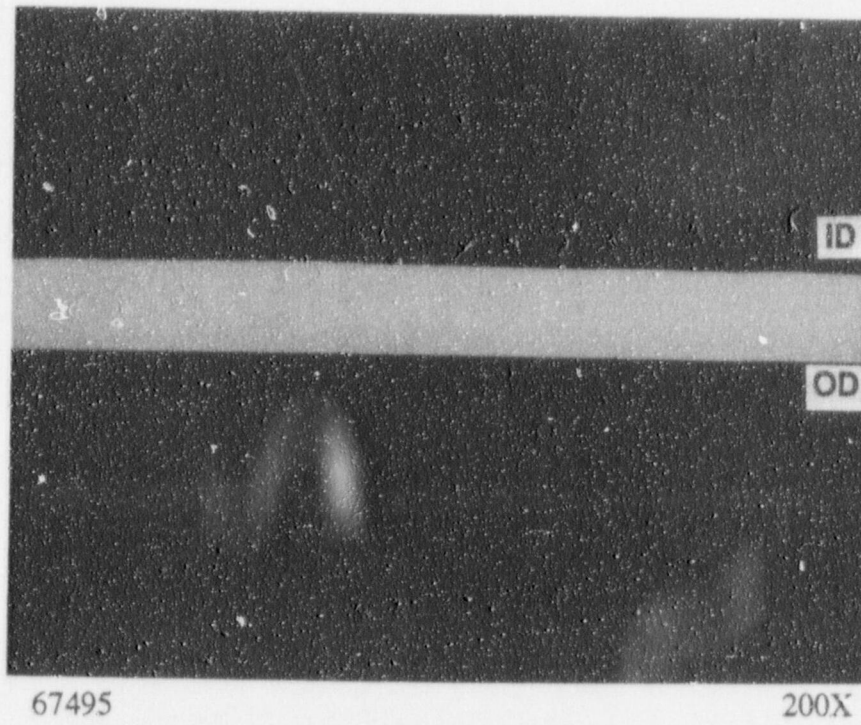
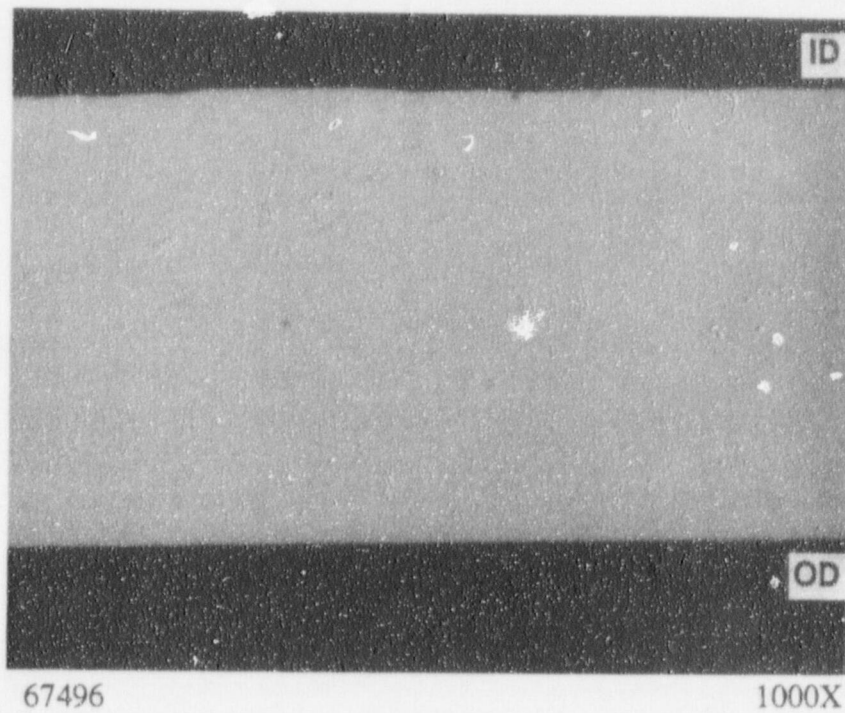
Figure 2-26. Raw Applicator. Unetched cross section of the wall of the needle at a location 4 cm from the tip.

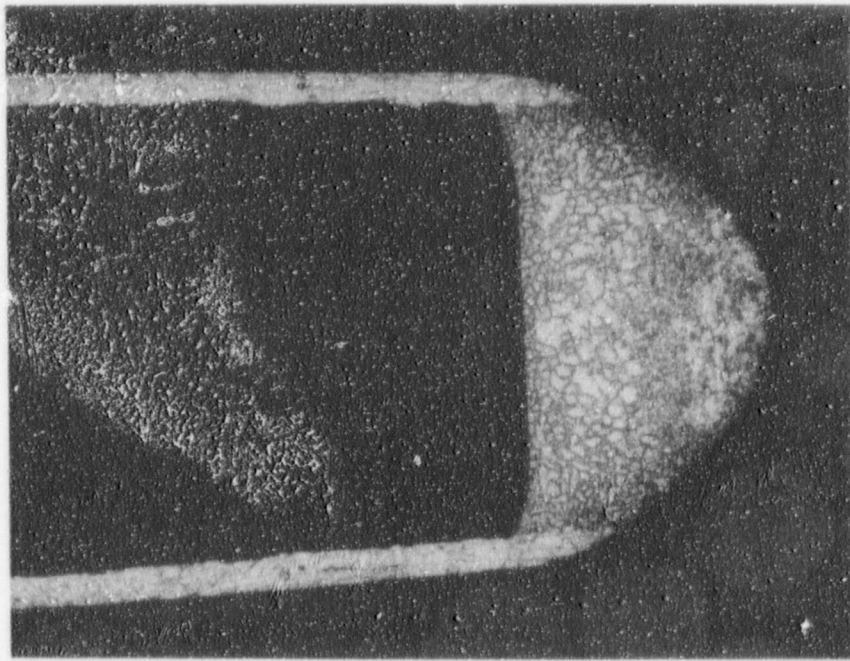
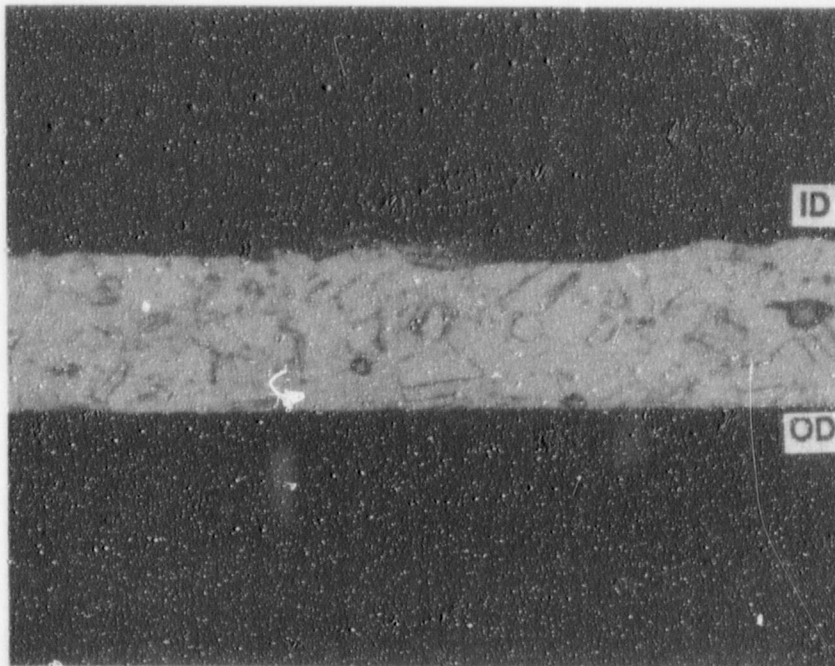
The microstructure of the stainless steel needle at the tip, and 4 cm, and 15 cm from the tip of the Subject Applicator are shown in Figures 2-27 and 2-28. The microstructure of the actual tip of the needle (Figure 2-27a) consists of a mixture of austenite and ferrite, a structure which is common for solidified weld metal in a Type 304 stainless steel. In discussions with the brachytherapy equipment manufacturer, it was learned that the end of the stainless steel needle tubing is closed and the tip formed by welding. The microstructure observed is consistent with this manufacturing process.

The microstructure of the needle immediately adjacent to the tip consists of predominantly randomly oriented polygonal grains of austenite (Figure 2-27b). This is consistent with a Type 304 stainless steel in an annealed condition. The region of predominantly polygonal grain structure extends for a distance of approximately 2 mm from the tip of the needle, at which point a transition to a much finer structure is observed. Although individual grains are not discernible in the fine structure at the magnifications available on the optical microscope, there is a distinct orientation to the microstructure running parallel or nearly parallel to the longitudinal axis of the needle. This structure is typical of a heavily cold worked material, and is consistent with a cold drawn, thin walled tube such as a needle. This microstructure extends for the remaining length of the needle, and typical examples as observed in the specimens from locations 4 cm and 15 cm from the tip of the needle are shown in Figure 2-28.

Figure 2-27. Subject Applicator. Cross section of (a) the tip, and (b) the wall of the needle adjacent to the tip. Etchant: Oxalic Acid

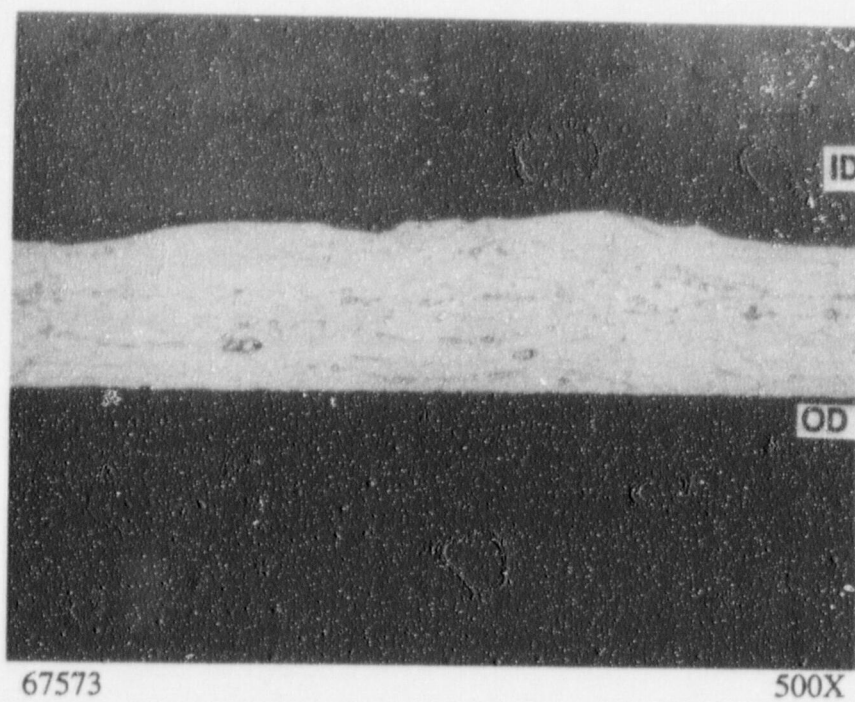
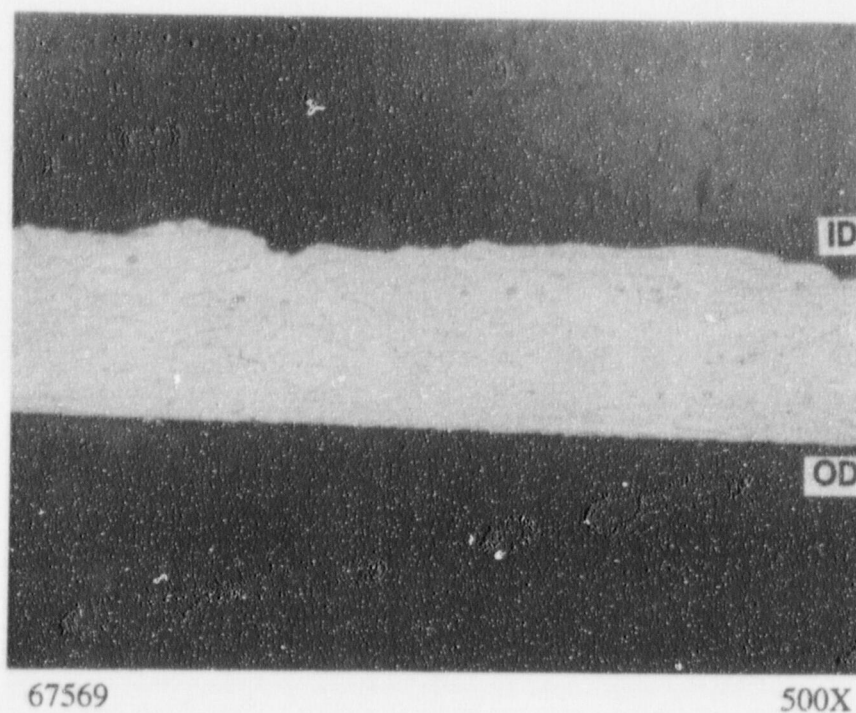
Figure 2-28. Subject Applicator. Cross section of the wall of the needle at a location (a) 4 cm, and (b) 15 cm from the tip. Etchant: Oxalic Acid.

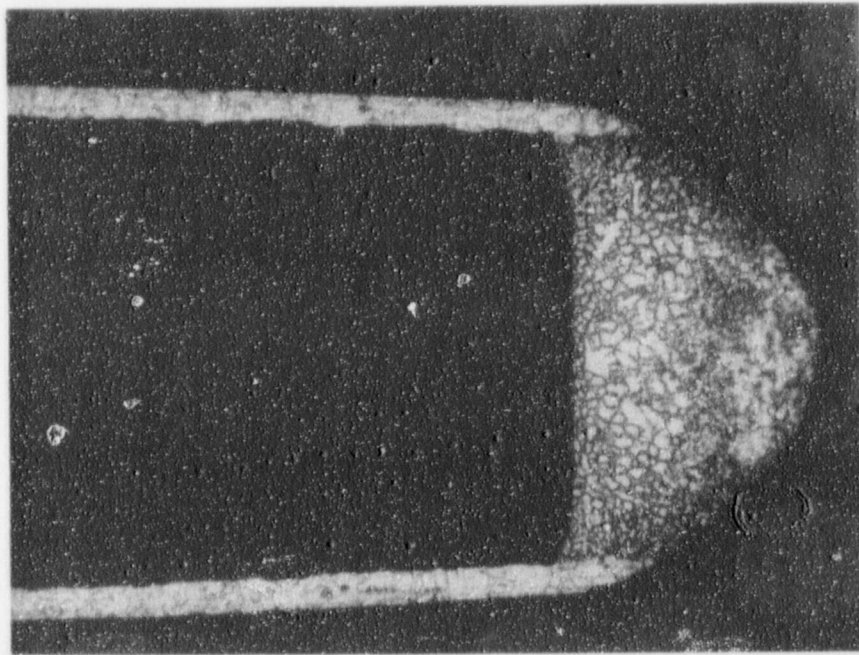
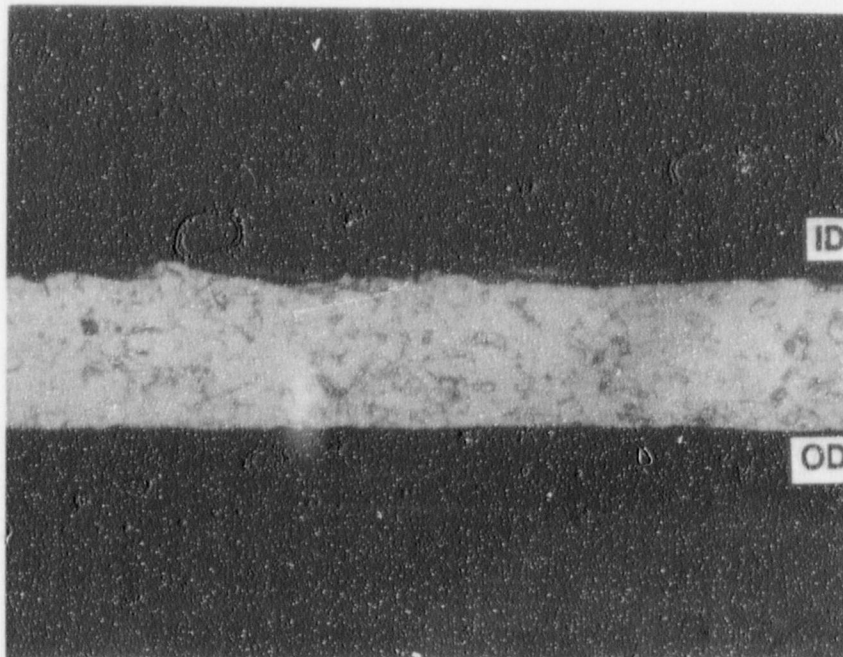
The microstructure of the stainless steel needle at the tip, 4 cm, and 15 cm from the tip of the Unused Applicator are shown in Figures 2-29 and 2-30. The microstructures and the distribution of the microstructures throughout this needle are the same as was described for the Subject Applicator. The tip of the needle consists of a mixture of austenite and ferrite and there is a recrystallized region which again extends for approximately 2 mm from the tip of the needle. The remainder of the needle consists of a microstructure of heavily cold worked stainless steel. This pattern of microstructures is consistent with a cold drawn tube which has been closed off and a tip formed on the end by welding. Again, any post weld stress relief which may have been applied was of limited extent.

Figure 2-29. Unused Applicator. Cross section of (a) the tip, and (b) the wall of the needle adjacent to the tip. Etchant: Oxalic Acid.

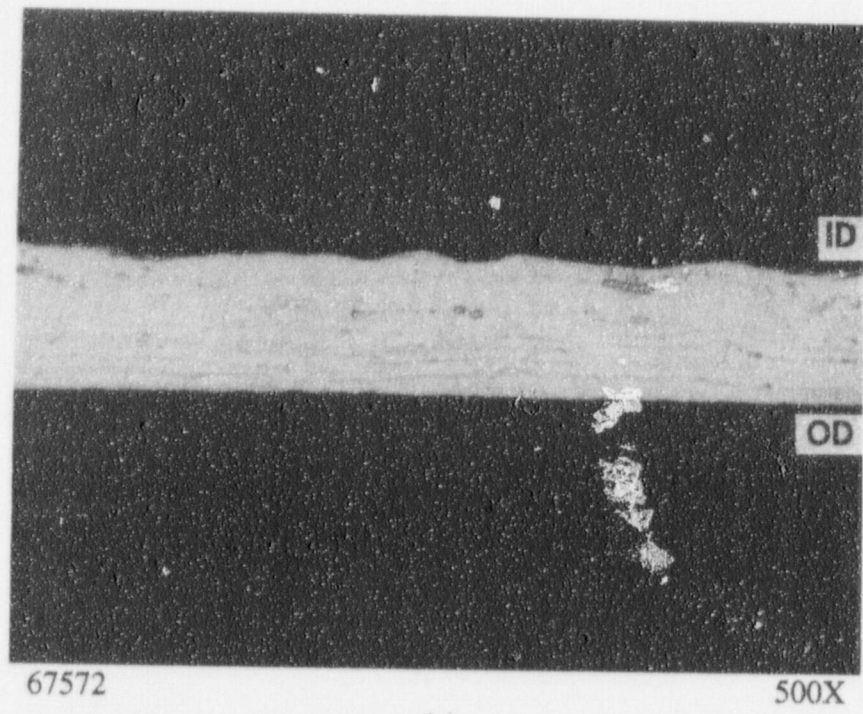
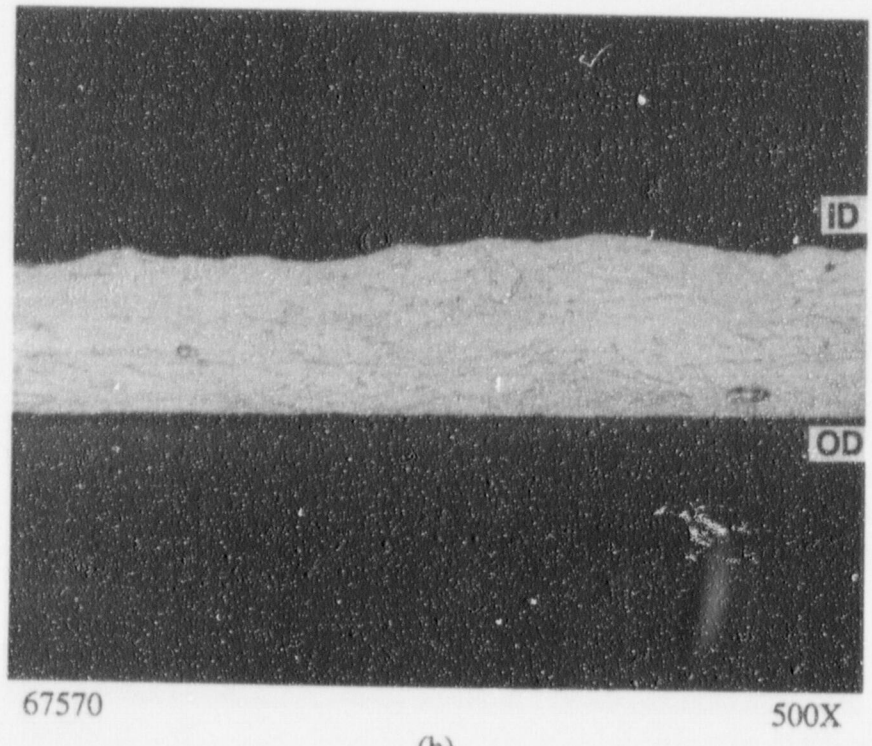
Figure 2-30. Unused Applicator. Cross section of the wall of the needle at a location (a) 4 cm, and (b) 15 cm from the tip. Etchant: Oxalic Acid.

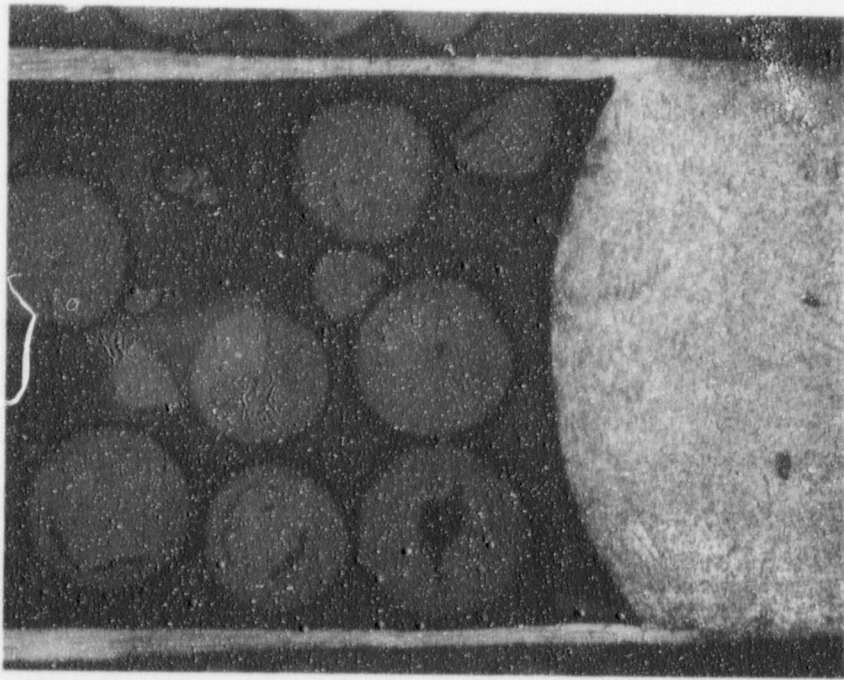
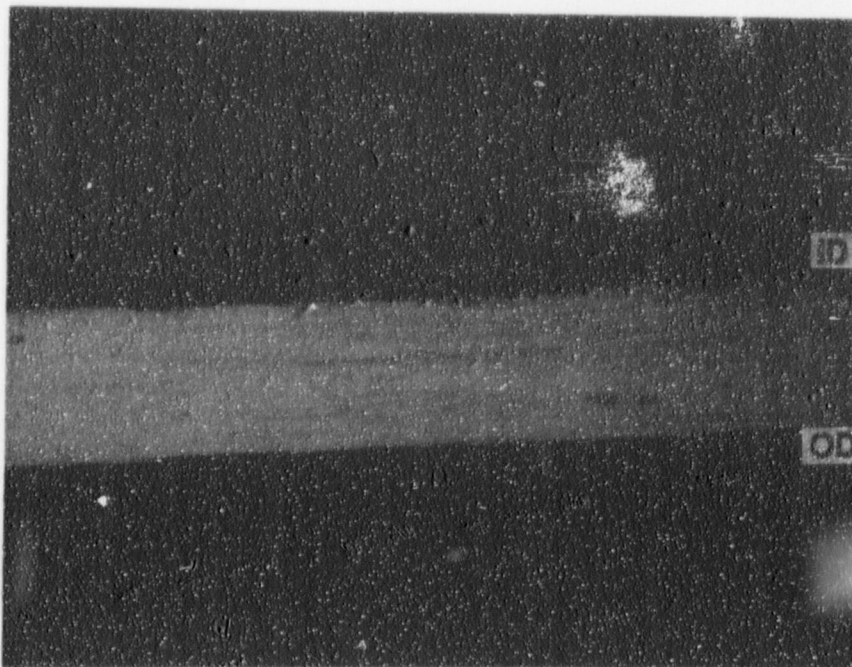
The microstructure of the stainless steel needle at the tip, 4 cm, and 15 cm from the tip of the Raw Applicator are shown in Figures 2-31 and 2-32. The microstructures and the distribution of the microstructures throughout this needle are somewhat different than had been observed in the Subject and Unused Applicators. The tip of the needle exhibits a finer mixture of austenite and ferrite and the orientation of the microstructure of the heavily cold worked tube is more consistently parallel to the longitudinal axis of the needle. The most significant difference is associated with the region of recrystallization immediately adjacent to the tip. In this needle the recrystallized zone extends for only approximately 0.25 mm down the length of the needle, and even in that region there is only partial recrystallization. This limited extent of recrystallization indicates that less heat was put into this part during welding, and it is unlikely that any post weld stress relief was utilized during the manufacture of this needle.

Figure 2-31. Raw Applicator. Cross section of (a) the tip, and (b) the wall of the needle adjacent to the tip. Etchant: Oxalic Acid.
