U.S. NUCLEAR REGULATORY COMMISSION

Report No: 50-461/97006 (DRP)

Facility: Clinton Power Station

Dates: February 15 - March 29, 1997

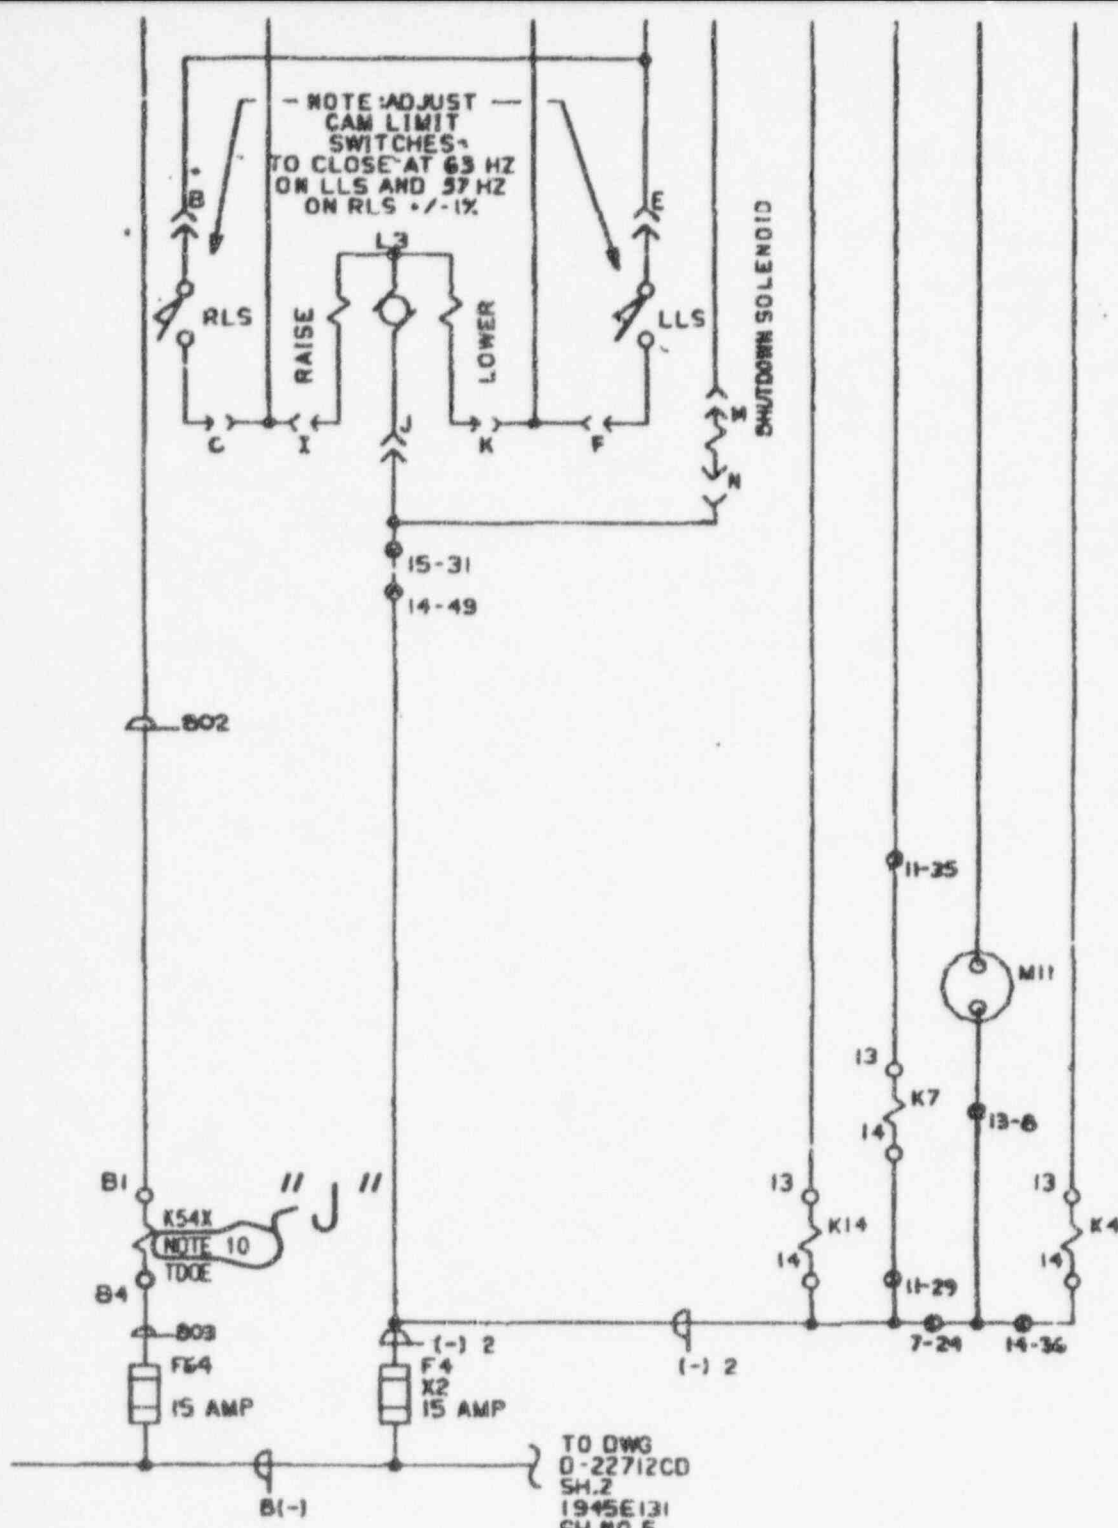
1. WIRING TO BE TYPE SIS 14 AWG MINIMUM.
2. ALL WIRING TO BE MARKED AT TERMINATIONS.
3. DASHED LINES INDICATE WIRING BY OTHERS.
4. ● INDICATES TERMINAL POINT
5. * ASTERISK INDICATES CUSTOMER FURNISHED COMPONENTS. E02.
6. → ARROW TOWARD COIL OR CONTACT INDICATES TIMED TRANSFER ON ENERGIZATION
7. ← ARROW AWAY FROM COIL OR CONTACT INDICATES TIMED TRANSFER ON DE-ENERGIZATION
8. FOR K15 DEVELOPMENT, REFER TO SH.5 OF THIS DRAWING.
9. K18 RELAY CONTACT CHANGED IN FIELD TO N/O (5 & 6).
