Accident Sequence Precursor Program Event Analysis

LER No:456/88-022Event Description:Loss of offsite power for approximately 2 hDate of Event:October 16, 1988Plant:Braidwood 1

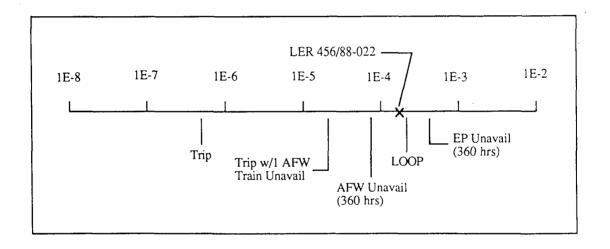
A 2-h loss of offsite power occurred at Braidwood 1. Emergency power was provided as designed, and all other plant responses were as expected. The core damage probability associated with the event is estimated to be 1.8×10^{-4} . The relative significance of this event compared with other potential events at Braidwood 1 is shown below.
