Accident Sequence Precursor Program Event Analysis

LER No.: 323/88-008
 Event Description: Loss of offsite power with safety injection
 Date of Event: July 17, 1988
 Plant: Diablo Canyon Unit 2

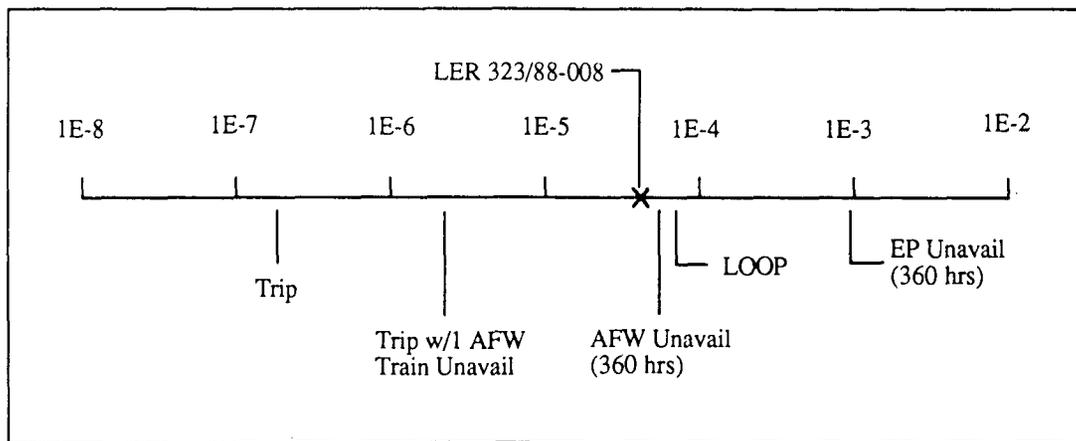
While at 100% power, an electrical connection on a reactor coolant pump feeder line arced to ground causing ground alarms to the pump and various other 12-kV electrical equipment. An operator attempted to isolate the ground by transferring one of the 12-kV buses from the auxiliary transformer to the startup transformer; however, the event was aggravated when the startup transformer caught on fire due to an unrelated failure. On subsequent loss of offsite power, all safety-related systems responded as designed. The conditional core damage probability estimated for the event is 4.1×10^{-5} . The relative significance of the event compared with other potential transients at Diablo Canyon is shown below.
