U.S. NUCLEAR REGULATORY COMMISSION

Report No: 50-282/97005, 50-306/97005, 72-10/97005

Facility: Prairie Island Nuclear Generating Plant

Dates: February 21 - April 4, 1997

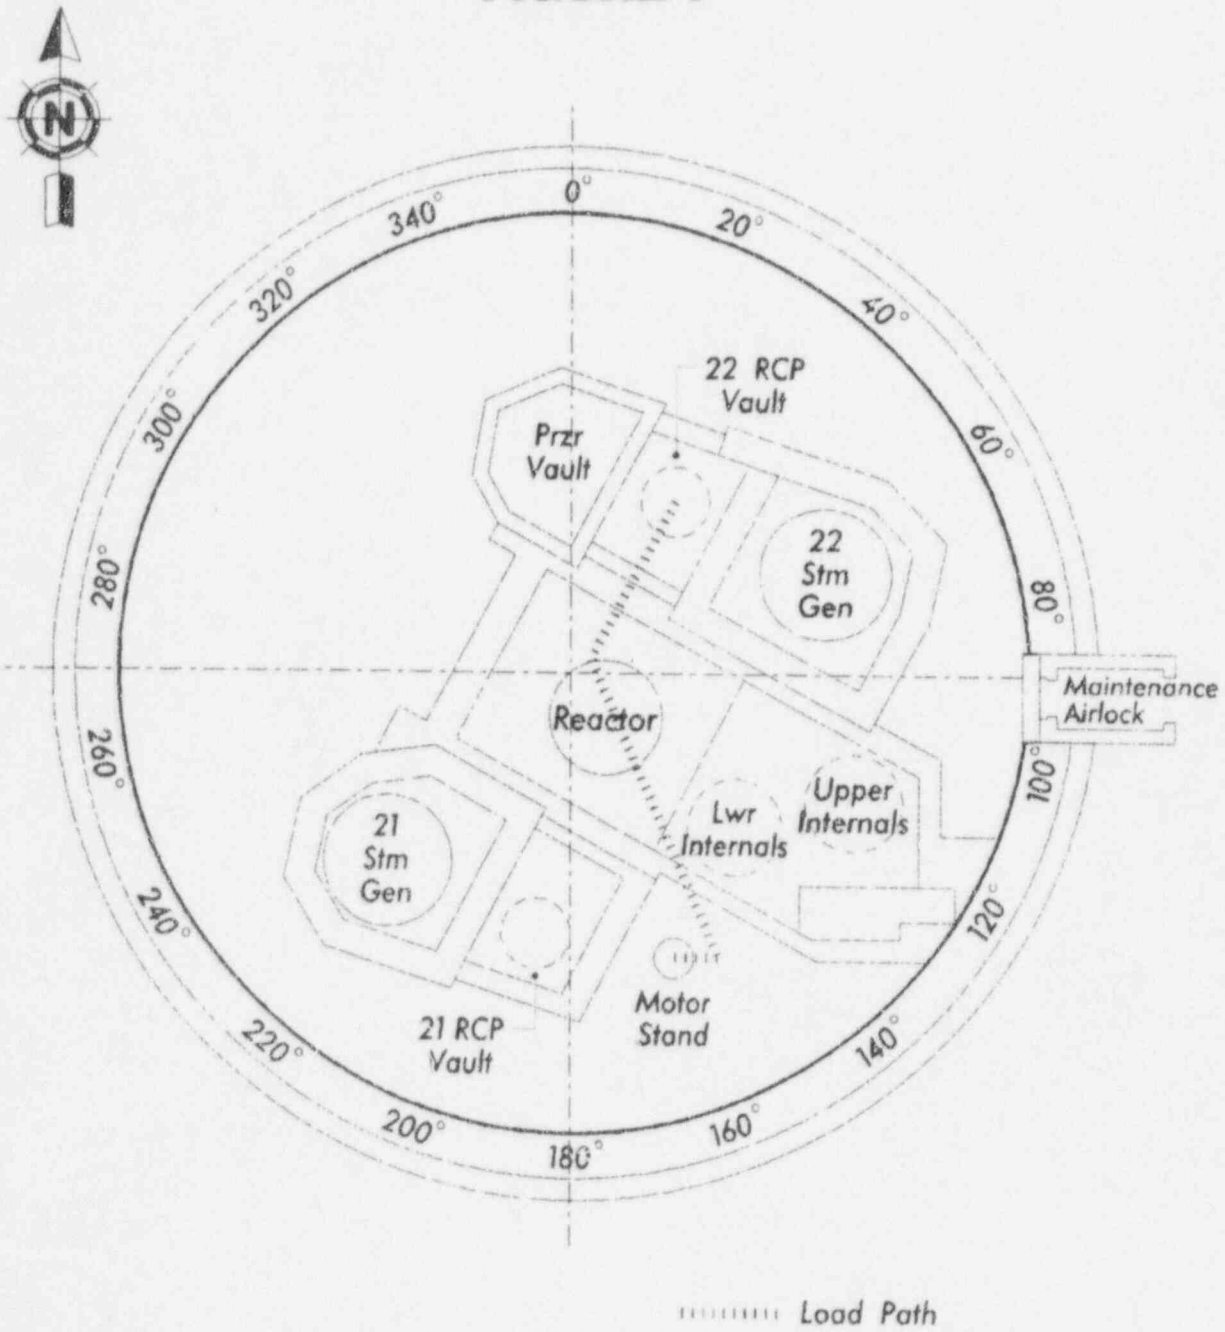
FIGURE 1

- *22 RCP Motor Rotor lifted using polar crane (See Figure 1.)*
- *Reactor Vessel head off*
- *Refueling Cavity flooded*
- *Both doors of Containment Maintenance and Personnel Airlocks open*
- *Inservice Purge Ventilation System*
