NUREG/CR-0309
ORNL/NUREG-38

**Test of 6-in.-thick Pressure Vessels.
Series 3: Intermediate Test
Vessel V-7B**

OAK RIDGE NATIONAL LABORATORY
OPERATED BY UNION CARBIDE CORPORATION - FOR THE DEPARTMENT OF ENERGY

Manuscript Completed – October 6, 1978

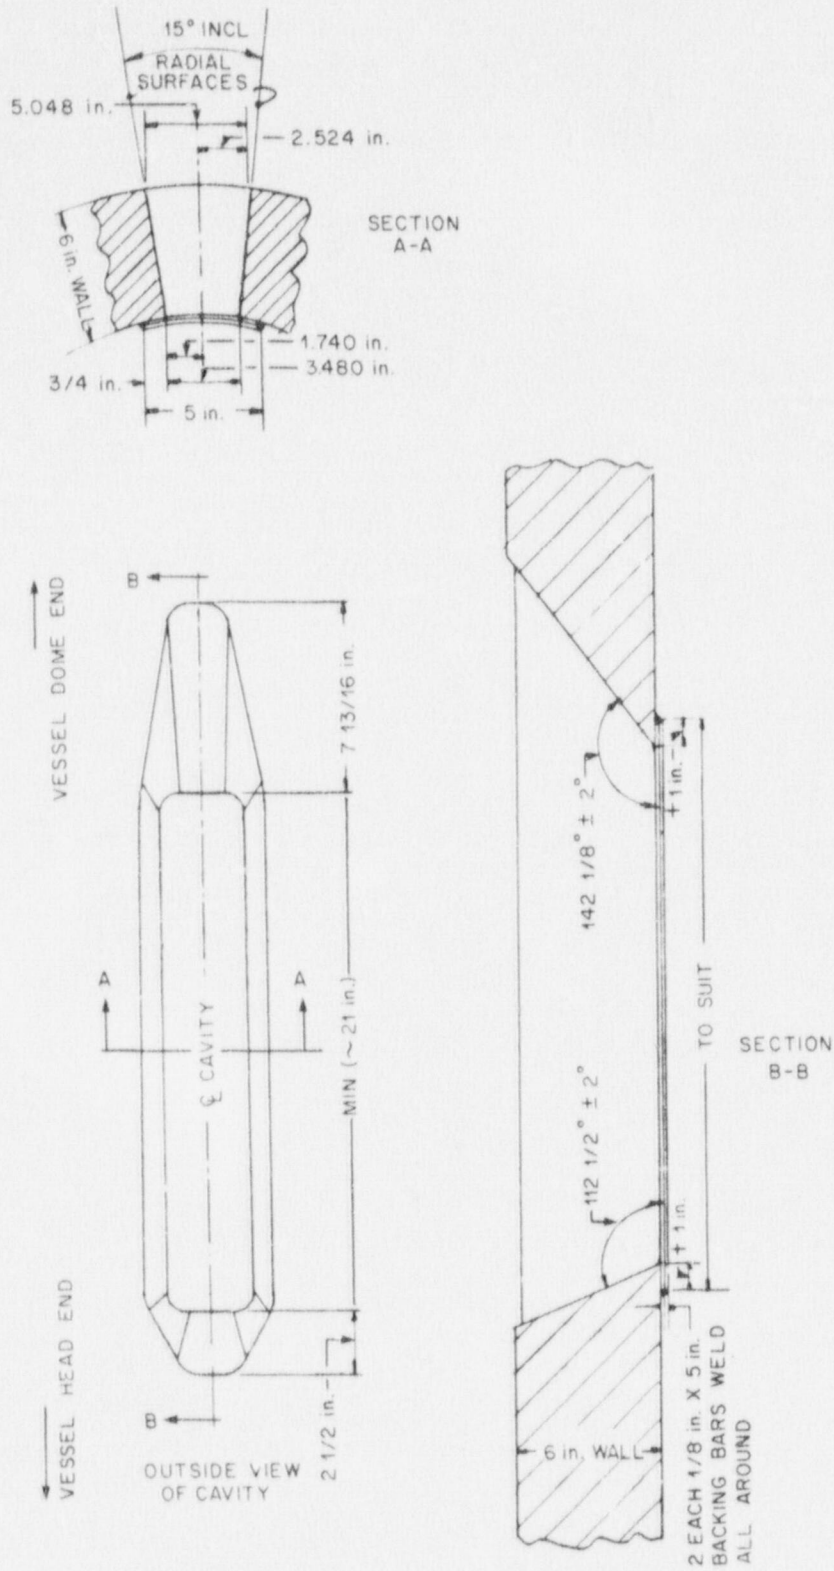
After the cavity was filled and the backing plates were removed, a region of porosity at the inside surface of the vessel at the 112.5° corner of the cavity (see Fig. 2.4) was found and repaired. The repaired zone was about 127 mm wide (5 in.), 25 mm high (1 in.), and 22 mm deep ($\frac{7}{8}$ in.) The weldment was inspected ultrasonically and radiographically after all welding was completed and the vessel had been at ambient temperature for at least 48 hr. No indications of imperfections of rejectable magnitude were found, although several regions of small porosity were found and studied intensively.

Fig. 2.4. Design of the V-7B weld repair cavity in vessel V-7.

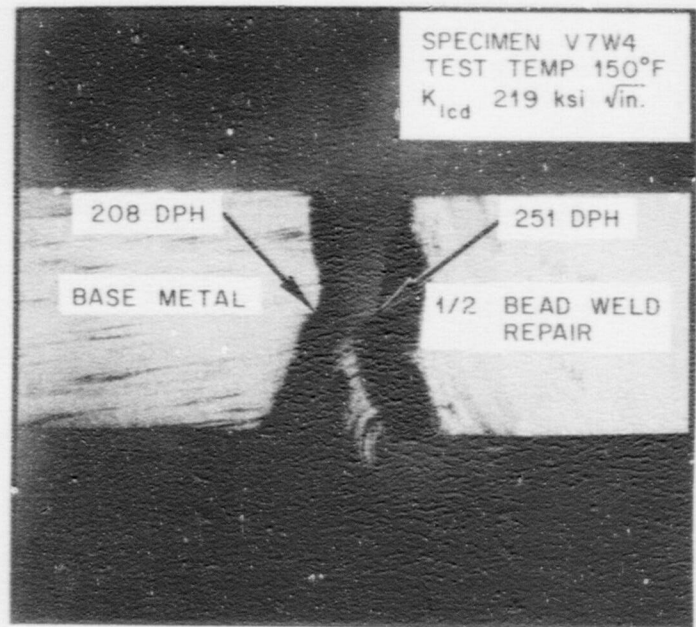
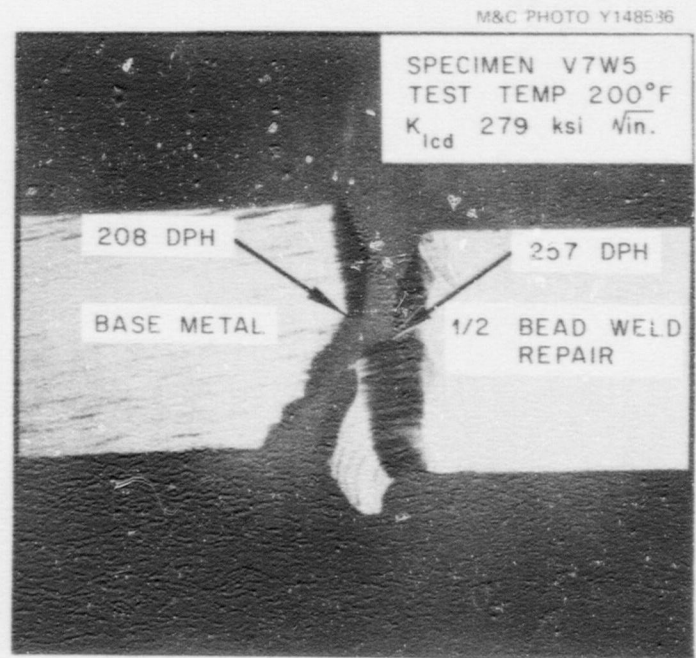
Metallographic examination of specimens from the V-7B prototype weldment, in which the fatigued cracks reside in the visible HAZ identified in Fig. 2.17, indicates that the crack propagation is through the base metal. Figure 2.21 illustrates the type of fracture behavior noted in the study. The fatigue crack front

Fig. 2.21. Specimens having crack tips in the dark etching region of the HAZ.

resides near the middle of the visible HAZ, a region with a fairly high hardness, approximately 250 to 300 DPH (diamond pyramid hardness). The crack propagation is along the interface between the visible HAZ (dark band) and the (apparently) unaffected base metal. The hardness in the region where the crack propagated is approximately 210 DPH. The hardness values are approximated from the traverse shown in Fig. 2.22. Similar fracture behavior was not noted for specimens with fatigue crack fronts in the weld

Regardless of whether the crack was initially in the HAZ or not, its ultimate behavior was expected to be controlled by the properties of the base material and repair weld. The HAZ is generally thin, and its superiority in toughness and tensile properties over the surrounding material tends to make the crack grow into the weaker material and thereafter avoid the HAZ. This behavior had been observed in the precracked Charpy specimen, as shown in Fig. 2.21.

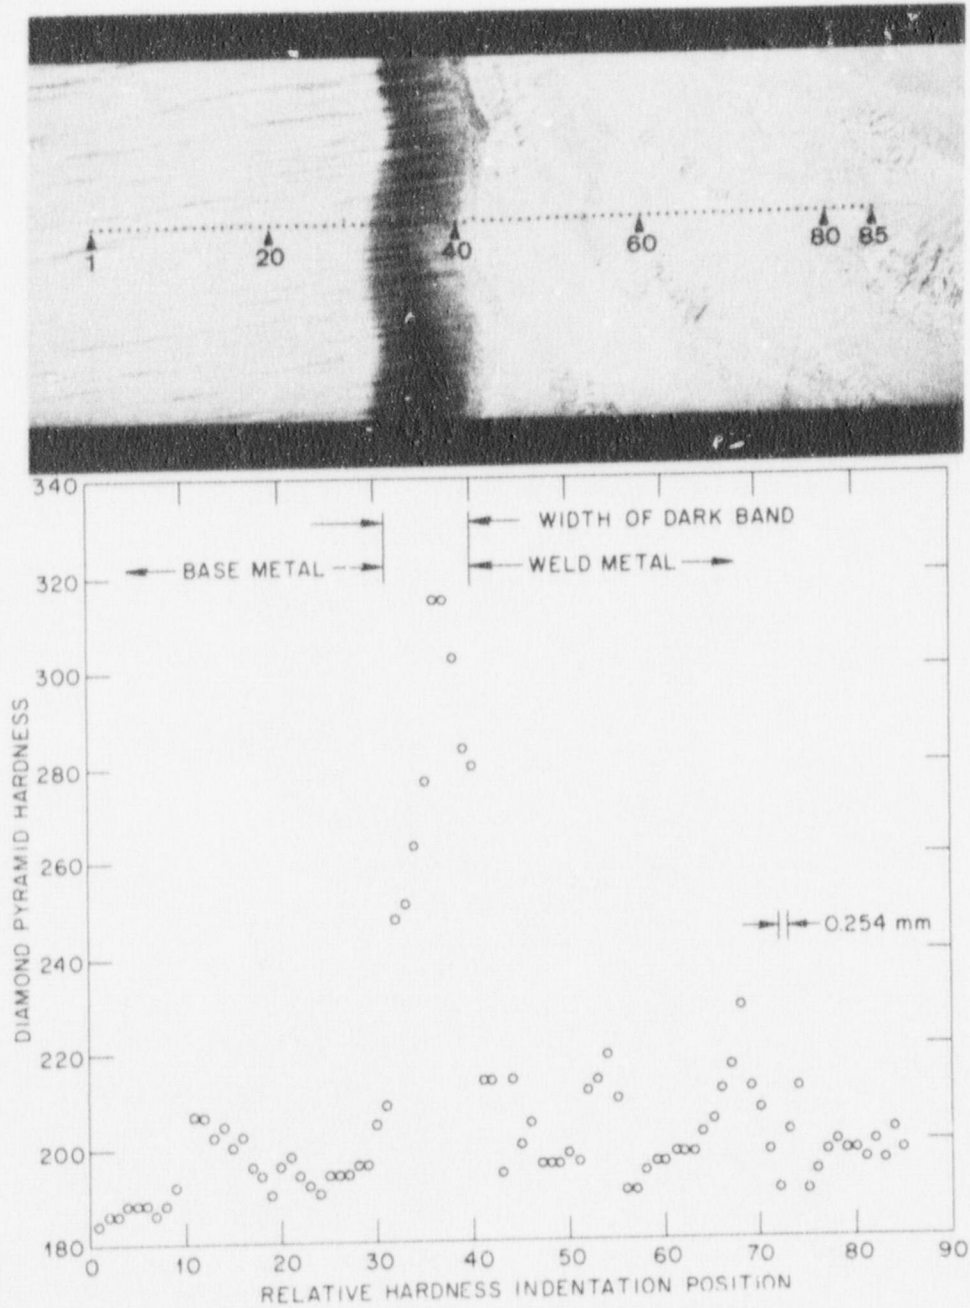
M&C PHOTO Y150569

Fig. 2.22. Hardness traverse of the heat-affected zone and adjacent areas of a cross section of the V-7B prototypical half-beak weld repair in the V-8 prolongation.

A microhardness traverse across the base metal–repair weld in specimen V7W7 was also obtained. Figure 2.22 is an enlargement of the region where the penetrations were made identifying the location of indentations and a plot of the hardness values associated with these locations. The actual hardness values are listed in Table 2.6. The highest hardness values occur in a 2.29-mm-wide (0.090-in.) region, which is the approximate width of the dark etchant band that identifies the HAZ in the base metal. The highest DPH value, 314 (R_c 31.6), occurred twice within 0.254 mm (0.010 in.) of each other. This is in agreement with three previous hardness traverses² across a similar HAZ in the V-7A prototype weld.

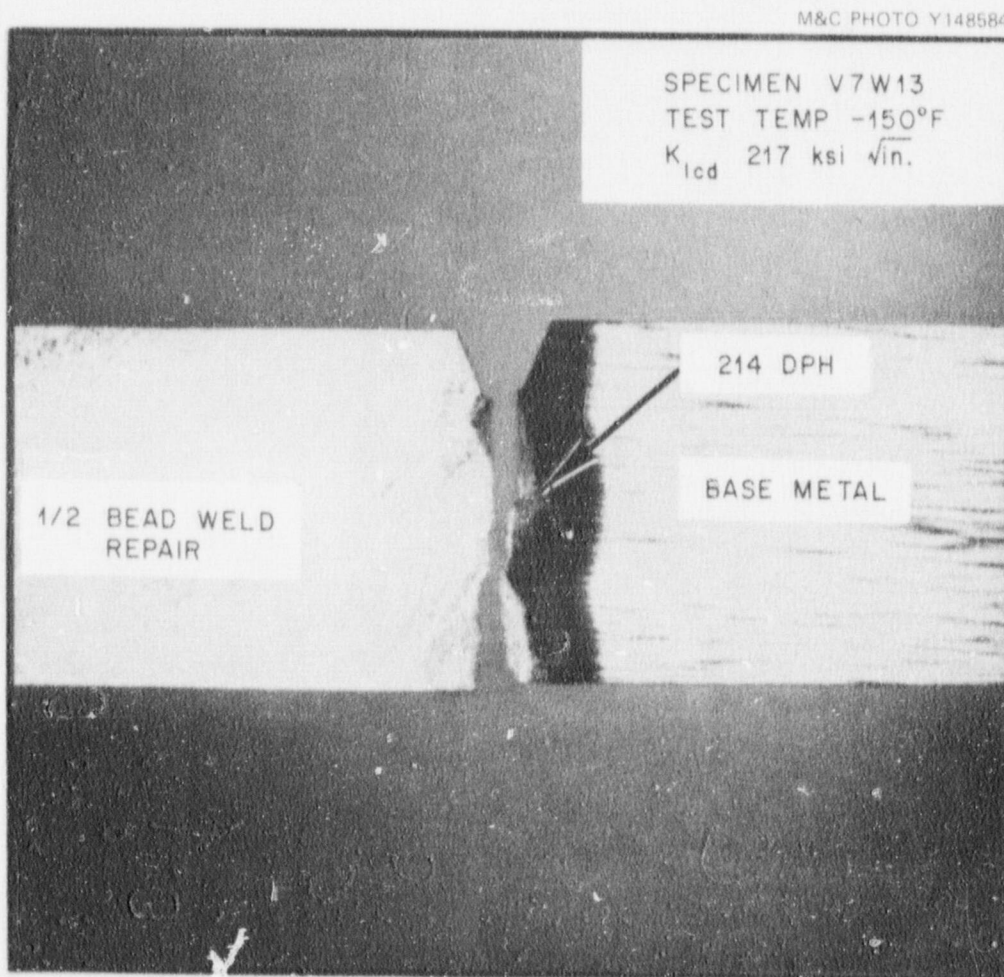
metal. Those specimens tended to propagate in a more direct path or to follow the contour of a weld pass. Figure 2.23 contains a photomicrograph of a specimen with the crack tip in the repair weld adjacent to the half-bead repair and base metal fusion line. The propagation path is essentially straight through the specimen.

Fig. 2.23. Specimen with crack tip in the weld metal.

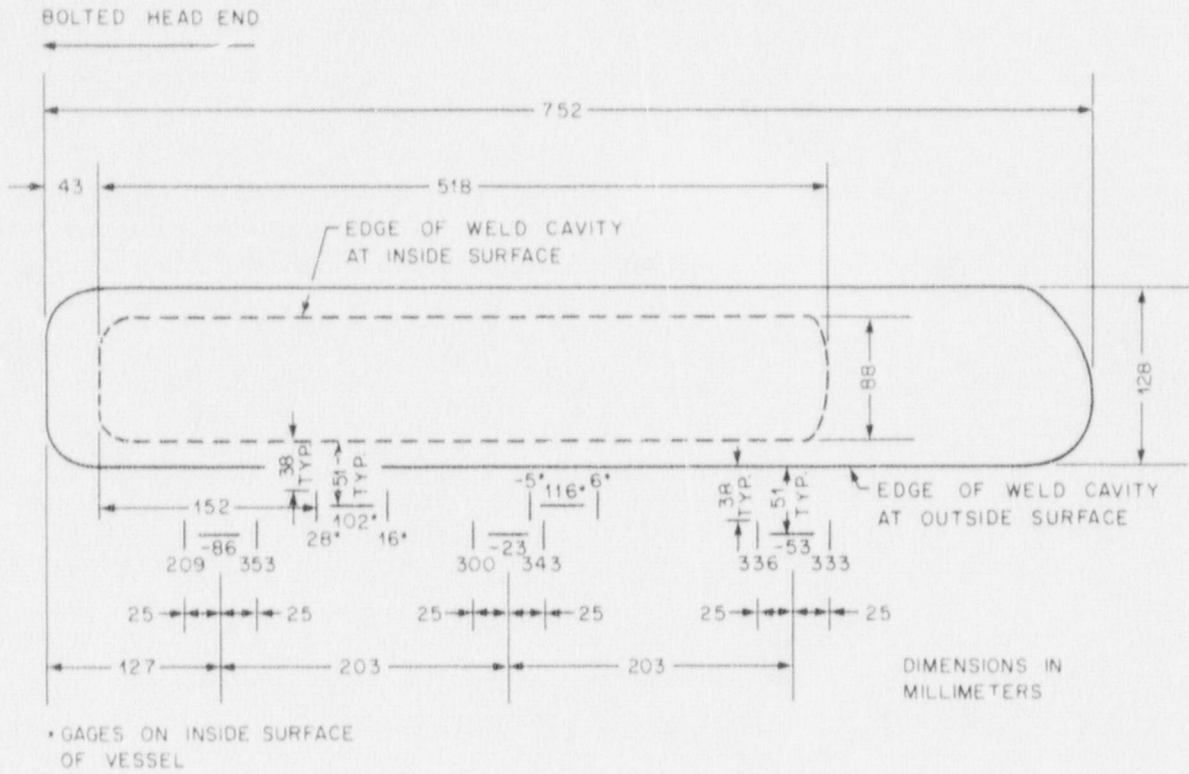
Figures 2.24 and 2.25 show the stresses computed by the method described above for the V-7B vessel repair weld and its simulation in the prolongation, respectively. The figures show plan views, drawn to scale, of the repair zones as viewed from the outside of the vessel and prolongation. The weld cavity outline of the outside surface is shown as a solid line and that of the inside surface is shown as a dashed line. The gage lengths, orientations, and the locations of gages relative to the actual weld cavity outlines are drawn to scale and are indicated by the short solid lines. The number by each gage indicates the stresses (in MPa) that were calculated, and the orientation designates whether a stress is axial or circumferential. Stresses denoted by an asterisk pertain to gages located on the inside surface, with all other stresses pertaining to the outside surface. If it is assumed that the stresses existing in the vessel and prolongation prior to the weld repairs were negligible, the stress change due to the repair weld can be taken as an absolute residual stress. That assumption is considered reasonable because the operation of cutting the large cavities would tend to relieve residual stresses near those cavities. The assumption is also supported by the observation that the stresses measured in the vessel are not significantly different from those measured in the prolongation, which did not have a prior loading history and which had been stress relieved during original fabrication.

Fig. 2.24. V-7B repair weld residual stresses (MPa) determined from weldable strain gage measurements.

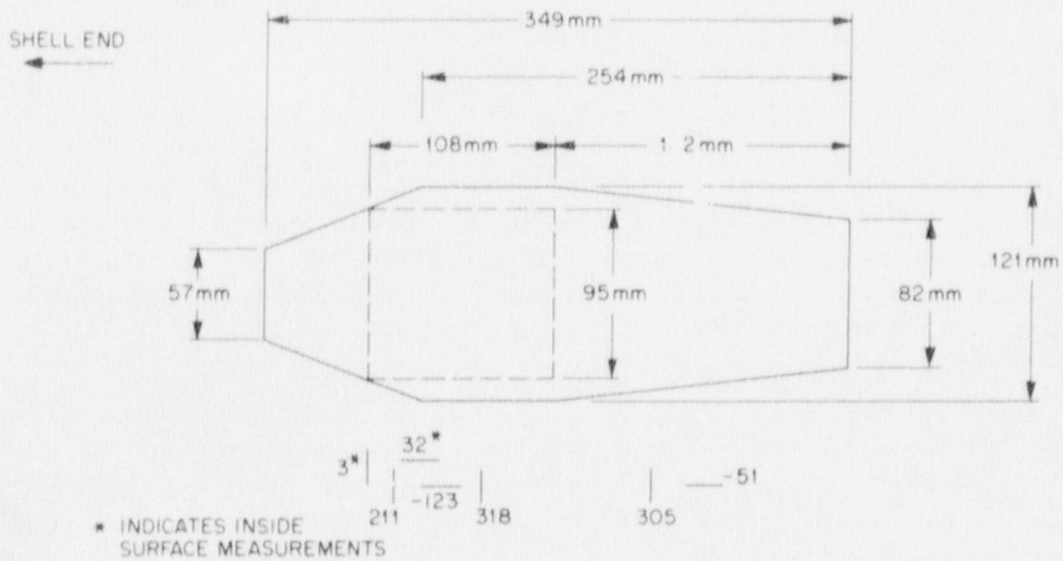
Fig. 2.25. V-7B prototypical repair weld residual stresses (MPa) determined from weldable strain gage measurements.

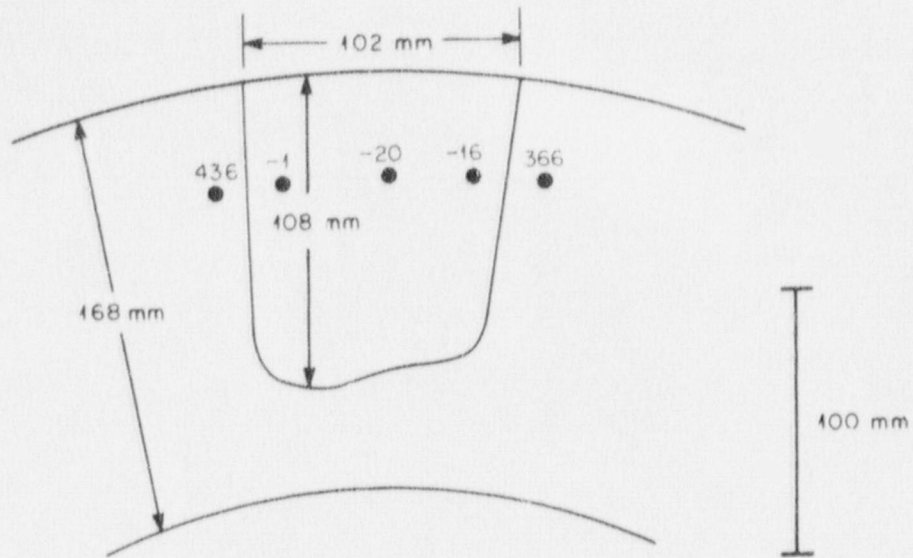
ORNL-DWG 78-4030

Fig. 2.28. Circumferential residual stresses (MPa) in the V-7B simulation repair weld (no correction for sectioning was applied).

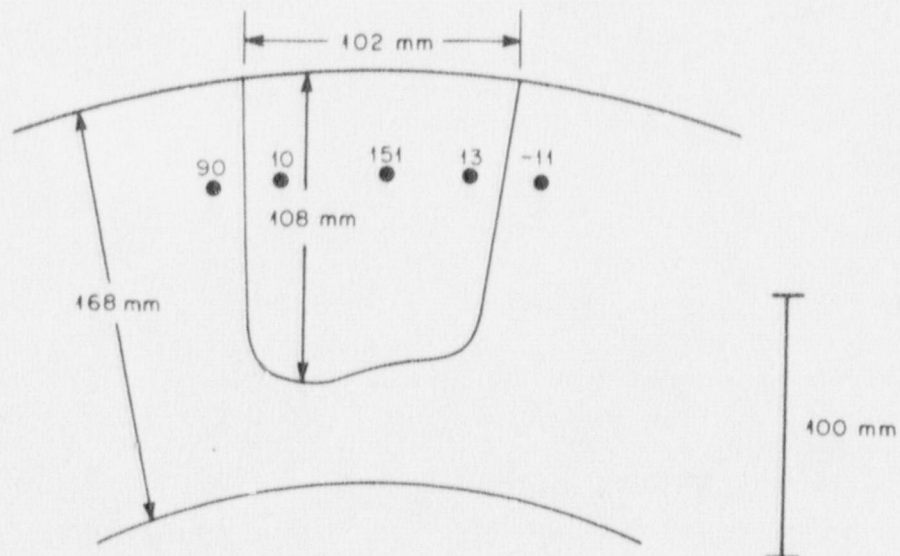
ORNL-DWG 78-4031

Fig. 2.29. Radial residual stresses (MPa) in the V-7B simulation repair weld (no correction for sectioning was applied).

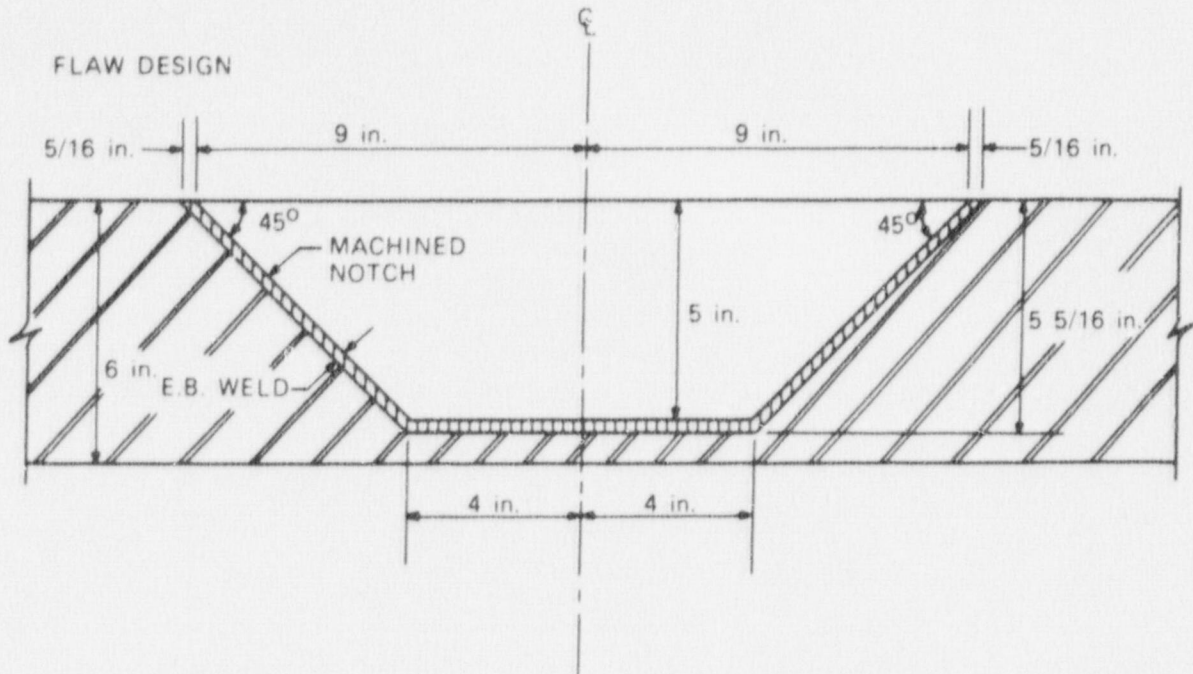
The repaired vessel was flawed in UCCND facilities at the Y-12 Plant by the same means and with the same flaw geometry used in the vessel for the V-7 and V-7A tests.^{2,5} The flaw geometry is shown in Fig. 2.31. The flaw was produced in three steps: machining a 25-mm-wide (1-in.) notch to within about 10 mm (0.4 in.) of the desired crack depth, making a narrow electron-beam (EB) weld along the periphery of the notch, and charging the EB weld with hydrogen until a sharp crack popped in.

Fig. 2.31. Flaw design for vessels V-7, V-7A, and V-7B.

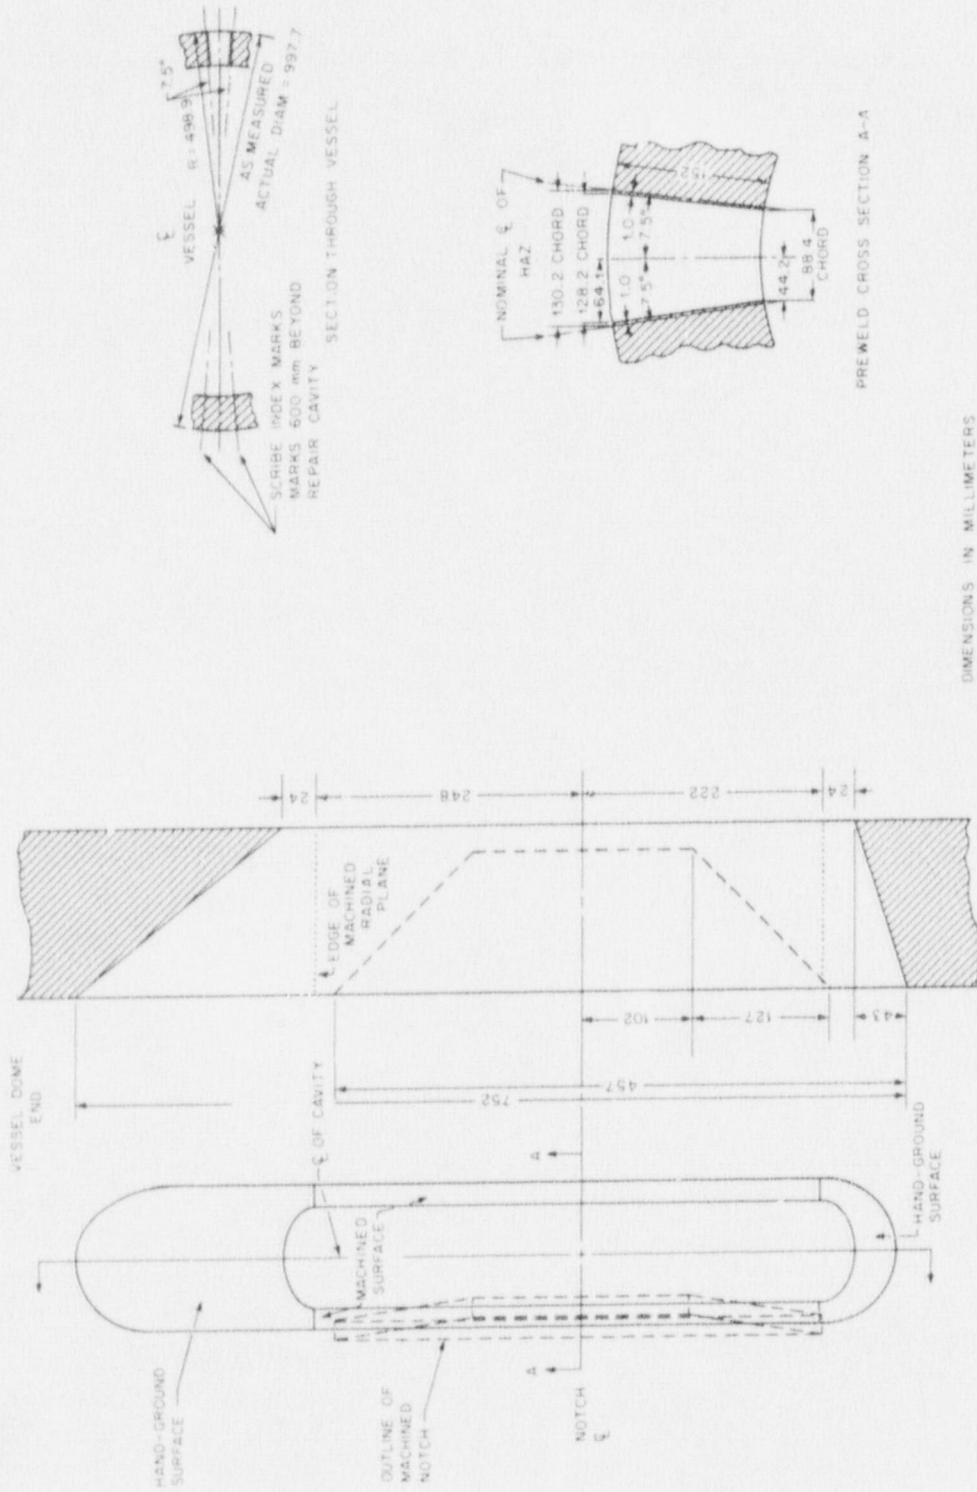
DIPLO. ENG. 75 154911

This preliminary investigation established the feasibility of producing a sharp crack in the HAZ of the second repair in vessel V-7, provided that the EB weld could be properly aligned with the HAZ. Experience with EB welding in the machined notches for the V-7 and V-7A tests provided some confidence that proper alignment could be accomplished if the procedures were carried out carefully and precisely. The necessary dimensional controls for finding the approximate locations of the heat-affected zones were assured by having the sides of the weld cavity prepared by machining and indexed with markings on the vessel surface. The axial centerline of the machined notch was located tentatively along the nominal centerline of one HAZ, as shown in Fig. 2.33.

Fig. 2.33. Vessel V-7B as-built repair cavity and machined notch details.

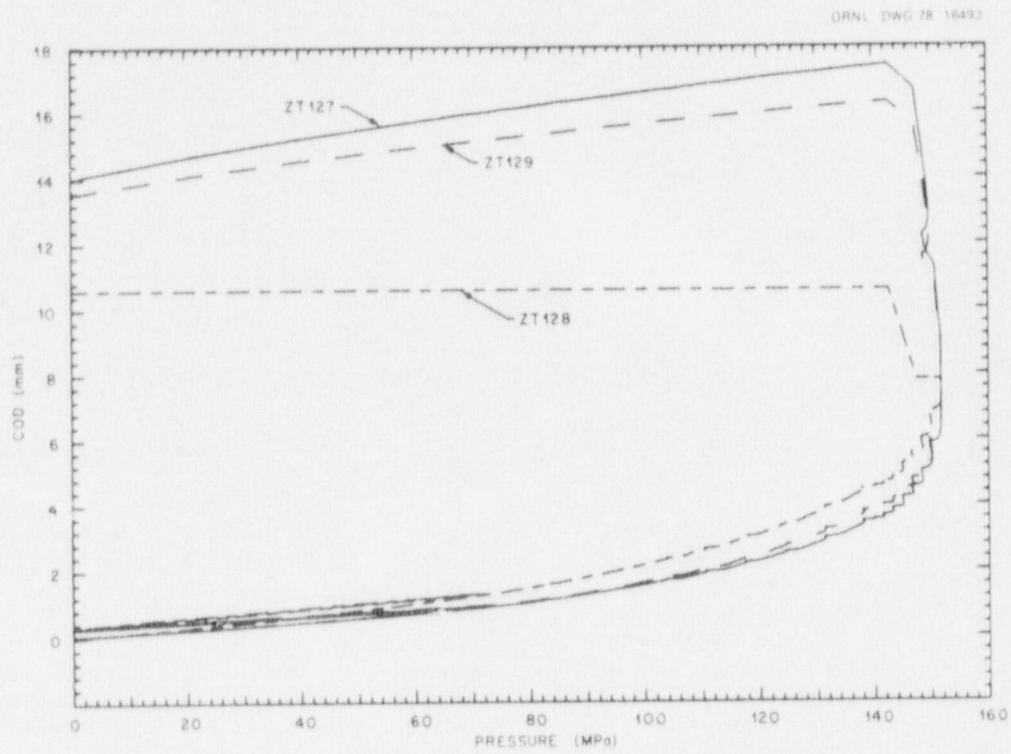
The COD data from the three displacement transducers are presented in Fig. 3.8. It is evident in the behavior of the COD transducer ZT 128 that this gage was affected by the rupture events, perhaps by the impact of escaping water. Figure 3.9 shows circumferential strain at 180° from the flaw, indicating gross vessel behavior.

Fig. 3.8. COD vs pressure for V-7B.

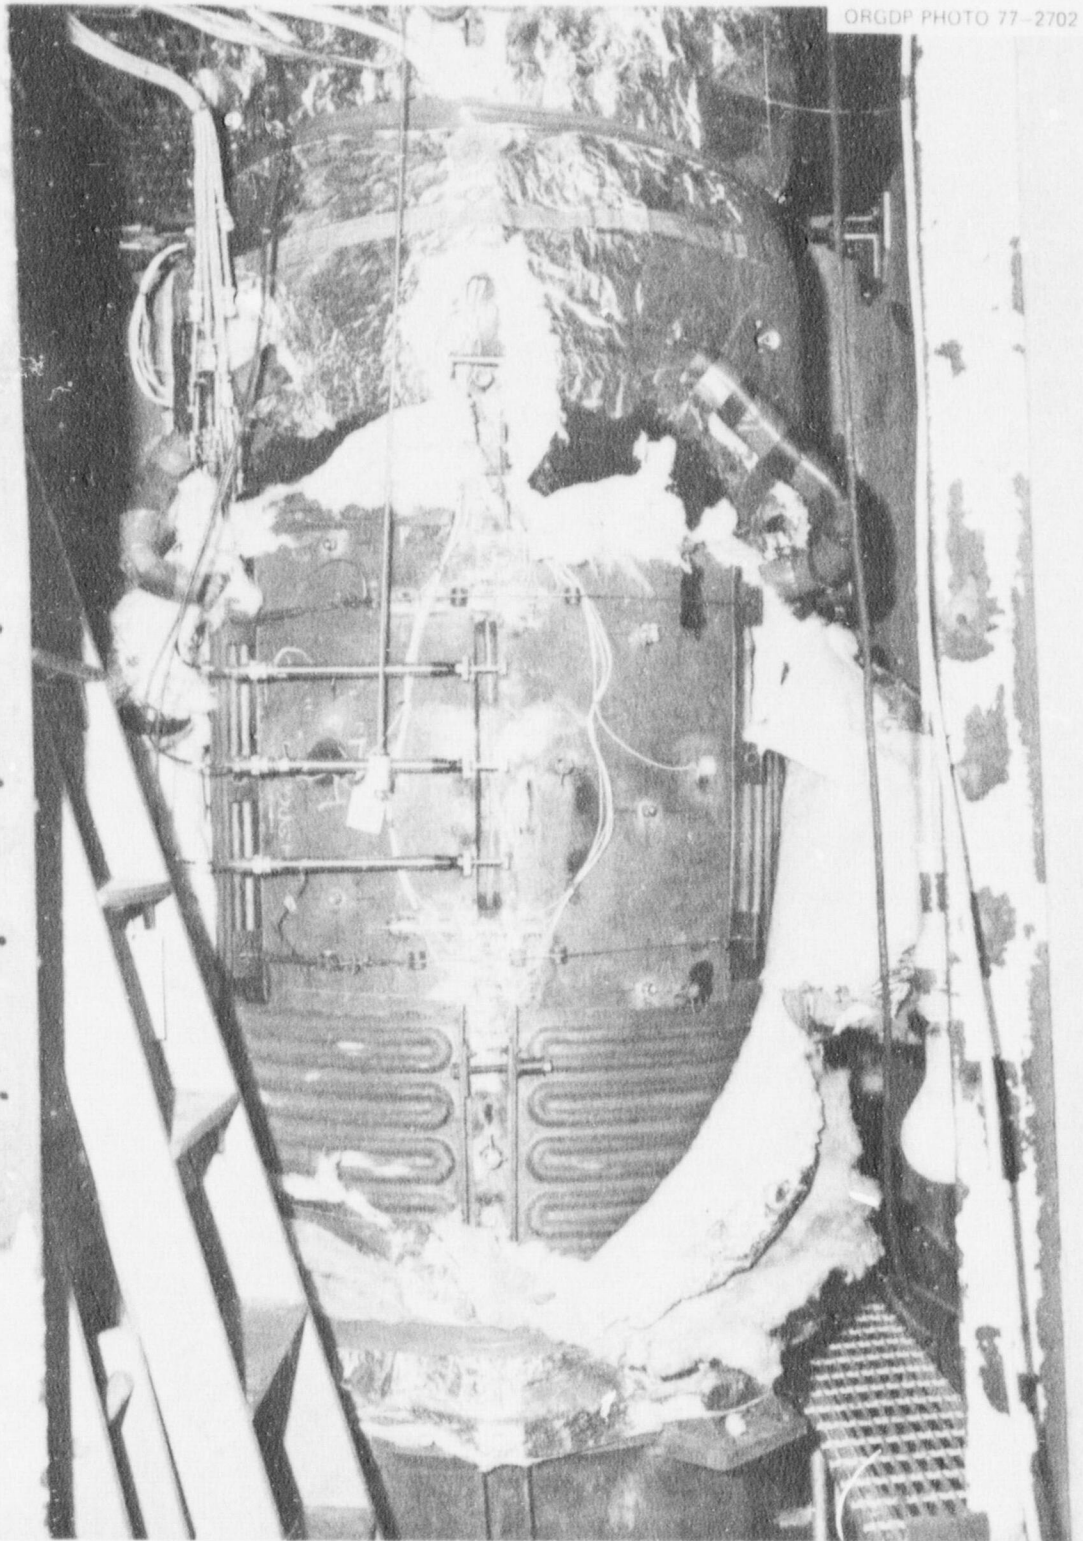
ORGDP PHOTO 77-2702

A posttest view of vessel V-7B is given in Fig. 3.10. Permanent deformation of the flaw can be detected along with crack extension at the ends of the machined notch. Complete data from the CCDAS are shown via microfiche described in Appendix A and attached to the inside back cover.

Fig. 3.10. Test vessel V-7B in pit after test.

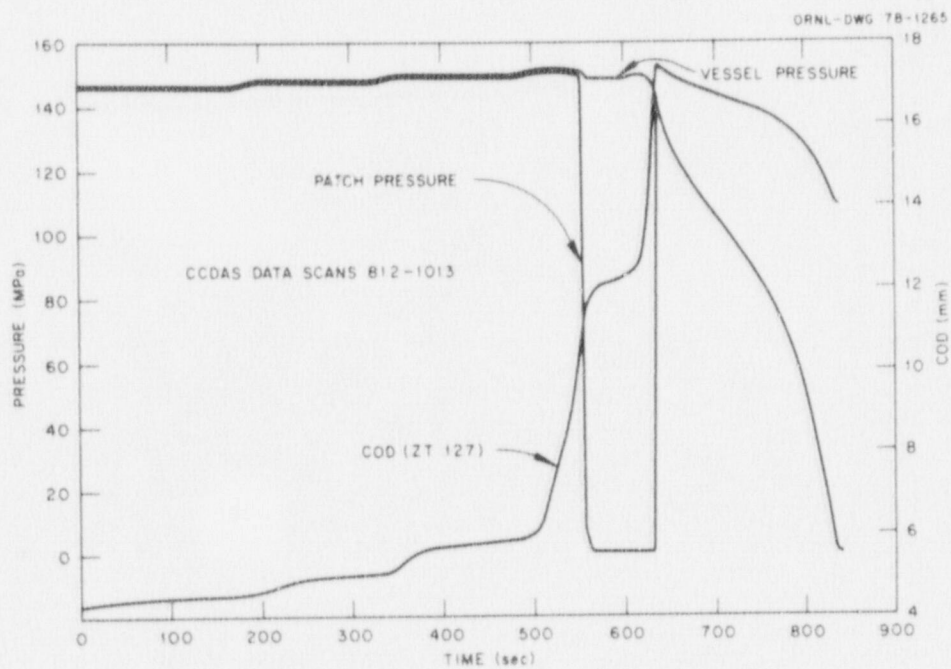
Figure 4.17 covers a period of time including the last three pressurization steps. Vessel rupture as sensed by the patch pressurization system (PPS) caused the large drop in patch pressure shown in this figure. Patch rupture about 70 sec later repressurized this system and initiated the complete depressurization of the vessel. The COD measurements superimposed on the pressure plot in Fig. 4.17 show that the flaw was probably growing at constant pressure about 30 sec prior to the indication of rupture by the PPS.

Fig. 4.17. Plots of vessel pressure, patch pressure, and COD (at ZT 127) during the last three pressurization steps, vessel rupture, and vessel depressurization. Time origin at scan 812.

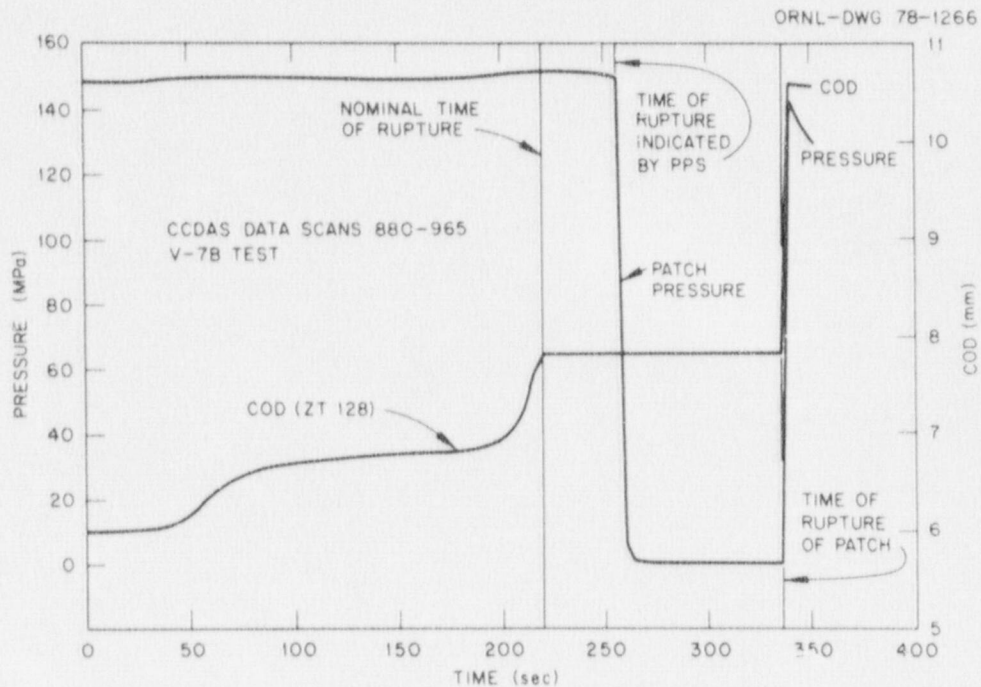
The development of this apparent instability and its relationship to the actual time of rupture are seen more clearly in Figs. 4.18 and 4.19. Figure 4.18 shows that the center COD gage (ZT 128) was subjected to

an extraneous force twice within about 120 sec; the second occasion occurred coincident with the patch rupture, which released a hard stream of water against the center COD probe. The earlier perturbation in ZT 128 is believed to have been caused by a similar impact during the rupture of the vessel. Thus we consider the time of this perturbation to be the nominal time of rupture, although leakage may have started a few seconds earlier.

Fig. 4.18. Patch pressure and central COD (ZT 128) vs time during development of vessel rupture. Time origin at scan 880.

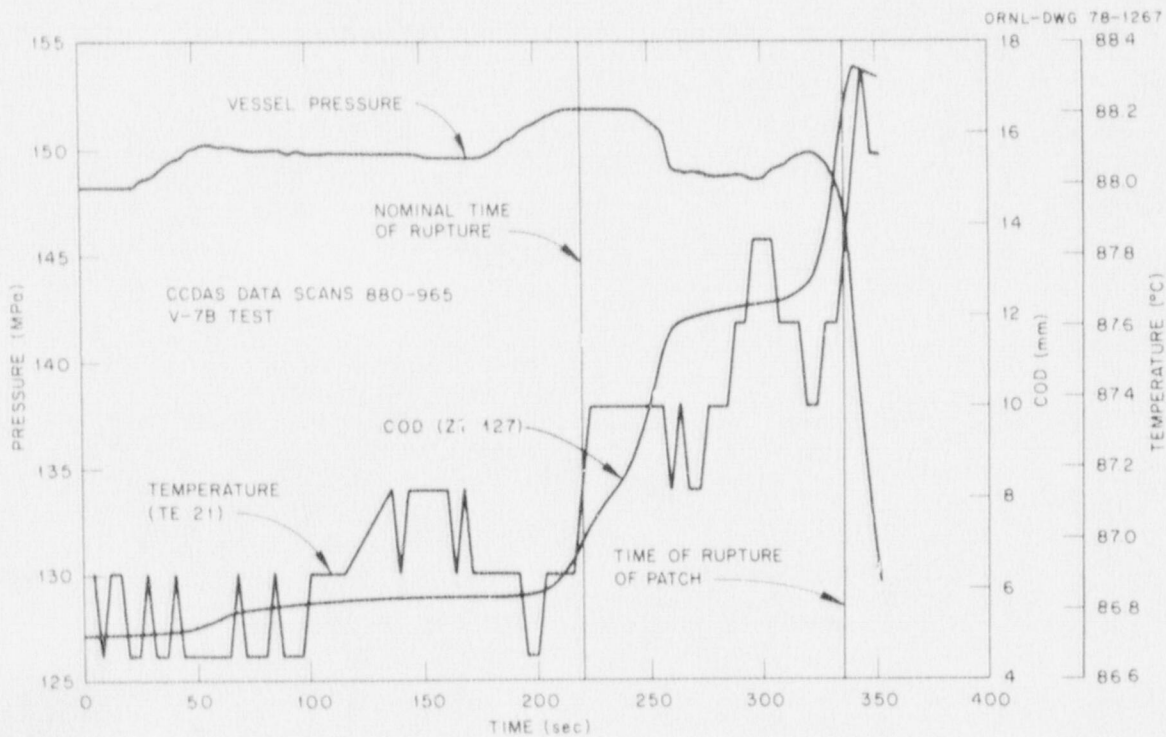
With this definition of nominal time of rupture as a reference point, the concurrent behavior of several variables is as shown in Fig. 4.19. The CODs were accelerating during the times after nominal rupture when vessel pressure was steady or increasing. This indicates that axial tearing of the flaw was probably taking place after rupture; this type of behavior did not occur during earlier pressurization steps or in the pneumatic V-7A test. A small temperature excursion of about 1 K (2°F) was observed near both ends of the flaw and in the ligament, as shown for one of these locations in Fig. 4.19. This occurrence is also unique to the rupture phase of the test and is consistent with the supposition that deformation and tearing at this time heated the metal. If this is the case, the ligament may have ruptured initially near one end rather than in the center since the central ligament temperature continued to increase after the nominal time of rupture until the rupture became large enough to affect the patch pressurization system. At that time the escaping fluid, chilled by expansion, cooled the notch as shown in Fig. 4.20.

Fig. 4.19. Vessel pressure, COD (ZT 127), and metal temperature near flow (TE 21) vs time during development of vessel rupture. Time origin at scan 880.

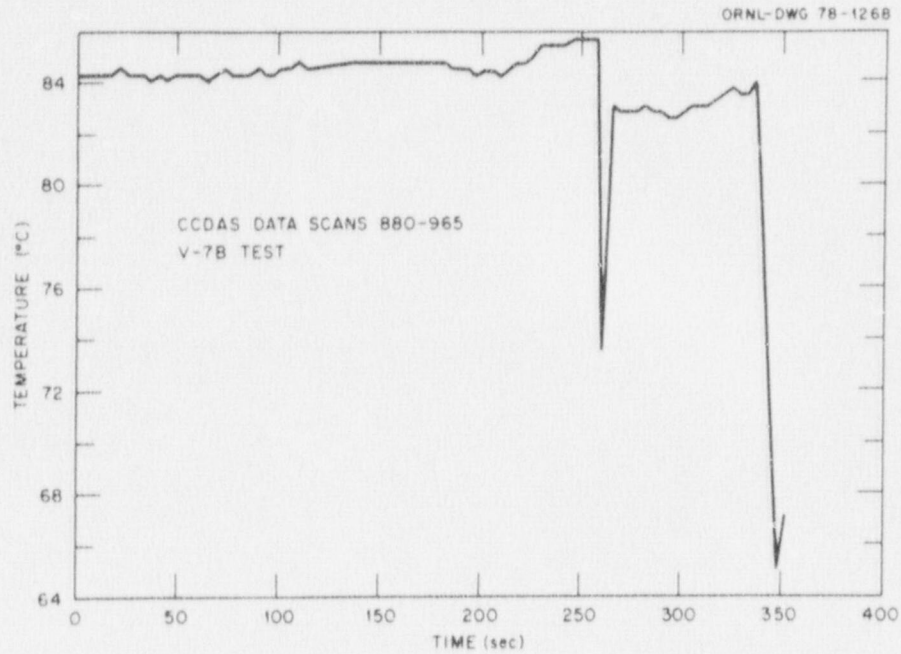
Fig. 4.20. Ligament temperature (TE 29) vs time during development of vessel rupture. Time origin at scan 880.

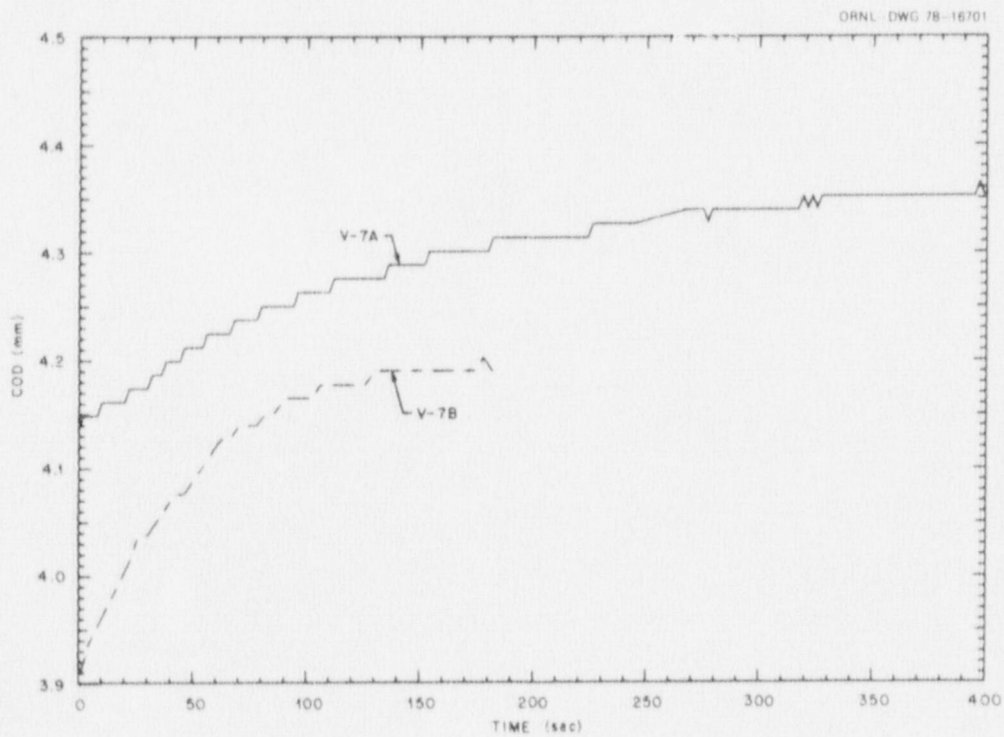
The stability of the V-7B flaw relative to the V-7A flaw may be indicated by a comparison of the CODs of the two vessels at about the same pressure. Vessel V-7A attained a maximum pressure of 144.2 MPa (20.9 ksi) prior to rupture, and that pressure was sustained within about 1% for 30 min after rupture. The fourth pressure plateau prior to reaching maximum pressure in V-7B was at a comparable pressure, 145.1 MPa (21.0 ksi). Figure 4.21 shows the central CODs vs time for these two cases. This comparison suggests that at comparable loads vessel V-7B was as stable as V-7A.

Fig. 4.21. Crack-opening displacement (ZT 127) in vessels V-7A and V-7B vs time during sustained load at about the maximum V-7A pressure (144 MPa for V-7A and 145 MPa for V-7B).

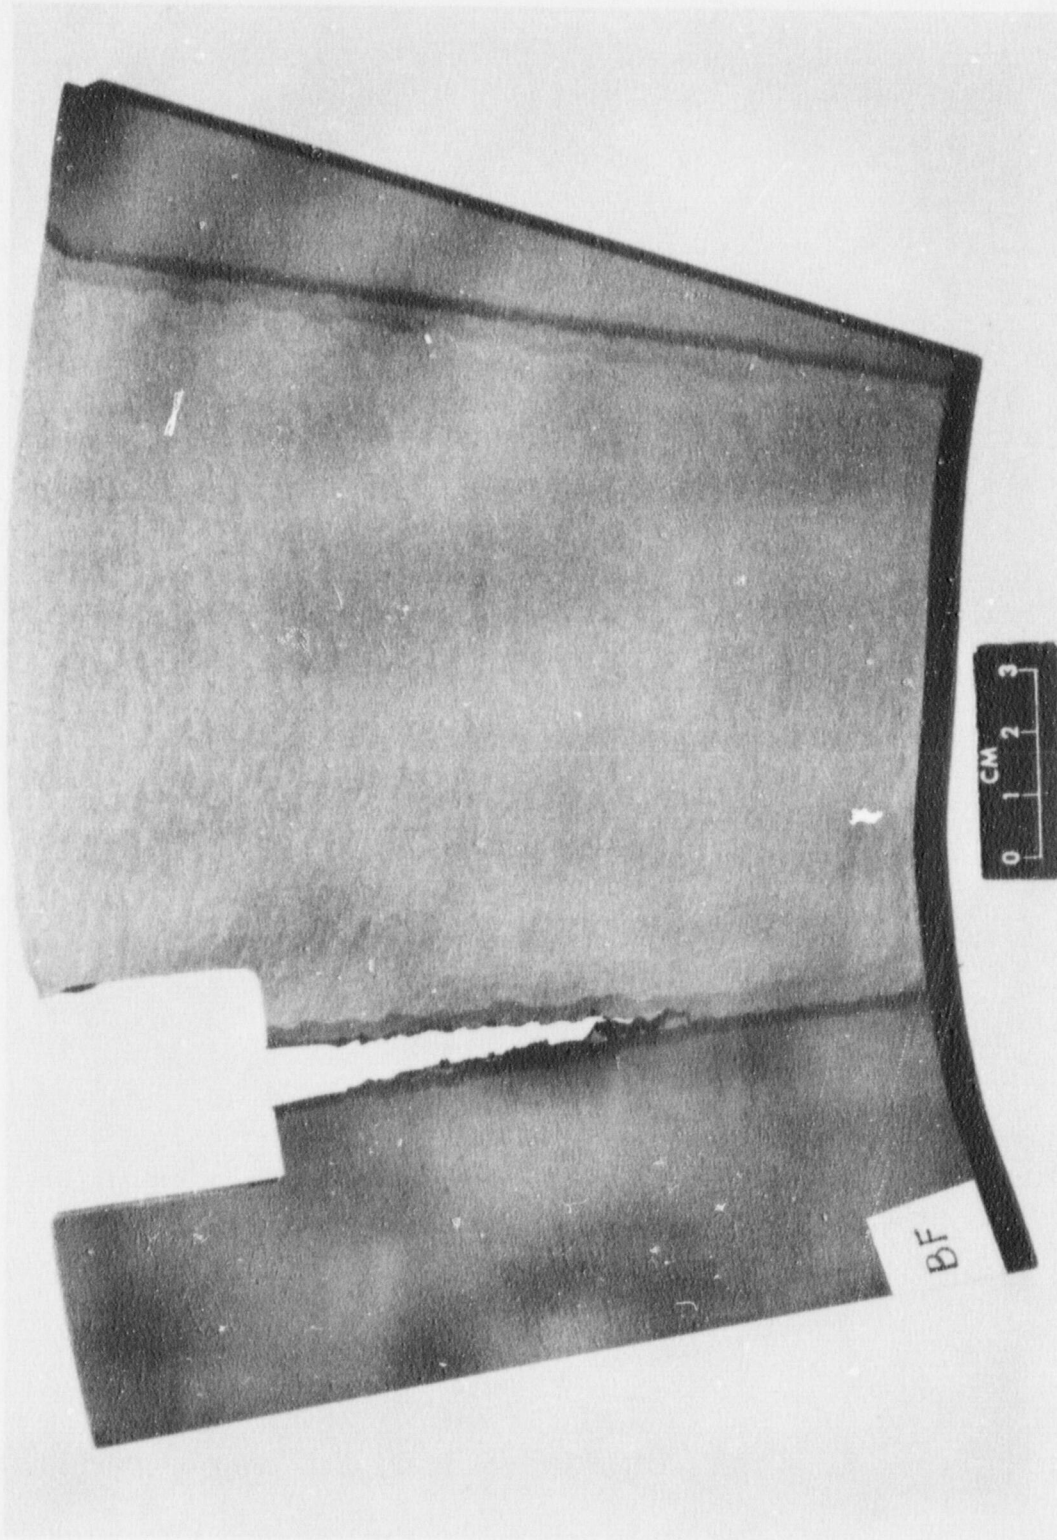
ORNL PHOTO 6546-78

The etched cross sections at several locations show the crack extension relative to the HAZ. As indicated in Figs. 4.27 and 4.28, the crack extension was entirely in the base metal in some regions, in weld metal in others, and in the HAZ only at crossover points (as in Fig. 4.27).

Fig. 4.28. Etched face O_f (slab O, flange side) of cross section of the flaw near the flange end of the notch in V-7B. See Fig. 4.25 for definition of cross sections.

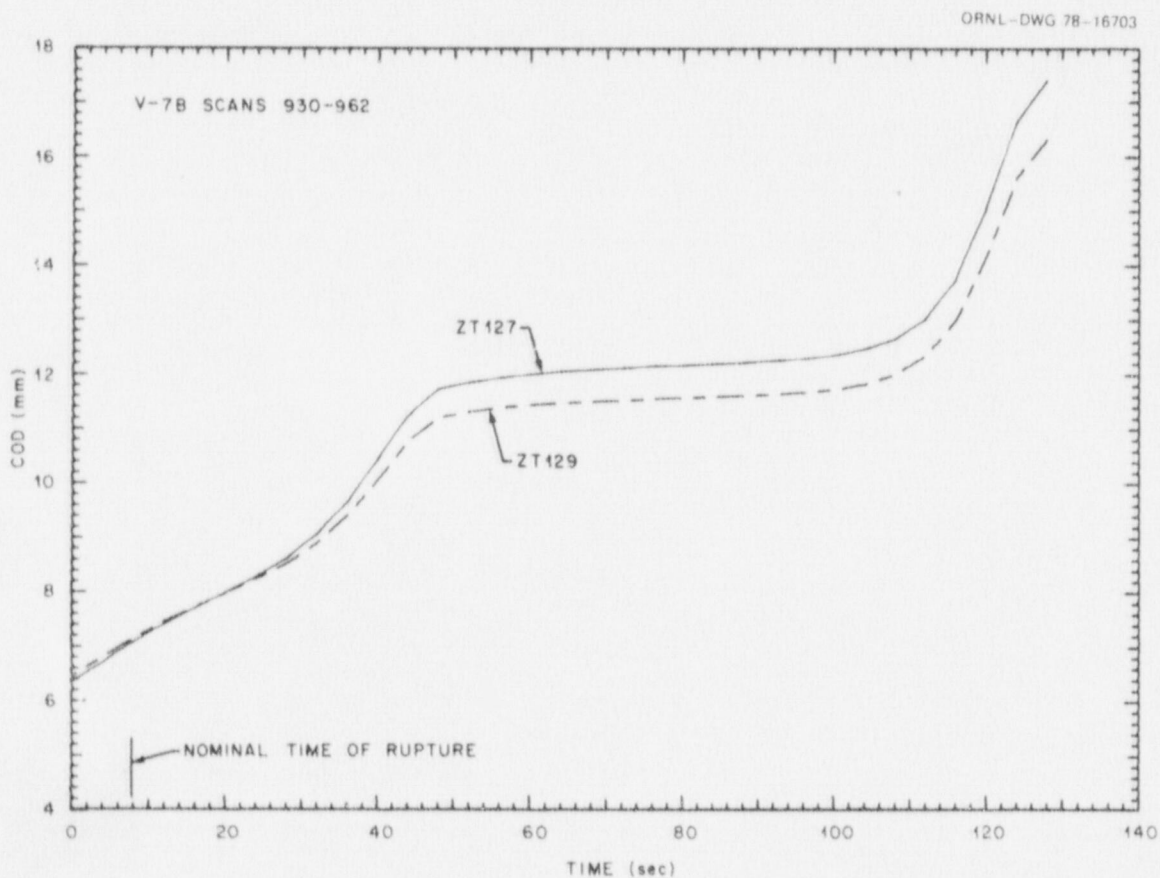
The continuing deformation of V-7B during constant load is shown in the strain and COD vs time plots of Figs. 4.31 and 4.32. Pressure changes during this interval are shown in Fig. 4.33. This behavior suggests that the structure as a whole was unstable at the maximum test pressure although the crack itself had not reached a condition conducive to fast fracture.

Fig. 4.31. COD near ends of flaw (ZT 127 and ZT 129) vs time in V-7B during final sustained loading (scans 930-962). Time origin is a 8 sec before nominal time of rupture.

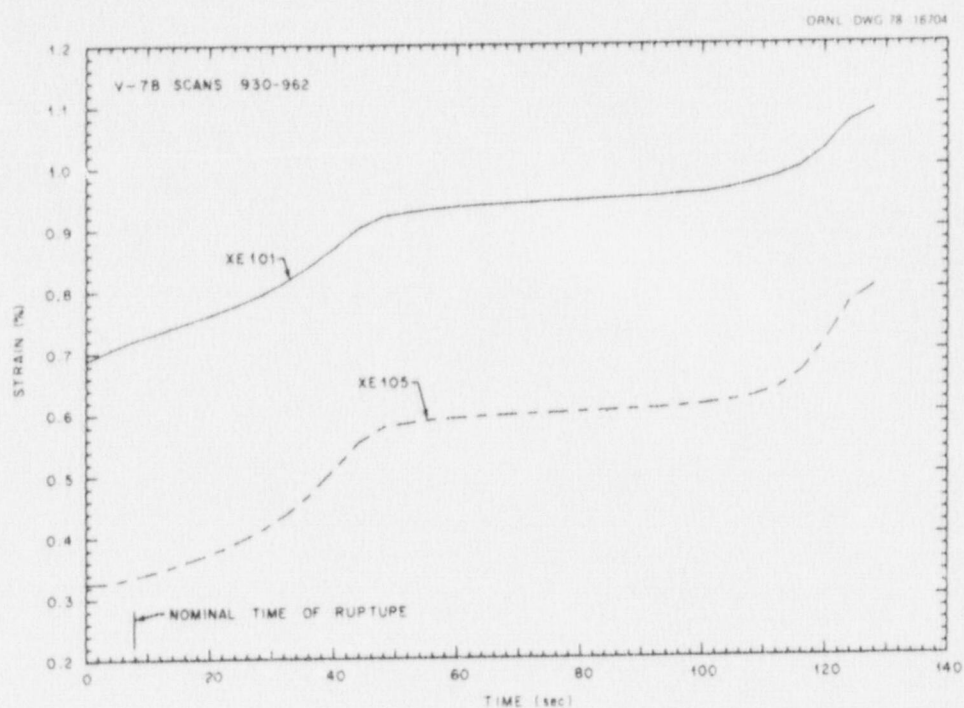
Fig. 4.32. Strain near ends of flaw (XE 101 and XE 105) vs time in V-7B during final sustained loading (scans 930-962).

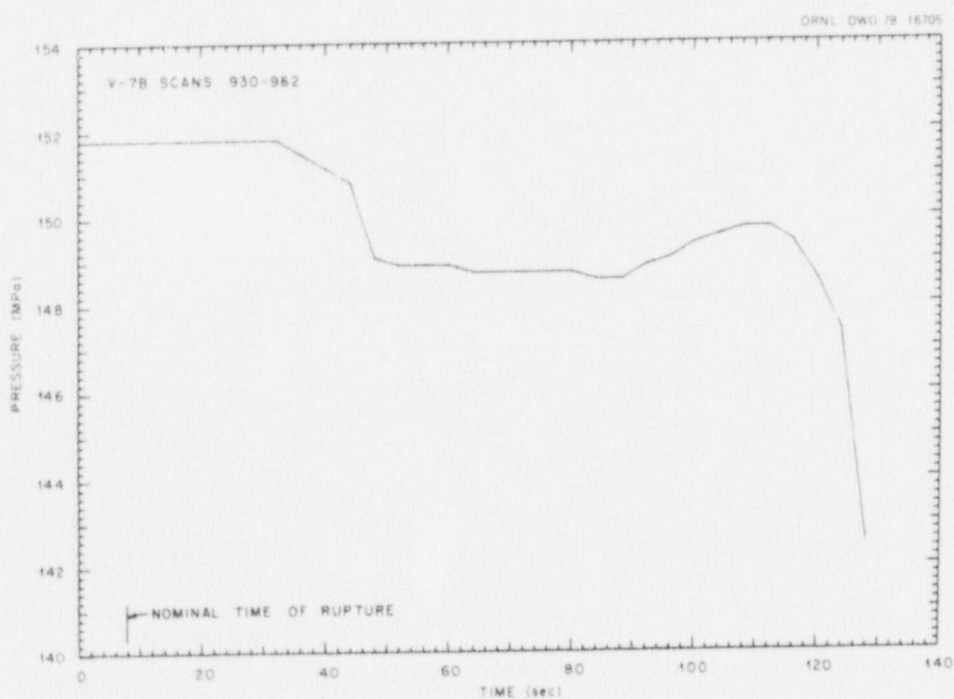
Fig. 4.33. Pressure vs time in V-7B during final sustained loading (scans 930-962).
