NUREG/CR-0309
ORNL/NUREG-38

**Test of 6-in.-thick Pressure Vessels.
Series 3: Intermediate Test
Vessel V-7B**

OAK RIDGE NATIONAL LABORATORY
OPERATED BY UNION CARBIDE CORPORATION - FOR THE DEPARTMENT OF ENERGY

Manuscript Completed – October 6, 1978

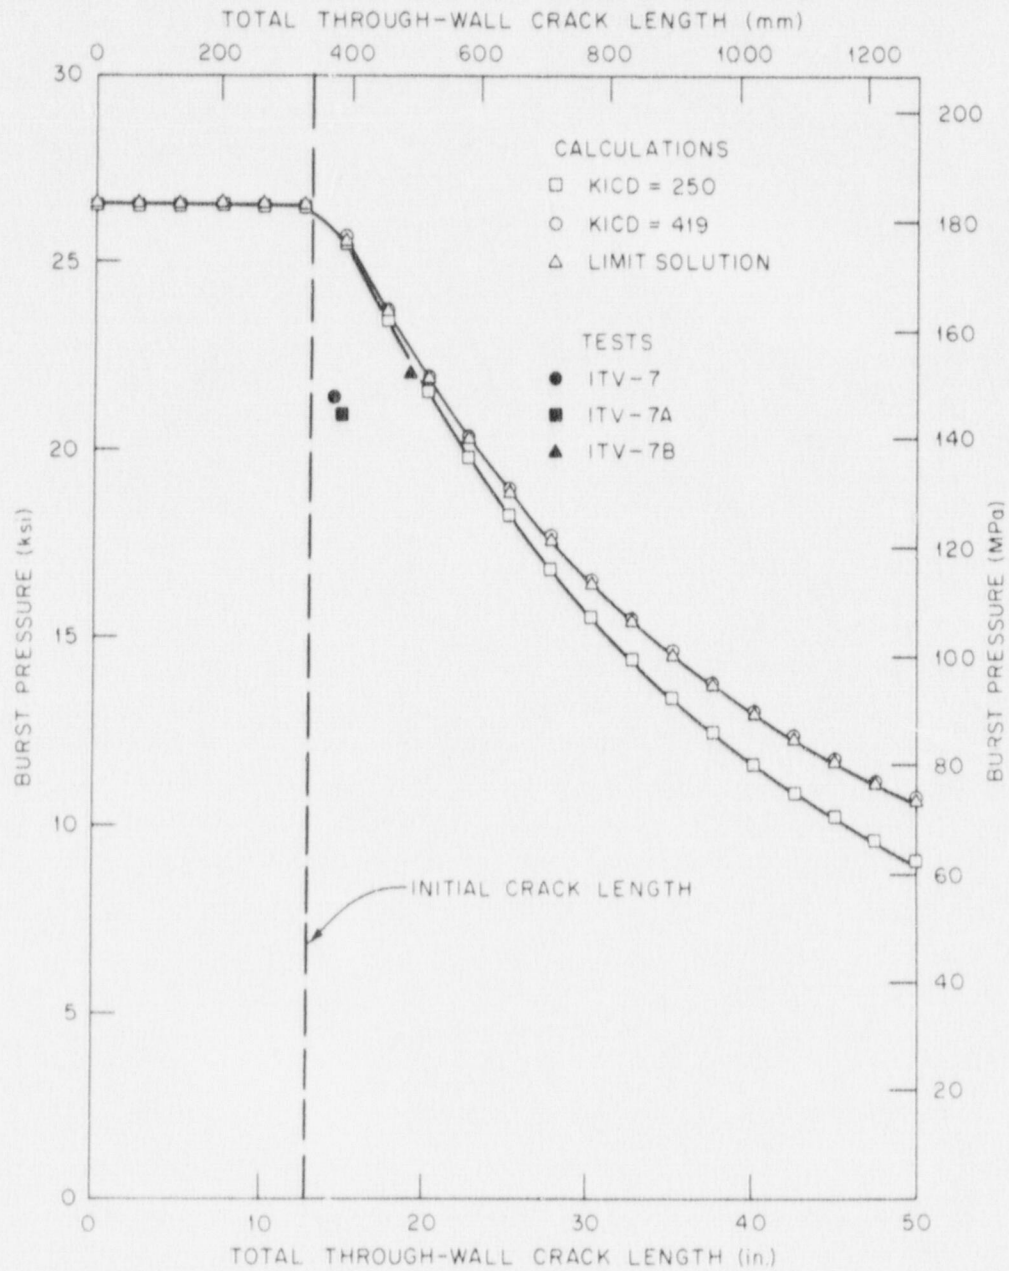
As indicated by pretest analyses, a burst was not expected in vessel V-7B with the initial crack length; results are shown in Fig. 4.34. Burst pressures for through-the-wall flaws in intermediate test vessels are shown by this figure to be very sensitive to the crack length for cracks at least as long as the V-7 series flaws; but variations in material toughness do not significantly affect the results. The final results of the V-7, V-7A, and V-7B tests are shown in this figure. The estimated burst conditions are consistent with the test results.

Fig. 4.34 Estimated burst pressures of an intermediate test vessel with a through-the-wall axial crack with results of tests V-7, V-7A, and V-7B.

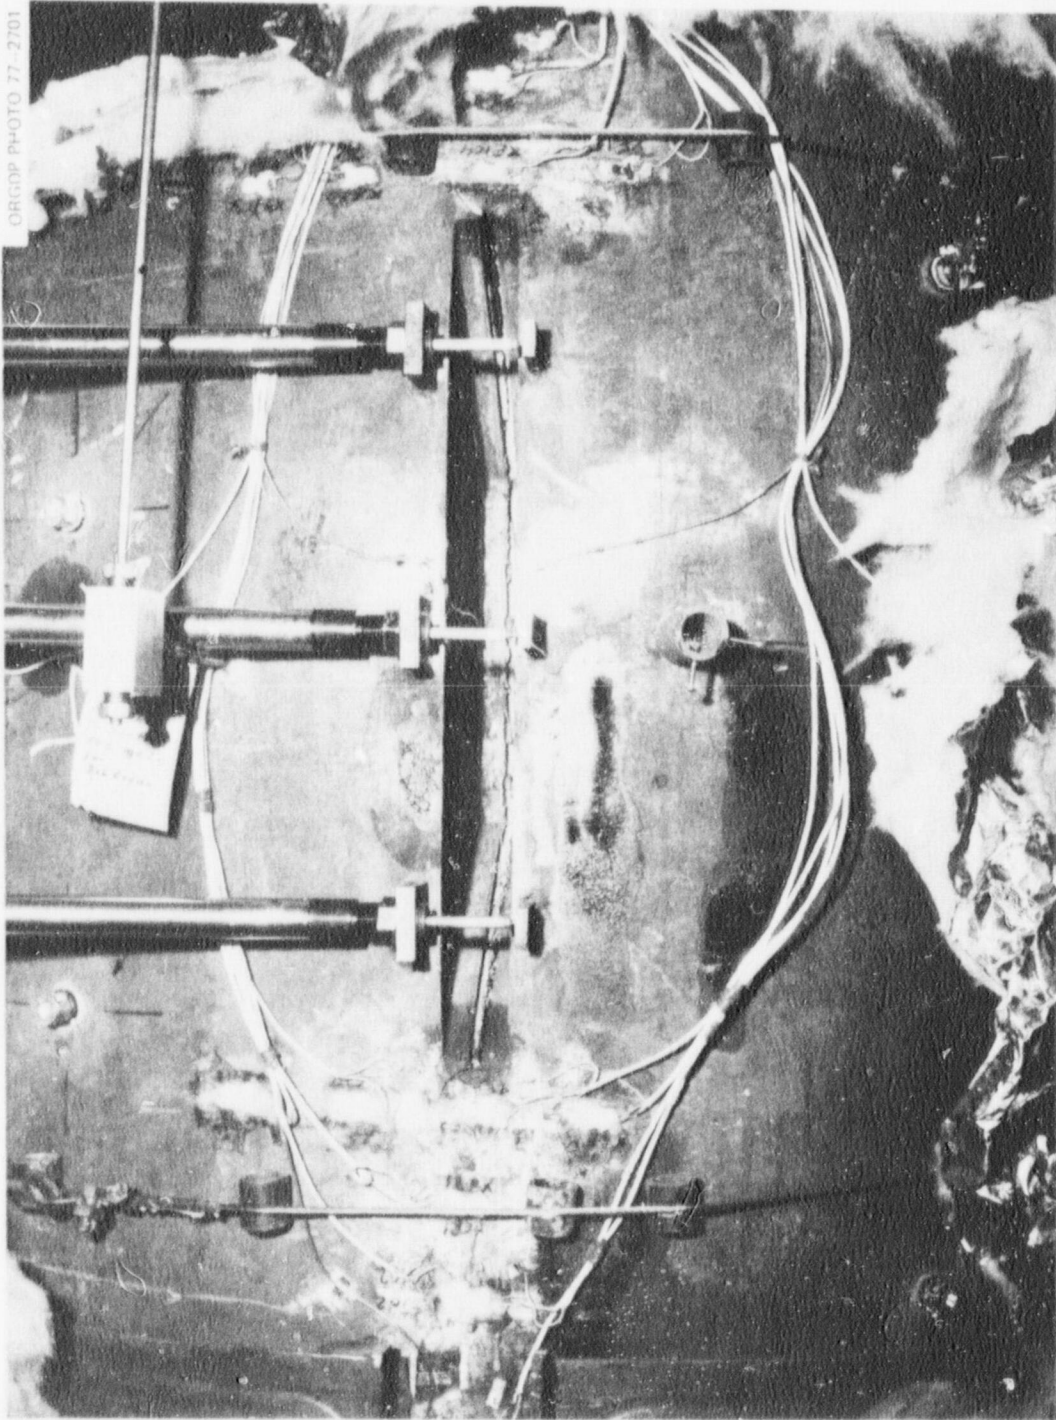
ORCOP PHOTO 77-2701

Fig. B.17. HSST V-7B vessel failure at machined flaw.

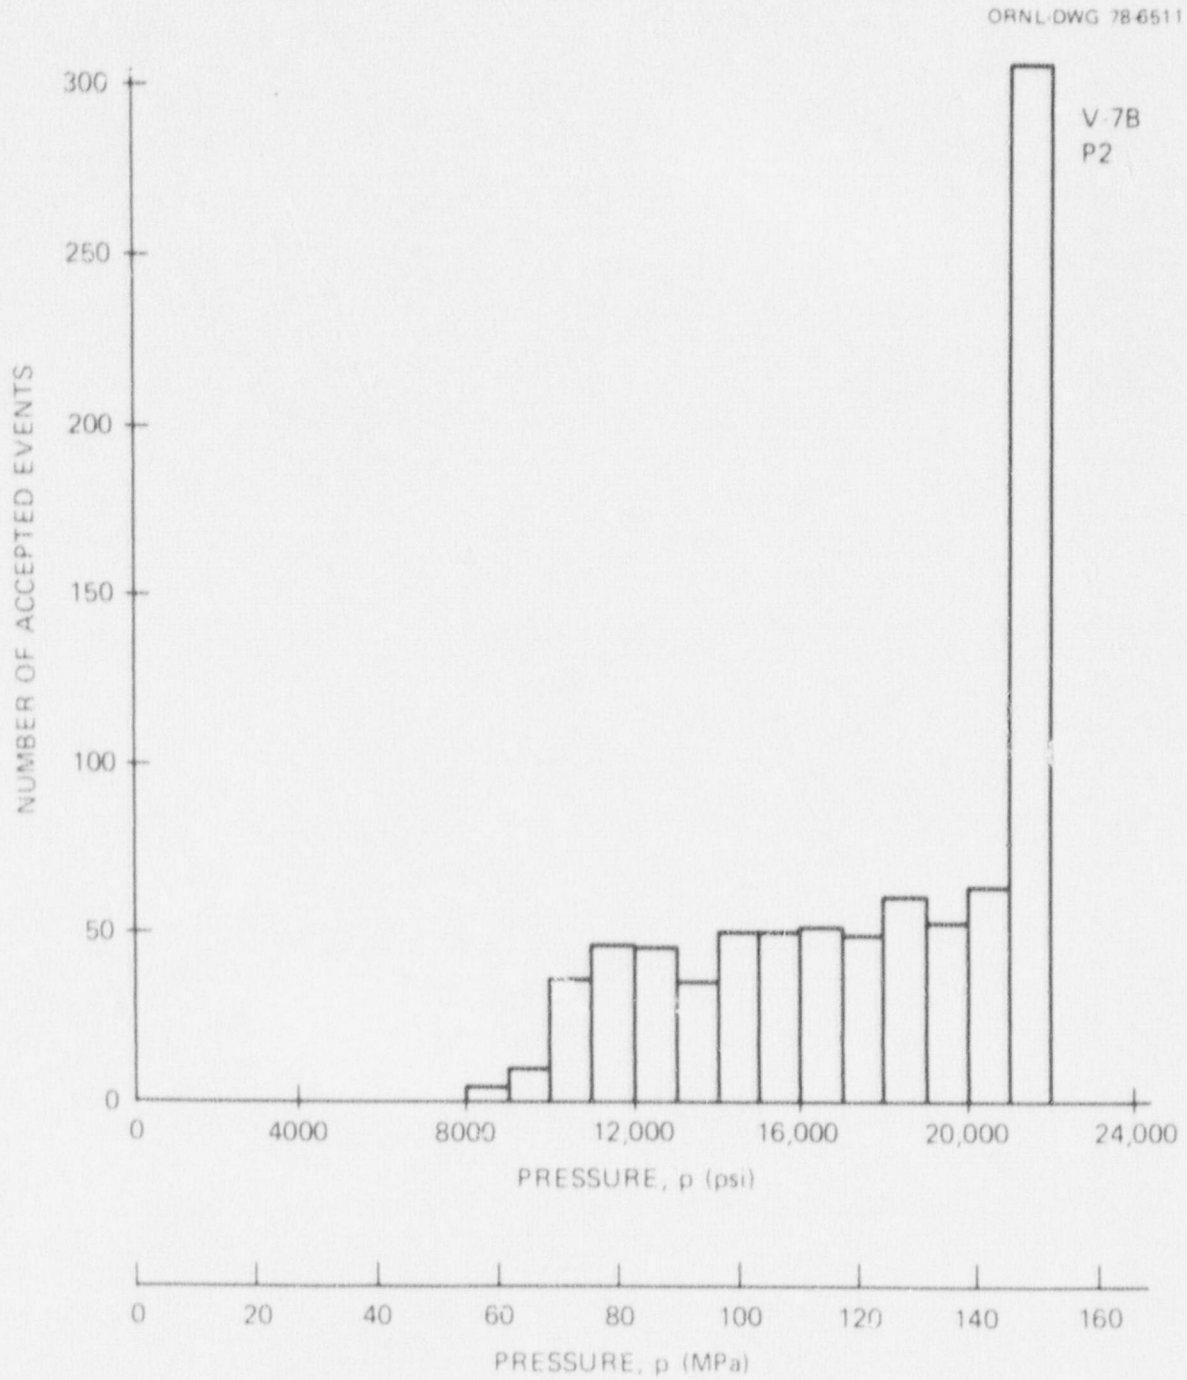
Fig. C.II. Event occurrence histogram: cycle 2.

During the second pressurization cycle, the vessel was loaded as shown in Fig. C.6 until a leak developed through the vessel wall at the flaw. The pressure was held constant for short intervals intermittently during the test while instrument scans were taken. For the first cycle, AE data were obtained throughout the loading cycle, and a total of 931 valid events were detected. Figure C.11 presents a histogram of event occurrence for each 3.4 MPa of load. Crack-opening displacements and summation of accepted events as a function of pressure are presented in Fig. C.12. It can be noted that the curves are of the same general shape in that both the displacements and number of events increase rapidly as failure is approached. Figure C.13 presents a summation of event magnitude voltages as a function of elapsed time* and pressure.

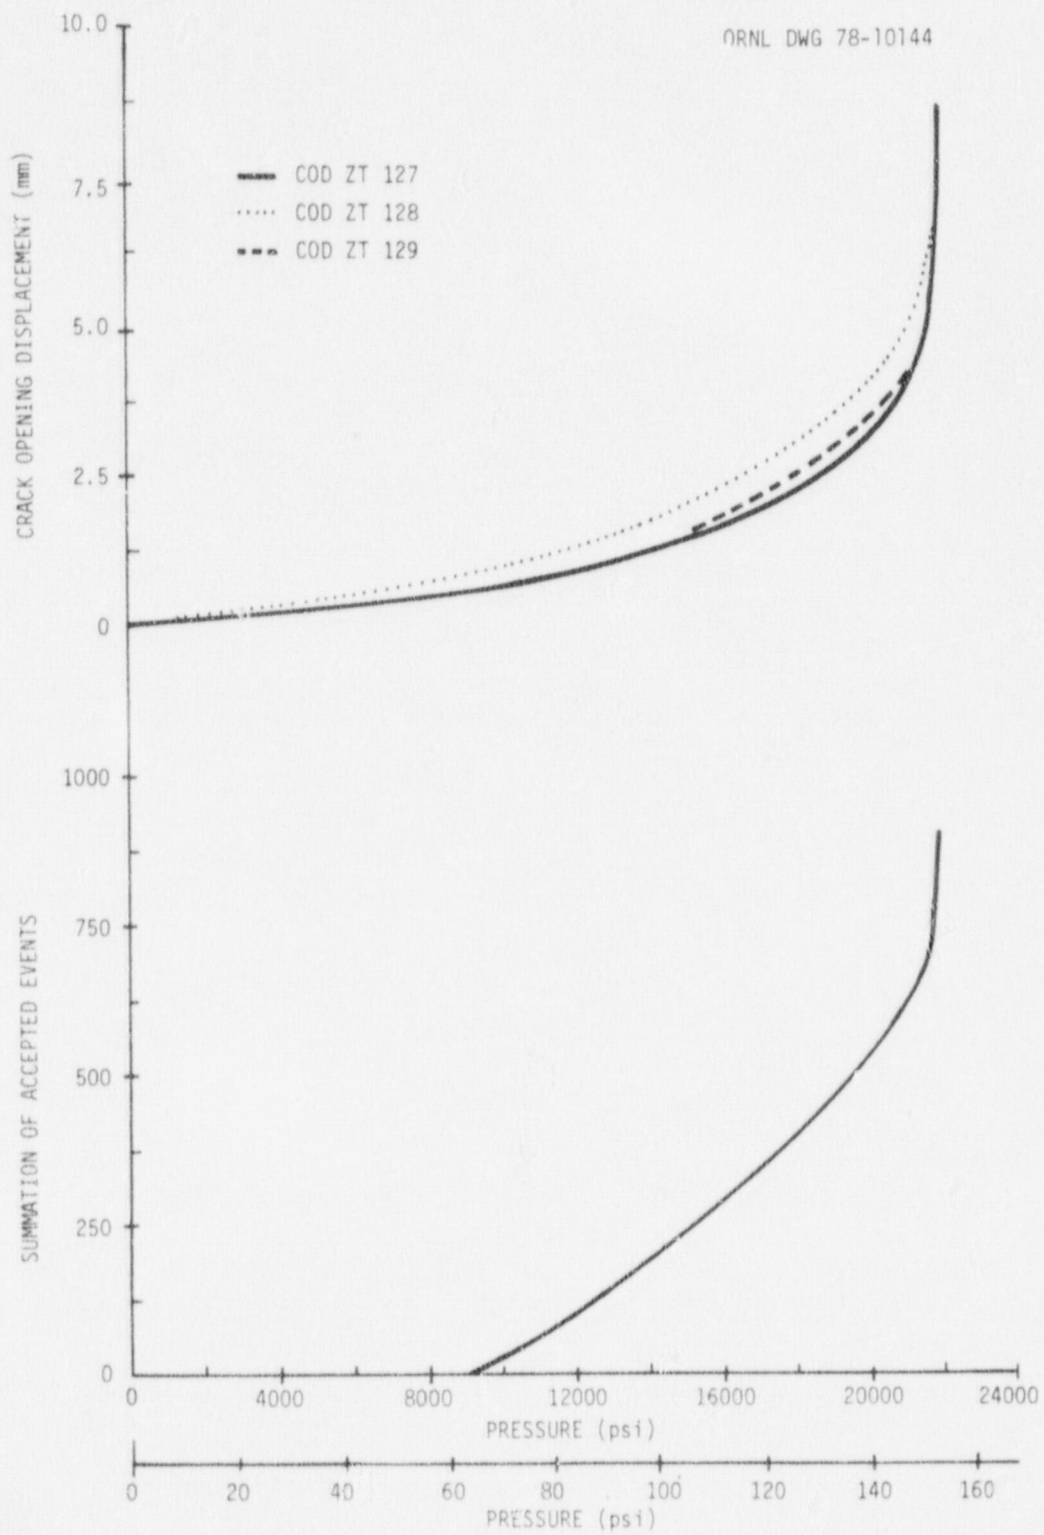
Fig. C.12. COD and summation of events vs pressure: cycle 2.

2. Plots of COD gages and summation of events as a function of pressure were geometrically similar.
3. At impending failure, the slope of the summation of events as a function of pressure changed drastically. This provides a possible technique for monitoring the vessel so that pressurization may be halted prior to failure. Also, as failure was approached, the magnitude of the emissions increased.

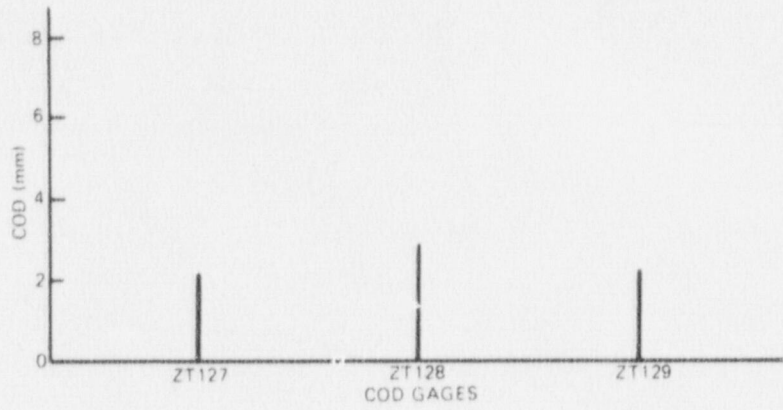
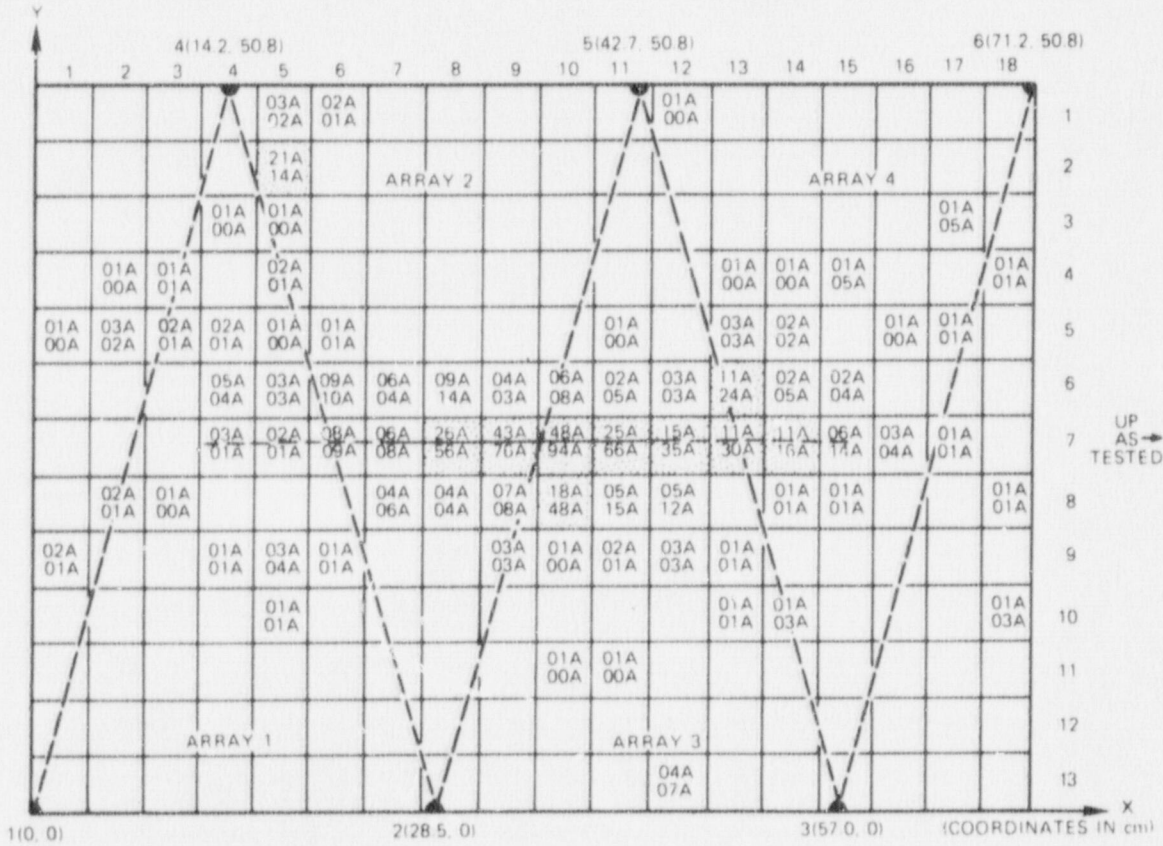
Fig. C.14. Grid display pressure cycle 2: P = 124.1 MPa, 402 events.

Two-dimensional grid displays were obtained for the second pressurization cycle both during and after completion of the test. Figures C.14 to C.19 present displays of events and voltage magnitudes as a function of location for pressures corresponding to 124.1, 144.8, 146.5, 148.2, 150 MPa, and at the conclusion of the test, respectively. Notations in these figures are the same as for Fig. C.10. Significant event occurrence by location* as a function of pressure interval is presented in Fig. C.20. As noted in the figures, regions of primary activity were adjacent to the flaw.

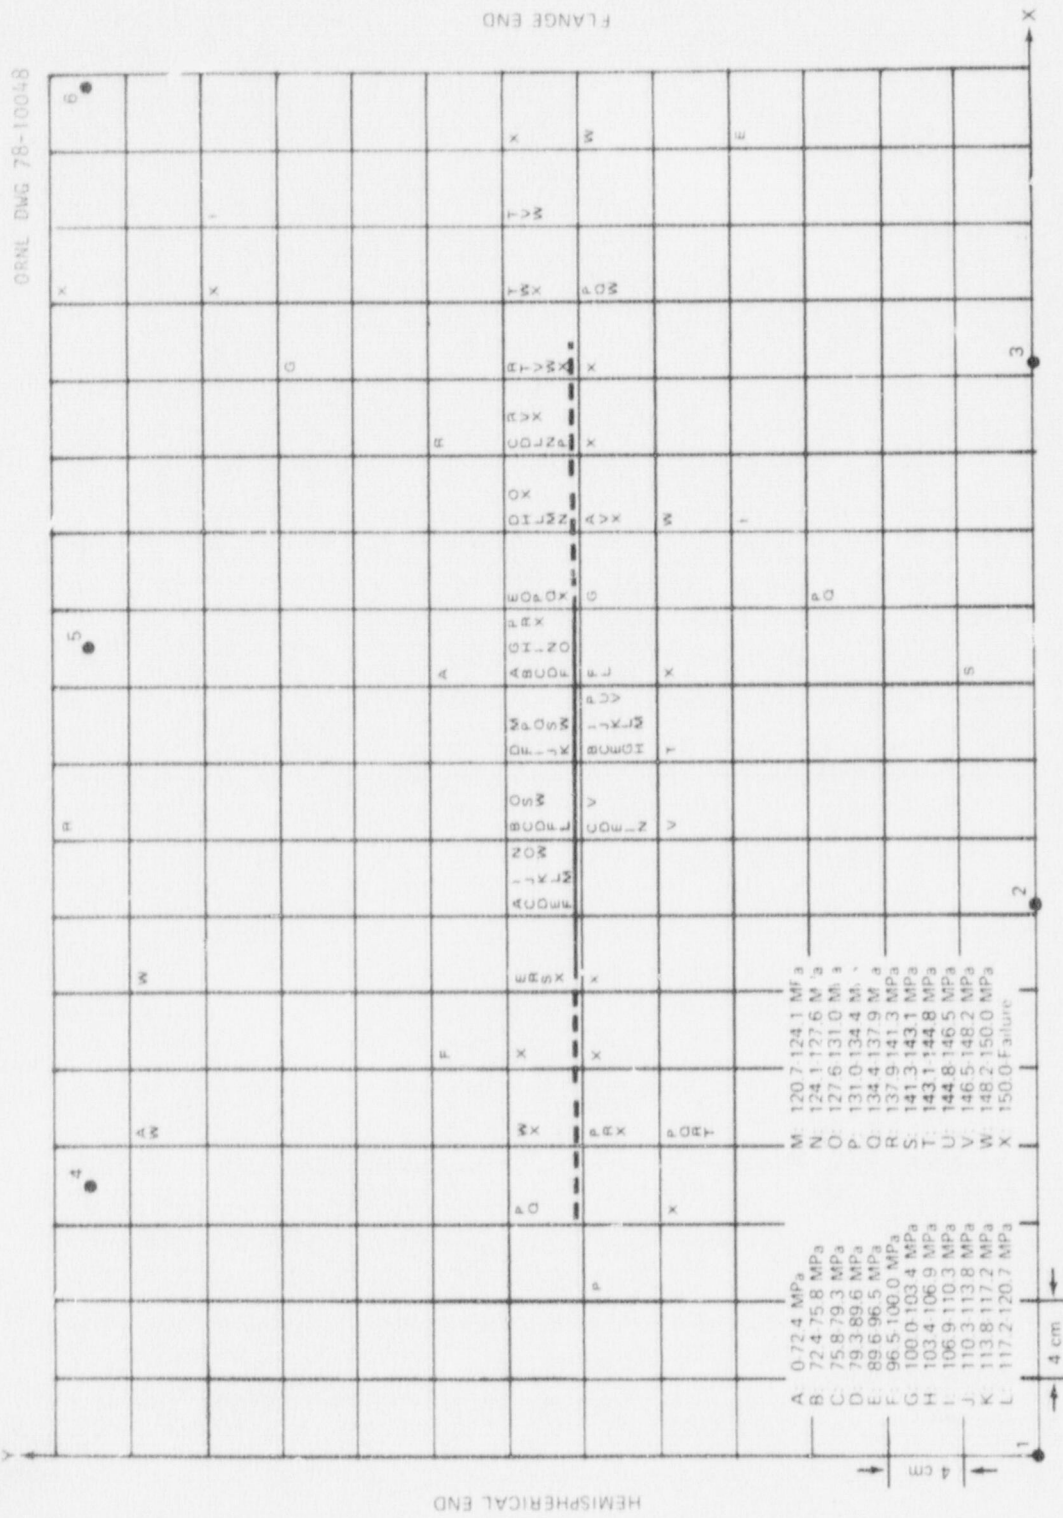
Fig. C-20. Significant event occurrence as a function of loading interval.

* Significant event occurrence by location is defined to be a grid square in the figure where at least four events or an event with a magnitude greater than 3.0 V has occurred during the pressure interval defined.
