RADIOLOGIC AND ENGINEERING ASSESSMENT

DOE ID NO.: GJ-97002-OT - PHASE II  
ADDRESS: THE 300 BLOCK OF MAIN STREET  
(BOTH SIDES FROM THIRD TO FOURTH STREETS)

JUNE 1989

SUPPLEMENTAL  
STANDARDS

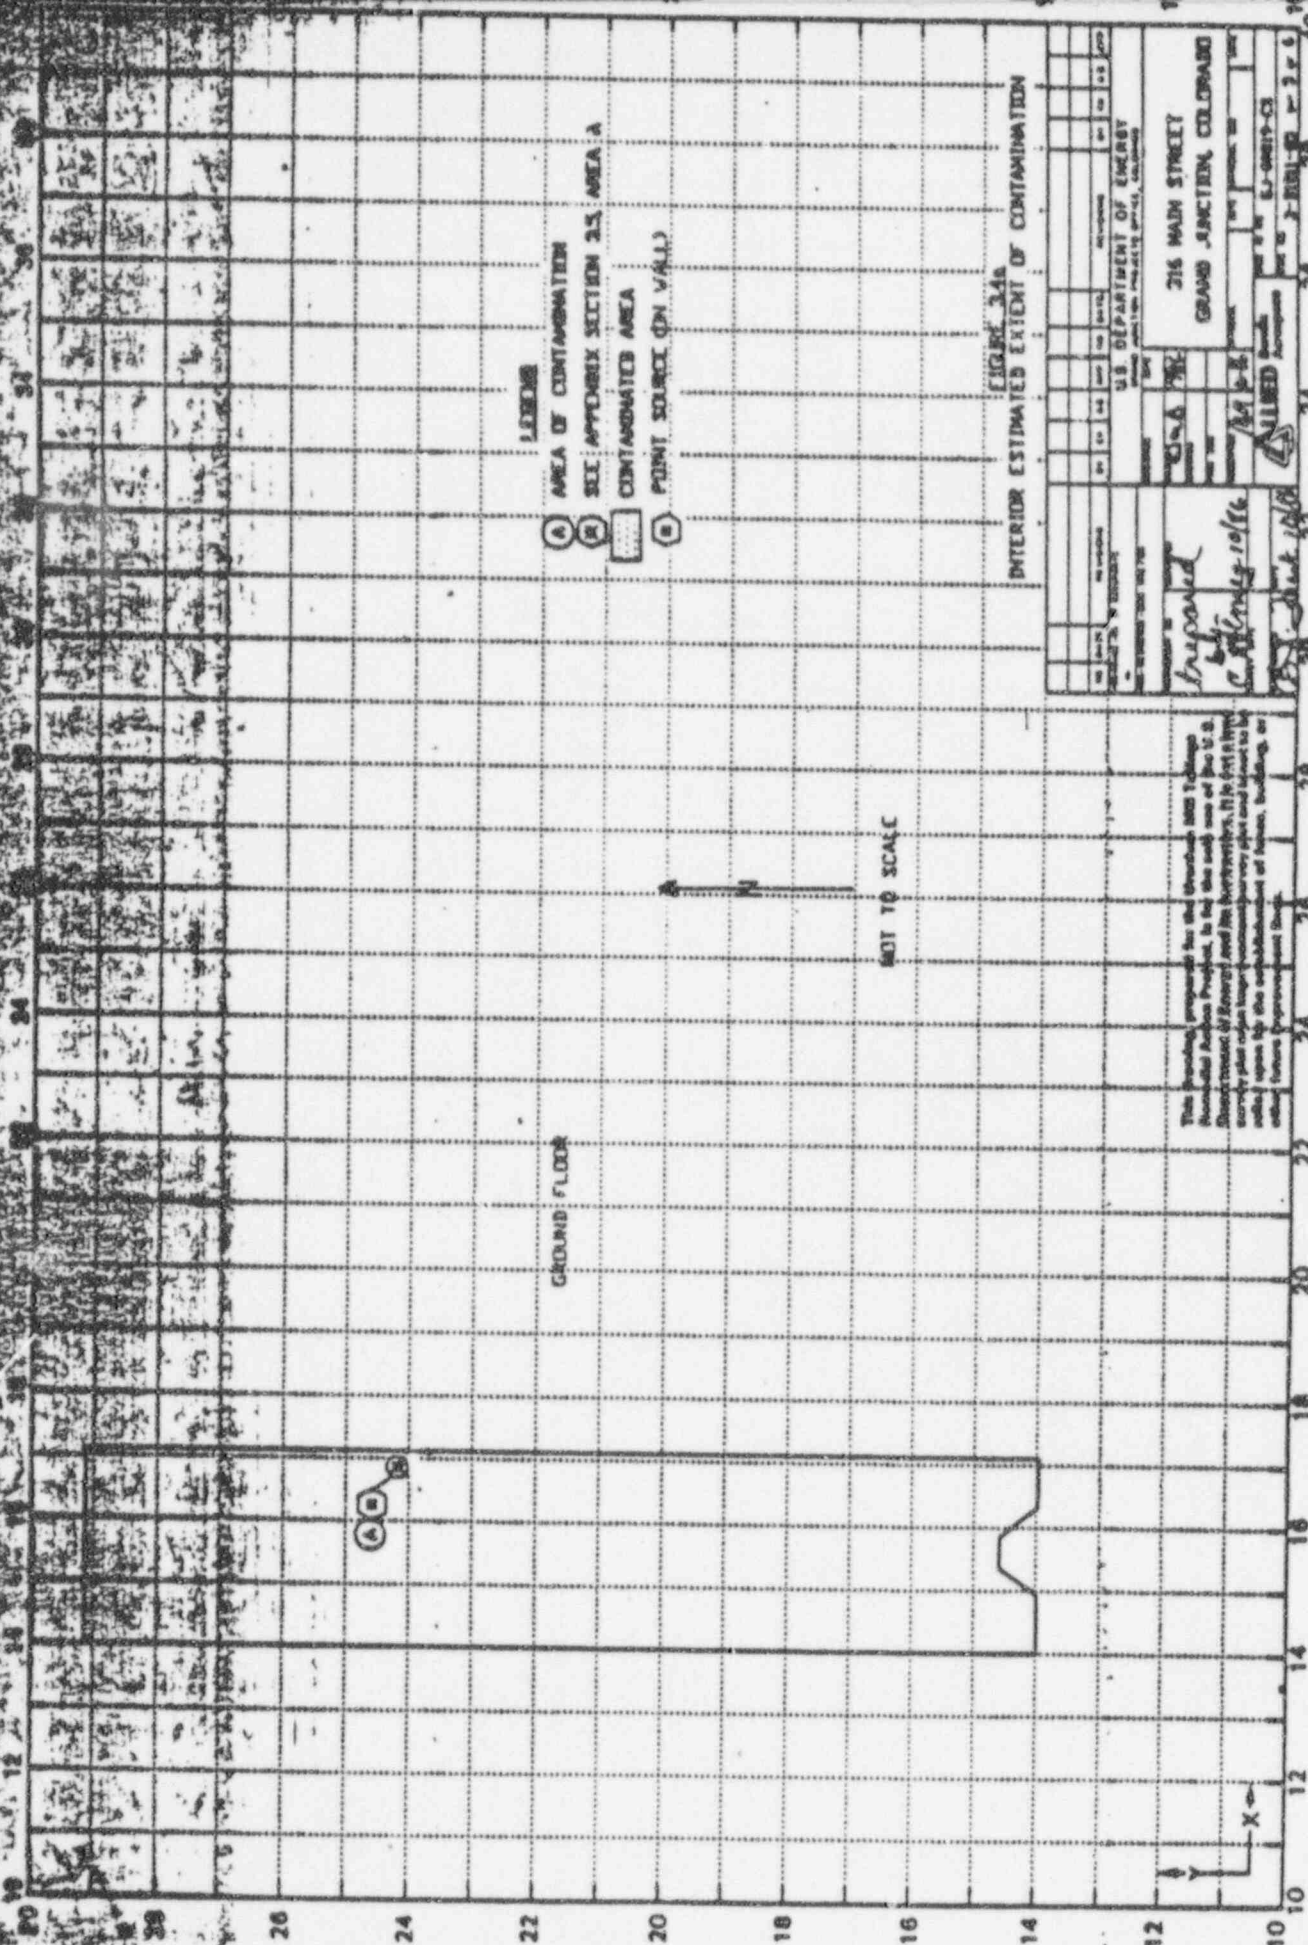
- (A) AREA OF CONTAMINATION
- (R) SEE APPENDIX SECTION 2.5 AREA A
- (C) CONTAMINATED AREA
- (S) POINT SOURCE (ON WALL)

Exterior Deposits A and B (Figure 3) should be removed and the appropriate cover material replaced.
