UNITED STATES
NUCLEAR REGULATORY COMMISSION

SUBJECT: GENERIC IMPLICATIONS OF THE SALEM 2 LOSS OF OVERHEAD
ANNUNCIATORS

ATTACHMENT 2
SUMMARY OF ROOT CAUSE ANALYSIS AND SAFETY SIGNIFICANCE

EVALUATION OF UNIT 1 AND 2
POWER OPERATED RELIEF VALVE (PORV) ACCEPTABILITY

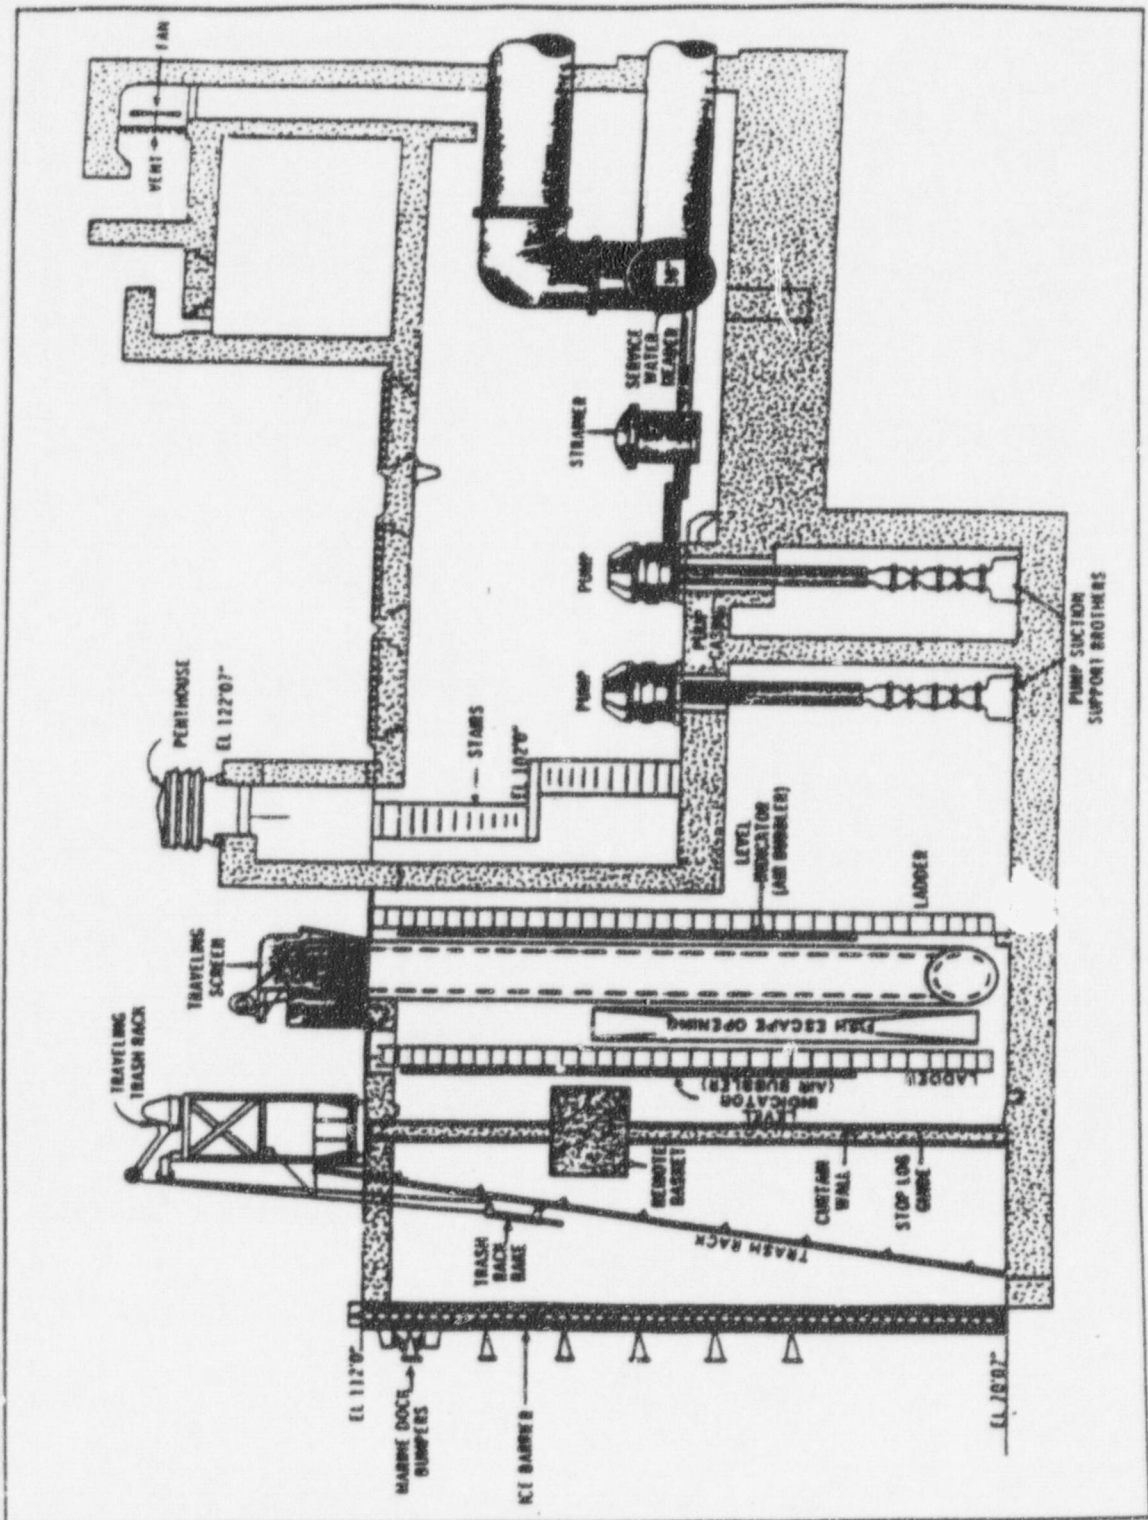
Figure 4. Salem CW Intake Structure and Equipment

Salem's SW intake is about 100 yds upstream (north) of the CW intake and Hope Creek's SW intake is about 3/8 mile upstream of the Salem SW intake. Water entering each intake structure passes through a trash rack, a moving screen, a pump, and, for SW, a filter. These are shown in Figs. 4 - 6 in Attachment 7. The bottom of both SW intakes is at about the river bottom, about 30 feet below surface grade. The CW intake bottom is 50 ft. below grade and the river bottom is dredged to that depth for the width of the intake structure and for a distance of 100 ft. from shore.
