NUREG/CR-4674  
ORNL/NOAC-232  
Vol. 20

# Precursors to Potential Severe Core Damage Accidents: 1993 A Status Report

Appendices E and F

Oak Ridge National Laboratory

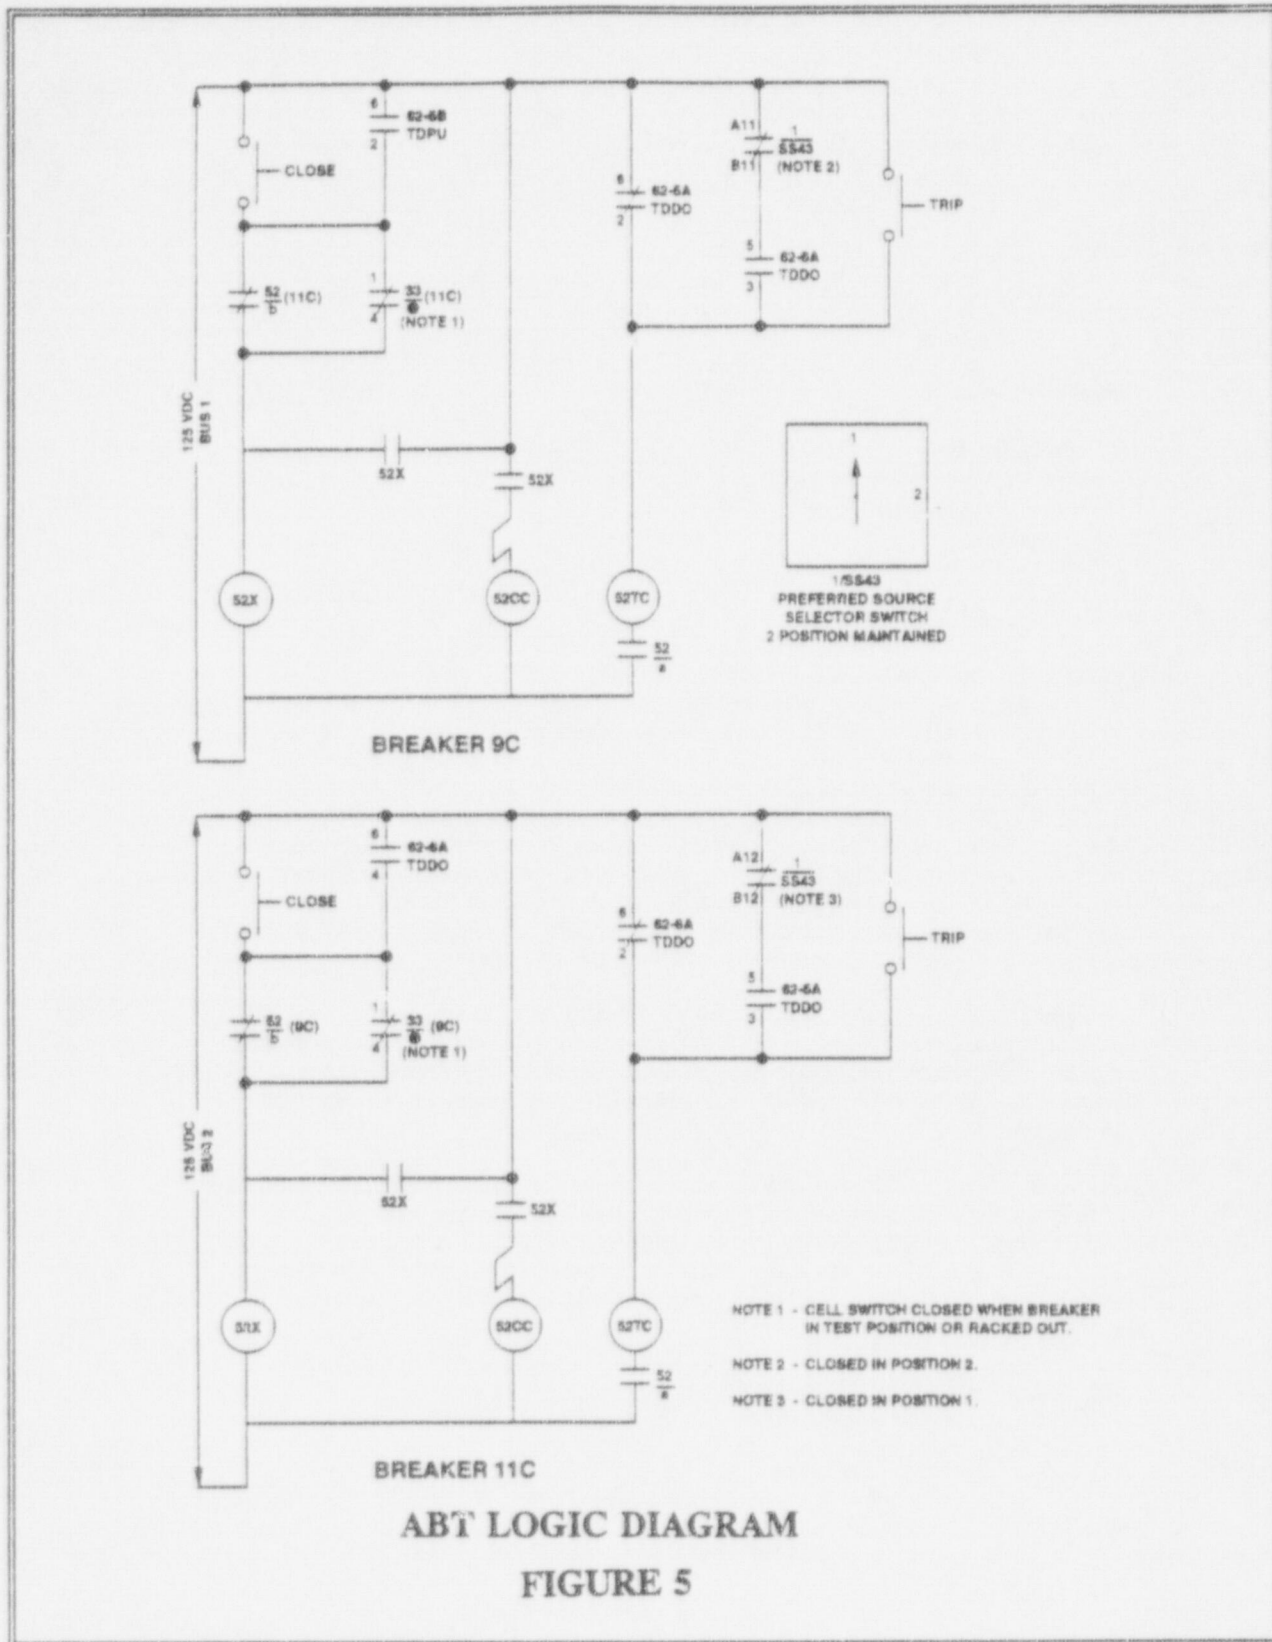
MCC-5 SIMPLIFIED DIAGRAM  
FIGURE 4

Motor-control-center-5 (MCC-5) and its associated automatic bus transfer scheme (ABT) are a design which is unique to the Haddam Neck Plant. The design is necessary because both trains of certain valves are required to mitigate the consequences of certain accidents assuming a single active failure. For example, MCC-5 supplies electrical power to the high and low pressure safety injection system injection valves. These valves are normally closed and must open for the high and low pressure injection systems to operate. For the low pressure safety injection (LPSI) system to satisfy its design basis flow, assuming a single failure of one LPSI pump, both injection valves must open. Similar constraints exist with the high pressure safety injection system. To address this design constraint, MCC-5 was designed with an automatic bus transfer (ABT) scheme which switches the 480 Volt electrical source for MCC-5 from its preferred supply bus (manually selected) to the alternate bus in the redundant train upon loss of power to the preferred source (see Figure 4). The transfer

The MCC-5 ABT scheme is shown in Figure 4. The components making up the circuitry are two Westinghouse DB-25 480 Volt air circuit breakers with their associated integral components (identified with a 52 or 33 prefix), three Agastat timing relays (identified with a 62 prefix), a two-position preferred source selector switch, and several manual trip/close pushbuttons. The Agastat timing relays are used to detect voltage on Buses 5 and 6 and thus are the components that initiate the automatic transfer. The breaker control relays (52X) provide contacts to momentarily energize their corresponding breaker's closing coil and provide the anti-pump protection which prevents repeated breaker closure attempts. A functional description of the operation of the ABT transfer is provided in Attachment B and Figure 5 of this inspection report.
