THE MEMORANDUM RELATING TO SHIPROCK (KEER-MOGEE) MILL INCIDENT

SUBJECT: Detailed Report of Data Regarding  
Shiprock Accident.

INVESTIGATION OF THE HOLDING POND RUPTURE AT THE KERR-McGEE OIL  
INDUSTRIES, INC., URANIUM MILL, SHIPROCK, NEW MEXICO - LICENSE  
R-157, AMENDMENT 2

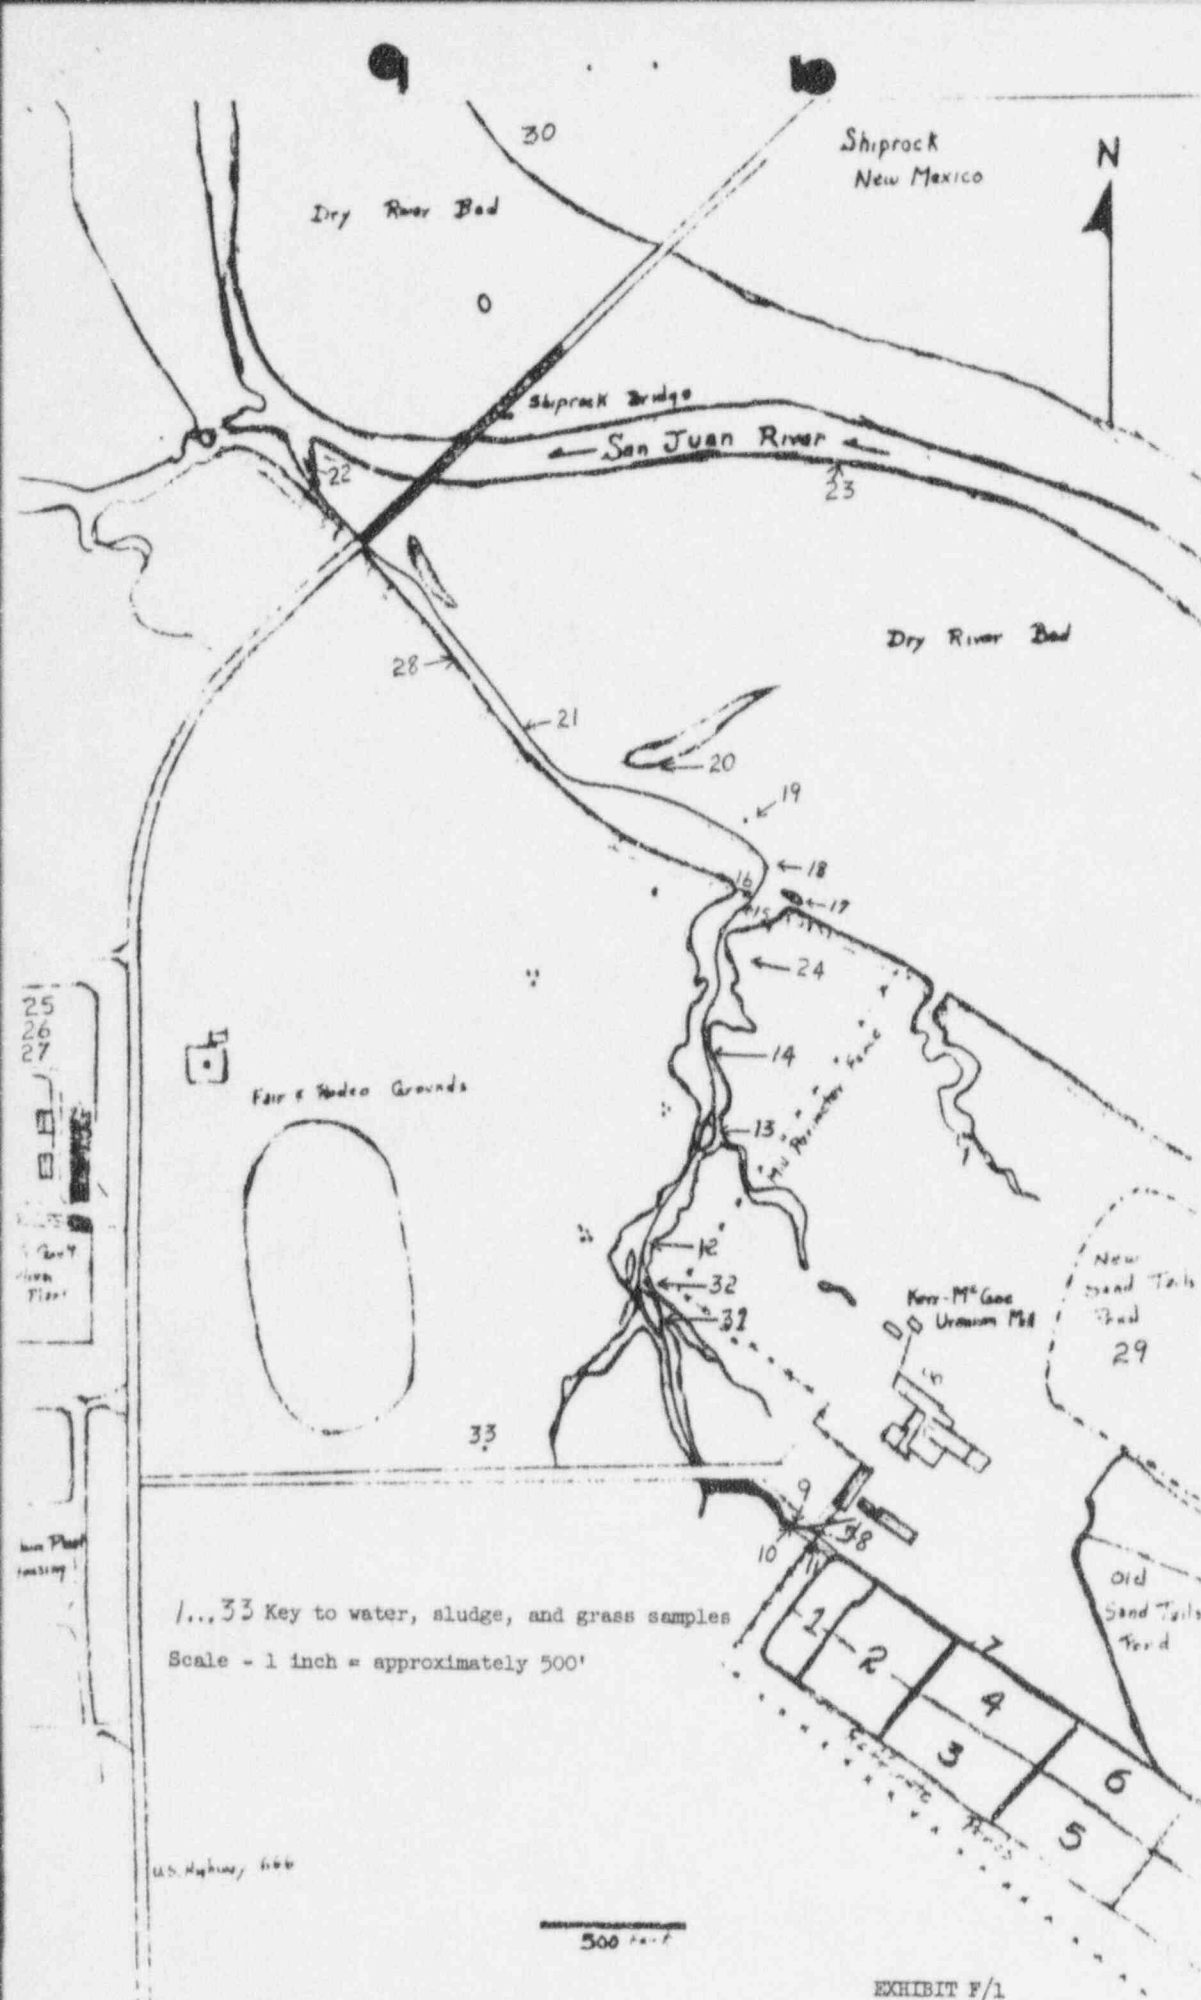
NECO-MCCEE OIL INDUSTRIES, INC.  
Shiprock, New Mexico

<u>Code</u>	<u>Description</u>
A	Holding pond - retaining wall broke releasing contents
B	Holding pond - filled simultaneously with Pond A
C	Approximate area on retaining wall that has been repaired
D	Eroded dry stream bed, down which the raffinate probably flowed
E	Confluence of cooling water stream and possible flood stream
F	Culvert through which the raffinate had to flow
G	Arroyo, down which the raffinate probably flowed
H	Helium plant water collection gallery
I	Approximate location of h. p. water collection pipes (approximately 3 feet under the sand)
J	Approximate location of one of the BIA wells
K	Confluence of cooling water stream and San Juan River
L	Approximate course of cooling water stream in the river bottom
