UNITED STATES
NUCLEAR REGULATORY COMMISSION
WASHINGTON, D. C. 20555

LICENSEE: Alabama Power Company (APCo)
FACILITY: Joseph M. Farley Nuclear Plant, Units 1 and 2
SUBJECT: SUMMARY OF MEETING HELD ON JANUARY 15, 1988, BETWEEN NRC AND
APCo REPRESENTATIVES TO DISCUSS GENERIC IMPLICATIONS OF A
CRACKED 6-INCH SAFETY INJECTION PIPE AT FARLEY UNIT 2 (TAC
66773)

Farley Nuclear Plant Unit 2 Cold Leg
Safety Injection Line Crack

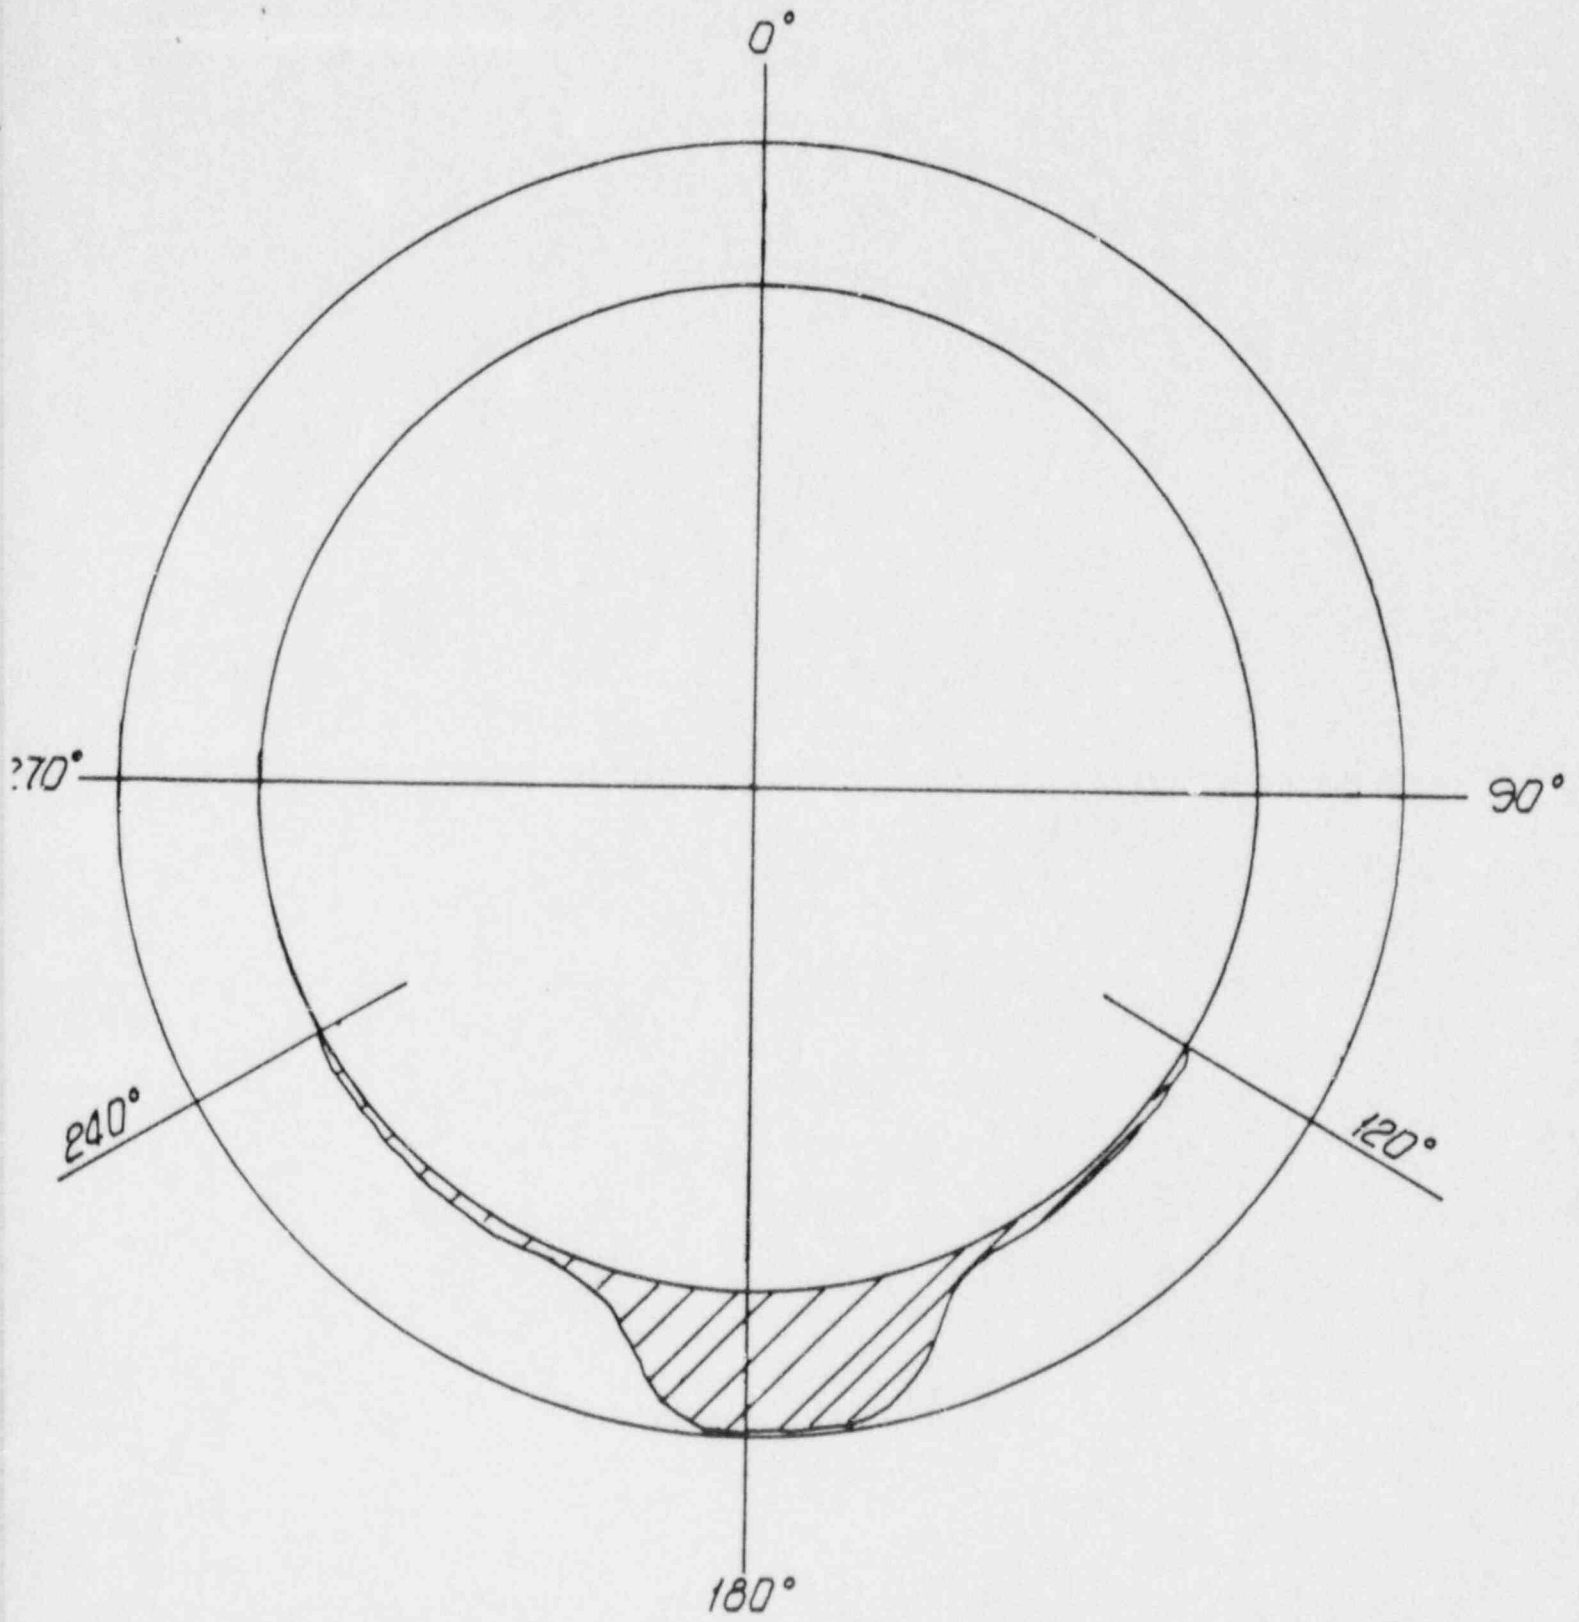
FARLEY NUCLEAR PLANT-UNIT 2
APR-1 4210
WELD NO. 16

1. Crack-like indications determined to be approximately 6" long and 100% through-wall for a distance of 1" and centered at the 6 o'clock position.
2. Partial examination due to support clamp.
3. Slag indication 3/16" long evaluated to be acceptable.
4. Porosity with linear indications located outside the area of interest.
5. These welds were removed and replaced as a part of the repair.
6. Weld No. 17 was radiographed to confirm the absence of defects as a result of a non-recordable indication found by UT.
7. Informational radiographs verified the presence of cracks on both sides of the weld.

- Corrective actions:
 - ° Unit 2, Loop B - None required as both welds were removed as a part of the repair (Table 1 and Figure 3)
 - ° Unit 2, Loop A - Both welds were radiographed and results were satisfactory

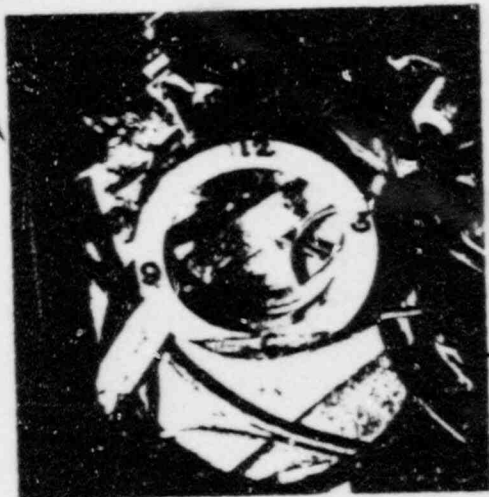
Light macrophotographs, schematically illustrating
the sectioning procedure employed for the leaked weld.

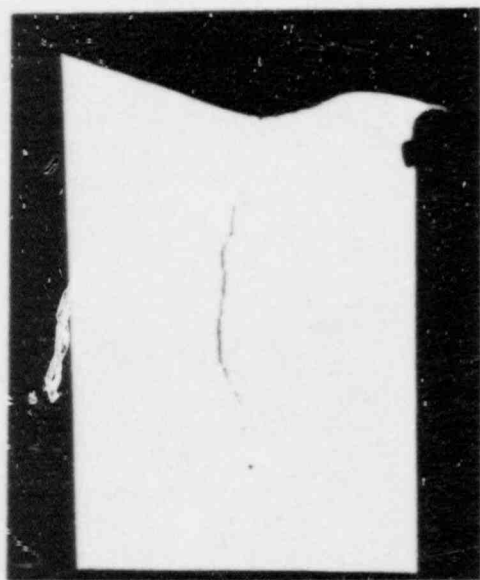
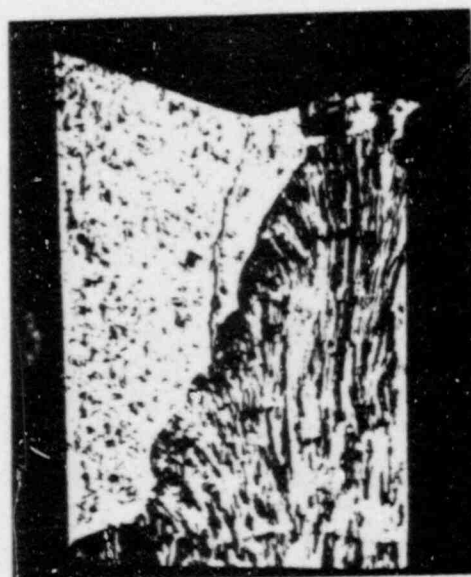
Light optical metallography results of the Section "C" illustrating the HAZ microstructures.

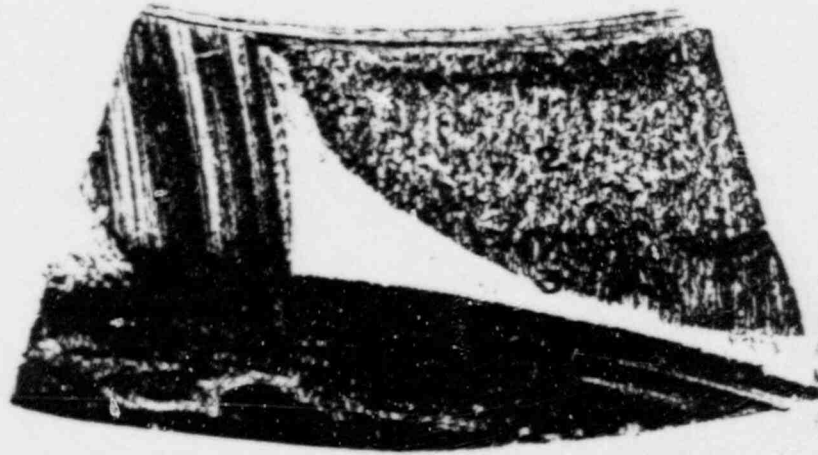
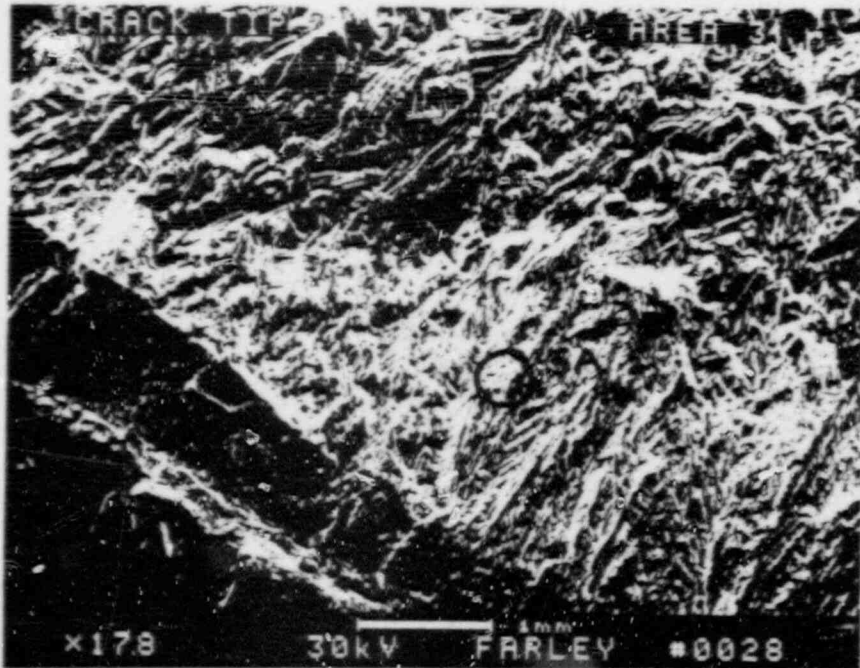
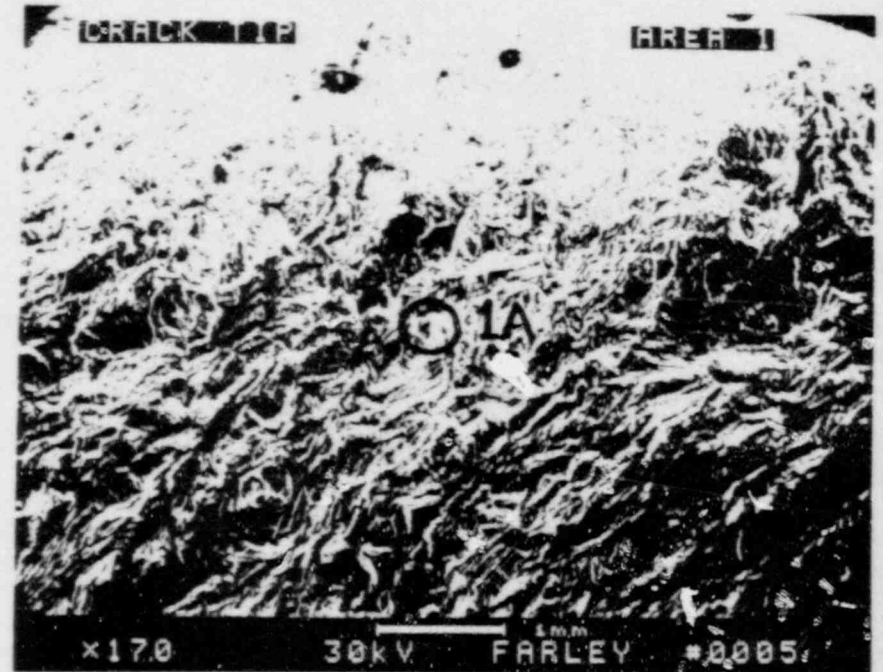
30
Scanning electron fractographs illustrating the fracture morphology of crack in piece "B".

- 0 FRACTOGRAPHIC EXAMINATION OF THE FRESHLY OPENED CRACKS BOTH IN THE BASE METAL AND WELD METAL REGIONS SHOWED THAT THE CRACKING WAS INITIATED ON THE INSIDE DIAMETER SURFACE AND PROGRESSED RADIALY OUTWARDS TO THE OUTSIDE DIAMETER SURFACE. CRACKING APPEARS TO HAVE BEEN INITIATED AT SEVERAL LOCATIONS OVER A BROADER REGION OF THE ID SURFACE RATHER THAN FROM A SINGLE ISOLATED INITIATION SITE. THE FRACTURE MORPHOLOGY FOLLOWED TRANSGRANULAR FACETS. HIGHER MAGNIFICATION SCANNING ELECTRON FRACTOGRAPHY CONFIRMED THE PRESENCE OF FATIGUE STRIATIONS PROGESSING FROM THE INSIDE DIAMETER SURFACE TO ALL THE WAY TO THE CRACK TIP NEAR OUTSIDE DIAMETER SURFACE. THE EVIDENCE OF FATIGUE STRIATIONS WAS ALSO CONFIRMED IN THE FRESHLY OPENED CRACK IN THE WELD METAL. HIGH RESOLUTION TRANSMISSION ELECTRON MICROSCOPY CONDUCTED ON REPLICAS TAKEN FROM VARIOUS LOCATION THE ENDOXED FRACTURE FACES CONFIRMED THAT THE FATIGUE STRIATION SPACING RANGED FROM APPROXIMATELY 4×10^{-6} TO 8×10^{-6} INCHES.

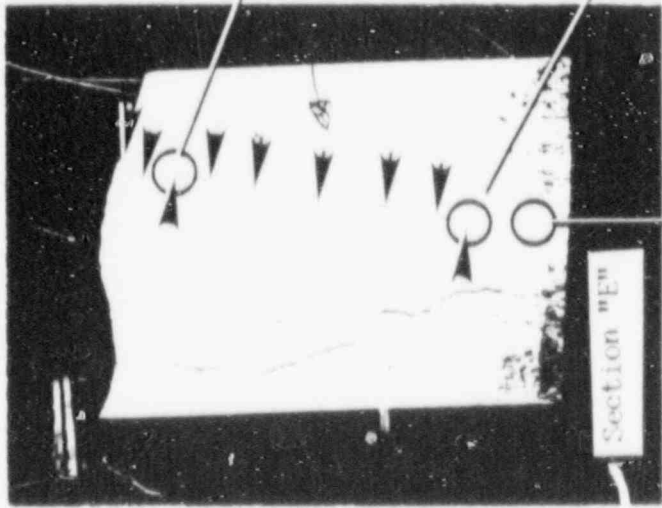
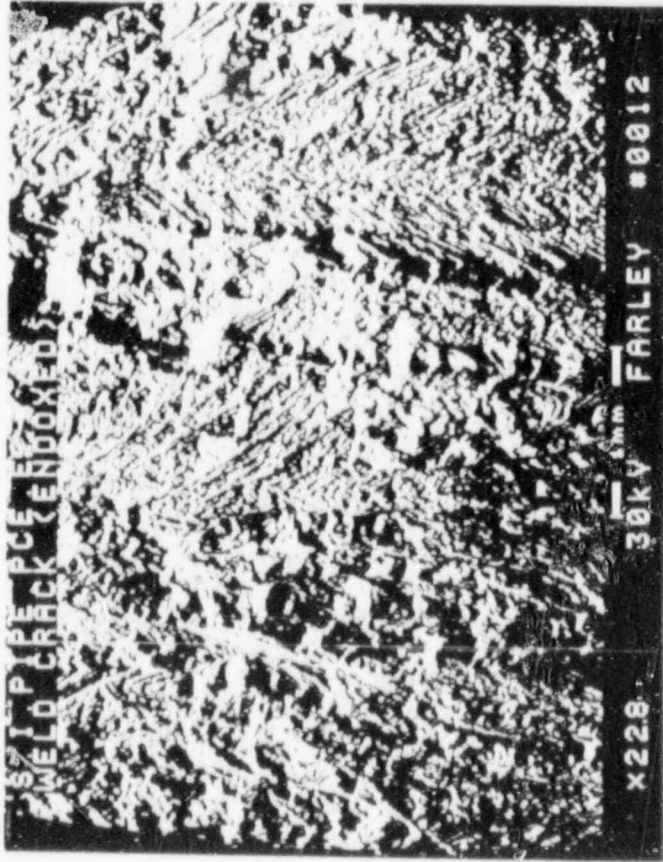
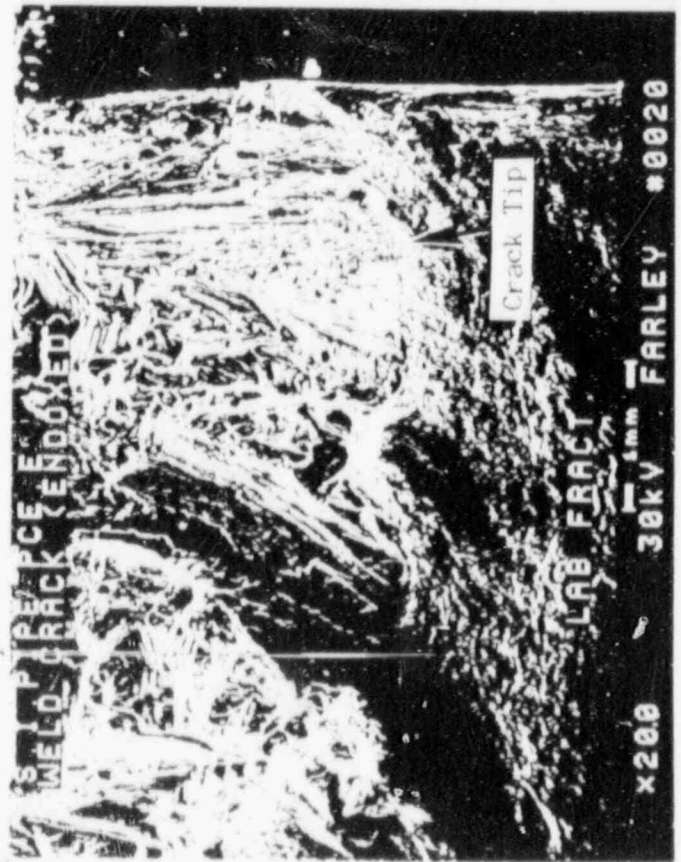
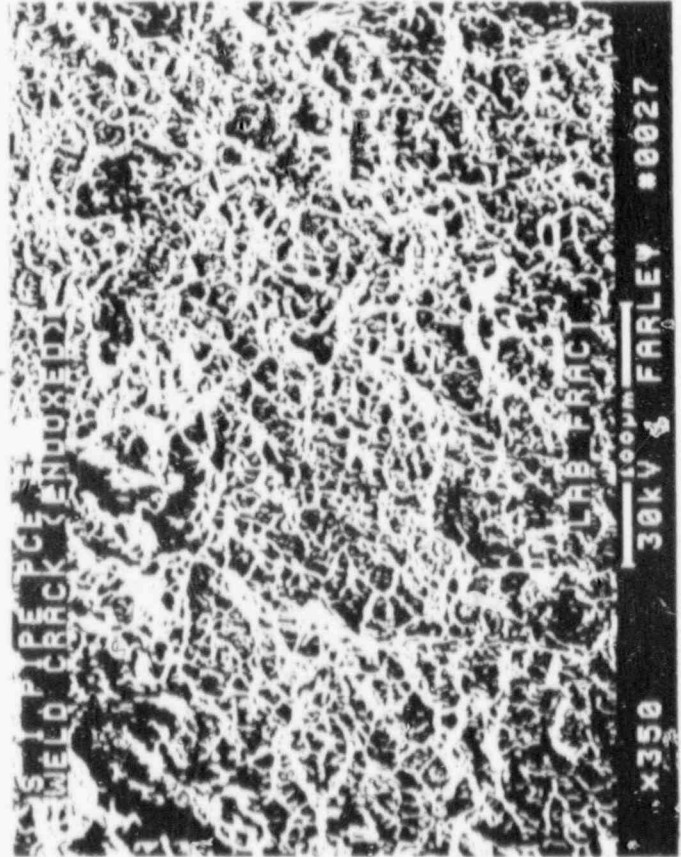
Scanning electron fractographs of the endoxided weld crack on the pipe side illustrating the morphology of the field fractured and laboratory fractured regions.

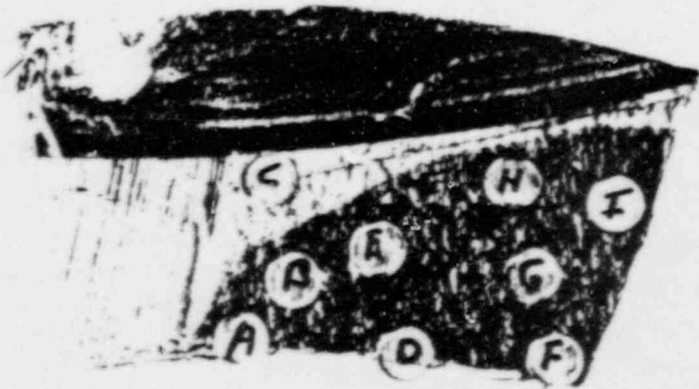
Sample B

Light optical fractographs illustrating the positioning of various replica grids employed for the examination of the evidence for fatigue striations in Samples B and D. (3.25x)

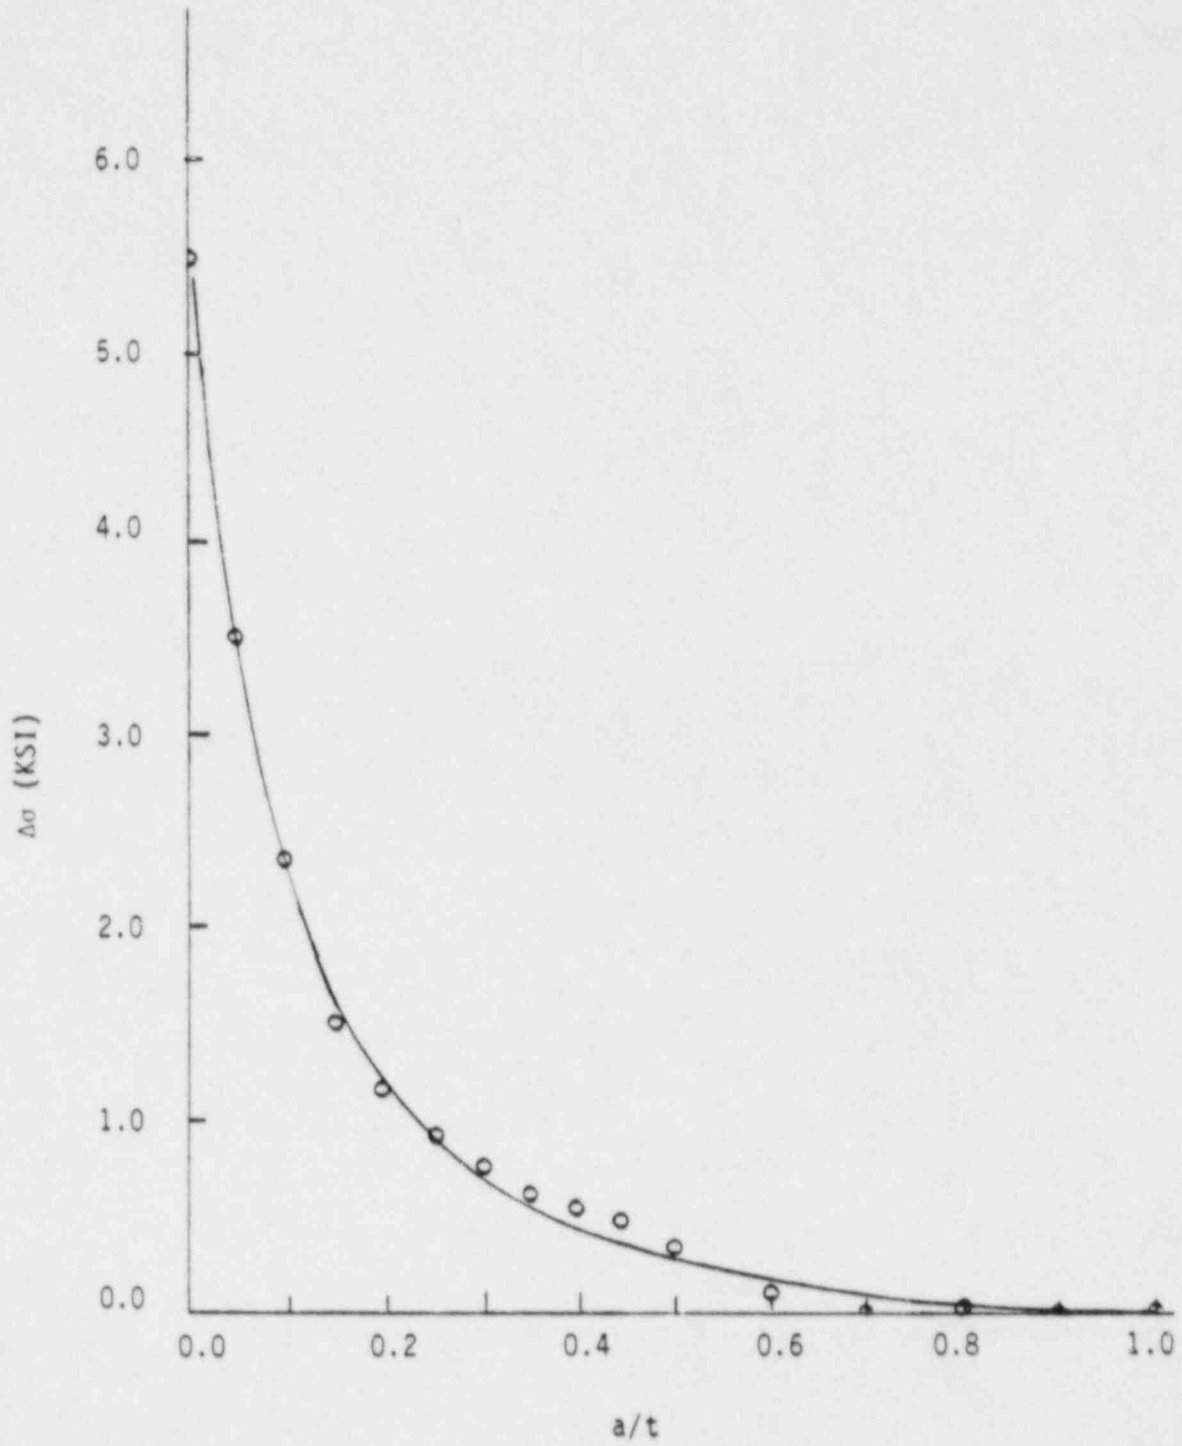
THROUGH-WALL STRESS DISTRIBUTION DERIVED FROM
PARABOLIC DISTRIBUTION OF STRIATION

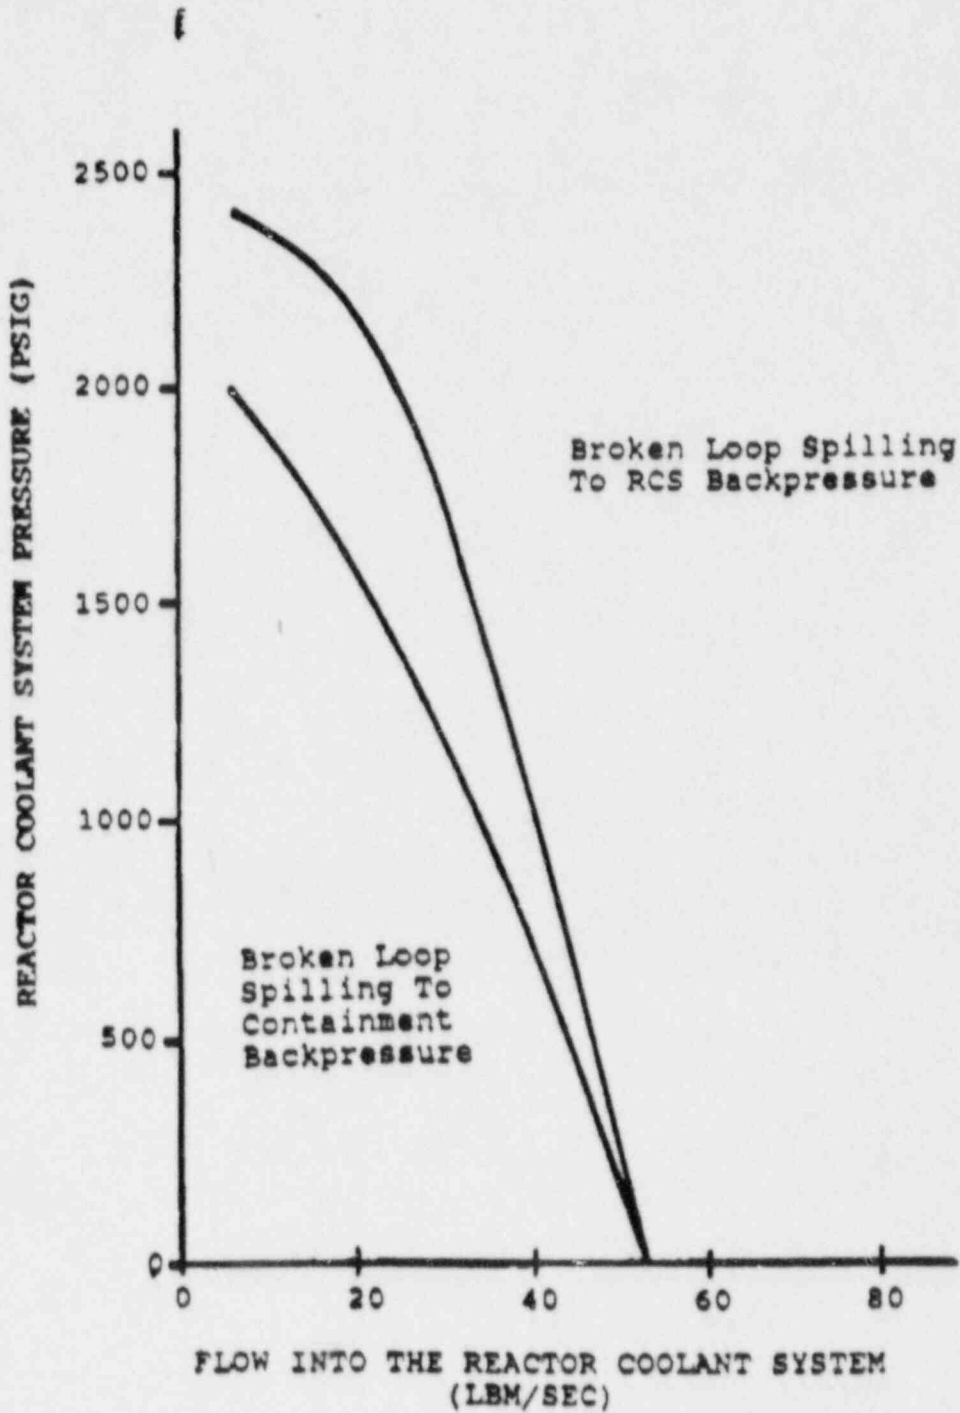
- ° Crack in SI line led to questions concerning Farley SBLOCA analysis of record (WFLASH)
- ° Review noted that the Farley WFLASH analysis inappropriately spilled the 6-inch break to RCS backpressure, not containment pressure
- ° Evaluation conducted to determine effect of the inappropriate spillage assumption
- ° This evaluation revealed an additional finding of an incorrectly reported PCT in the Farley FSAR

JOSEPH M. FARLEY ECCS HIGH HEAD INJECTION CURVES
(Minimum Safeguards, 1 Pump Operating, 1 Line Spilling)

- ° Increase of PCT by 45.7°F due effects of earlier core uncover and delayed recovery time (3.84 seconds)
- ° Increase of PCT by 9°F due to more precise reading of computer analysis output instead of summary sheets
