In Reply Refer To:
Docket: 50-267

FORT ST. VRAIN

NRC - PSC

MANAGEMENT CONFERENCE

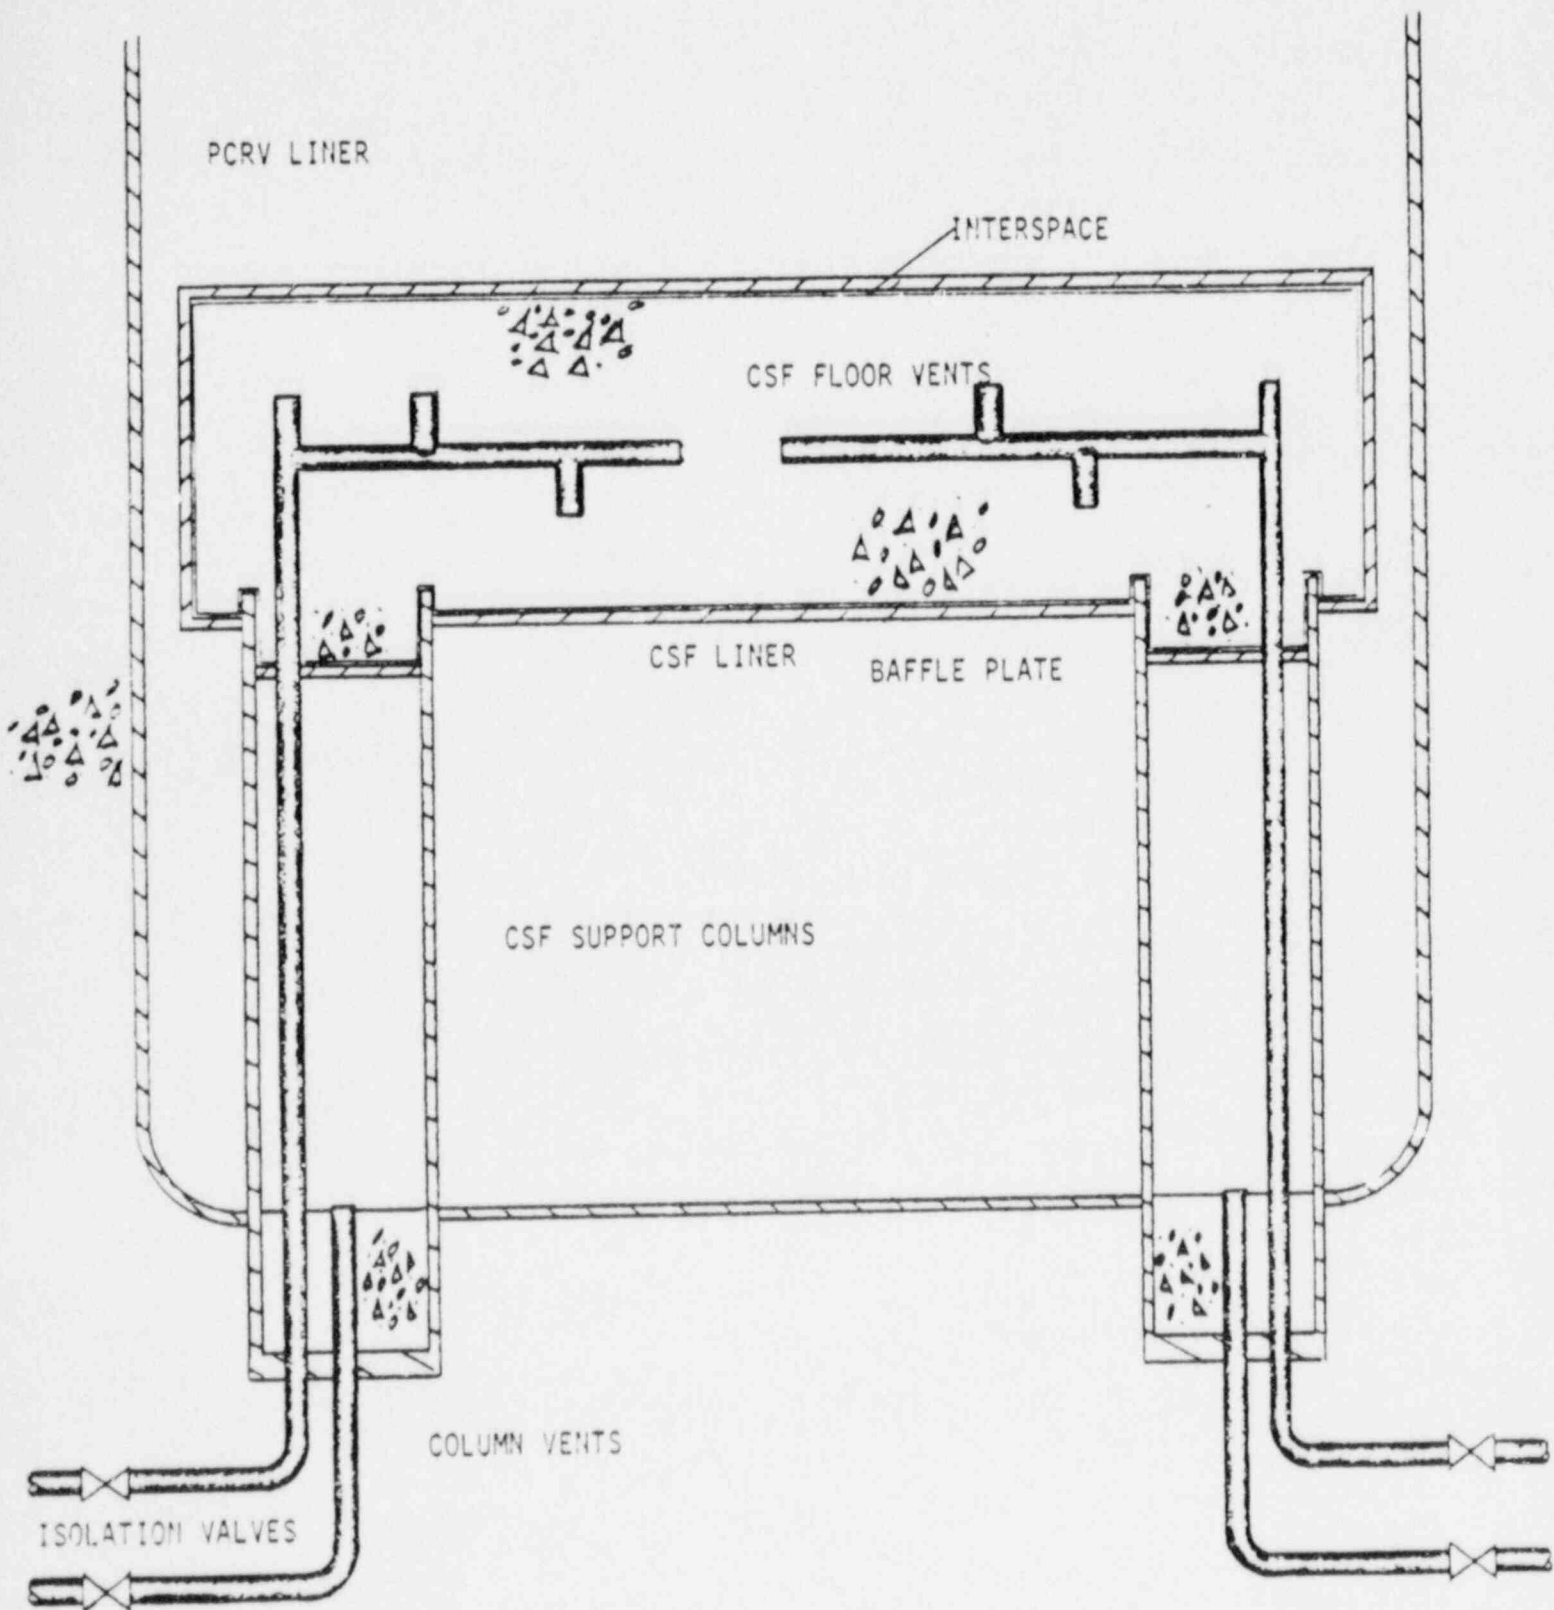
FIGURE 1 CORE SUPPORT FLOOR VENT SYSTEM

- o CSF COOLING TUBE F4T21 WAS REMOVED FROM SERVICE AND CAPPED EXTERNAL TO THE PCRV
- o SEPT, 1982 SIGNIFICANT CSF VENT GAS FLOW NOTED FOLLOWING A REACTOR SCRAM FROM 70% POWER
- o TWO (2) OF THE ORIGINALLY EPOXY REPAIRED CSF SIDEWALL TUBES WERE IDENTIFIED AS LEAKING
- o INSTALLED A LAMINAR FLOW ELEMENT IN THE CSF VENT SYSTEM TO PERMIT FLOW DETERMINATION MONITORING AND TRENDING (DEC 1982)
- o CHARACTERIZED CSF LINER LEAK BASED ON PRIMARY COOLANT CONDITIONS

- o OUT OF THE MANY EVALUATIONS A PASSIVE VENT SYSTEM WAS IDENTIFIED AS A POSSIBLE SOLUTION TO THE CSF LINER LEAK

- PASSIVE VENT SYSTEM WORK BEING RE-EVALUATED FOR PHASED IN APPROACHES
