Reactor Operating Experiences

1975 - 1977

U.S. NUCLEAR REGULATORY COMMISSION LICENSEE OPERATIONS EVALUATION BRANCH

REACTOR OPERATING EXPERIENCES
1975-1977

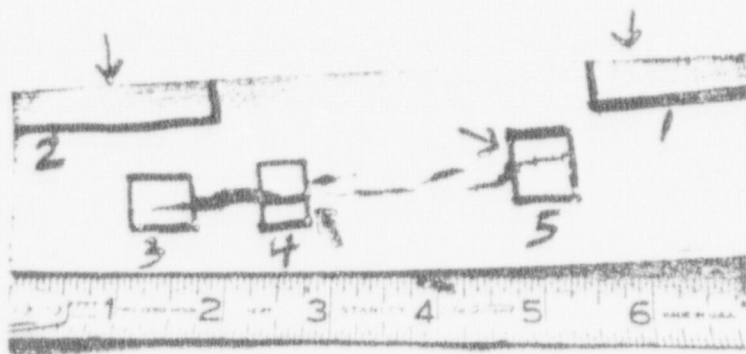
Figures 3 and 4 are photographs of the outside and inside surfaces respectively after the application of a dye penetrant. Since the cracks are more severe on the inside surface, it appears likely that they were initiated on this surface.

The main crack was approximately 3" long on the outside and 6" long on the inside surface. The numbers in Figure 4 represent the various sections which were individually subjected to metallurgical examination. Figures 5 and 6 illustrate the formation of transgranular cracks in the heavily cold worked surface. This propagation changed to an intergranular mode below the cold worked surface. This specimen was obtained from Section 1 of the sample shown in Figure 4. In Figure 7 significant carbide precipitation at the grain boundaries is clearly visible for the Number 1 sample.

Based on laboratory tests, the structure and hardness of all five specimens, obtained from the pipe sections illustrated in Figure 4, were similar.

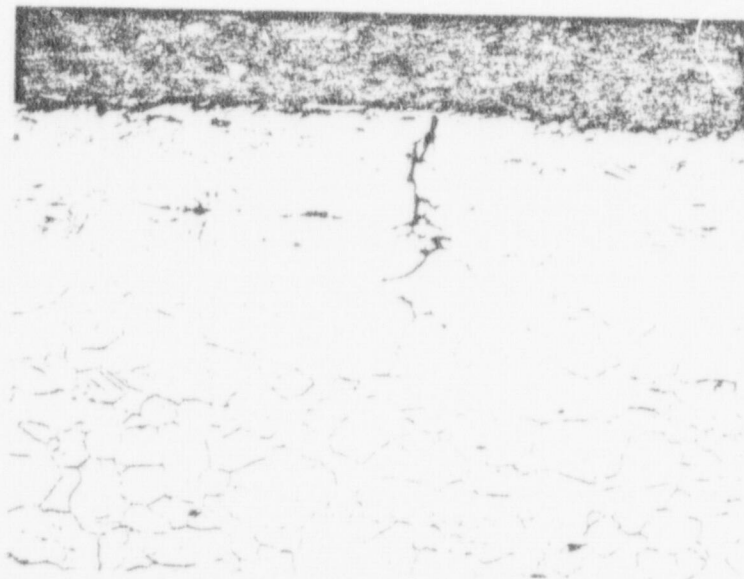
Figure 8. Magnification 100x

Figure 8 (a photograph of Section 2 specimen noted in Figure 4) reveals another crack in the cold worked surface which appears to be transgranular although it has started to propagate in an intergranular mode.
