# Aging and Qualification Research on Solenoid Operated Valves

Prepared by V. P. Bacanskas, G. J. Toman, S. P. Carfagno

Franklin Research Center

Prepared for  
U.S. Nuclear Regulatory  
Commission

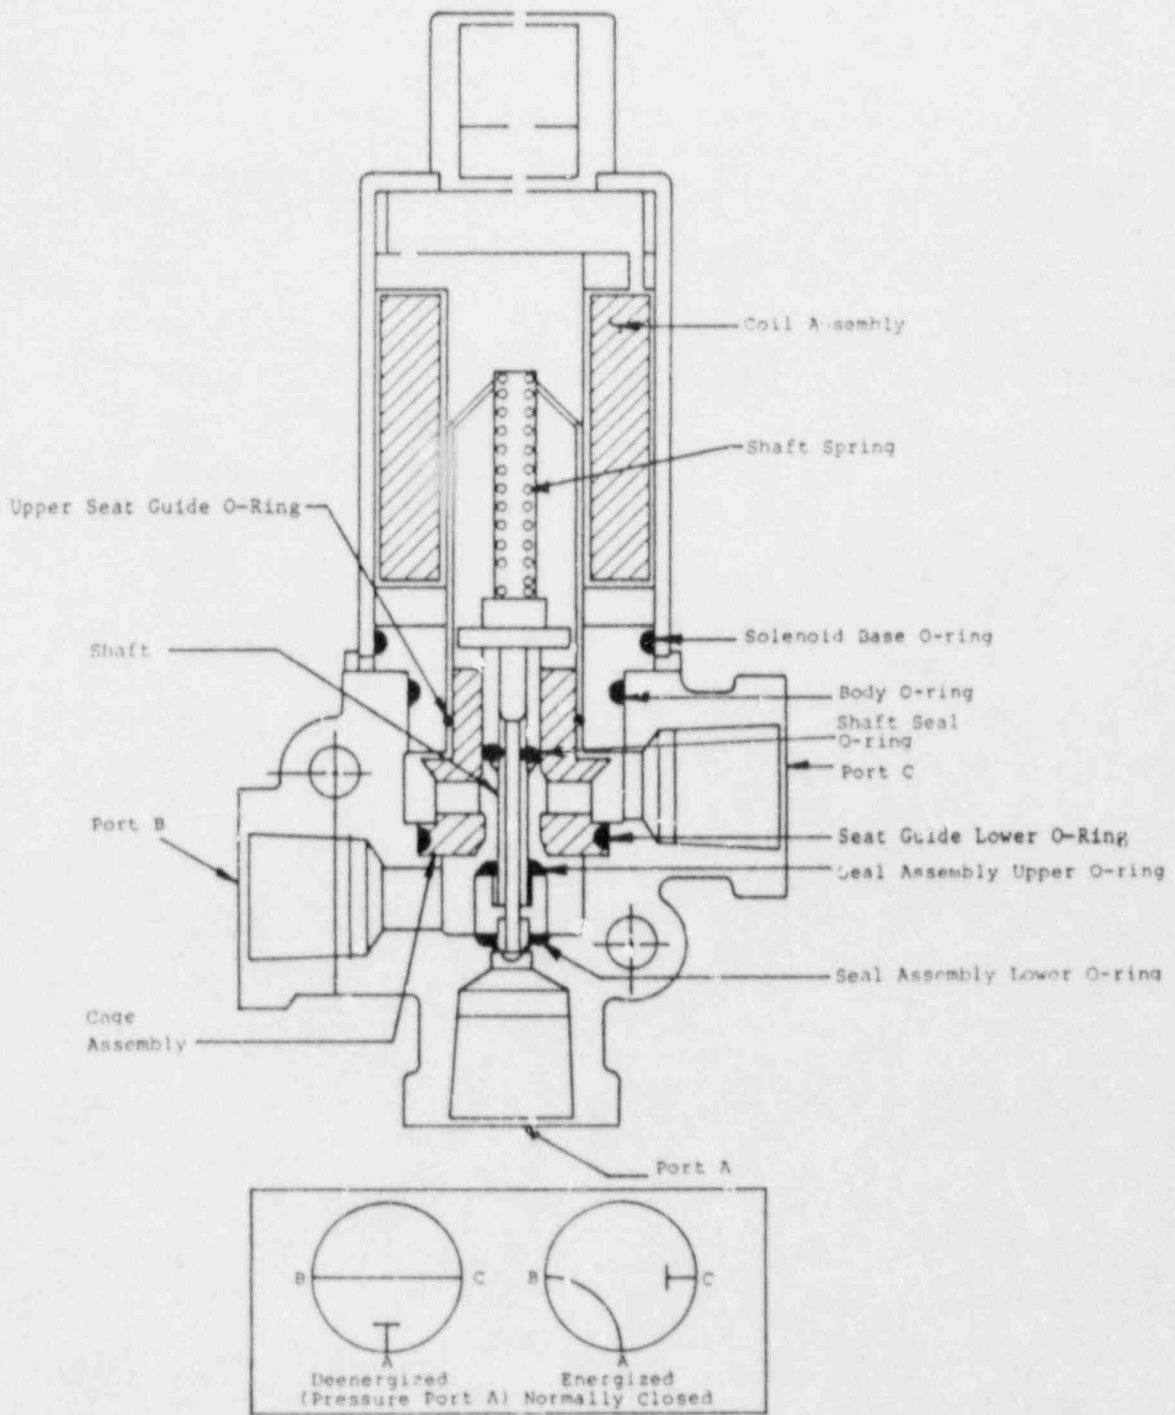
Figure 2. Section View of Valcor V-70900-2i SOV

Two of the three Valcor SOVs (6096-22 and -23) failed to return to their deenergized position upon deenergization of their coils. A failure analysis showed that the failure to transfer was caused by sticking of the shaft seal O-ring to its guide tube. Using a spare Valcor\* SOV, the temperature of the shaft seal O-ring was measured as 278°F (137°C) at the thermal aging temperature of 230°F (110°C). The temperature measurement confirmed that the temperature at the shaft seal O-ring had not exceeded the manufacturer's suggested limit of 300°F (149°C).

Further evaluation of the failure indicated that the observed failure could have been the result of peculiarities of the accelerated thermal aging procedure which would not occur in a plant environment. Two possible causes were hypothesized.\*\* The first hypothesis was that the physical and chemical changes of the EPDM O-ring that occurred at the elevated aging temperature and caused it to adhere to the guide tube, rather than slide in it, are different from the changes that occur under service conditions. The second hypothesis was that creep of the O-ring at the aging temperature under the stress of the process pressure far exceeded the creep that could occur under the same pressure at service temperatures. At the aging temperature (278°C [137°C]), the O-ring tends to soften; therefore, the 150-psig process pressure would tend to compress the O-ring between the shaft it rides on and the shaft guide tube (see Figure 7). When the oven temperature was reduced to room temperature with the SOV energized, the O-ring returned to a less pliable state and prevented movement of the shaft.

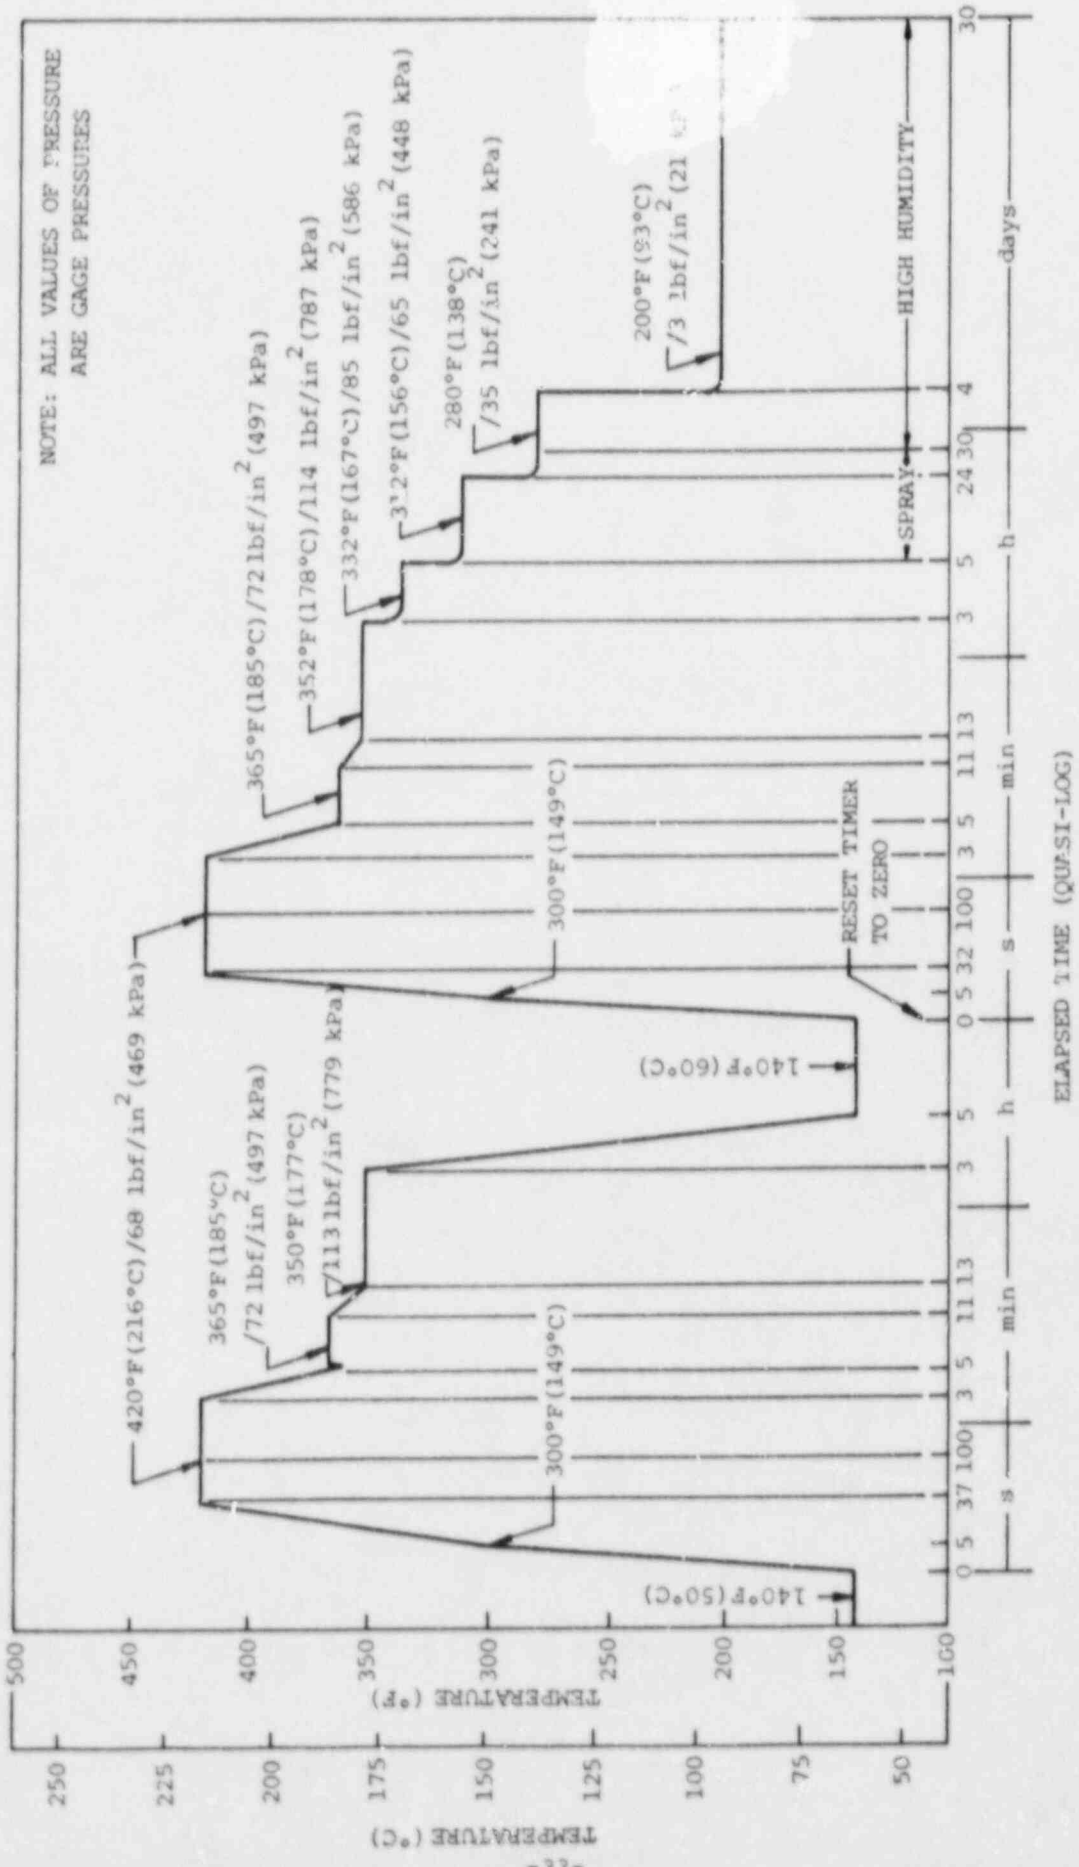
Figure 8. Actual Temperature and Pressure Profile of Simulated MSLB/LOCA Exposure

1. During the drop in temperature/pressure from 420°F (216°C)/68 lbf/in<sup>2</sup> (469 kPa) to 365°F (185°C)/68 lbf/in<sup>2</sup> (469 kPa) of the first transient, the temperature inadvertently decreased to a minimum of 335°F, as shown in Figure 8. The total period of this deviation was less than 2 minutes and is not considered to have a significant effect on the program. The temperature deviation is shown on an expanded time scale in Figure 9.

The actual temperature/pressures recorded throughout the first and second transients to the peak temperatures are shown in an expanded time scale in Figures 10 and 11, respectively. Aside from the minor deviation mentioned in Item 1 above, the actual temperature profile (Figure 8) was practically identical to the specified profile (Figure 6, Appendix A).
