# Loss of Power and Water Hammer Event at San Onofre, Unit 1, on November 21, 1985

U.S. Nuclear Regulatory  
Commission

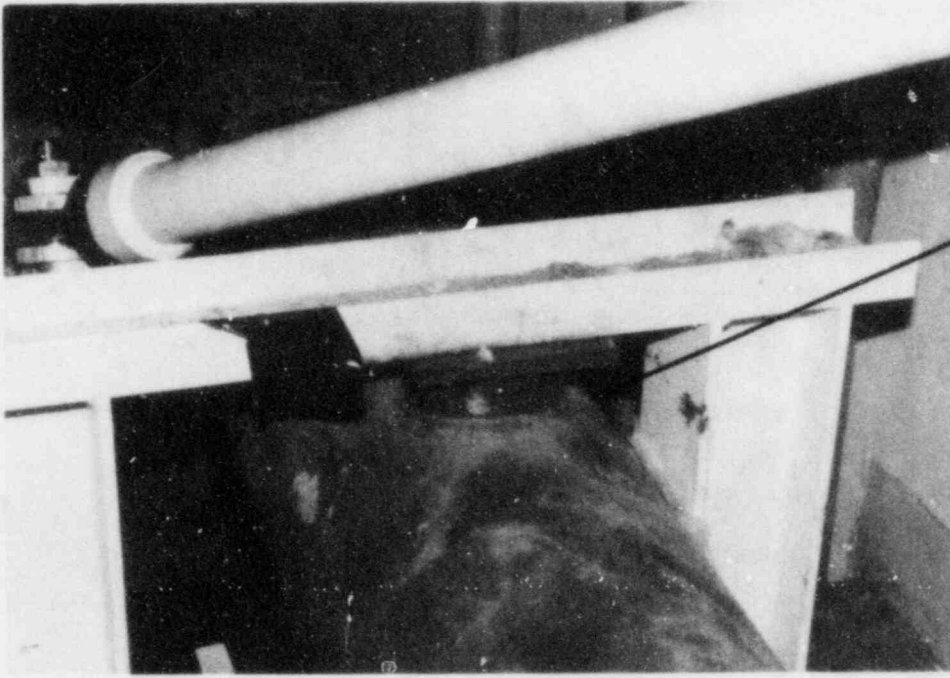
Figure 6.10 FW Line "B" Loop Support HOOD

NOTE LATERAL  
MOVEMENT OF  
PIPE WESTWARD  
APPROXIMATELY  
8 INCHES, AND  
DISPLACEMENT OF  
PIPE INWARD  
TOWARDS CONCRETE  
WALL.

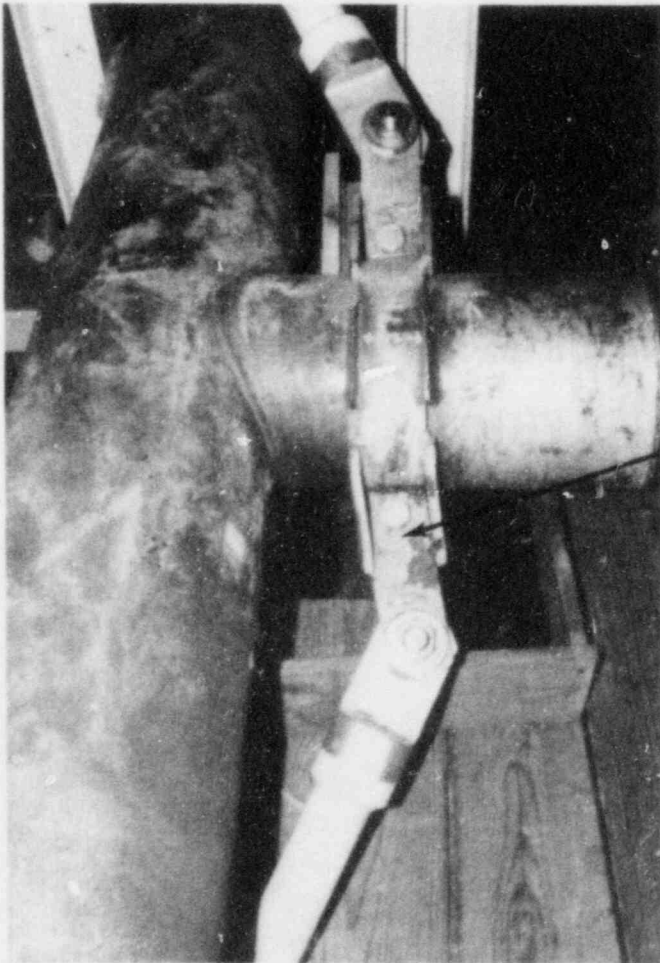
Figure 6.11 FW Line "B" Loop Supports H005 & H006

NOTE BENT BRACKET  
DUE TO LATERAL  
PIPE MOTION; VIEW  
LOOKS WESTWARD  
TOWARDS SUPPORTS  
H00A, H00B, & H00C.

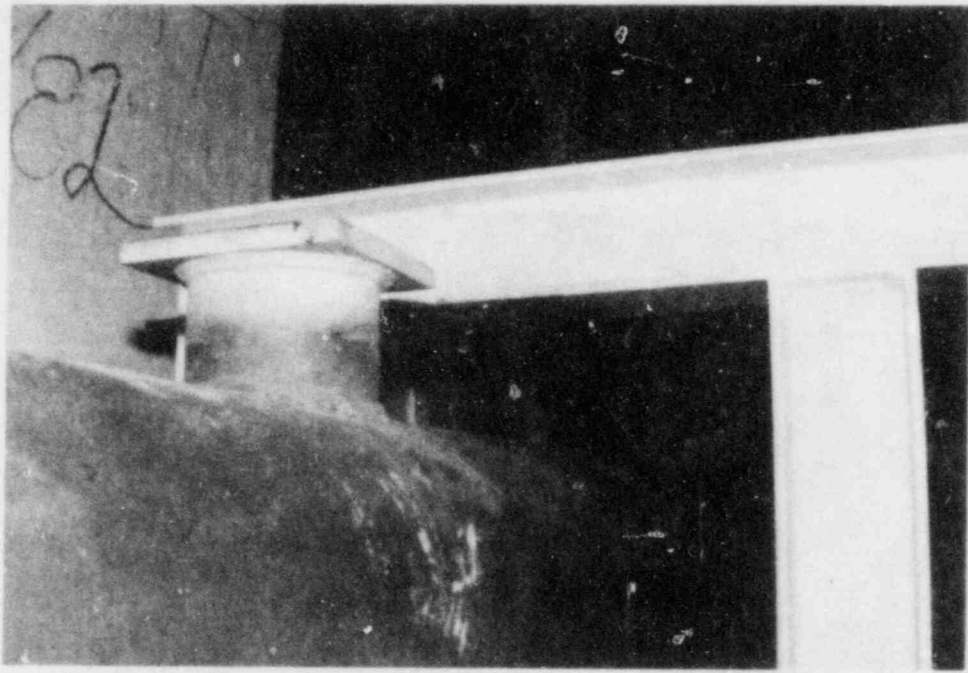
Figure 6.14 FW Line "B" Loop Support HOOG, Looking Northward

6.14	View of support H00G looking in opposite direction from Figure 6.13.	H00G
6.15	View of horizontal and vertical support pads displaced southward approximately 12 inches.	H00H

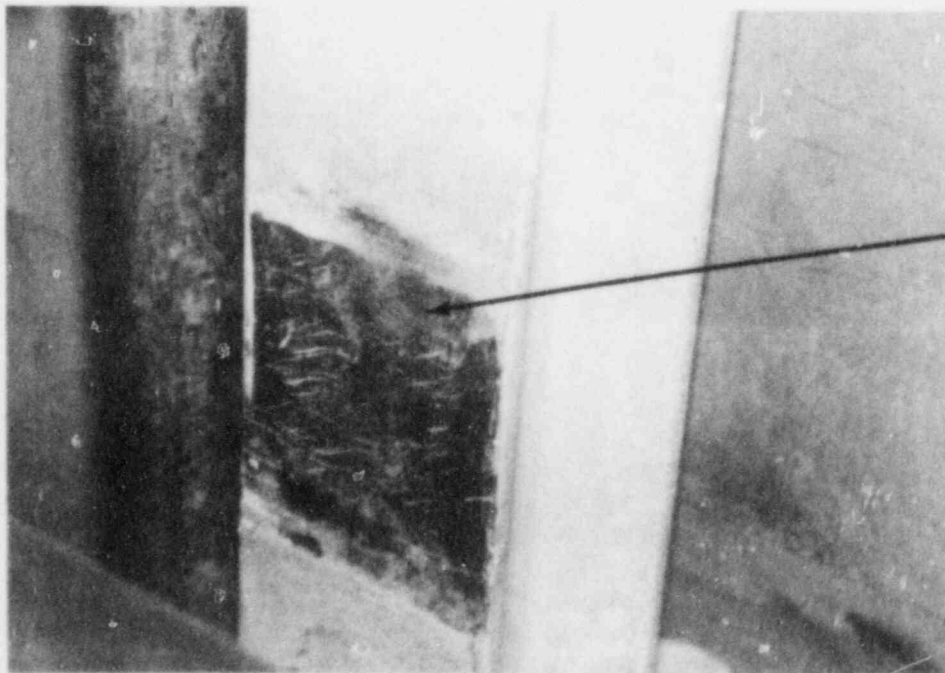
Figure 6.17 FW Line "B" Loop Support Point 120

SCRATCH MARKS SHOW  
EVIDENCE OF INITIAL WATER  
HAMMER LOADS DRIVING FW  
LINE INWARD (EAST) AND  
LATERAL (SOUTH) FOLLOWING  
REBOUNDING AT THE  
DOWNSTREAM ELBOW.

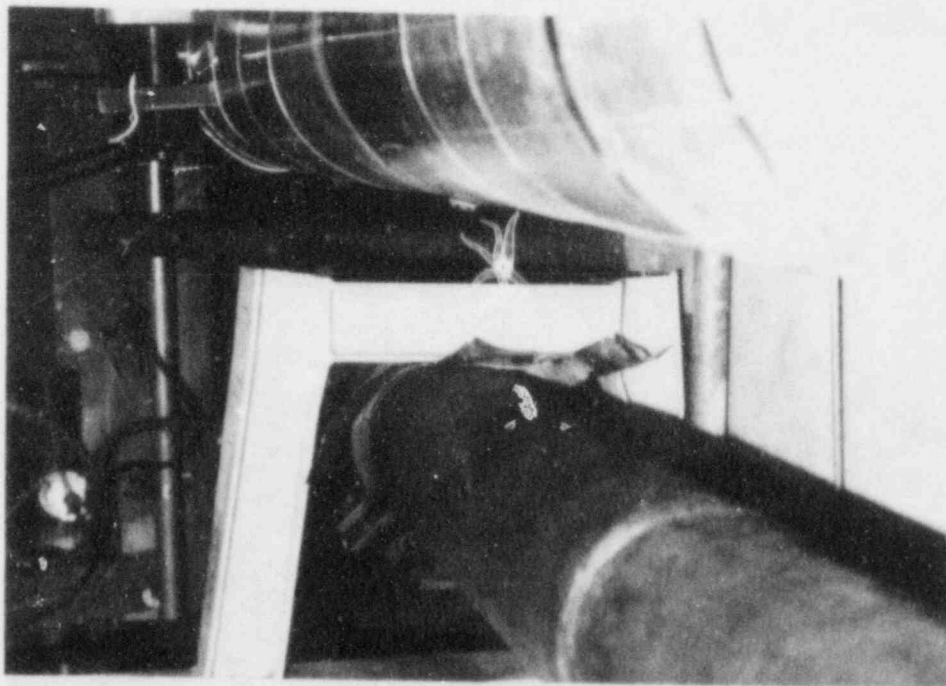
Figure 6.19 FW Line "B" Loop Support Station HOOK

VIEW LOOKING  
SOUTH; FW LINE  
HAS MOVED INWARD  
& UPWARD

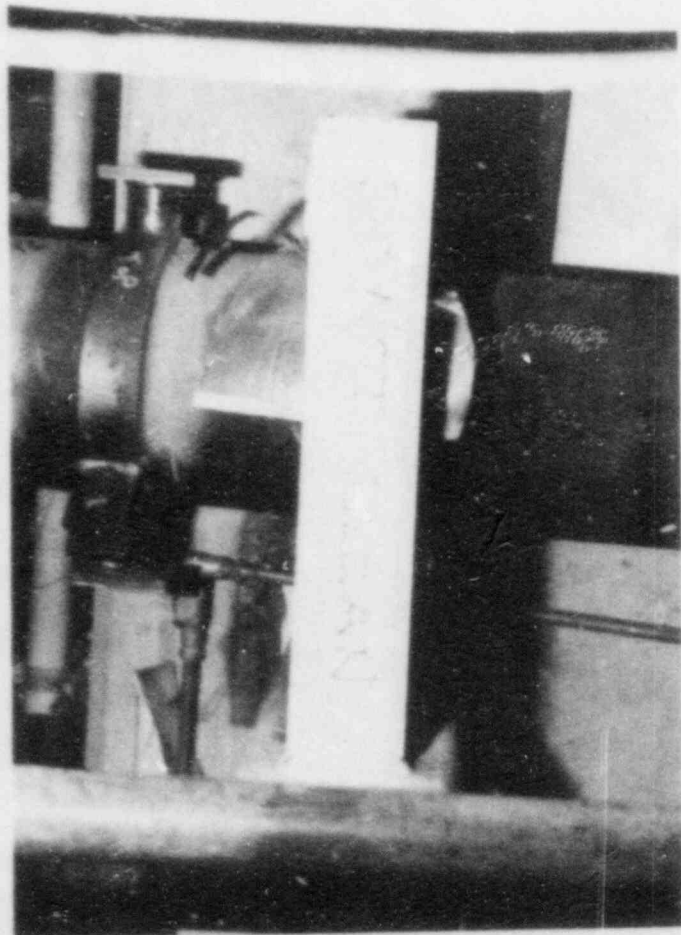
Figure 6.20 FW Line "B" Support Station HOOK

SIDE VIEW OF  
SUPPORT STATION HOOK

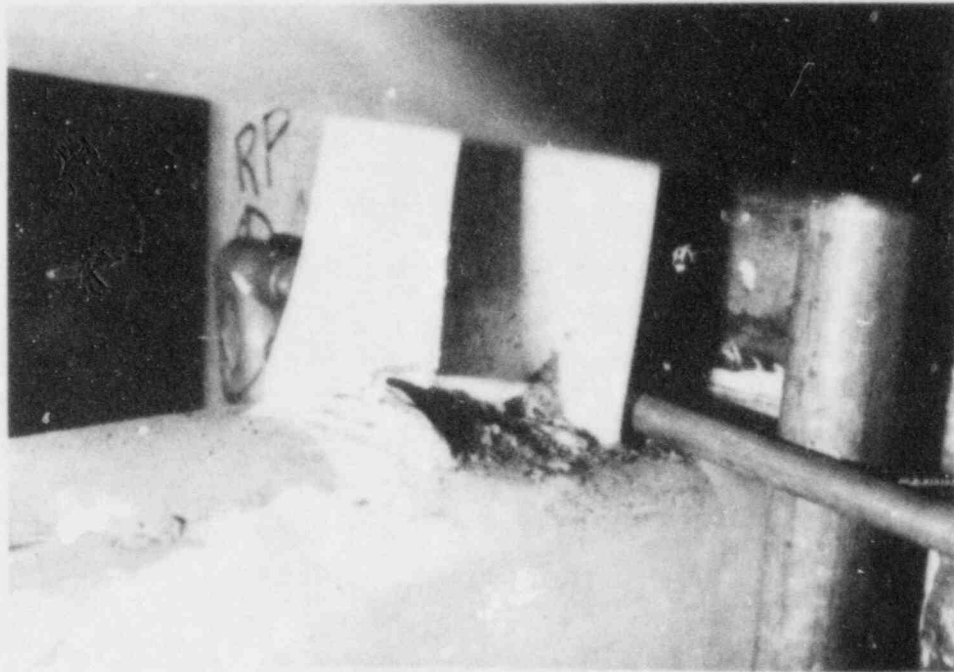
Figure 6.24 Torn Pipe Support Structure HOOK

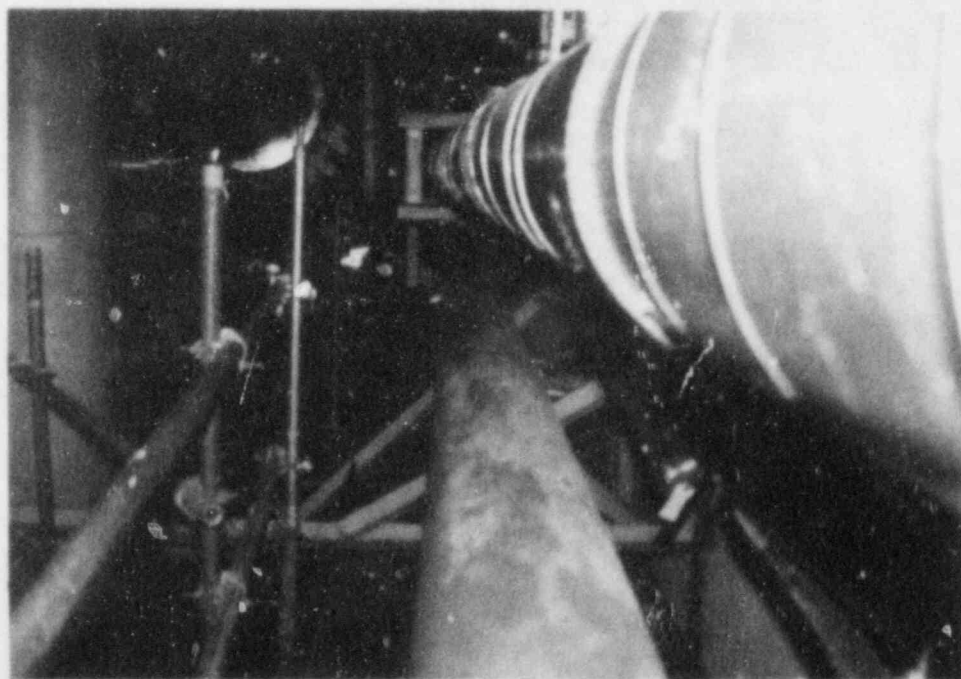
Figure 6.25 Outward (or Lateral) Set in FW Line "B" Looking West Toward Support HOOL

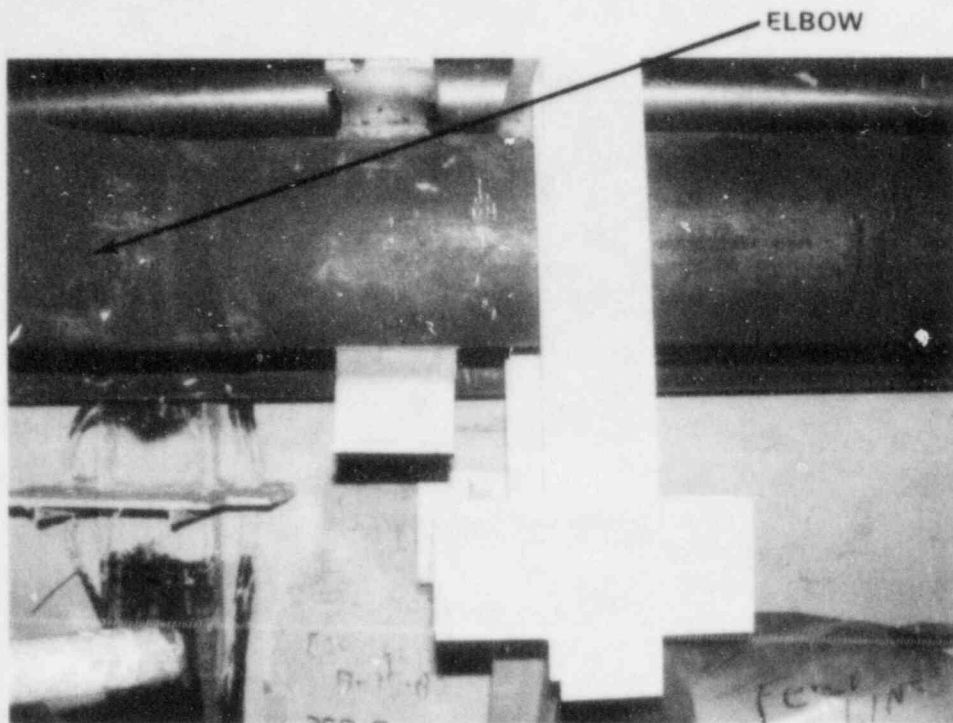
Figure 6.28a FW Line "B" Loop Support at Support HOOM

NOTE SUPPORT STRUCTURE  
BENT EASTWARD AND  
FW PIPE BEING  
RESTRAINED FROM  
FURTHER VERTICAL  
MOVEMENT BY SUPPORT HOOM  
(AT TOP).

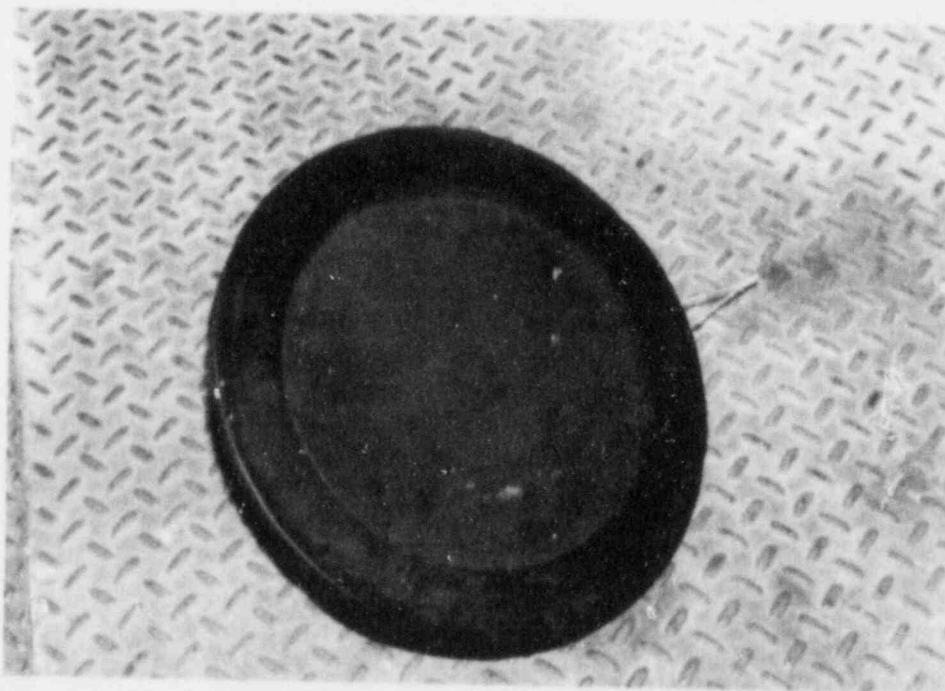
Figure 6.48 FWS-346 Seat Ring Damage

NOTE DAMAGE  
(i.e., CUTS) TO DISC  
SEATING SURFACE

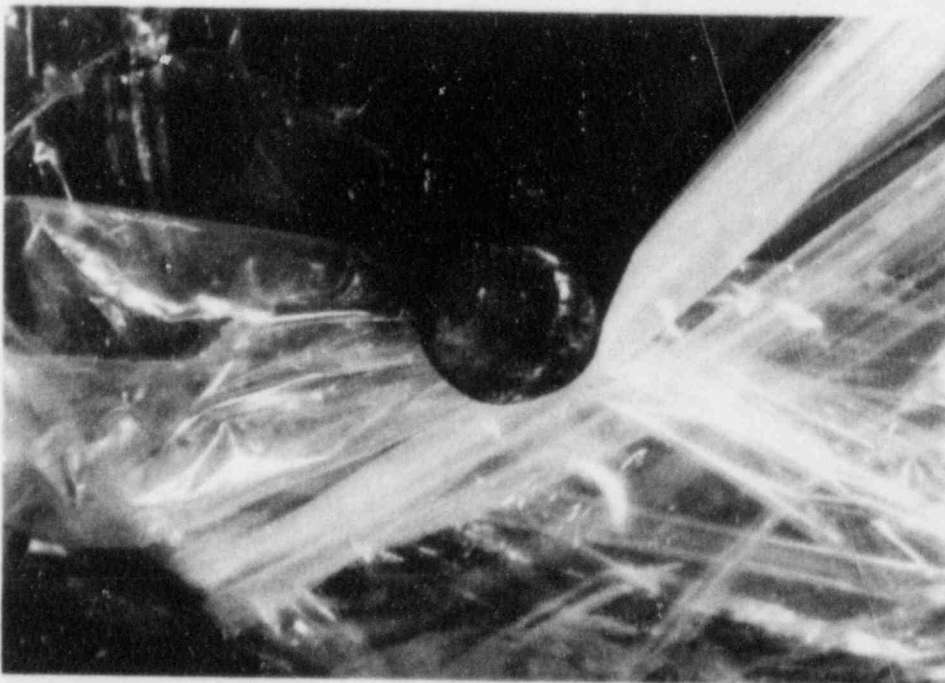
Figure 6.52 FWS-346 Bonnet

NOTE DAMAGED  
DISC STOP  
ATTRIBUTED TO  
CONTINUED  
IMPACT BY  
CHECK DISC

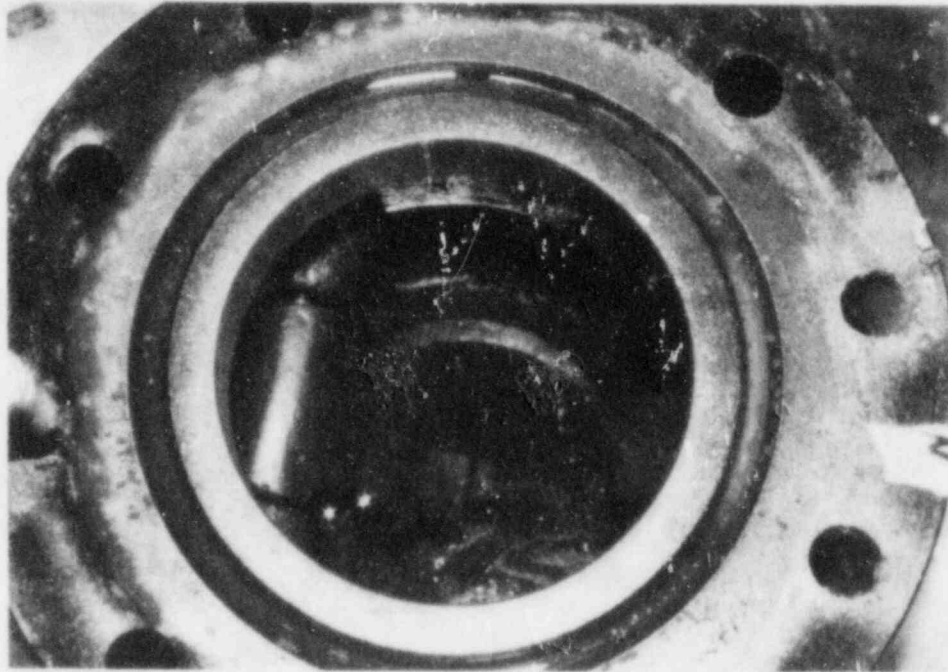
Figure 6.54 Interior Cavity of FWf. 346

NOTE SCRATCH  
MARKS AT BOTTOM  
OF VALVE CAVITY

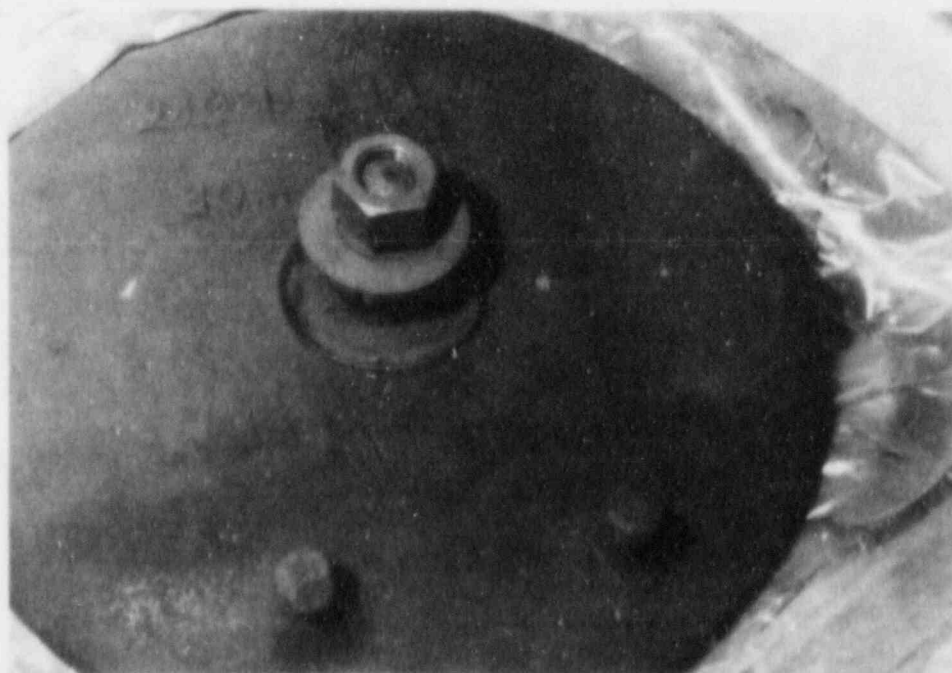
Figure 6.60 FWS-438 Closure Disc

Figure 6.59 illustrates FWS-438 "as-assembled" and "as found" following post-event examination. The nut had loosened and the disk had rotated the anti-rotation "nub" under the hinge arm, thereby preventing the disc from returning to the full seal position. Figures 6.60 and 6.61 show the topside of the FWS-438 check disc. Evidently one nub had been subjected to impact for some time (Figure 6.60). There was no provision for a locking pin in disc nut pin FWS-438.

NOTE  
FLATTENED  
POSITIONER  
"NUB"

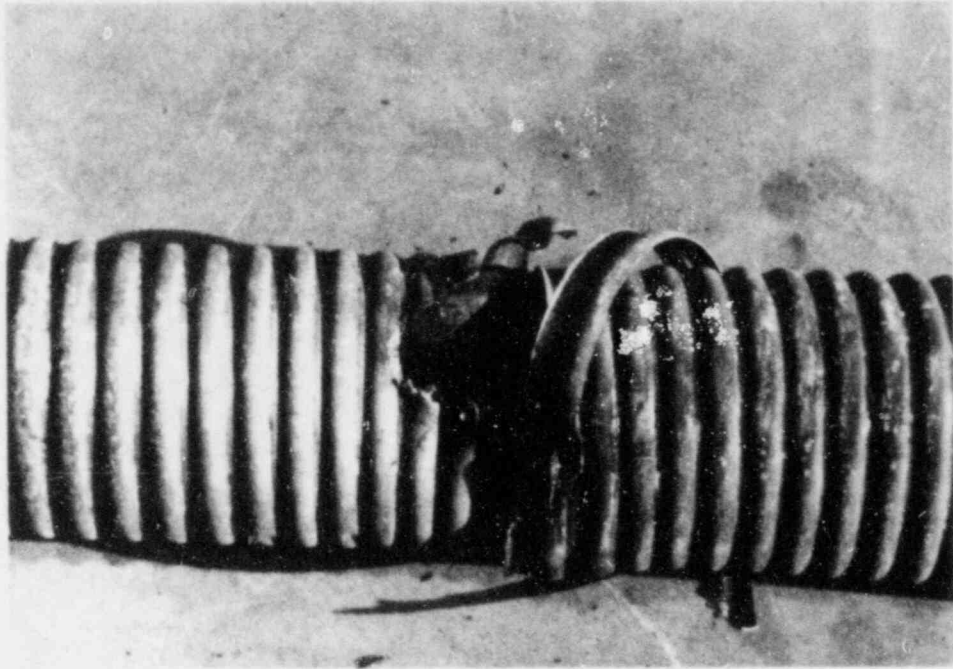
Figure 8.3 Cable Section When Phase-to-Phase Faults Occurred

In the process of searching for the ground fault on 4160-V bus 1C, plant personnel had located it on the X winding (secondary side) of auxiliary transformer C between the transformer and the bus. At 03:35, the operators had isolated the fault from bus 1C, but kept the transformer with a ground energized. At 04:51, the auxiliary transformer C differential relay actuated, tripping and isolating the transformer. After the trip, the targets on the differential relay identified that phase B and C trip had occurred. Subsequent investigation has located the fault to be in one of the interconnecting cables between the transformer and bus 1C. The interconnecting cables are 3/c-750 Kc mil aluminum armored cables, which run in cable trays located in the turbine building. The cable tray which contained the faulted cable section was located directly beneath a feedwater pipe flange, which appears to have leaked for sometime. Figures 8.1, 8.2, 8.3 and 8.4 show the details of the damaged cable section. A detailed examination of the damaged cable will be performed by SCE.

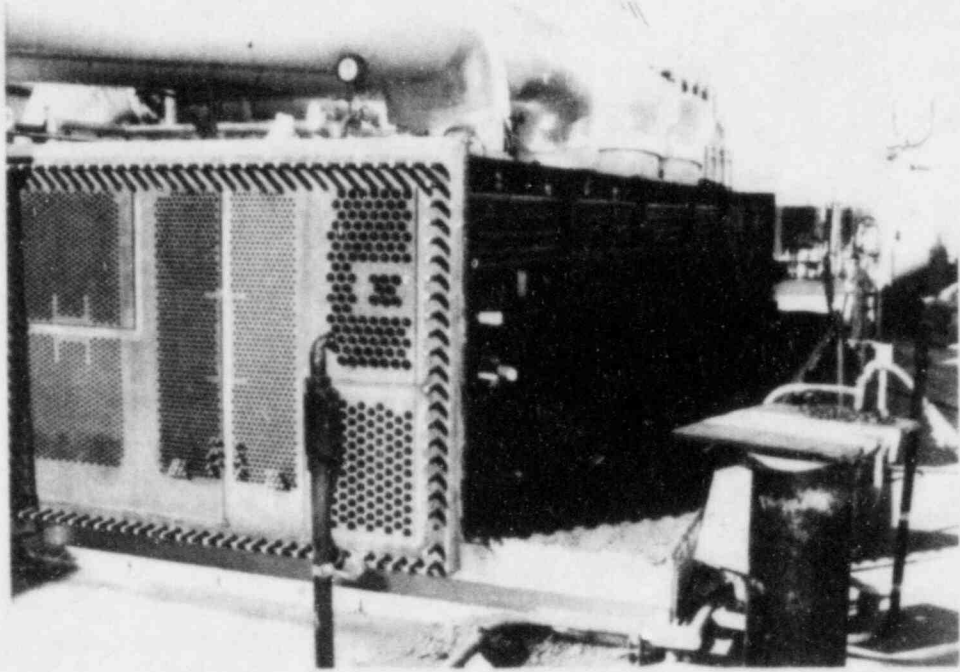
Figure 8.9 Flash Evaporator Unit with Evaporator Heater Flash Chamber and South Waterbox Removed (Northwest View)

SCE personnel have partially disassembled the east flash evaporator unit to determine the extent of damage. Figure 8.9 shows the unit with the evaporator heater, flash chamber, and south water box removed. The flash evaporator condenser tubes are visible in this view. Figure 8.10 shows a rupture of one of the evaporator condenser tubes. SCE is continuing its investigation into the damage to the east flash evaporator unit.
