EE-12-0013-REV. B

INTEGRATED SYSTEMS STUDY OF THE CONTROL ROD DRIVE MECHANISM
ROD POSITION INSTRUMENTATION

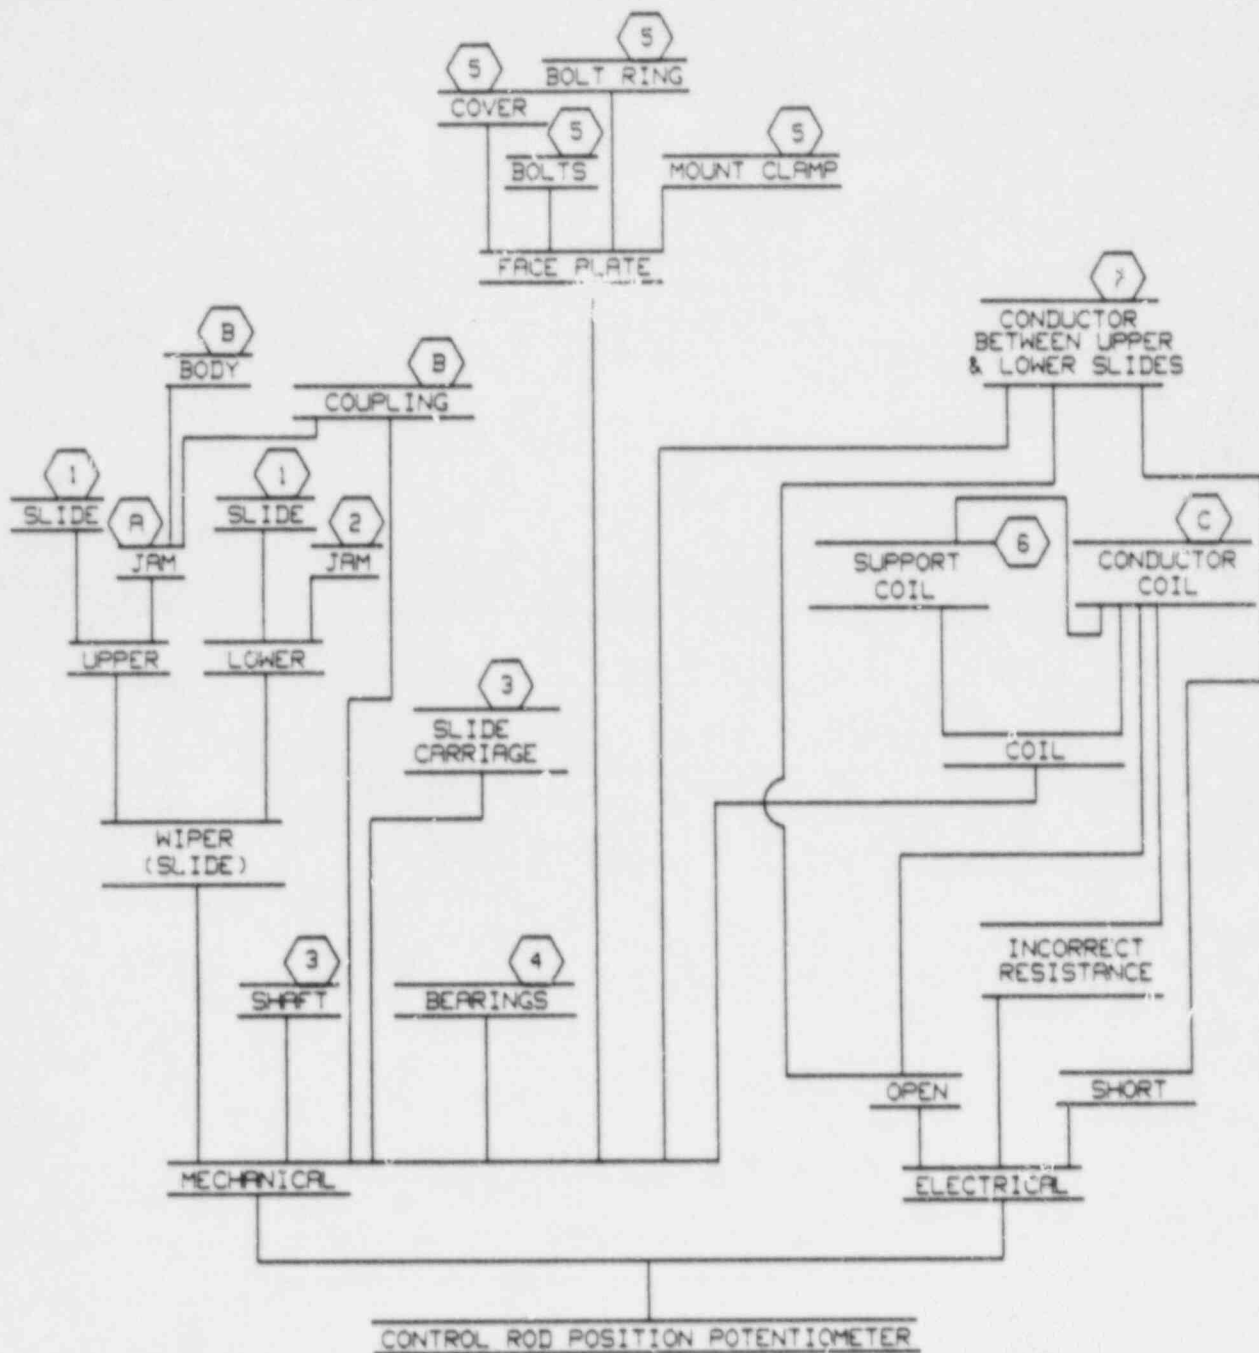
FMEA OF POSITION TRANSMITTERS

- 1 - Not a Failure (Intended Function)
- 2 - Not a Credible Failure (Failure of some other type required to provide stimuli for this failure). Failure of this type for both analog and digital portions of a single potentiometer simultaneously is not considered credible.

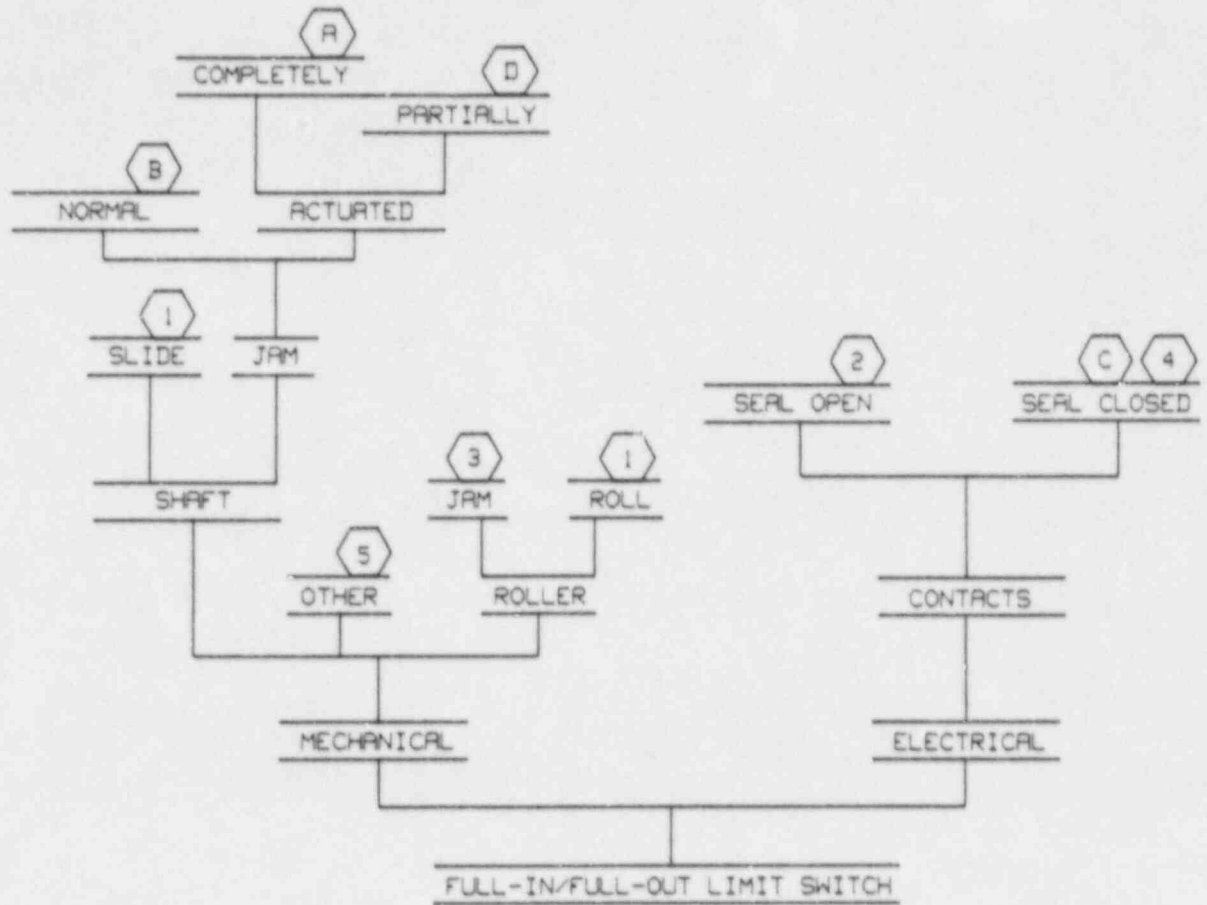
FMEA OF IN/OUT LIMIT SWITCHES

Pg. 1 - A - Full-In/Full-Out Switch fails mechanically by jamming the shaft in the completely actuated position.

Cause - Shaft Failure
Investigate cause of shaft failure.

Conclusions: Shaft fails due to high lateral forces caused by Cam angle $>15^\circ$ (recommended max per Mfr). Failure is by erosion, deposition of eroded metal, corrosion until space between shaft and housing is filled and will not allow free movement. To verify: (1) Contact manufacturer for concurrence; (2) Check for corrosion/erosion/deposition on only 1 side of shaft (side opposite Cam approach)
Verify as required.

- 1 - NOT A FAILURE (INTENDED FUNCTION)
- 2 - NOT A CREDIBLE FAILURE MODE (NO CIRCUIT AVAILABLE)
- 3 - NOT A CREDIBLE FAILURE MODE (BASED ON MATERIALS 303&440SS)
- 4 - NOT, BY JUDGEMENT, A CREDIBLE FAILURE MODE (SNAP ACTION SWITCH) SEE 'C'
- *5 - NO CREDIBLE FAILURE MODE (BASED ON STRUCTURAL AND MECHANICAL RUGGEDNESS OF SWITCH)

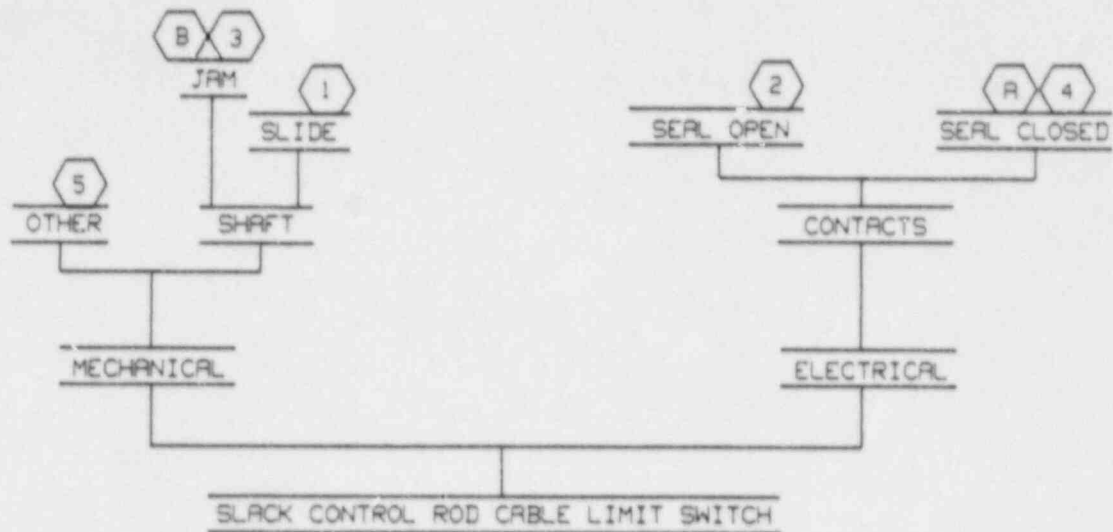
FMEA OF SLACK CABLE SWITCHES

*
Note - A known cable failure occurred in this position; therefore, the conclusion of a faulty slack-cable switch is unfounded.

- 1 - NOT A FAILURE (INTENDED FUNCTION)
- 2 - NOT A CREDIBLE FAILURE MODE (NO CIRCUIT AVAILABLE)
- *3 - NOT A CREDIBLE FAILURE MODE (NO STIMULUS TO PRODUCE THIS FAILURE)
- 4 - NOT, BY JUDGEMENT, A CREDIBLE FAILURE MODE (SNAP ACTION SWITCH) SEE 'A'
- *5 - NO CREDIBLE FAILURE MODE (BASED ON STRUCTURAL AND MECHANICAL RUGGEDNESS OF SWITCH)
