Houston Lighting & Power

South Texas Project Electric Generating Station
Units 1 and 2
Docket Nos. STN 50-498 and 499
Microbiological Influenced Corrosion in Unit 2
Standby Diesel Generator Jacket Water Cooling System

Evaluation of Unit 2 Diesel Generator MIC

Effects of Corrosion Pits and Cracks
on
Bellows Seal Performance

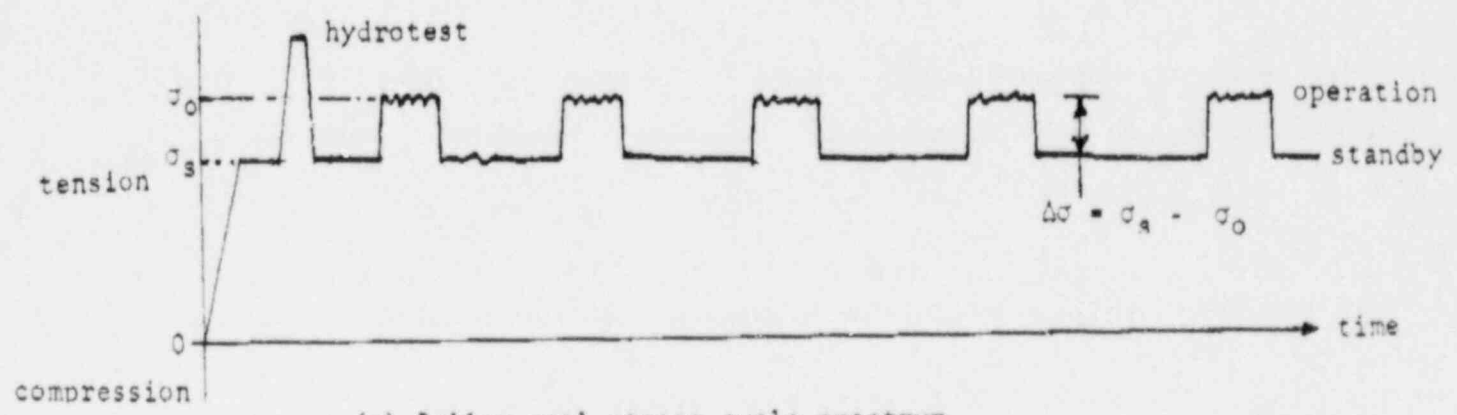
Fatigue cracks occur in metal components when they are subjected to cyclic stresses (or strains). The peak stress values are much less than the tensile strength of the material in a high cycle fatigue. The bellows seal would experience a small number of relatively large stress amplitudes because of startups and shutdowns and a large number of low stress amplitudes due to vibration during operation. Figure 3 illustrates schematically the type of stress cycles that a bellows may experience. Figure 3(a) is a case where the bellows was extended by a small amount during installation in the cylinder block; the bellows can be compressed during installation. Figure 3(b) shows idealized fatigue cycles and the definitions of stress terms.

(a) Bellow seal stress cycle spectrum

Figure 3 A simplified stress cycles for the bellows seal as compared with idealized fatigue cycles and definitions.

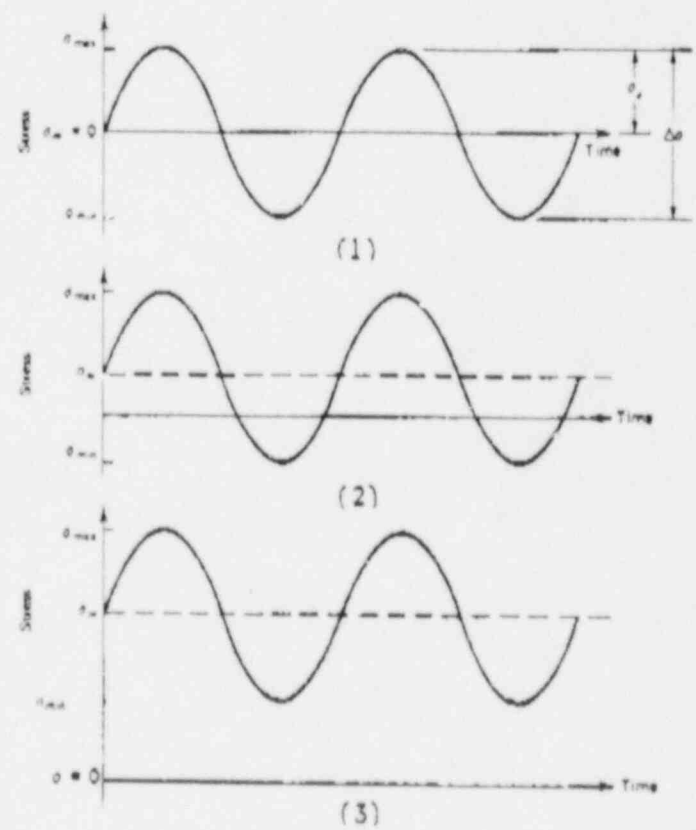
(b) Idealized fatigue stress cycles

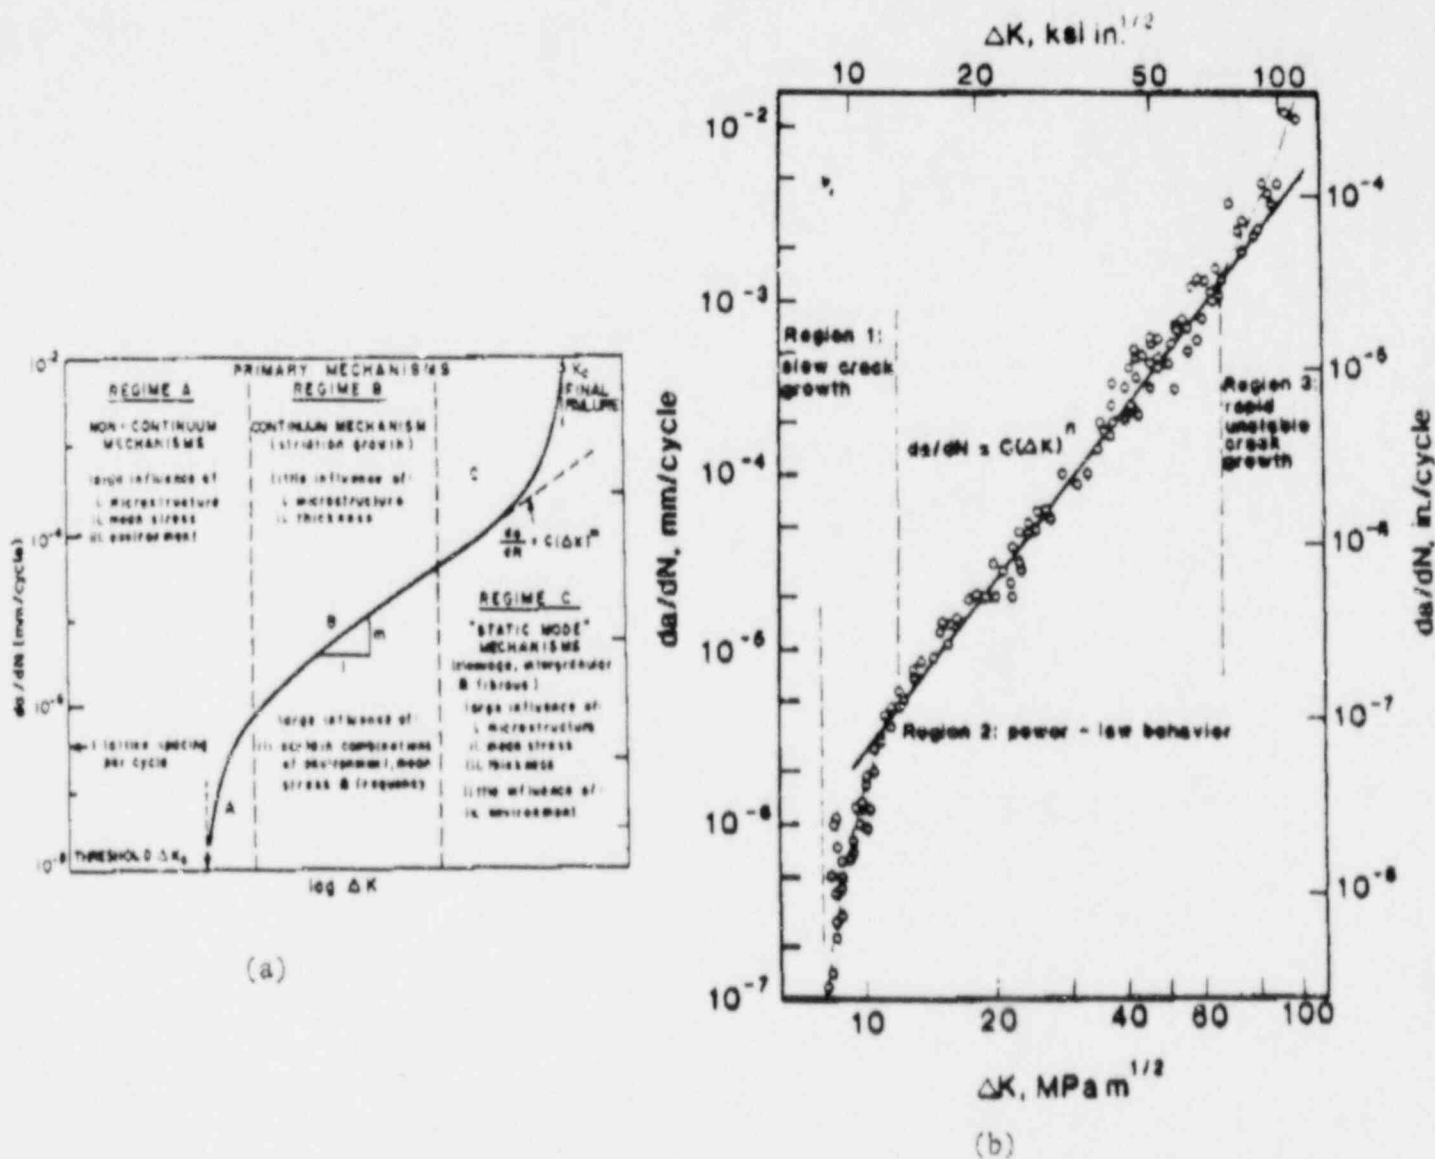
Figure 4(a) is a schematic relationship between da/dN and ΔK and Figure 4(b) a data plot of fatigue cracking for A533 steel at ambient temperature, shown here as an illustration. In general, in Region B, the crack growth follows a power-law behavior. The ASME Section XI Task Group for Piping Flaw Evaluation recommends the following equation for fatigue crack evaluation of flaws in austenitic stainless steel piping.⁽²⁾ This equation will give conservative (high) estimates of fatigue crack growth rate as the code requirements are conservative.

Figure 4 (a) Schematic relationship between fatigue crack growth rate da/dN and stress intensity factor range ΔK .

(b) A plot of fatigue crack data for A533 steel at ambient temperature

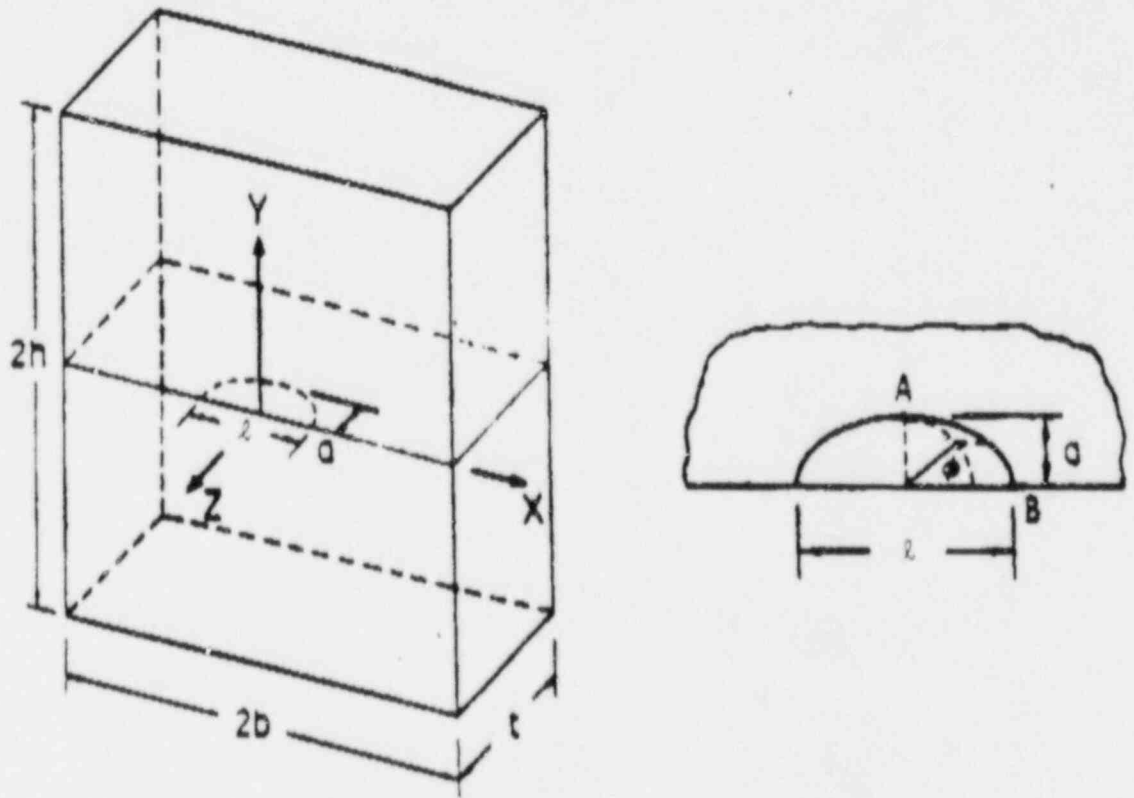
Figure 5 A surface crack in a finite plate

where F = shape factor
 t, b, c, ϕ = see Figure 5, a surface crack in a finite plate
 a = crack depth (or one-half the crack length in a
 through-wall crack)

In ductile and tough materials like the bellows material (Type 321 SS), K is higher at $\phi = 90$ degrees (Figure 5) than at other angles. Thus, the aspect ratio (depth/length) of a crack tends to be high as compared with the cracks in less ductile and tough materials like carbon steel. This means that fatigue cracks in bellows seal would tend to be short (say, less than 0.1 inch in length) when they just break through the wall, leading to leak. (This does not apply to stress corrosion cracks.) Therefore, even if fatigue cracks develop at the bottom of a pit or at the bottom of a small stress corrosion crack due to stress cycles from startups and shutdowns, it will be a short crack which may "weep." No massive leaks are possible. Furthermore, it is unlikely that

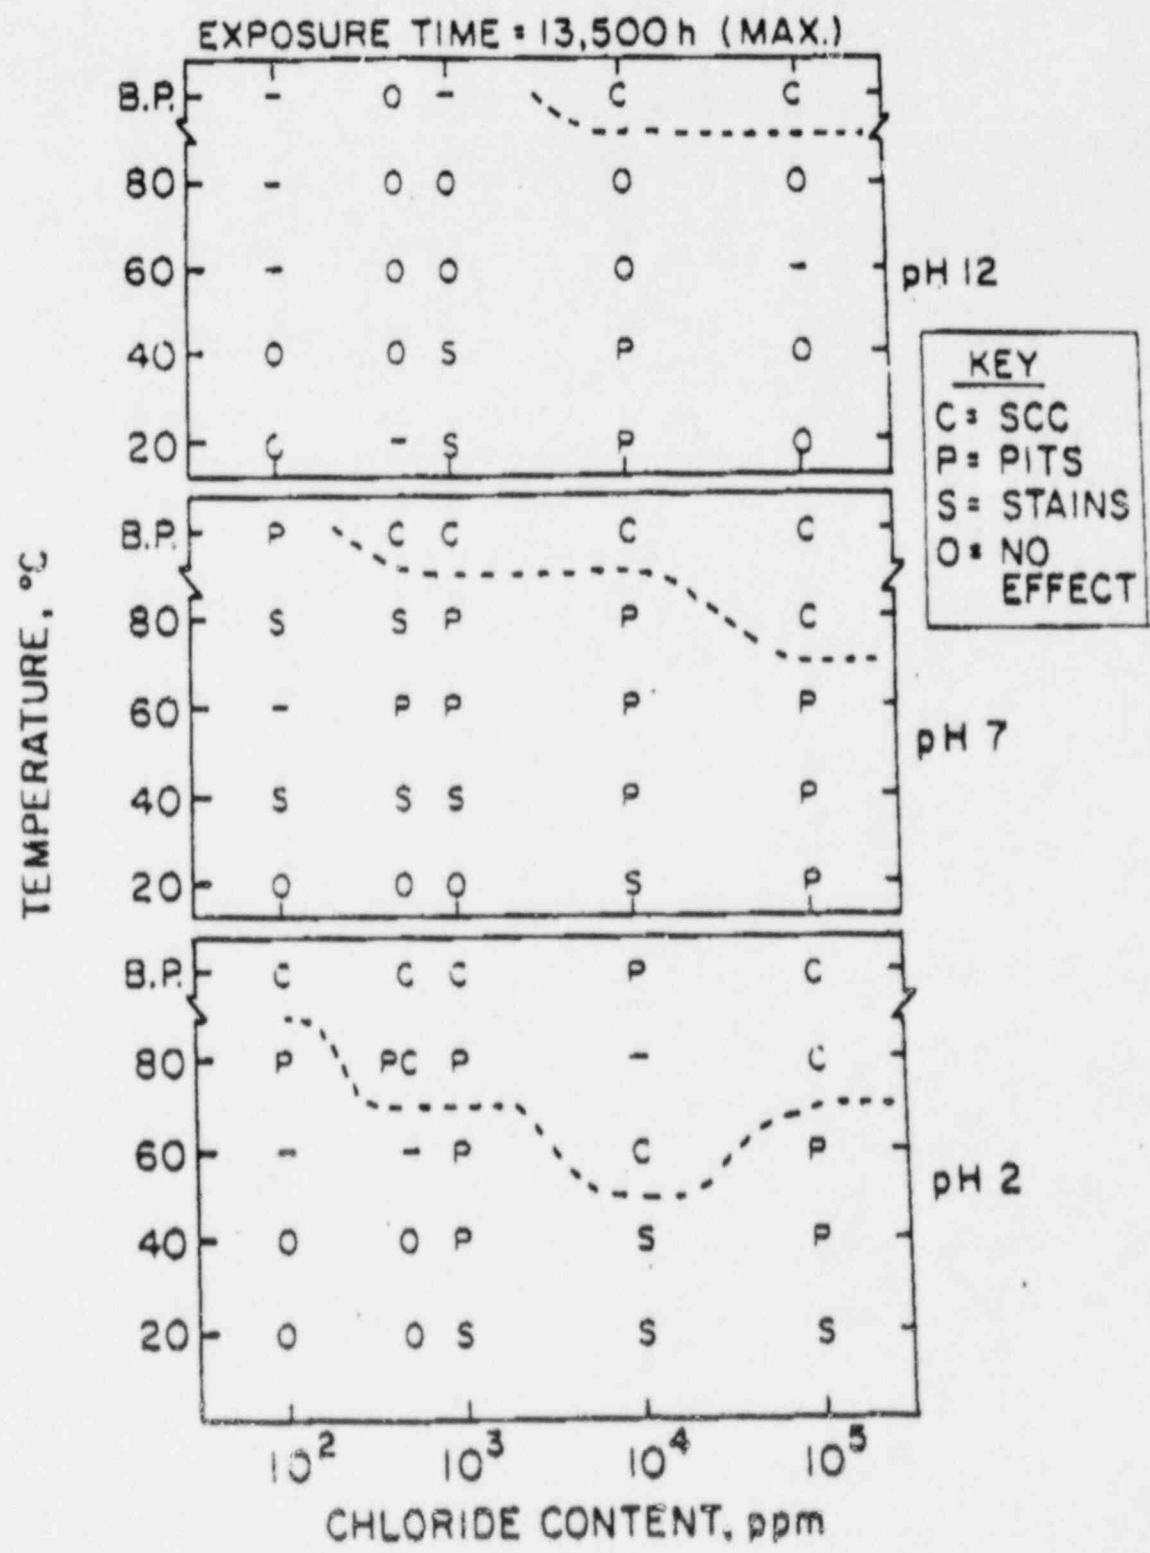
There is an extensive amount of literature reporting that high pH reduces the tendency of austenitic stainless steels to chloride stress corrosion crack. For example, Theus and Staehle⁽⁴⁾ show an increase in time to failure at 200°C as the pH increases from 1 to 13. Sedriks⁽⁵⁾ gives the most definitive data. Figure 6 (attached) shows the effect of pH, chloride ion content and temperature on both stress corrosion cracking and pitting. Uhlig and Revic,⁽⁶⁾ in addition to mentioning the beneficial effects of alkalinity, also state that eliminating oxygen and addition of certain inhibitors, e.g., nitrates, reduces stress corrosion cracking of austenitic stainless steels. Theus and Staehle⁽⁴⁾ also show the beneficial effects of reducing oxygen.

Figure 6 Effect of pH on the chloride content and temperature required to produce cracking of Type 304 stainless steel in sodium chloride solution. (After Truman)
