LICENSEE EVENT REPORT (LER)

FACILITY NAME (1)
Sequoyah Nuclear Plant (SQN) Unit 2

TITLE (4)
Turbine and Reactor Trips Resulting From a Failure of the 'B' Phase Main Transformer Sudden Pressure Relay.

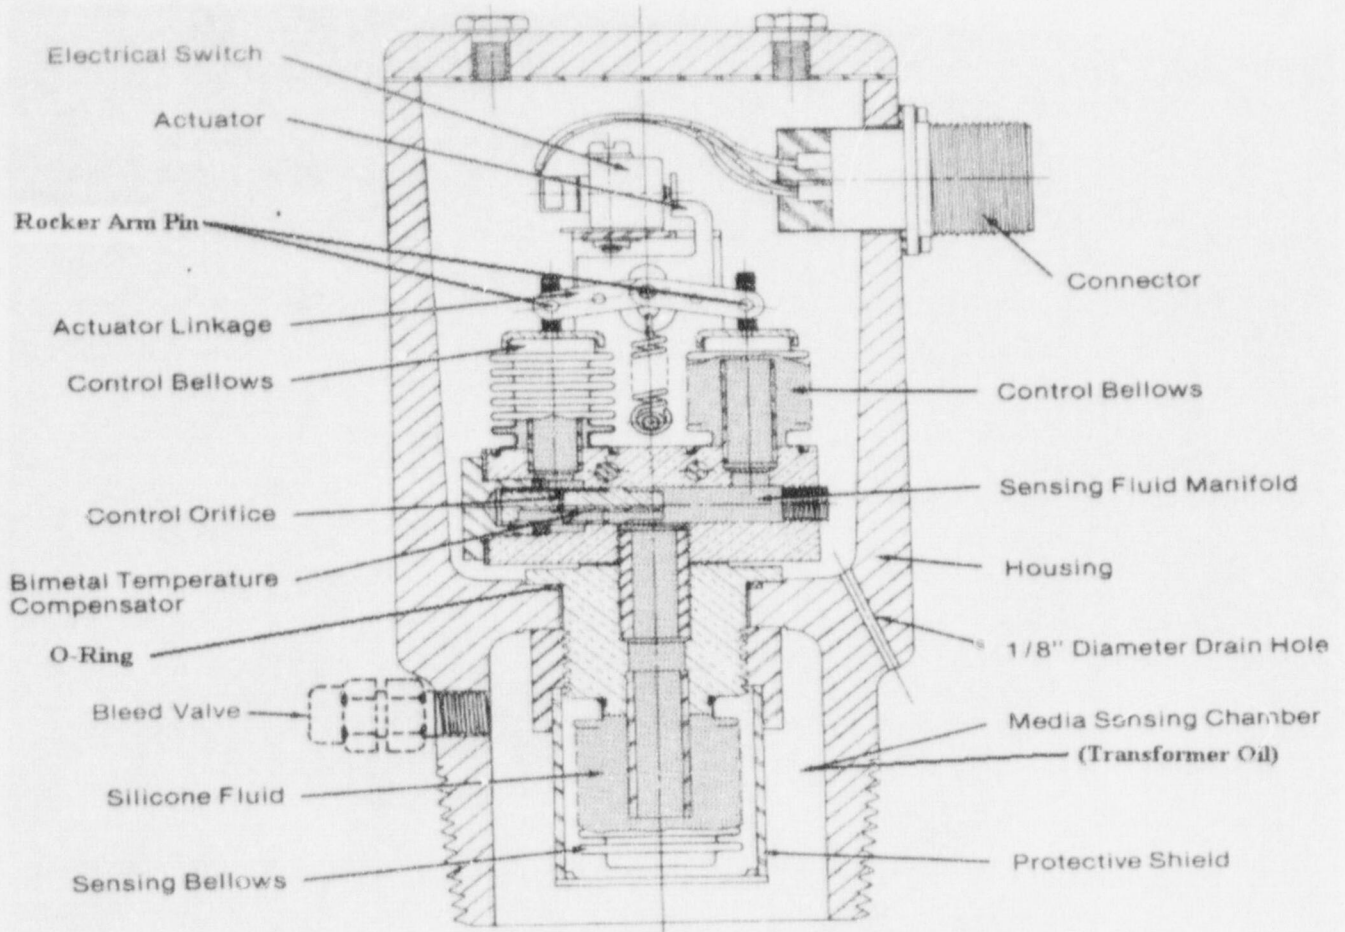
QUALITROL 900 SERIES "RAPID PRESSURE RISE" RELAY

The sudden pressure relay, Qualitrol Corporation Model No. 900-003-01, was examined and found to have failed (the device was in a constant trip condition). Detailed inspection of the component identified significant wear on the rocker arm pins. One of the rocker arm pins had worn to the degree that proper operation of the device was prevented. In addition to this failure mechanism, the wear products (particles of metal [brass with a high percentage of copper content]) were accumulated and trapped in an oil film around the exposed electrical switch wiring as it attached to the connector. This condition could have lead to arcing and subsequent actuation of the auxiliary trip relays within the plant. The oil within the electrical switch enclosure is attributed to either a low torque on the protective shield, resulting in an incomplete seal on the o-ring that seals the relay mechanism or failure of the bellows assembly and leakage of the silicon fluid into the housing.

PRINCIPLE OF OPERATION: Changes in the transformer's internal pressure deflects the **Sensing Bellows** and responding **Control Bellows** that are part of a sealed system filled with **Silicon Fluid**. A small **Control Orifice** in the line of one of the **Control Bellows**, whose effective area is varied with temperature by a **Bimetal Temperature Compensator**, causes differential deflection of the two **Control Bellows**. The resultant "cocking" of the **Actuator Linkage** trips the **Electrical Switch** at unsafe rates of pressure rise. When the two **Control Bellows** again reach equilibrium, the **Electrical Switch** automatically resets itself.
