TELETHERAPY FACILITY SURVEY
VETERANS ADMINISTRATION HOSPITAL
EAST ORANGE, NEW JERSEY

K. David Steidley
K. David Steidley, Ph.D., C.H.P.

8/18/85

I. GENERAL

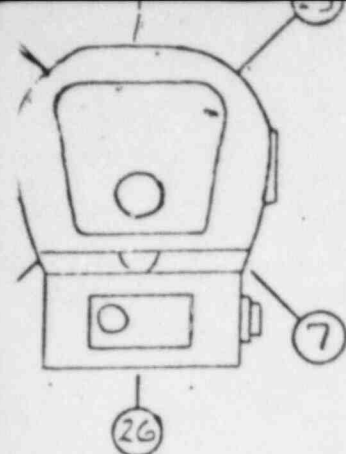
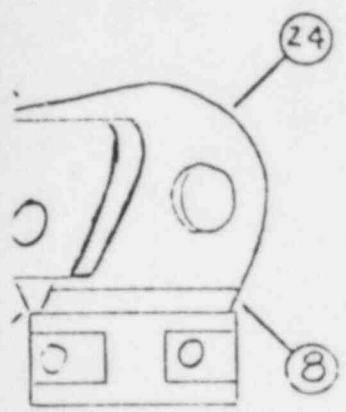
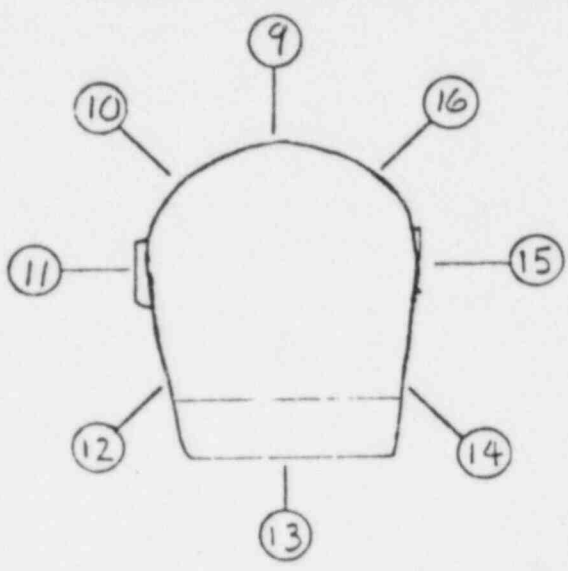
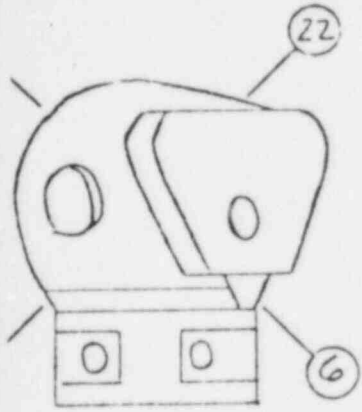
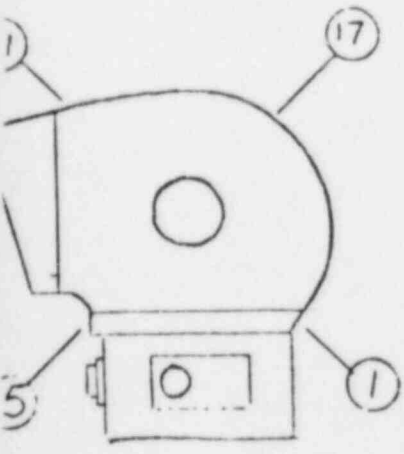
HEAD #590- E SERIAL No. 116
 SOURCE, CAT. AMS-3801/1.5 cm. DIA.
 Rim 5494 on 7/30/85
 CURIES 5444 on 8/1/85
 COBALT HEIGHT 2.75 CAP TYPE SOLID
 SURVEY DATE 8/14/85 ENGR. VS/DM
 METER USED MFG. Victoreen MODEL 491 SER.# 1572
 METER CALIBRATION DATE 5-7-85

No.	Dist.	Read	True	No.	Dist.	Read	True
1.	70cm.	1.2	+	14.	67cm.	1.1	+
2.	70	1.6	+	15.	73	0.4	+
3.	70	1.6	+	16.	73	0.6	+
4.	70	2.5	+	17.	73	0.6	+
5.	67	1.8	+	18.	73	1.1	+
6.	70	2.8	+	19.	73	0.8	N
7.	70	2.0	N	20.	71	0.4	E
8.	70	1.9	E	21.	69	0.5	A
9.	73	0.2	A	22.	71	0.4	R
10.	73	0.6	+	23.	73	1.0	R
11.	73	0.5	R	24.	73	0.6	+
12.	67	0.7	+	25.	76	1.6	+
13.	63	0.8	+	26.*	41	8.5	+

Note: * On test stand multiply true by .74
