Enclosed are responses to questions forwarded with your March 8, 1988 letter to Thomas E. Murley, who testified for the Nuclear Regulatory Commission at the Senate Labor and Human Resources Committee hearing on the proposed restart of the Pilgrim plant.

## SPENT RESIN CONTAMINATION LEVELS

FIGURE 2  
SPENT RESIN CONTAMINATION/RELEASE  
PATHWAY

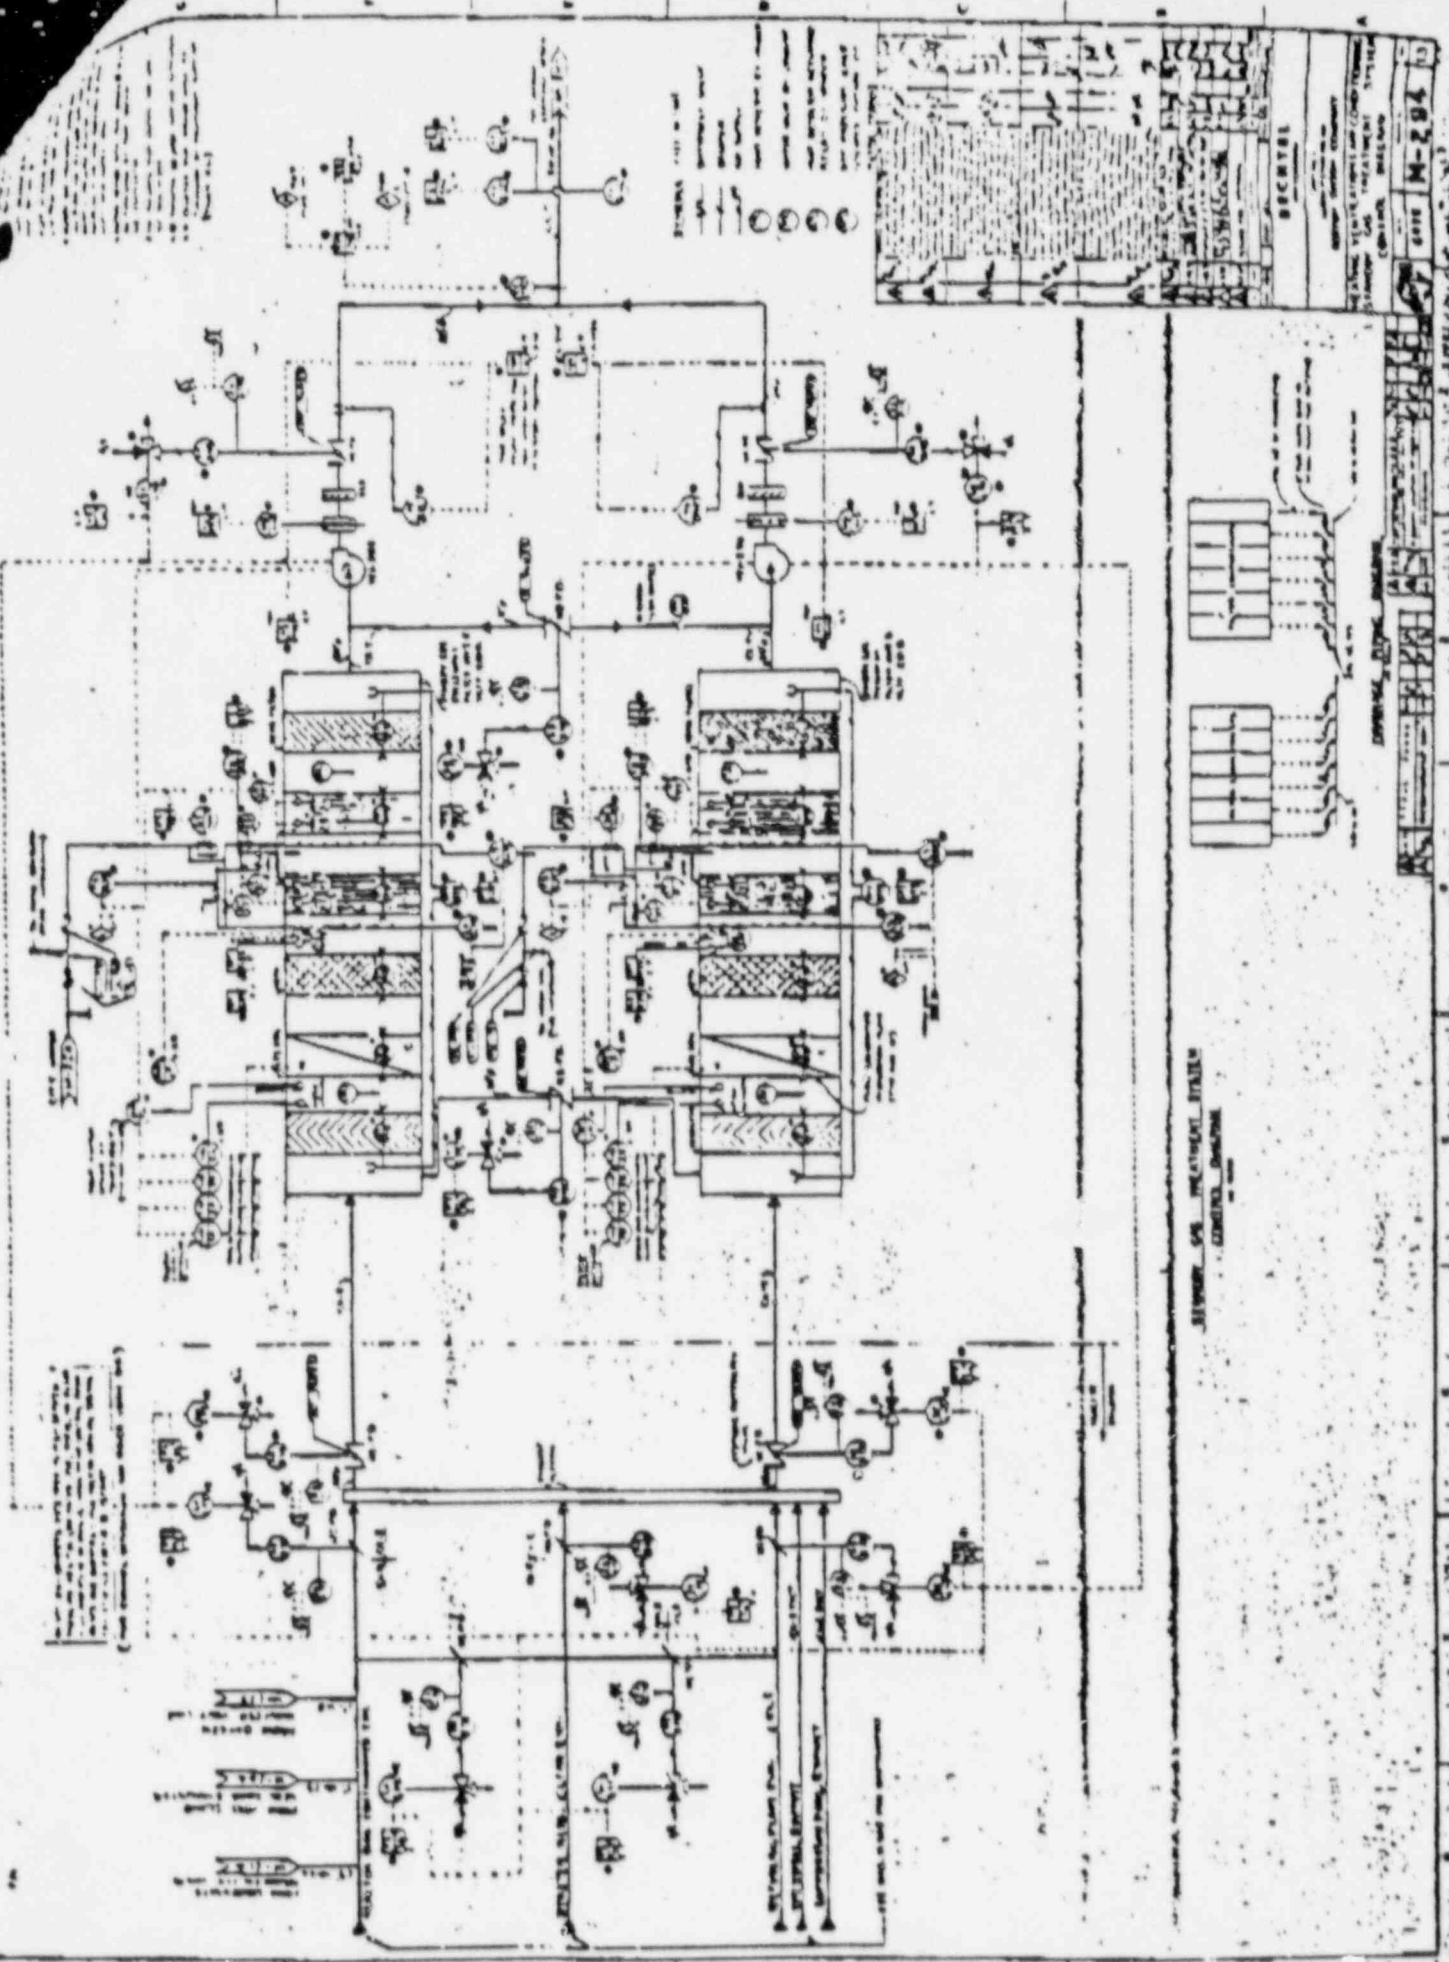
ATTACHMENT E

The Condensate Demineralizer System has been identified as the source of the resin contamination found in the ductwork. More specifically, the processes associated with condensate demineralizer resin backwash/transfer have been determined as the causal factors as discussed below:

Since the contaminated exhaust filters were found to be degraded and replaced on March 15, 1982, and since the analysis of the resin indicated that it was at least a year old, it was concluded that the most likely pathway of the resin was from the condensate demineralizer vent to the contaminated exhaust plenum, through the contaminated exhaust filters and out the Reactor Building Vent Stack.

1. Discontinue back flushing, regenerating or ultrasonically cleaning condensate demineralizer spent resins until the source of the resin contamination of ventilation systems is identified and corrective actions taken for its cause. In the event long term plant design changes are needed to correct the cause of the resin release to the ventilation system, resin cleaning operations may be performed provided that: a) appropriate procedure revisions and other administrative controls are established to prevent further resin releases to the ventilation system; b) a test of the adequacy of the procedure revisions and other administrative controls is performed using clean resin and; c) the integrity of the Contaminated Exhaust Ventilation filters has been verified by DOP testing.

5. Establish a surveillance and preventative maintenance program for contaminated ventilation exhaust systems to ensure exhaust filter integrity. This program will also include provisions for system inspection to identify resin accumulation.
6. Provide to this office by July 15, 1982 a report detailing the history and extent of the duct contamination, its causes, the circumstances surrounding the release of the resin, and the amount and extent of onsite and offsite releases of radioactive material. This report will also describe the corrective actions taken and the additional management oversight initiated to prevent recurrence.
