Subject: LaSalle County Station Unit 2  
Response to Confirmatory Action Letter  
NRC Docket No. 50-374

ATTACHMENT A

COMMONWEALTH EDISON COMPANY RESPONSE TO

THE MARCH 17, 1988, CONFIRMATORY ACTION LETTER (CAL)

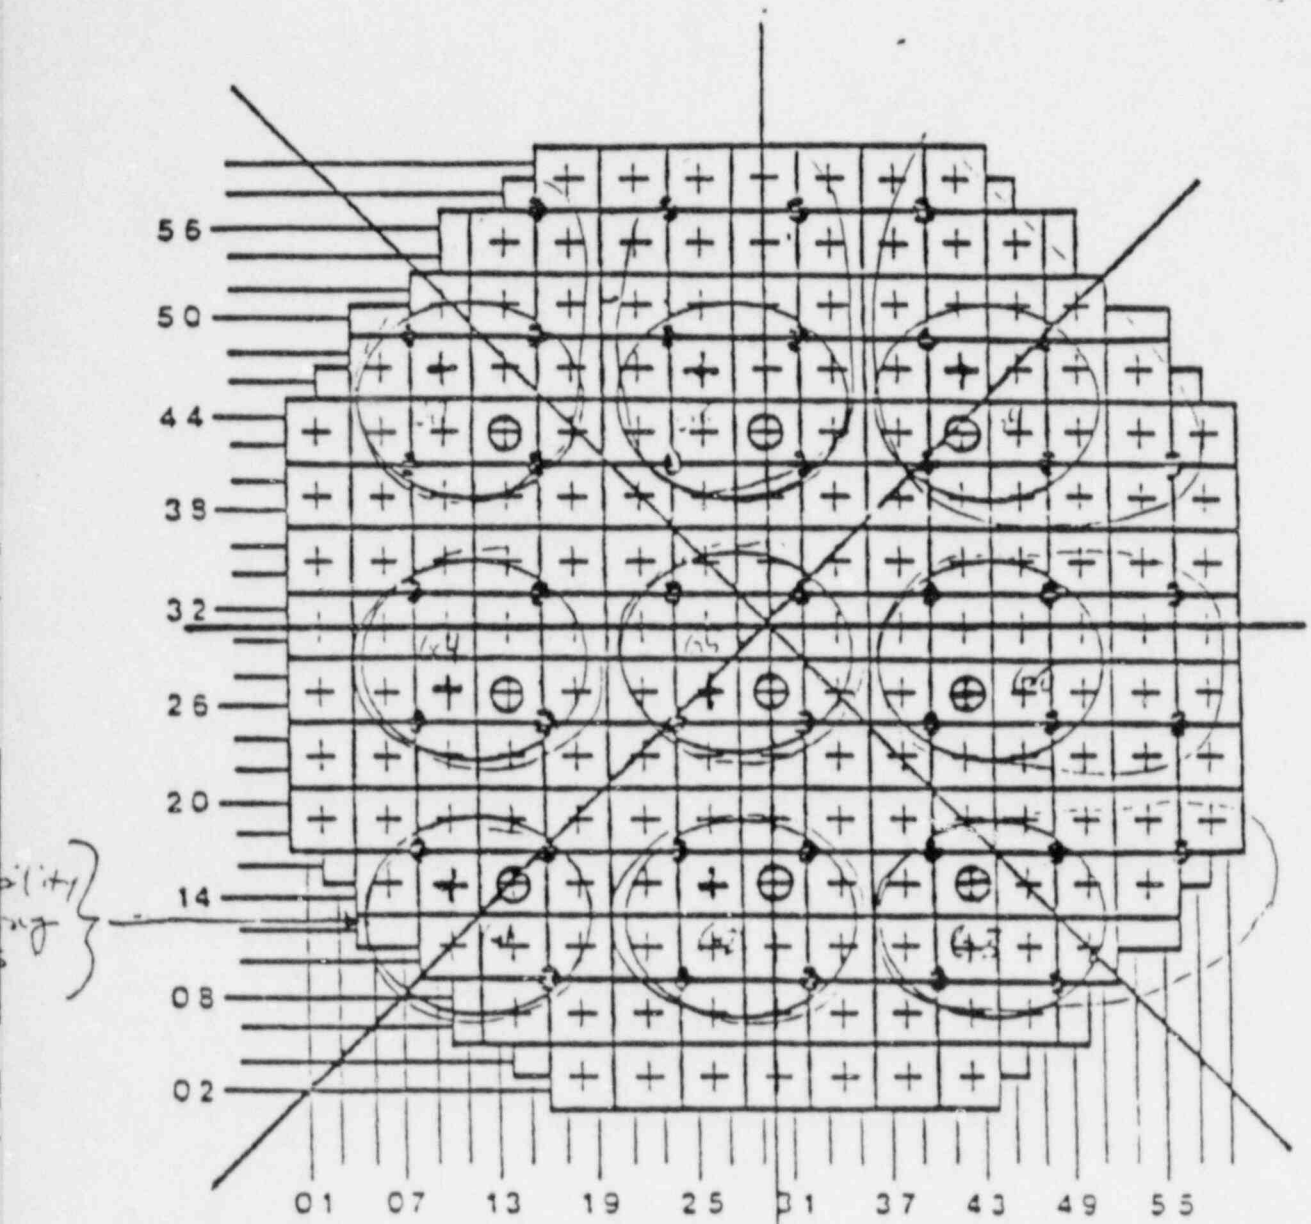
Figure 3

Selected Control Rods  $\oplus$

- b. After inserting control rods, frequently monitor the APRMs and monitor the local regions of the core by using the control rod select switch to display the various LPRM strings which surround the selected control rod. A minimum of nine control rods should be selected to adequately display LPRMs representing each octant of the core and the core center (Figure 3). If there is any abnormal increase in the expected signals, insert additional control rods to suppress the oscillations using the plant's prescribed control rod shutdown insertion sequence.

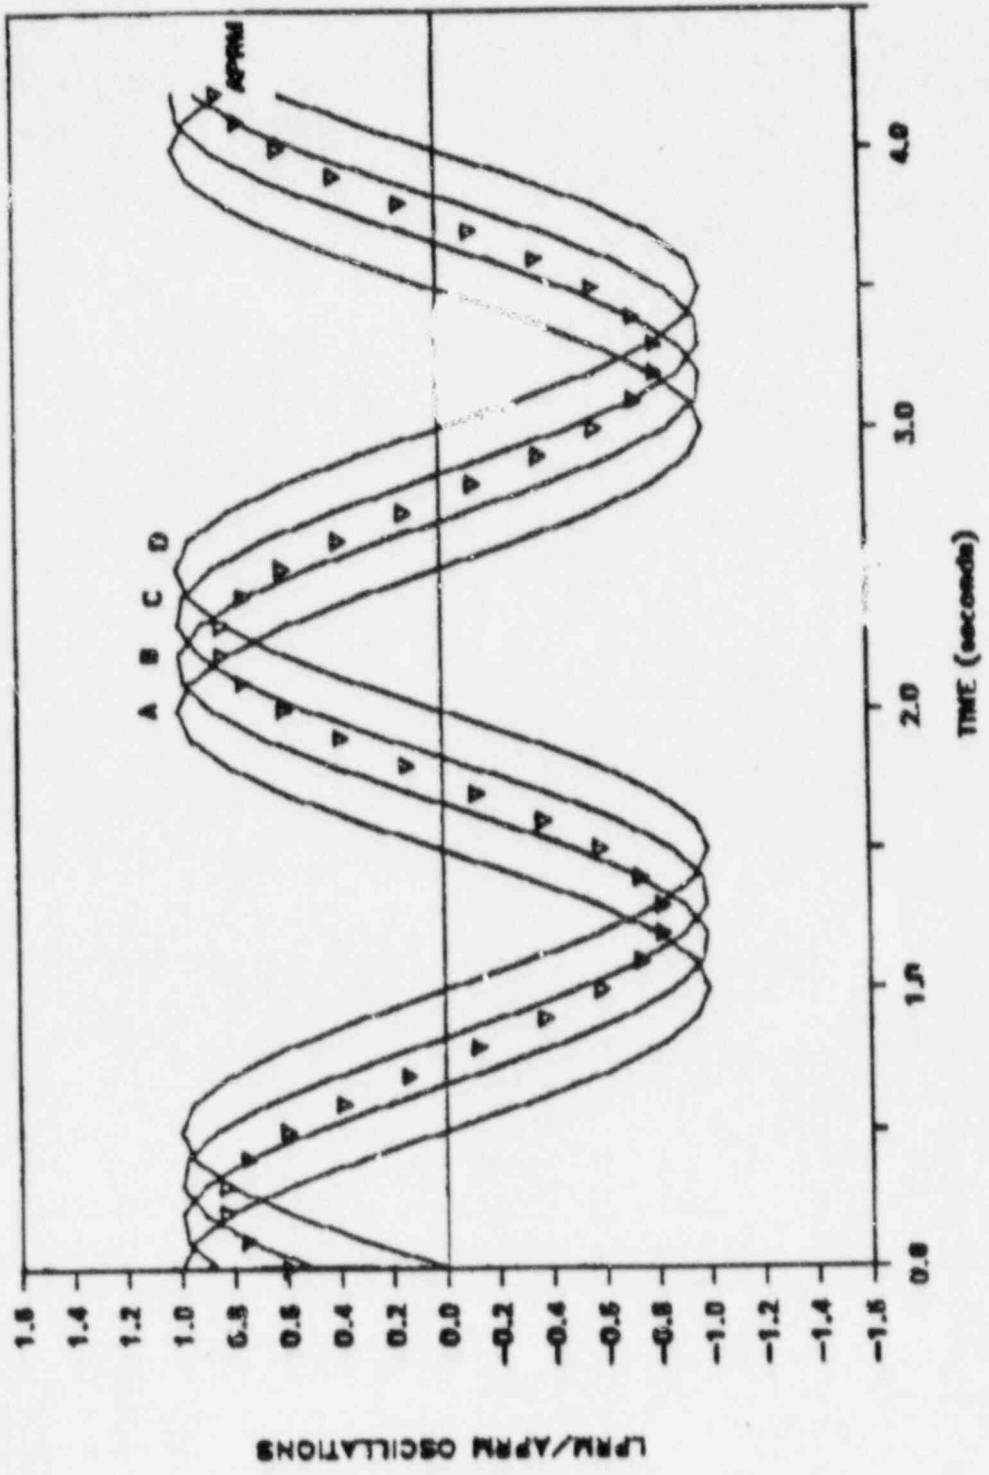
FIGURE 3  
LPRM AXIAL PHASE RELATIONSHIP

Another factor that must be considered in the relationship between the LPRM and APRM signal is the phase lag that occurs from the bottom to the top of the core during density wave oscillations. Since the oscillations are caused by a perturbation in the coolant density, the effect of the perturbation must travel up the channel before impacting the higher level LPRMs. This propagation of the perturbation causes a phase shift between the signals at the four LPRM levels. The effect on the APRMs is that each LPRM level does not react its peak at the same time and therefore the APRM to LPRM relationship during these transient conditions is not the same as it would be during steady state operation. Figure 3 shows an example of how the phase relationship affects the APRM to LPRM relationship. Four LPRMs (Levels A, B, C and D) are assumed to be oscillating with the same magnitude but  $90^\circ$  out of phase (A to D level). The average of the four signals (indicative of what an APRM signal would do) oscillates at the same frequency but its peak magnitude is not as high as the peak of each individual LPRM since the four peaks do not occur at the same time. However, since the LPRMs are indicating a true phase lag between the oscillations at different axial locations, the APRMs are correctly measuring the core average neutron flux during core wide oscillations.

The APRM signal is the average of the 21 LPRMs assigned to the channel with an appropriate gain adjustment determined from the known values prior to the pump trip. The phase lag between the four LPRM detector levels is based on actual test data from Caorso which shows approximately an  $82^\circ$  shift from the A to D level. Figure 4 shows the results of the above analysis. For the peak LPRM oscillation just up to the LPRM Upscale alarm setpoint, APRM A is predicted to reach 84.5% of rated which is very close to the value estimated from data recorded during the event. The analysis also predicts that several of the D level LPRMs will go below the LPRM Downscale setpoint (5% of scale) and that LPRM Downscale alarms should occur before the first LPRM Upscale alarm is reached. The analysis also estimates that for APRM oscillations with a peak of less than approximately 74% of rated, no downscale alarms should occur. From the Hathaway Event

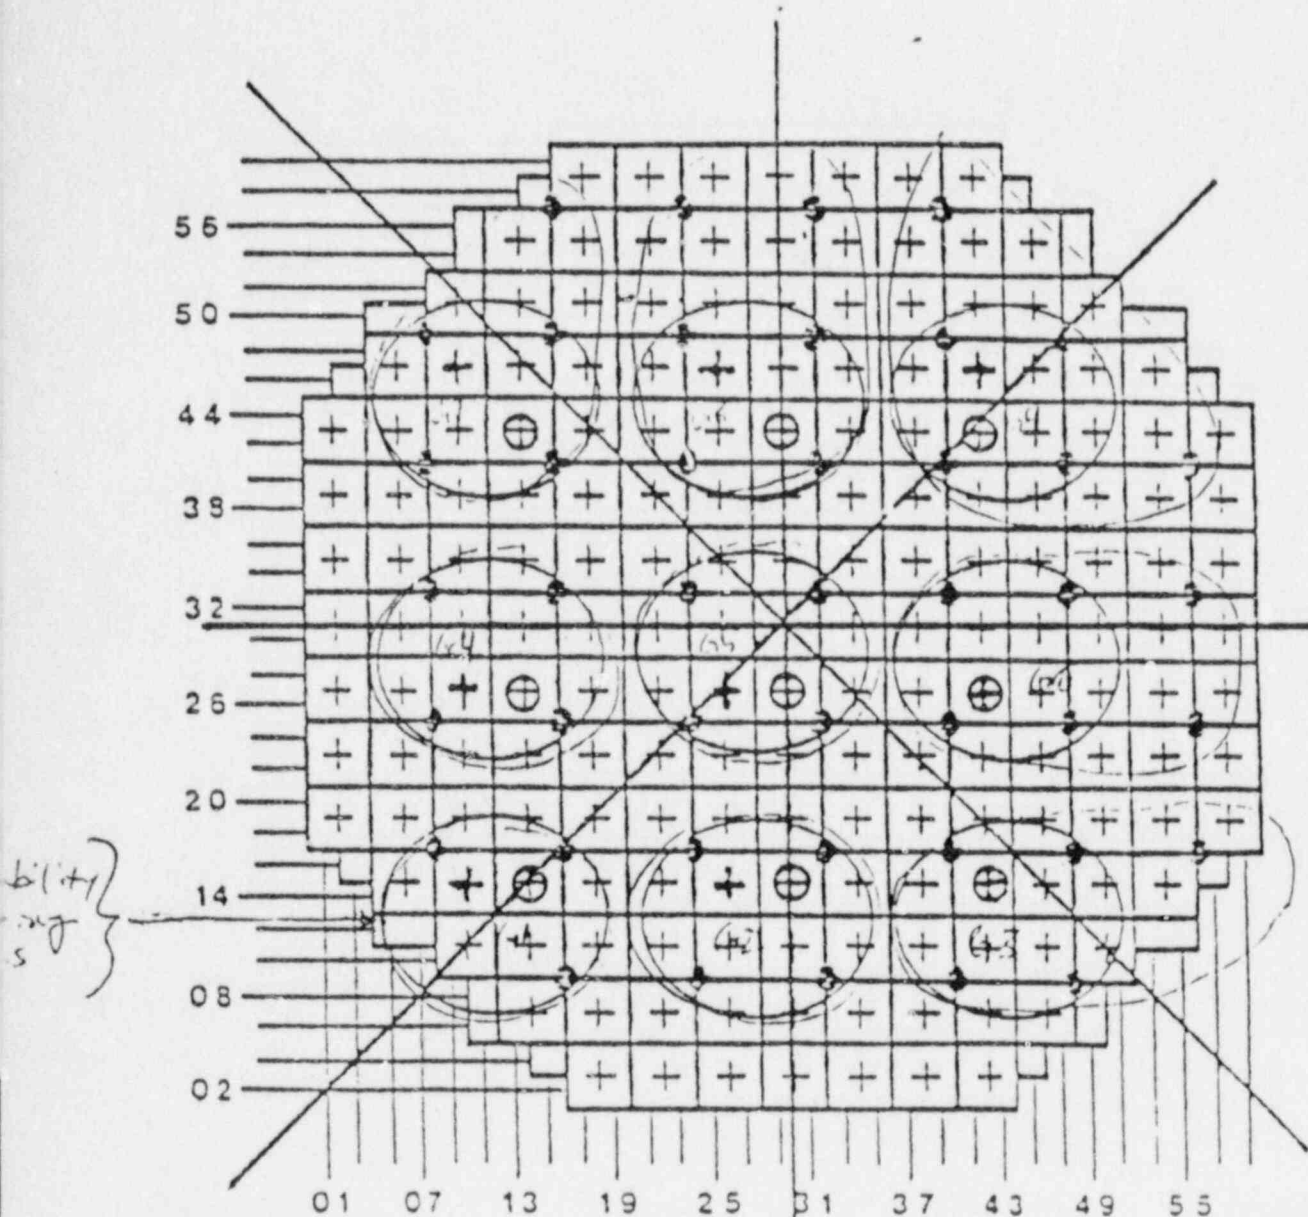
Figure 3

Selected Control Rods ⊕

TYPICAL LOCAL REGION MONITORING SCHEME

- b. After inserting control rods, frequently monitor the APRMs and monitor the local regions of the core by using the control rod select switch to display the various LPRM strings which surround the selected control rod. A minimum of nine control rods should be selected to adequately display LPRMs representing each octant of the core and the core center (Figure 3). If there is any abnormal increase in the expected signals, insert additional control rods to suppress the oscillations using the plant's prescribed control rod shutdown insertion sequence.

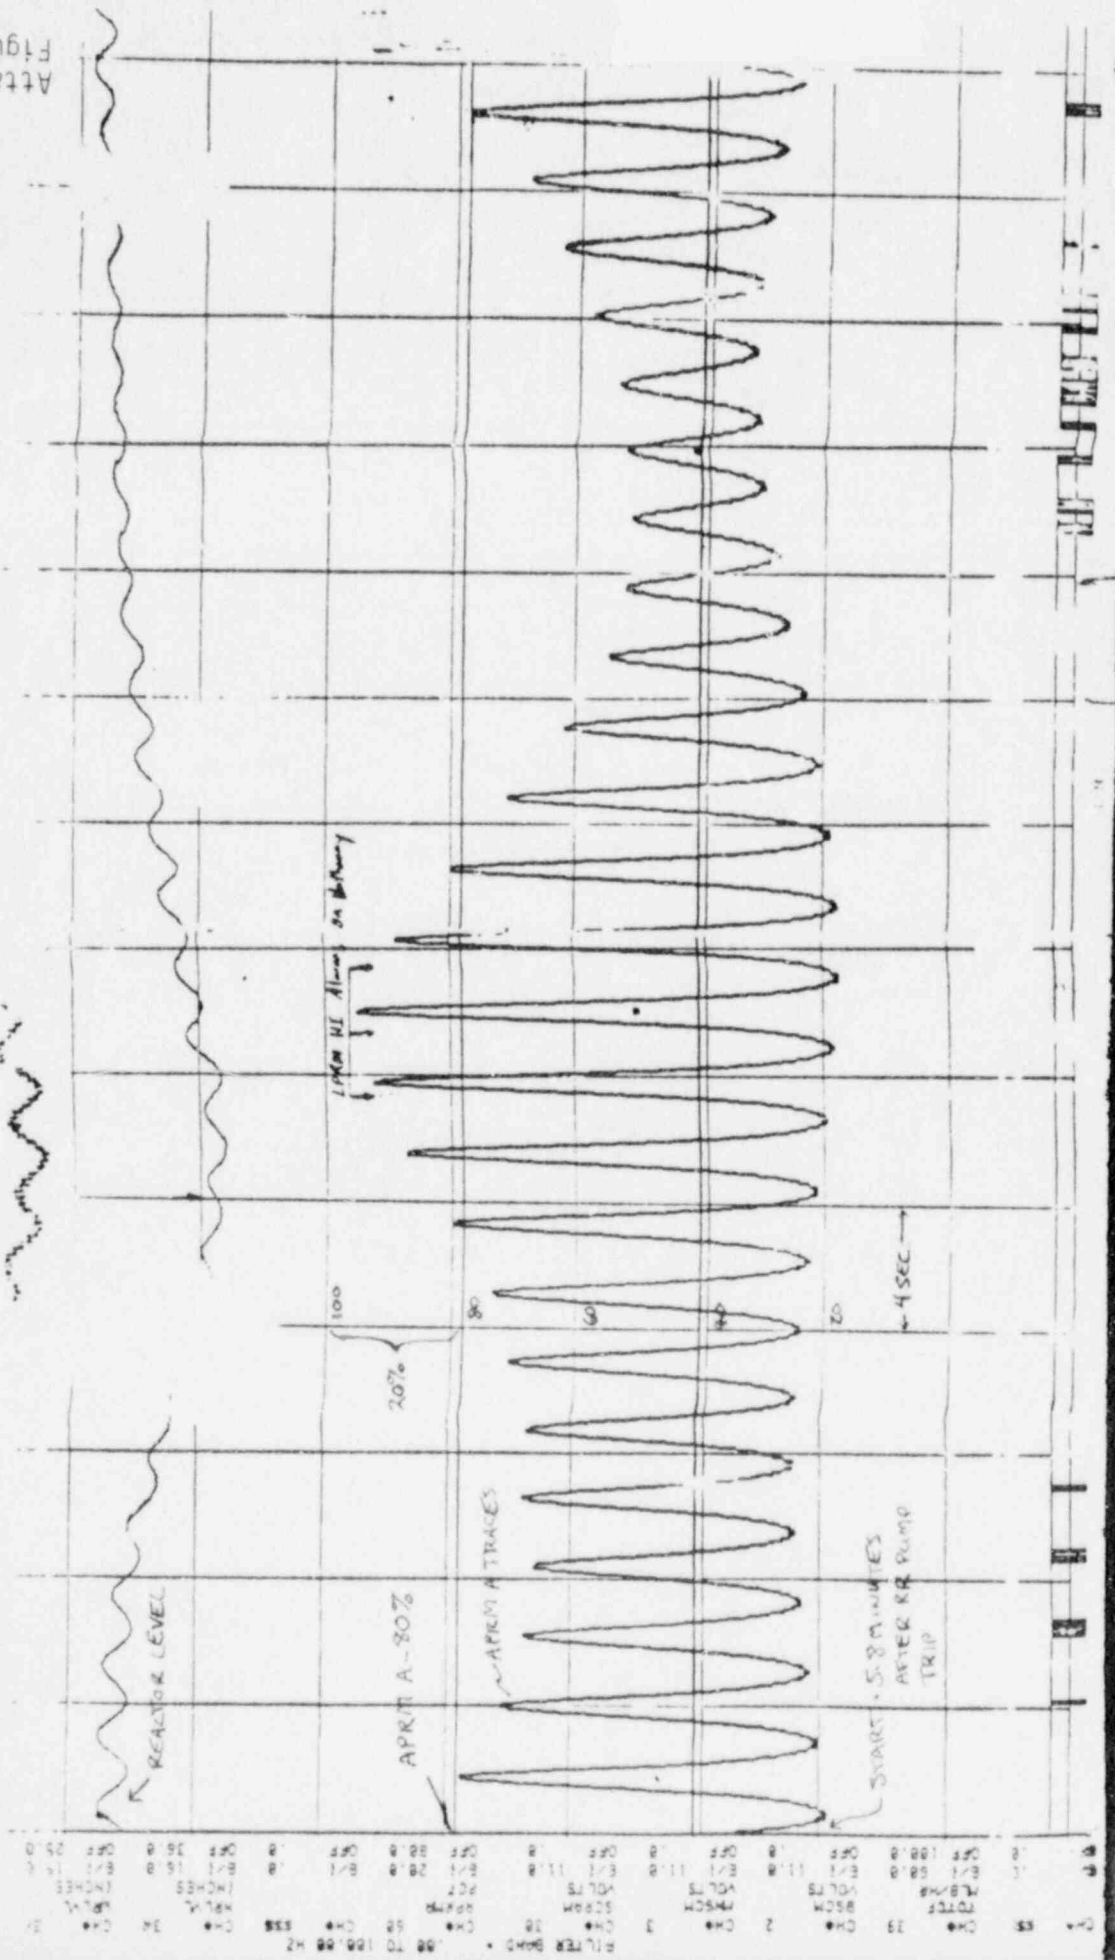
Attachment 3  
Figure 4

Startrec Traces - Oscillations
