Metallurgical Laboratory Note No. 85-990

Metallurgical Analysis of the 3A and 3C Wear Rings
Removed from the Residual Heat Removal Pump Impellers,
Peach Bottom Unit #3

Testing & Laboratories Division

January 8, 1986

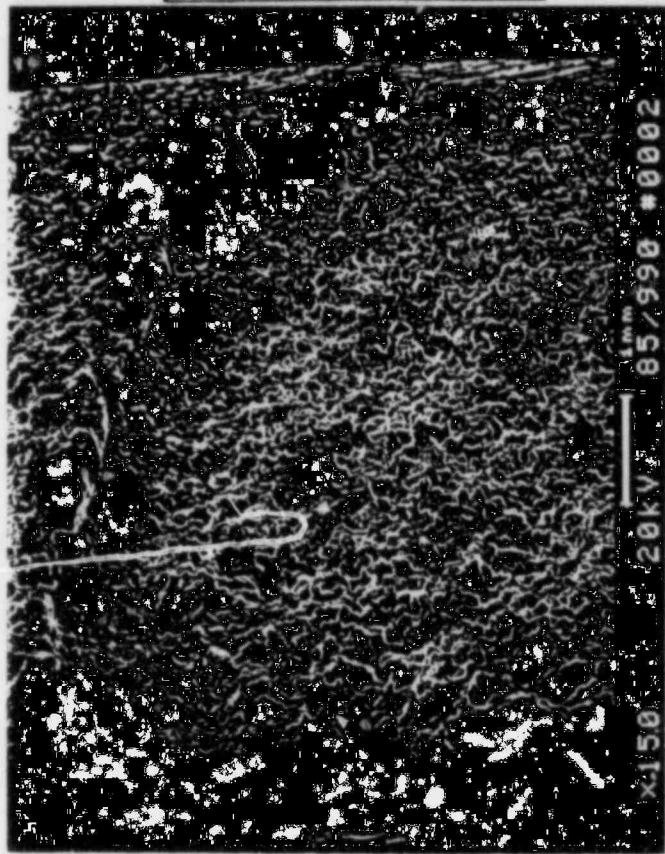
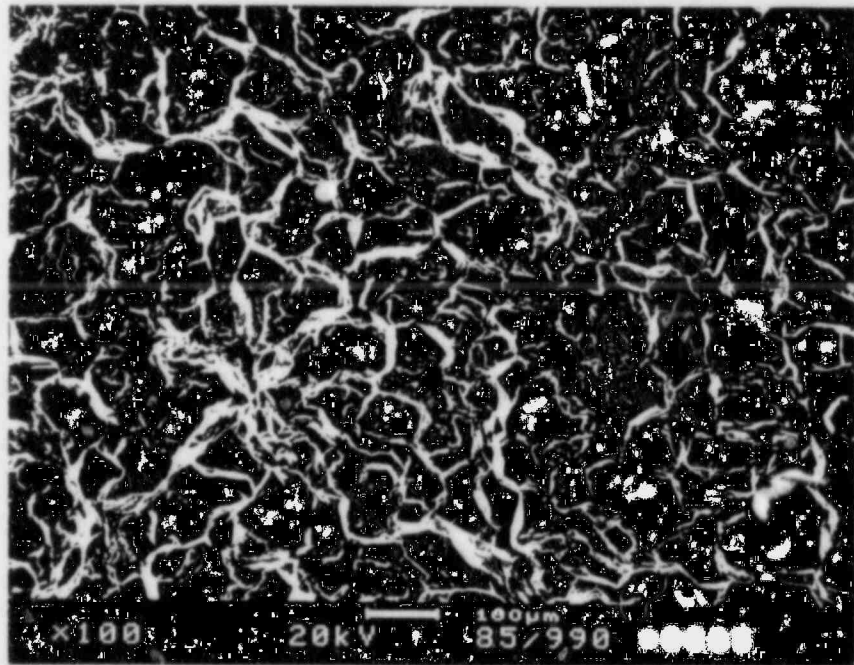
FIGURE ⑩

OD to Volute case.

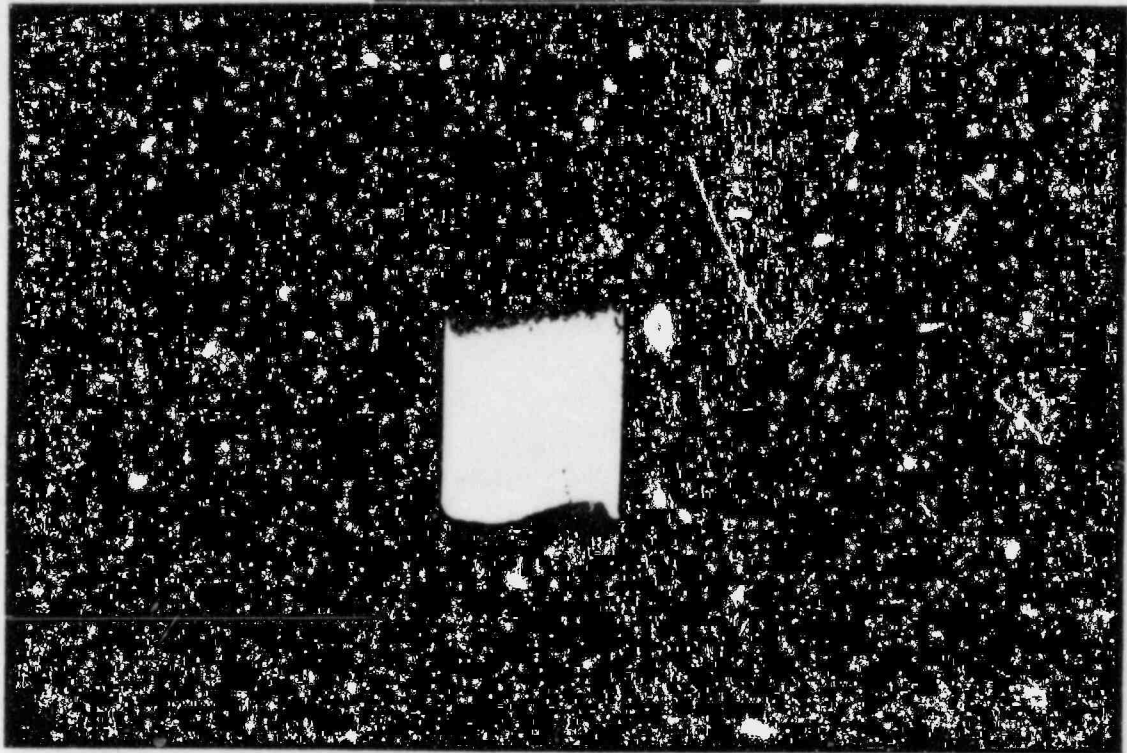
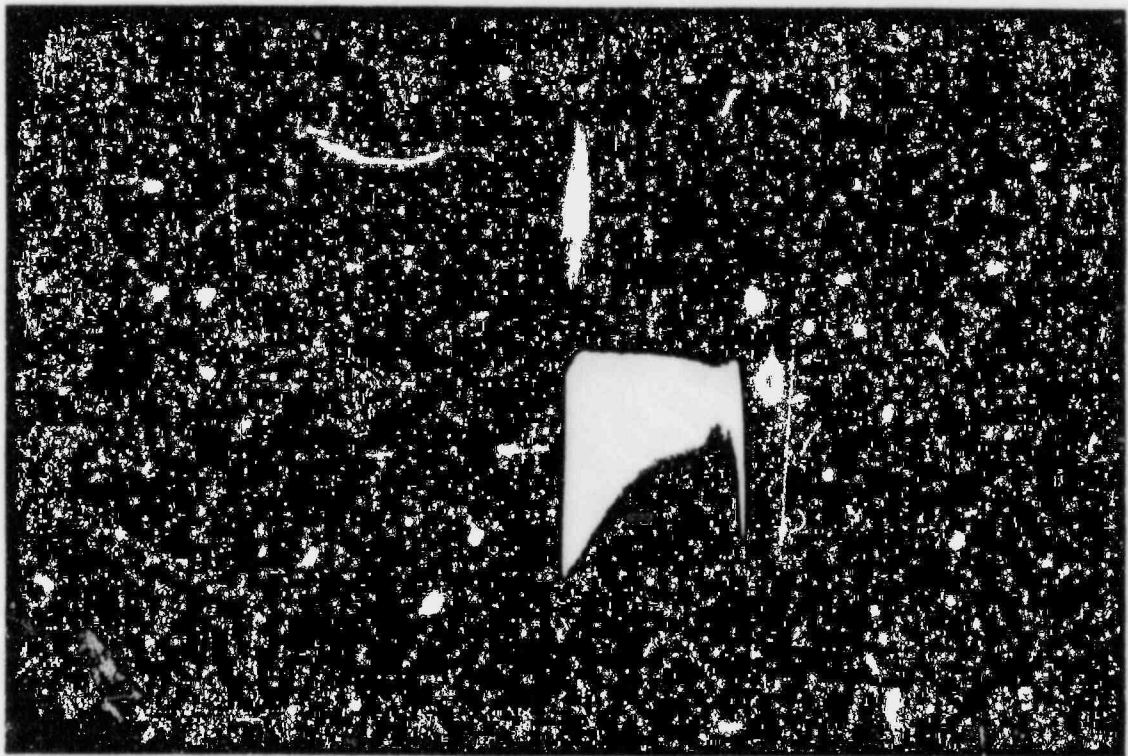
FIGURE ⑪

Additionally, several parallel cracks adjacent to the main fracture were observed on the wear ring O.D. surface. The pattern of these cracks was reported as being similar to that of grinding cracks.

CRACKING FROM MAIN FRACTURE

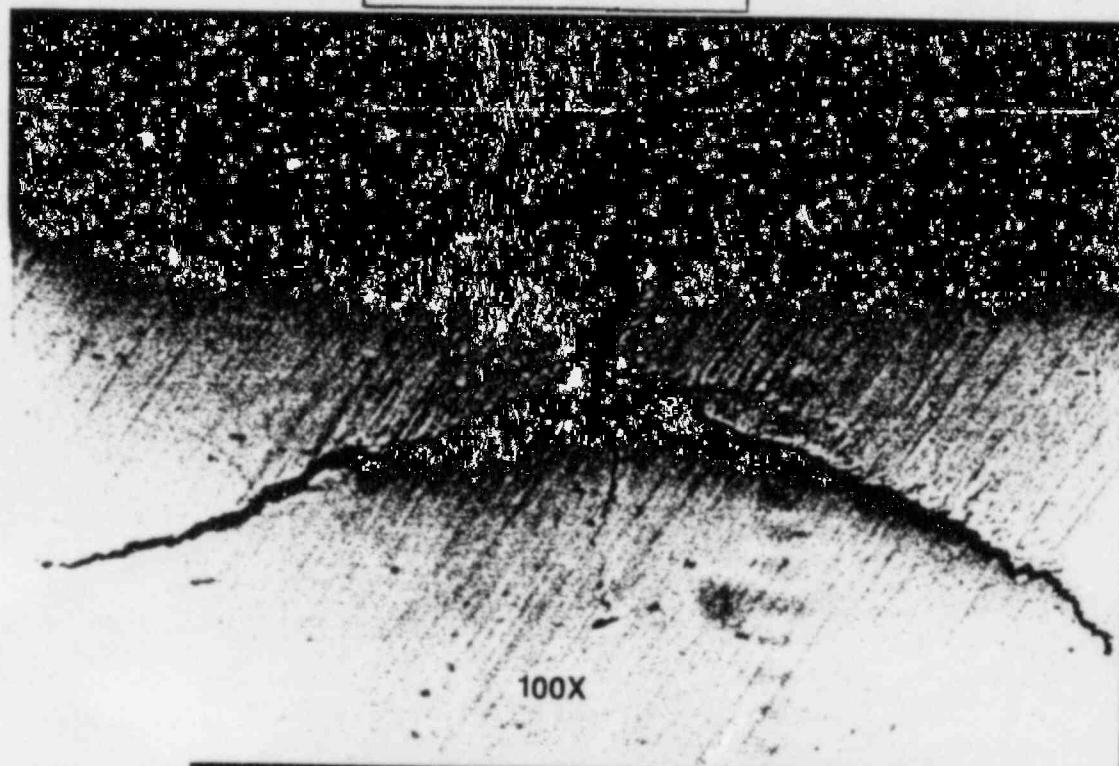
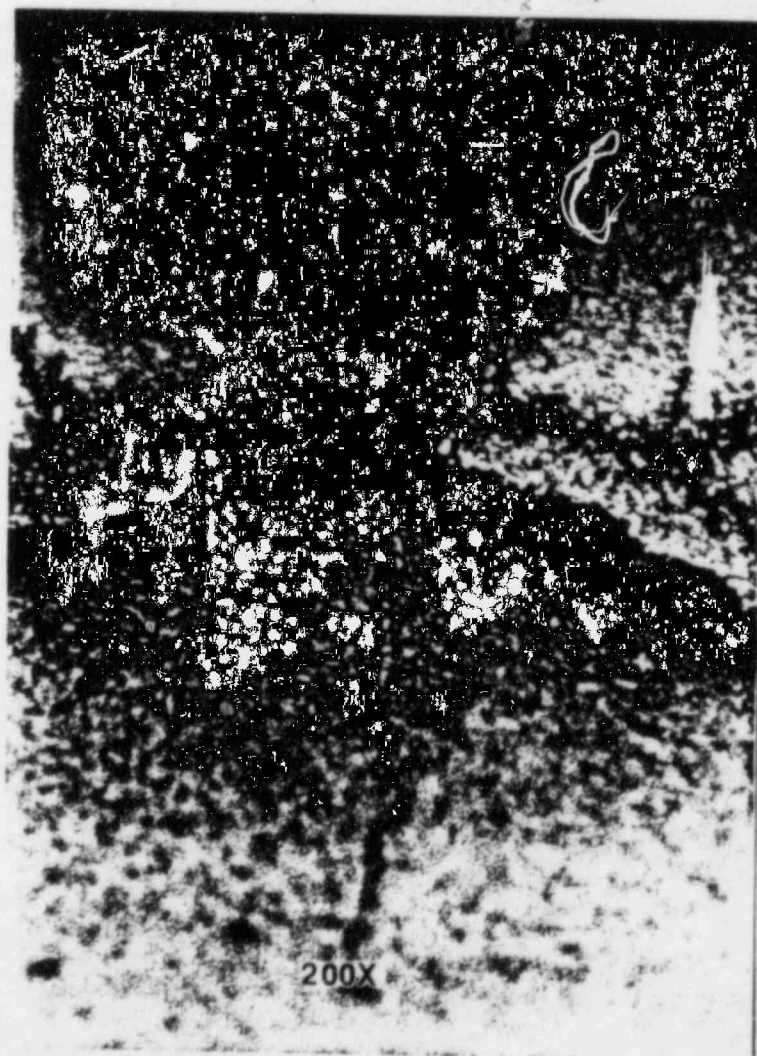
FIGURE 15

4. Debris within the O.D. surface discontinuities and corrosion deposits on the fracture surface were examined by x-ray microprobe. The presence of harmful contaminants were not detected. (Figures 6 & 7)
5. The material was verified to be ASTM A182 grade F6A (410) as specified by Bingham-Willamette. (Figure 8)
6. The mode of fracture, observed by electron microscopy and metallography, was intergranular cracking. (Figures 9 & 10)
7. The O.D. of the wear rings contained undesirable indications which appeared to be folds or laps typical of a machining operation and possible quench cracks from fabrication heat treatment. (Figures 11, 12, 13, & 14)
8. The microstructure was characteristic of a 410 Martensitic stainless steel in the quenched and tempered condition. There was no evidence of elongated or worked grains on the I.D. or O.D. surface. (Figure 15)
