# Loss of Integrated Control System Power and Overcooling Transient at Rancho Seco on December 26, 1985

U.S. Nuclear Regulatory  
Commission

## ABSTRACT

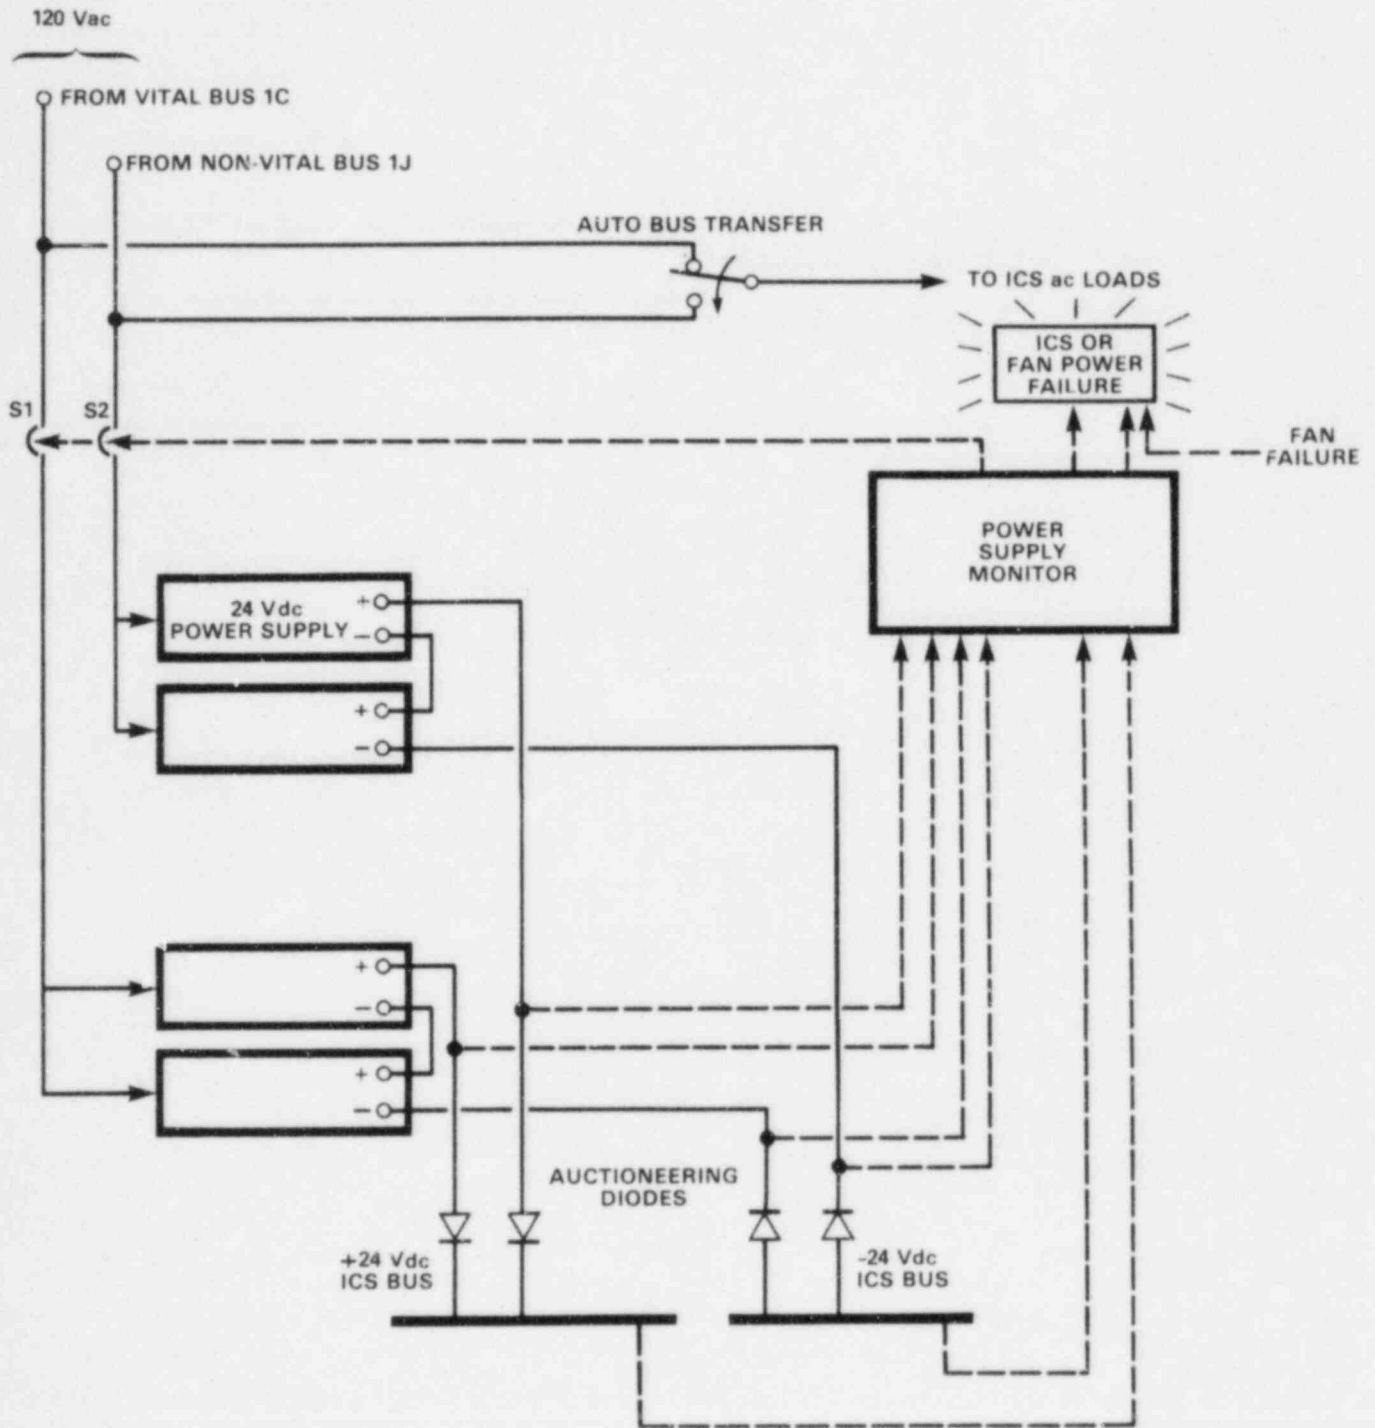
Figure 3.5 ICS direct current power supplies

Apparently, when the STA investigated the loss of ICS power, he did not adequately understand the system configuration. As can be seen in Figure 3.5, with power still available on the 1C bus (i.e., the ABT had not transferred) and the ICS dc power supplies de-energized, the most credible cause for the ICS power failure was the opening of switches S1 and S2.

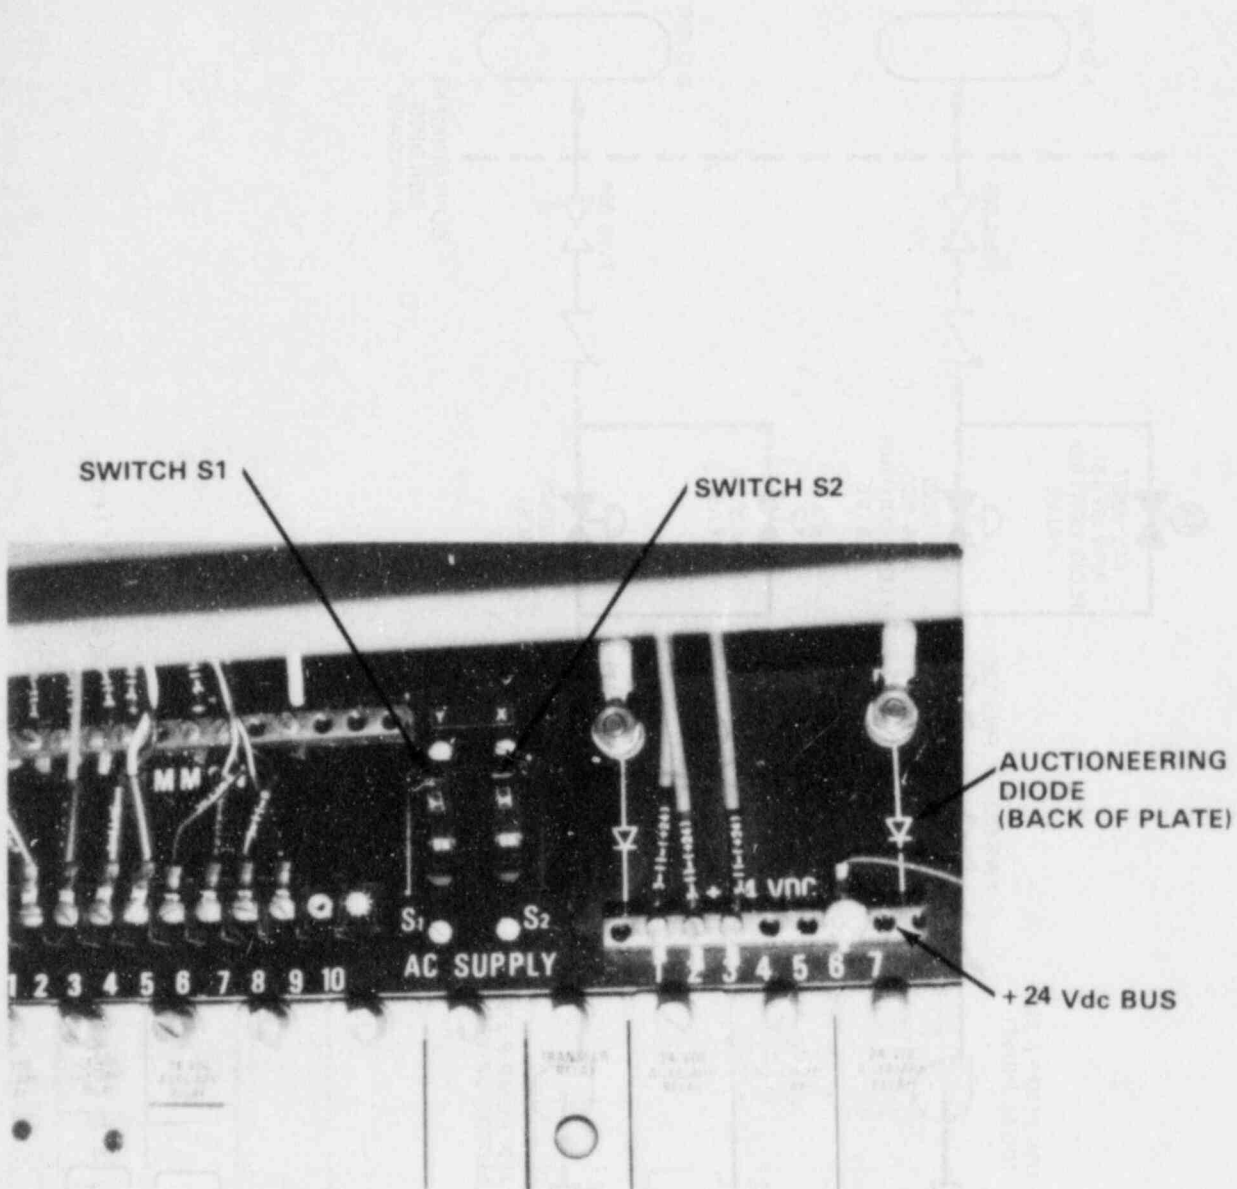
Figure 3.7 ICS power switches S1 and S2

The loss of the ICS dc power was caused by a failure in the ICS power supply monitor which opened the two switches (S1 and S2) which supply 120 Vac power to the ICS.

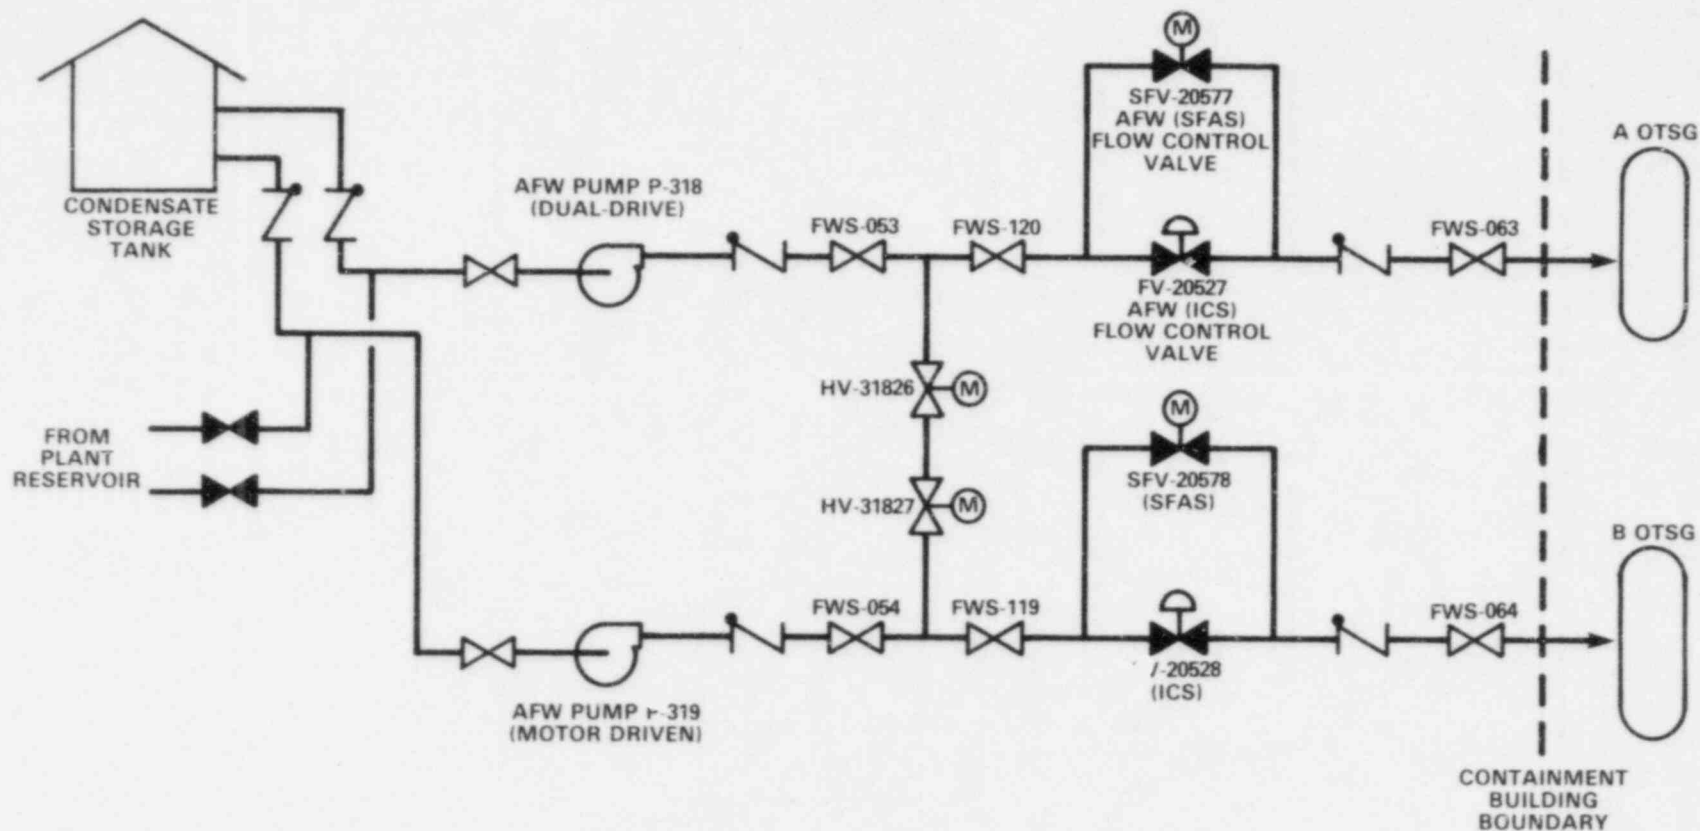
Figure 3.8 Auxiliary feedwater system (simplified)

When attempting to close the A AFW (ICS) flow control valve, the operator encountered more resistance. The AFW system configuration may have contributed to this difficulty. The pump discharges are cross-tied through HV-31826 and HV-31827 (See Figure 3.8). Thus, closing the AFW flow control valve to one OTSG apparently shifted much of the flow to the other OTSG line. Therefore, the increased flow might have contributed to his difficulty in closing the A AFW (ICS) flow control valve compared with the B AFW (ICS) flow control valve, although the valves are designed to be flow balanced. The reason for this difficulty has not been determined.

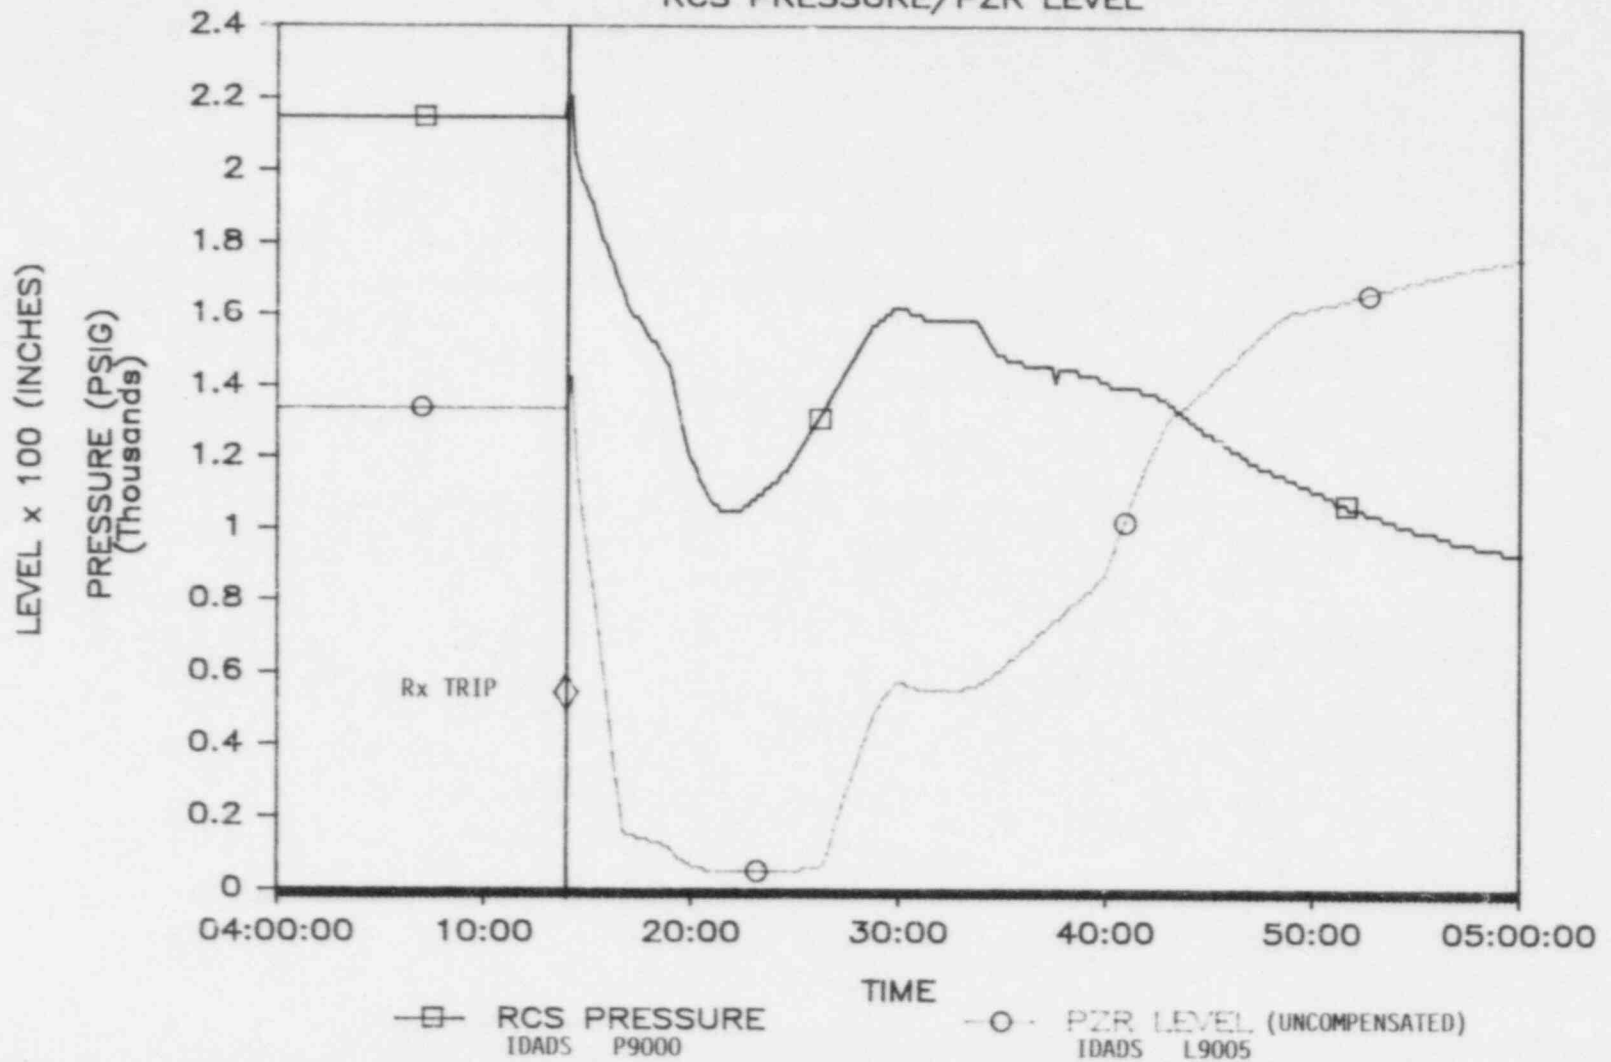
Figure 4.1 RCS pressure/pressurizer level from 4 a.m. to 5 a.m. on December 26, 1985

The mass balance showed that the pressurizer emptied at approximately the same time that a sharp drop in RCS pressure began to occur at 04:19 a.m (see Figure 4.1). During this time, the surge line flow was steam which was condensing in the hot leg and/or OTSG.

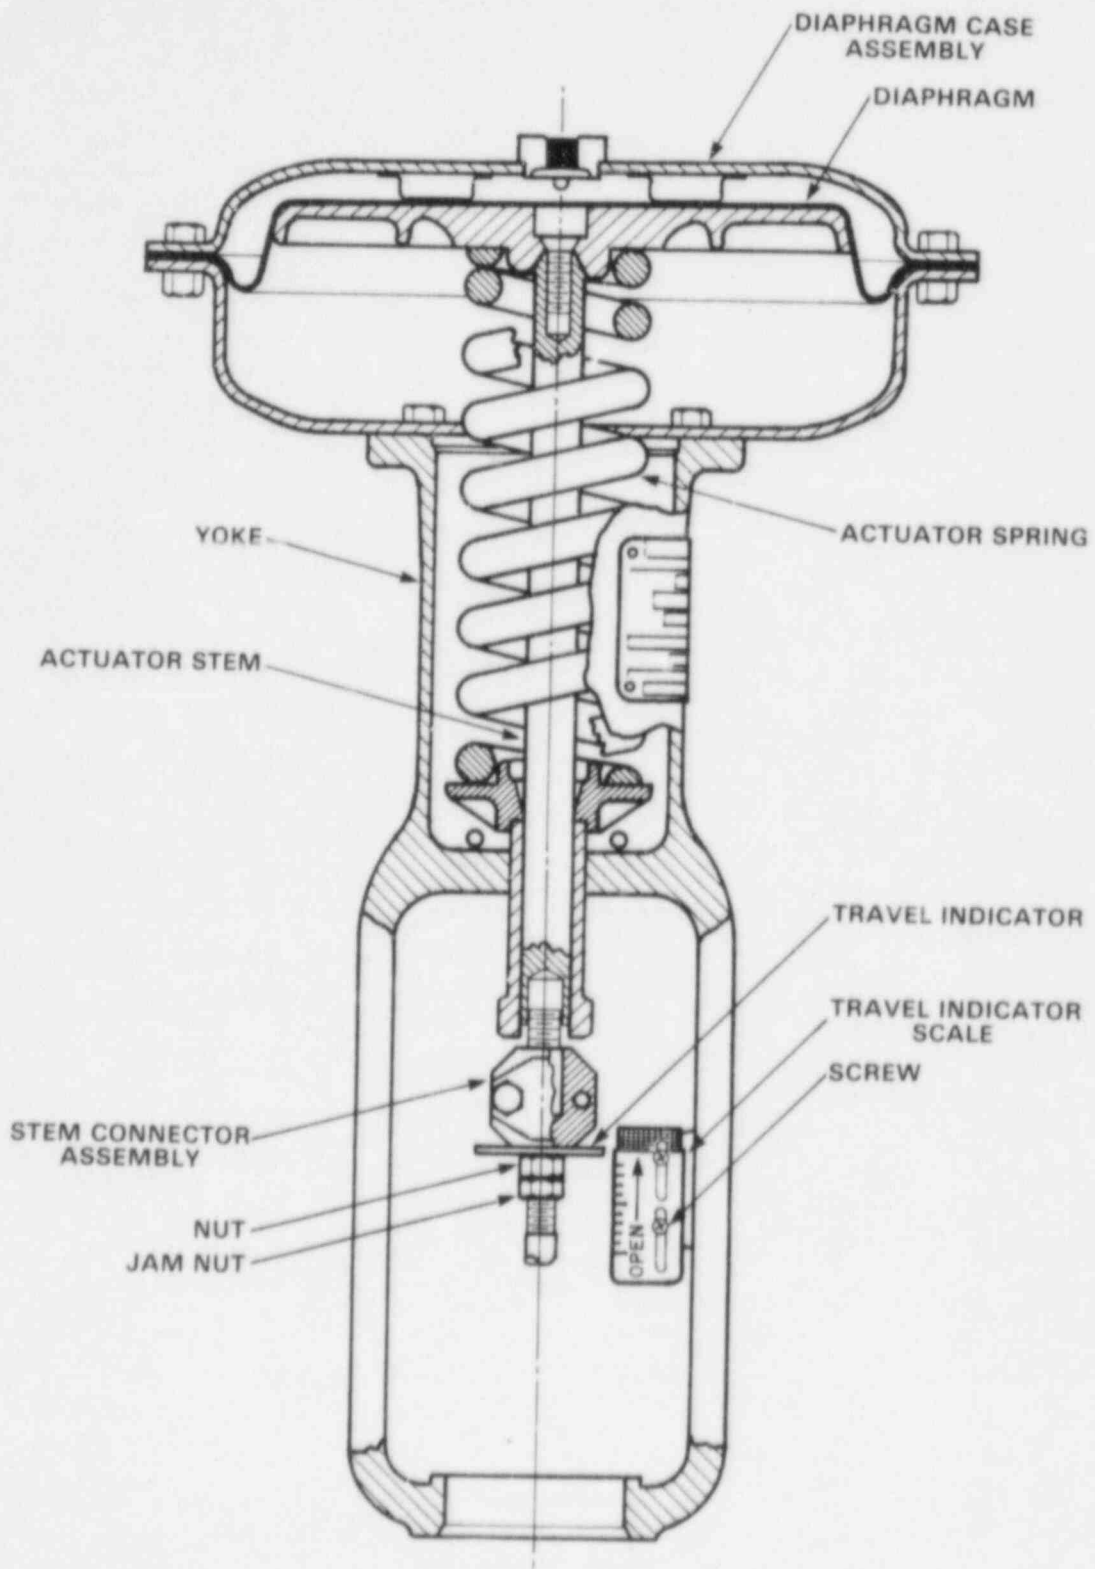
Figure 5.1 AFW(ICS) flow control valve

AFW (ICS) flow control valves, are direct-acting, spring-opposed, and air-actuated (See Figure 5.1). SMUD representatives have stated that the entire AFW system is safety related. However, it is obvious that these valves are not fully safety related because they are controlled by the nonsafety-related ICS. The valves use a Fisher diaphragm actuator and have a valve stroke of 2 inches. Air is supplied to the top of the diaphragm. A travel indicator is attached to the valve stem and a travel indicator scale is mounted on the valve actuator yoke (see Figures 6.2 and 6.3). The indicator consists of two horizontal discs attached to the valve stem by a nut and a jam nut. The indicator scale is graduated vertically, with an arrow pointing upward to the open position. The closed position is not specifically labeled on the scale. However, the bottom mark on the scale corresponds to the closed position.

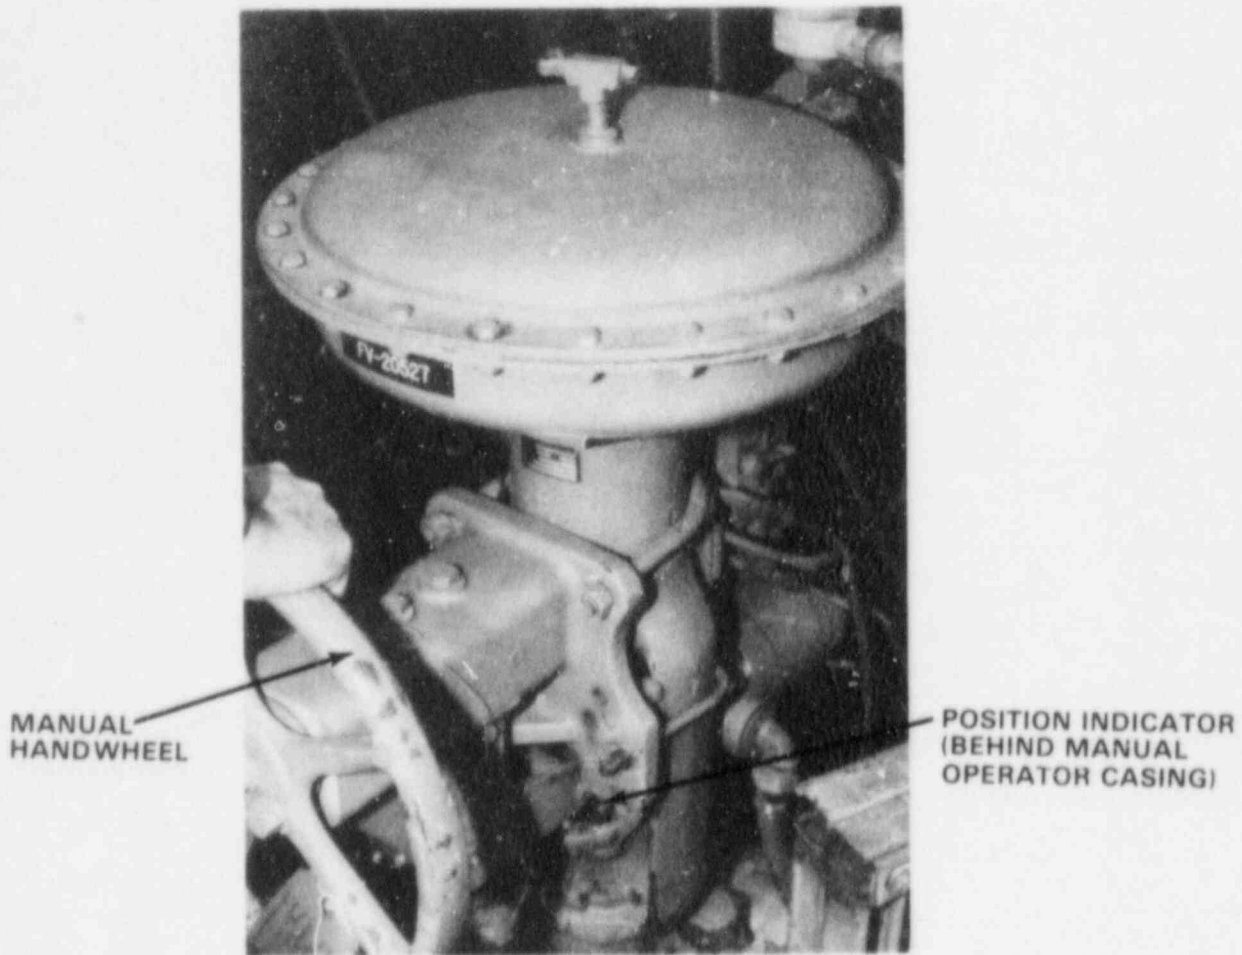
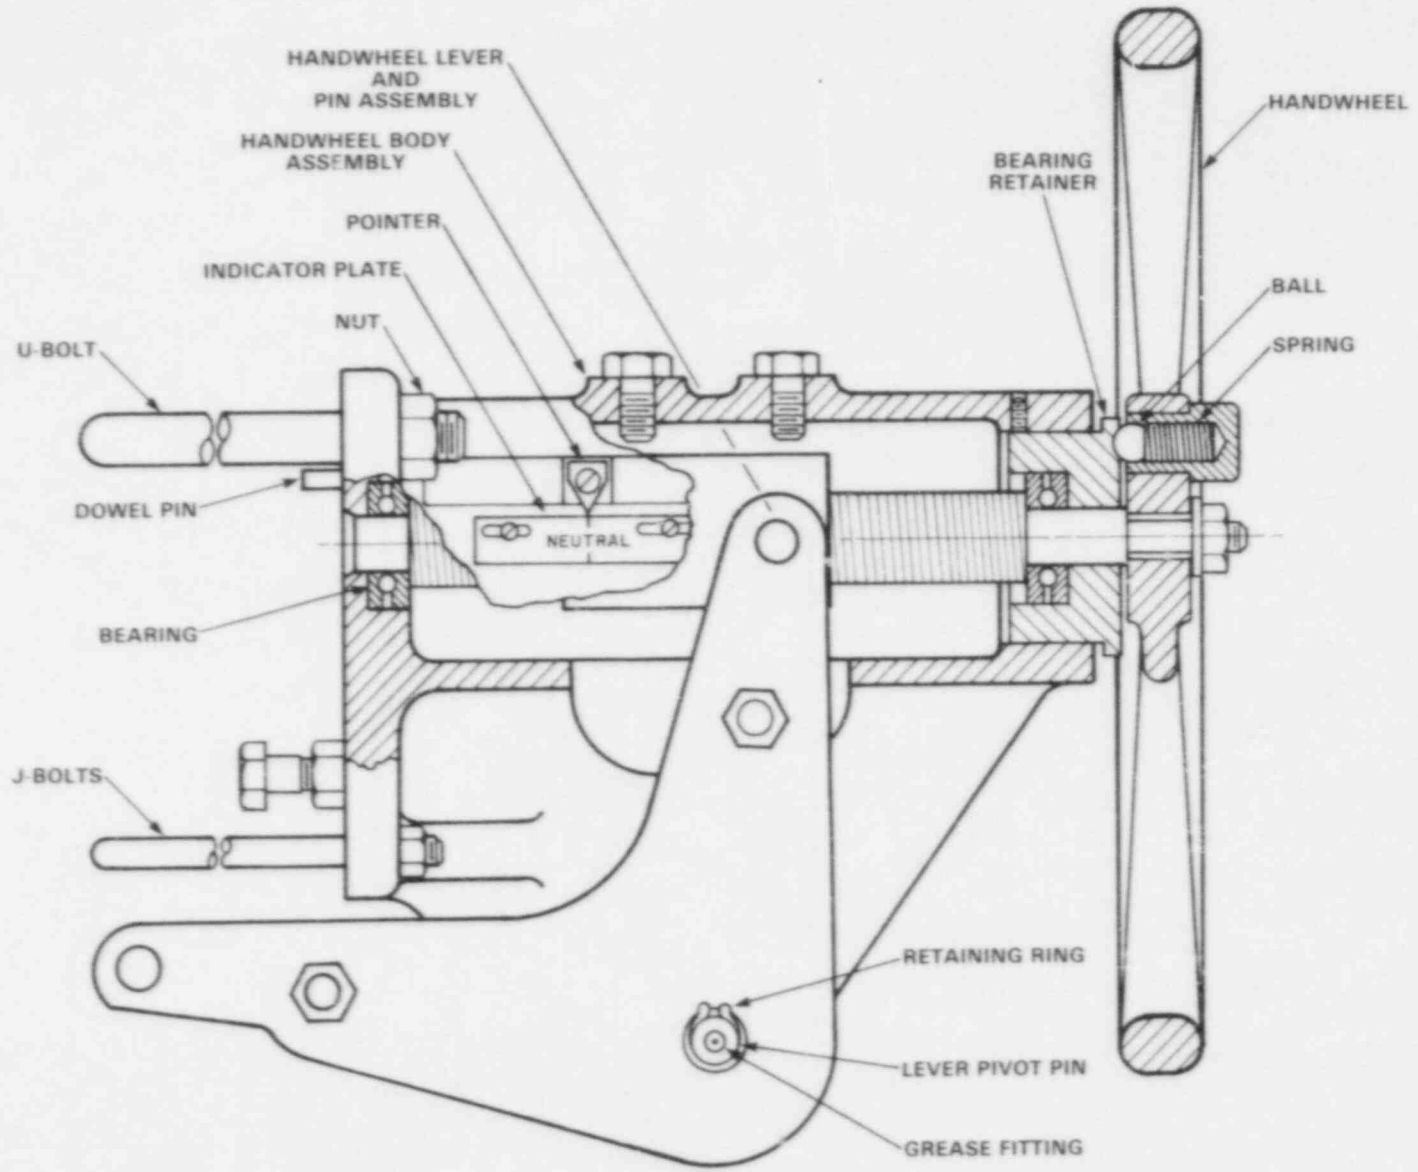
The valves are furnished with a side-mounted handwheel assembly (see Figures 5.2 and 5.3). The handwheel assembly is attached to the actuator yoke by a U-bolt and two J-bolts. A lever and pin assembly couples the handwheel to the valve stem. Two dowel pins are provided to ensure the handwheel is properly positioned on the yoke. A "neutral" position indicator is provided, indicating the handwheel position at which automatic operation of the valve is possible over full range of valve travel. When the handwheel is positioned at any other point than "neutral," automatic full travel will be restricted in one direction.

Figure 5.2 A AFW(ICS) flow control valve (FV-20527)

Figure 5.3 AFW(ICS) flow control valve manual operator

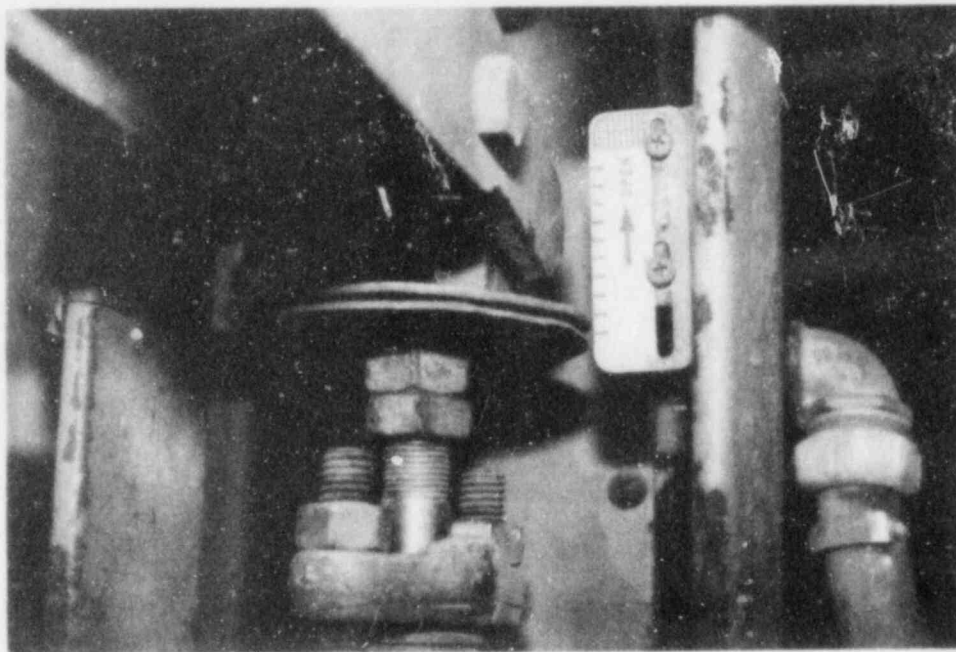
Figure 6.2 Position indication on AFW (ICS) flow control valve

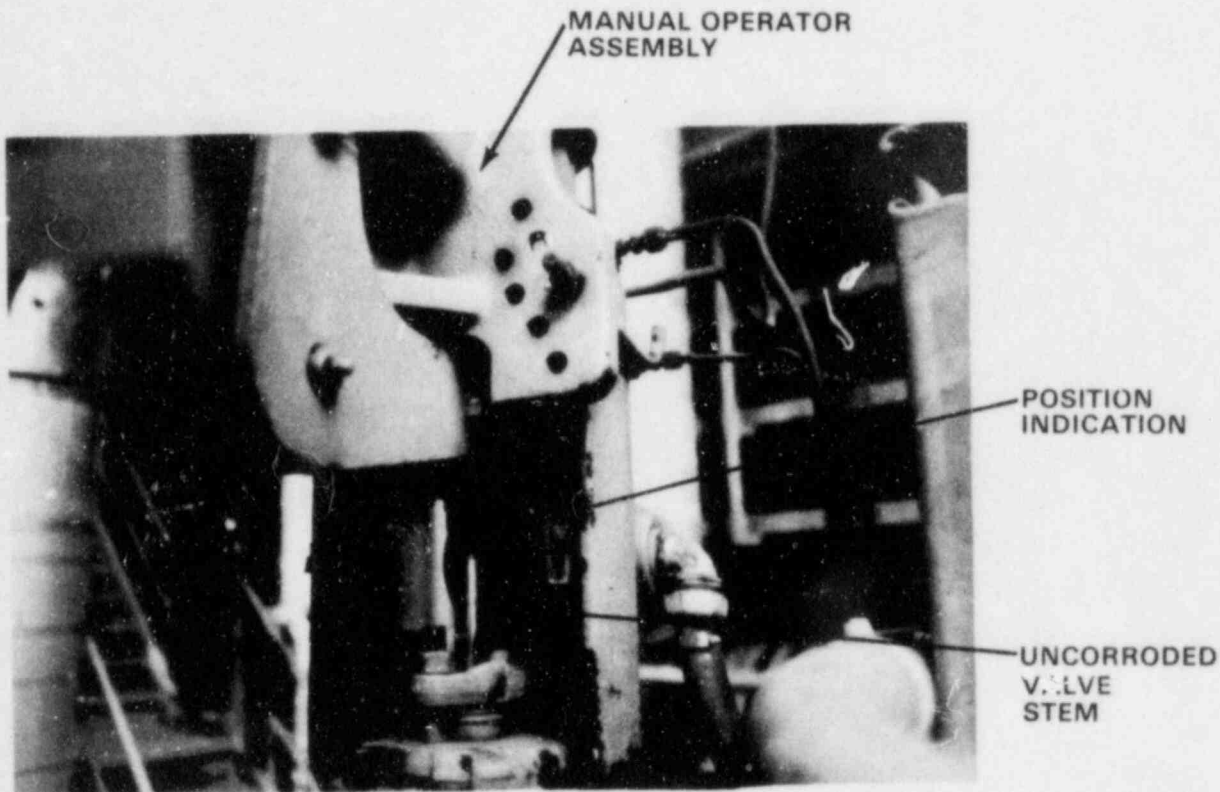
Figure 6.3 A AFW (ICS) flow control valve (FV-20527)

During this event, the nonlicensed operators were required to manipulate valves in the plant they had been trained to operate, one of which was the AFW (ICS) flow control valve to the OTSG. An operator did not accurately determine the position of the valve when using the manual handwheel mechanism to close the valve. Although position indicators are mounted alongside the valve stem, the operator did not use it to determine the valve position. Even if it had been used, the accuracy of the indicator is questionable because of the poor gradation and marking on the scale and the existence of a 1/8-inch separation between indicator discs (see Figure 6.2). In addition, the position indicator is located such that the operator cannot see it directly while operating the handwheel (see Figure 5.2). The valve stem, however, can be observed from the handwheel, and the operator chose to use the amount of visible uncorroded stem, instead of the position indicator gauge, as his indicator of the valve position (see Figure 6.3).

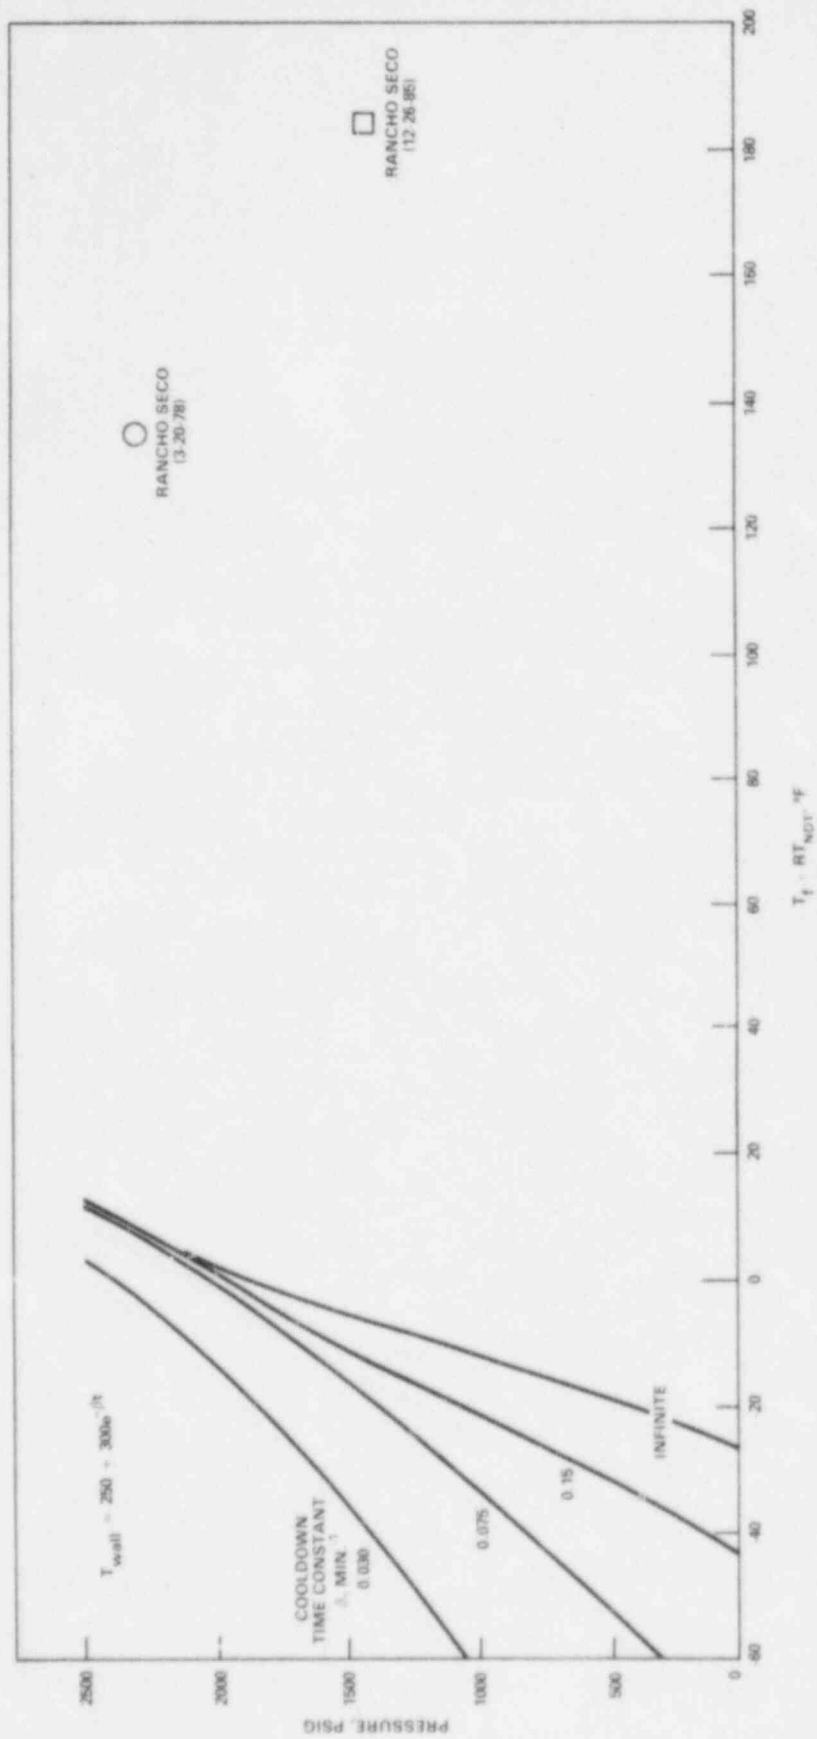
Figure 8.2 Critical values of pressure and  $T_f - RT_{NDT}$  for crack initiation in reactor vessels

rate-time constants, beta. If the final RCS temperature ( $T_f$ ) drops below the reference nil ductility temperature ( $RT_{NDT}$ ) at high pressure (upper left side of the figure), the initiation and/or propagation of cracks can take place in the vessel wall. The overcooling events at Rancho Seco which occurred on December 26, 1985 and March 20, 1978 are shown for comparison on Figure 8.2. For both transients, beta was approximately 0.05 to 0.1  $\text{min}^{-1}$ . For the cooldown which occurred on December 26, 1985, Figure 8.2 indicates that the critical RCS temperature was approximately 170°F. That is, the RCS temperature would have had to rapidly drop another 215°F (i.e., to an RCS temperature of 170°F) while maintaining pressure around 1400 psi to have seriously threatened reactor vessel integrity.

In another hypothetical scenario, the event proceeds, as it actually did, for 26 minutes, but ICS power is not recovered and no further actions are taken by the operators. Under these circumstances, calculations indicate that the RCS could have approached the critical area in Figure 8.2 in about another hour and a half.
